**NAPA COUNTY FIRE DEPARTMENT  
FIRE MARSHAL'S OFFICE**  
1199 Big Tree Road, St. Helena, CA 94574  
Phone #(707) 963-3601 Fax #(707) 963-1549

**Re: Fire Safety Analysis  
Lake Berryessa Resort Areas**

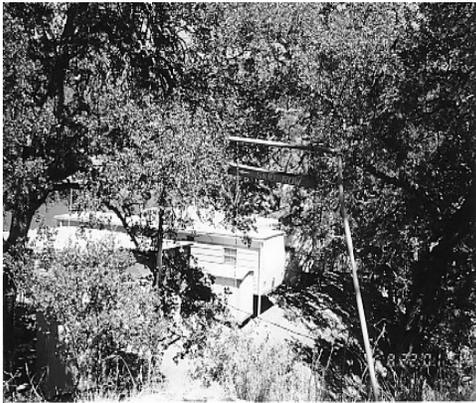
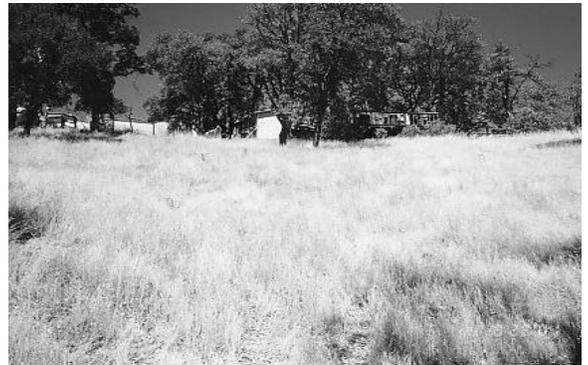
fire. During a recent inspection, dead trees and vegetation were found directly adjacent to trailers and outbuildings (figure 1 and 2) with zero clearance around the structures. Most of the LPG tanks inspected also did not have the required ten feet of clearance required by PRC 4291. PRC 4291 is enforceable for all existing structures in State Responsibility Areas (SRA).

The maintenance issues can be remedied with a limited amount of time and resources. Those remedies would include creating and maintaining defensible space and enforcing fire access road requirements by limiting parking on or about the roadways. The planning and development issues will require significant changes in the roadway and water systems in the resorts.

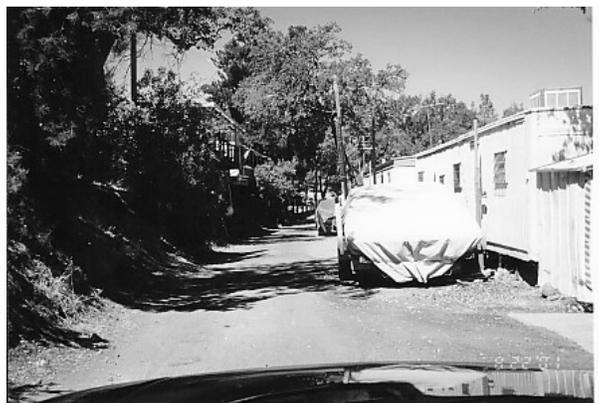
Figure 3

Access is a major fire protection need. Failure to provide a reasonable access for emergency equipment and civilian evacuation concurrently can result in a major loss of life, property and natural resources. Section 15.32.410 of the Napa County Fire Code (NCFC) requires that Fire Apparatus access roads shall have an unobstructed width of not less than 20 feet and an unobstructed vertical clearance of not less than 15 feet. These minimum requirements shall not be obstructed in any manner, including parking of vehicles (figure 3). A fire engine, sitting at an intersection,

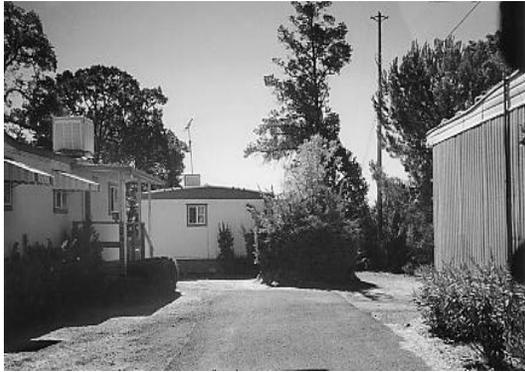
Figure 4

Many of the roadways in the resorts, due to narrowness, obstacles and turns make them inaccessible to fire engines. The turning radius on many of the roads, make traversing them difficult. Responding fire apparatus has to drive past a road and then turn around to gain access. Dead end roads, within the resorts, also do not comply with today's codes (figure 4). Dead-end roads are required to have turnarounds for large equipment in the form of either a hammerhead T or terminus
