# Lake Tahoe Dam

## Overview

## Lake Tahoe Dam Rehabilitation Study

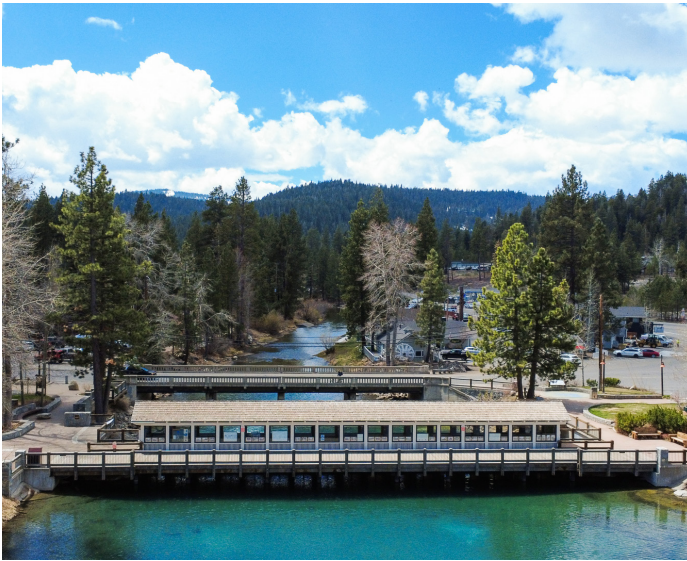
*Lake Tahoe Dam*

Lake Tahoe Dam is a concrete spillway structure measuring 18.2 feet high and 109 feet long. It includes 17 adjustable rectangular gates capable of releasing a maximum of 2,100 cubic feet per second of water into the Truckee River. While Lake Tahoe's natural rim is at an elevation of 6,223 feet, the dam allows for the controlled storage of water up to 6,229.1 feet, providing about 744,600 acre-feet of storage capacity. The dam controls the top 6.1 feet of Lake Tahoe and regulates the lake outflows into the Truckee River, supporting a range of downstream needs.
