— BUREAU OF —
RECLAMATION

October 2020 Boca Dam Construction Photos

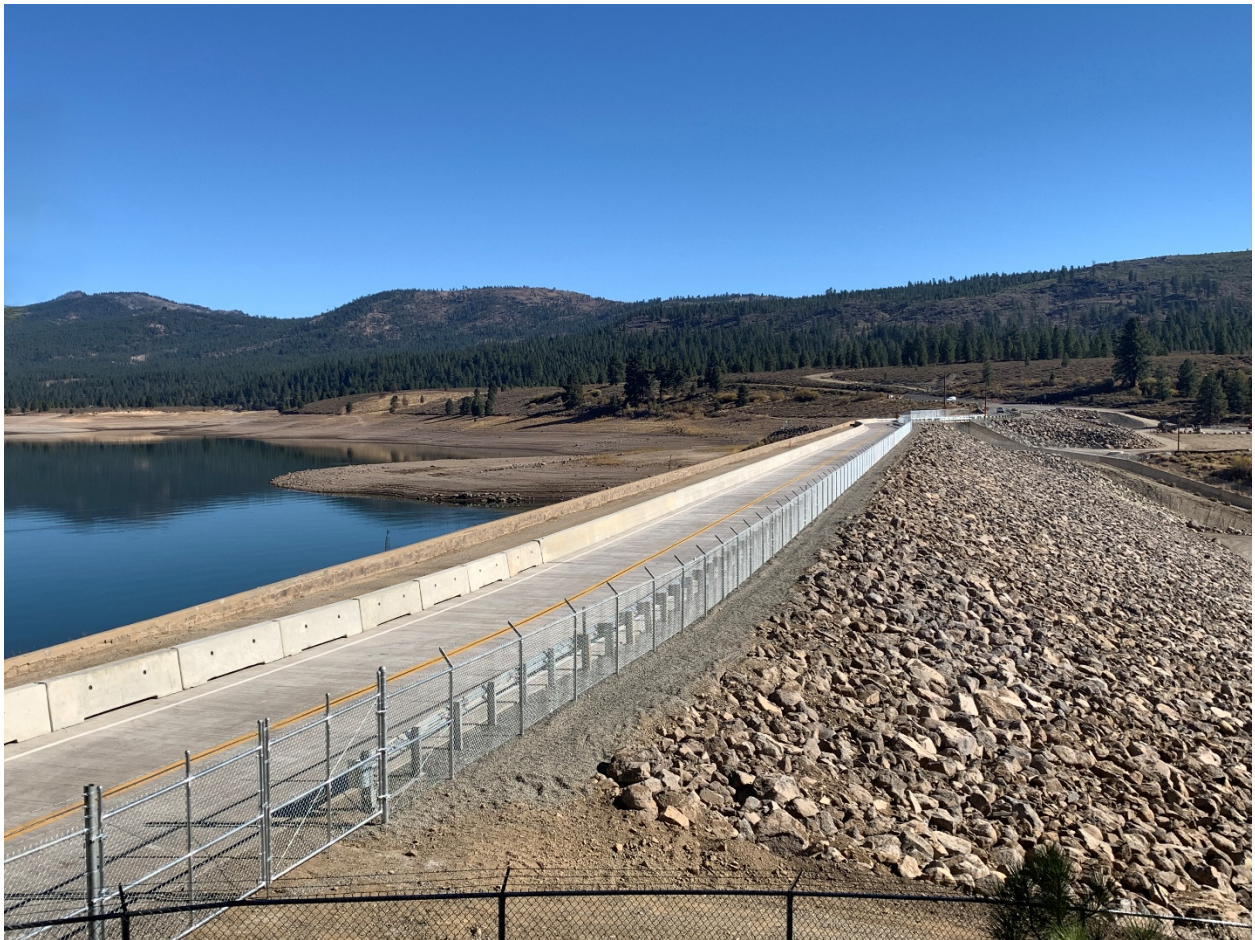
View of completed Boca Dam Reservoir Road and embankment.

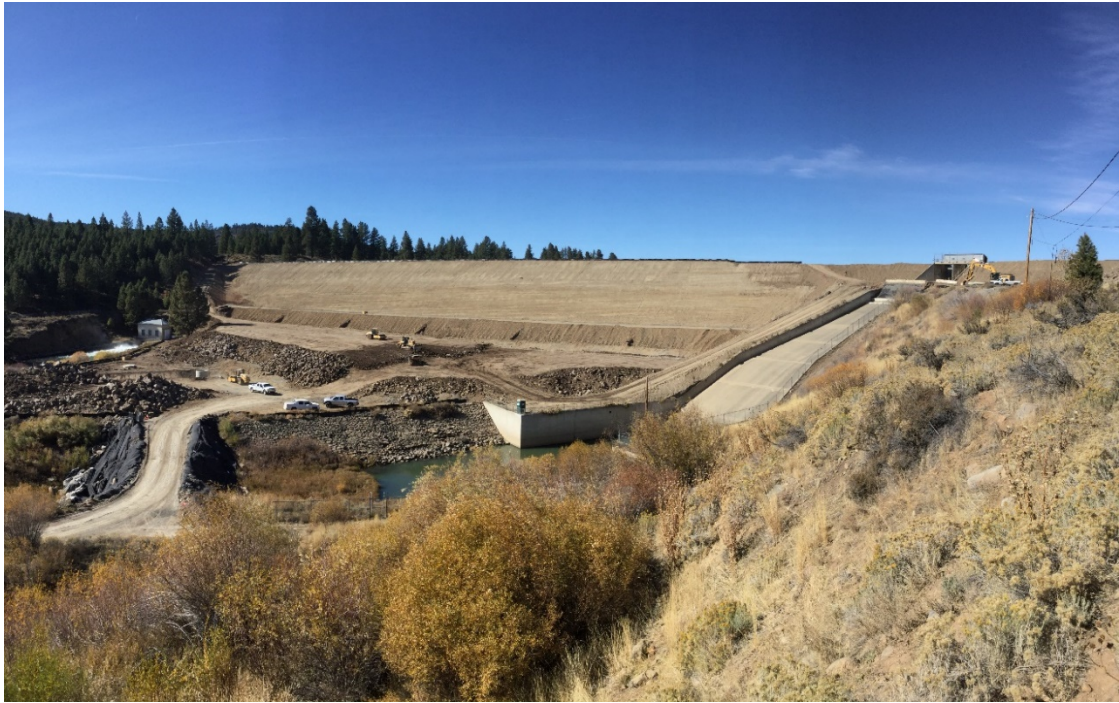
Construction of stability berm in progress

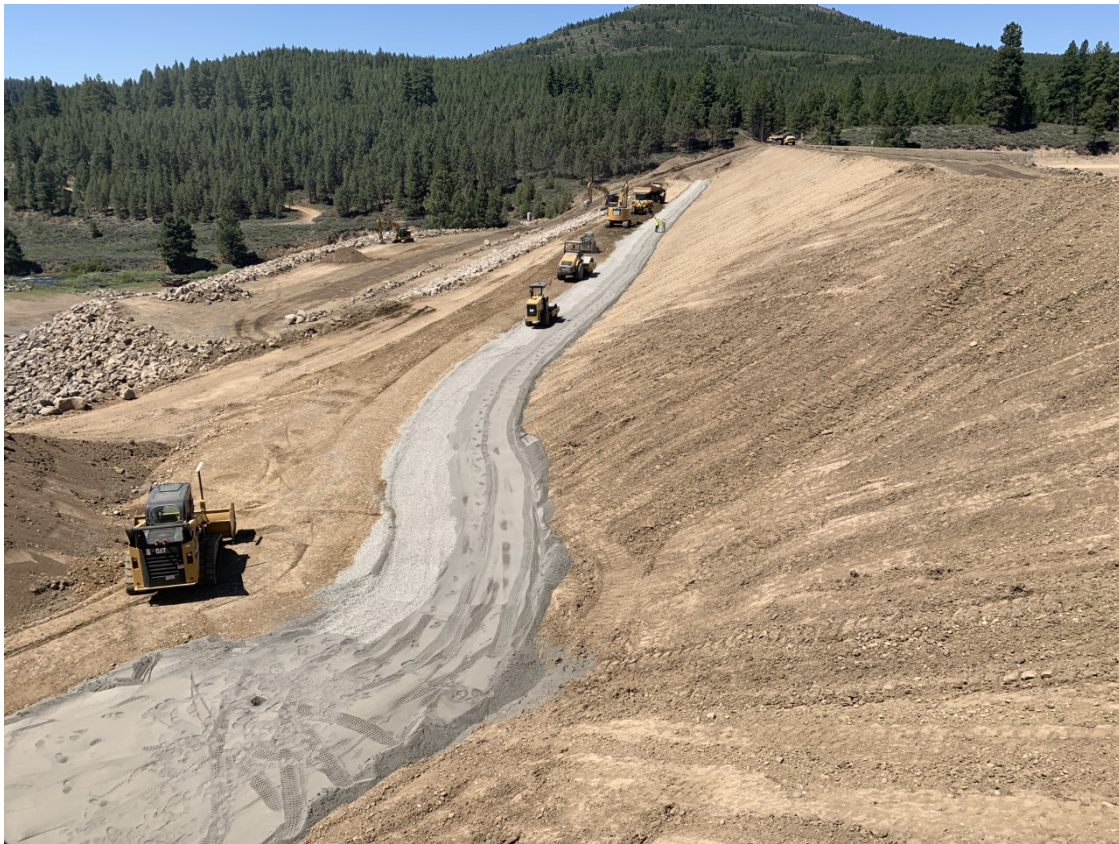
Construction of filter zones at Boca Dam; filter zones layer filter sand against existing embankment, followed by drain rock. The filter zone is then encapsulated with in-reservoir-borrow material.

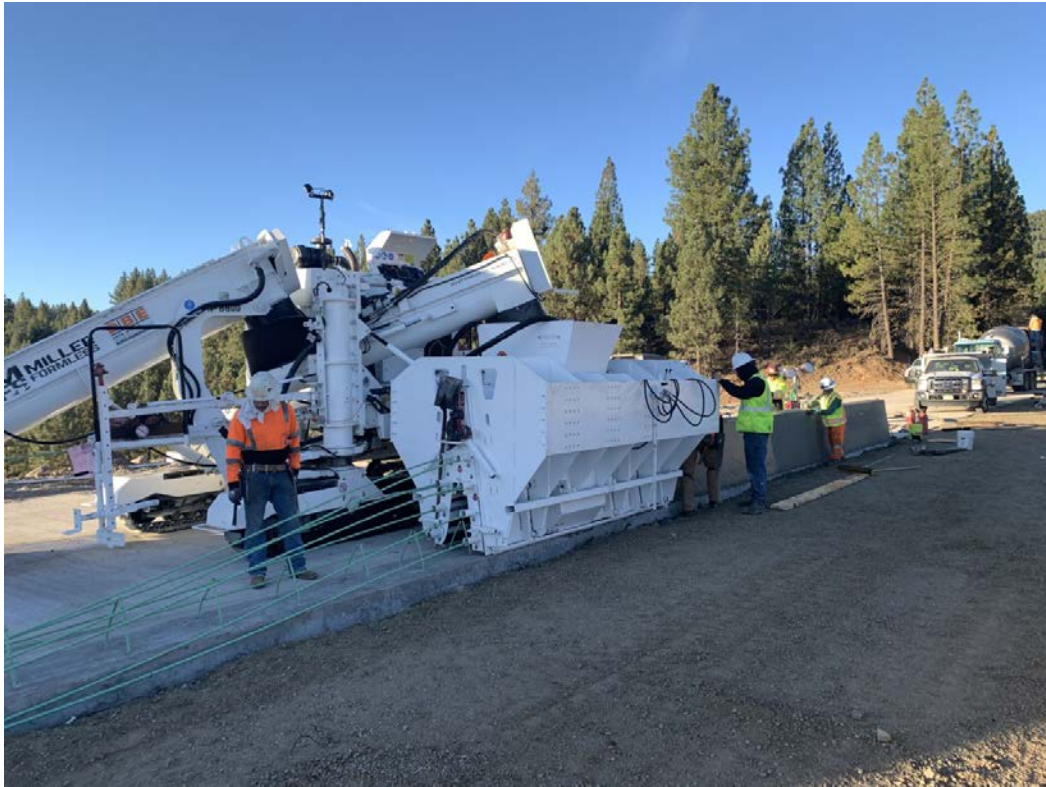
Concrete barrier placement using slip form method; this method places concrete into a continuously moving form.

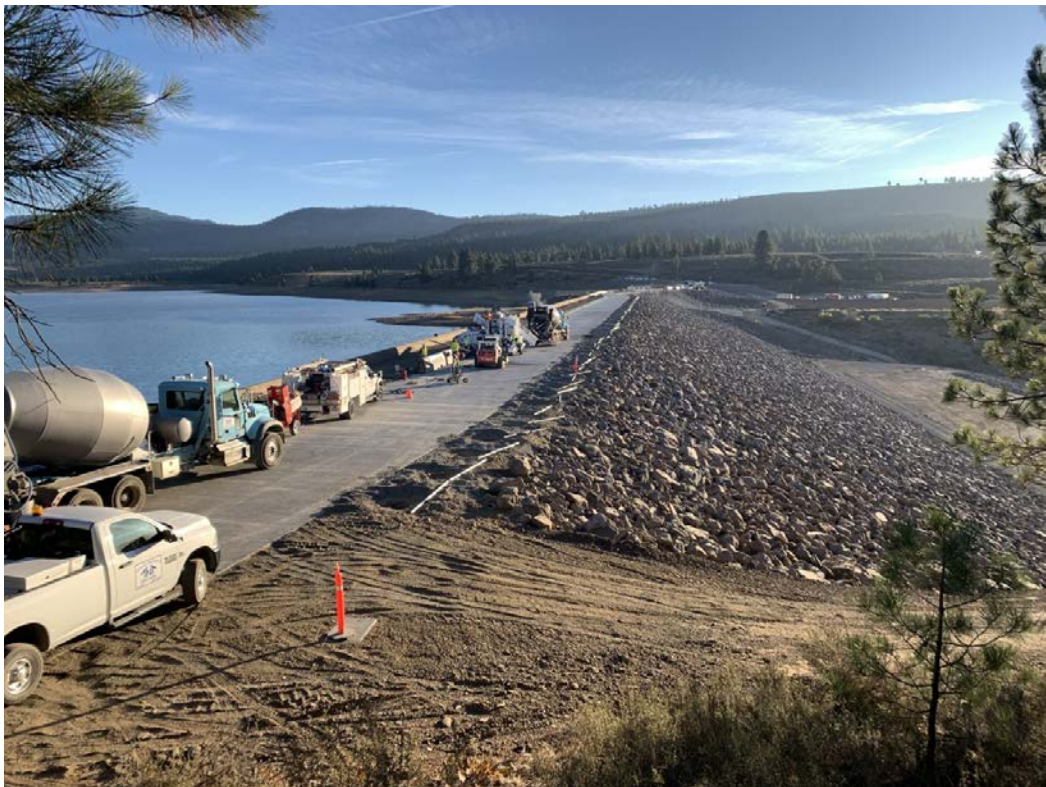
Construction of concrete barrier in progress

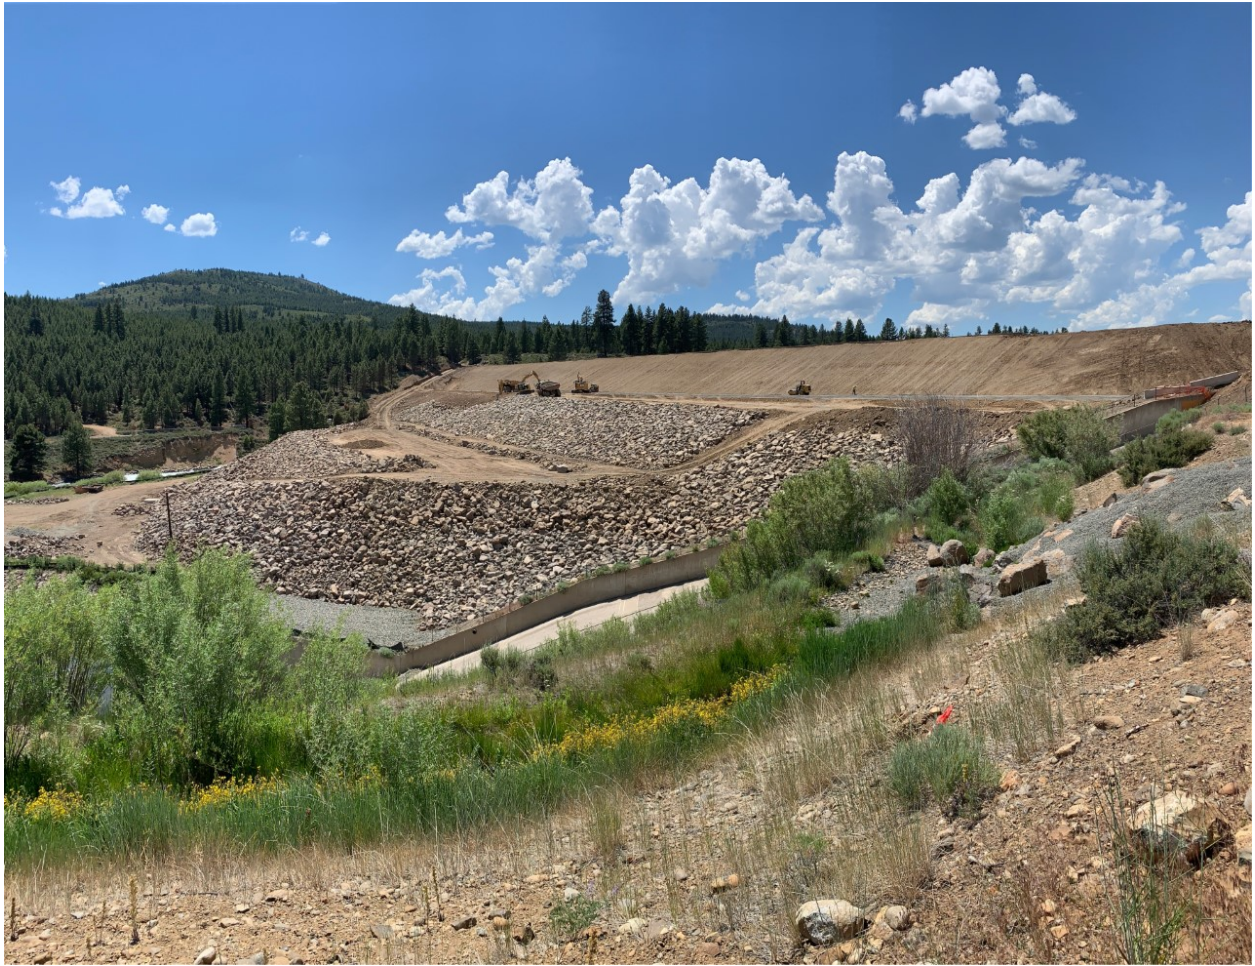
Construction of dam embankment and filter zones in progress (remove period after progress).

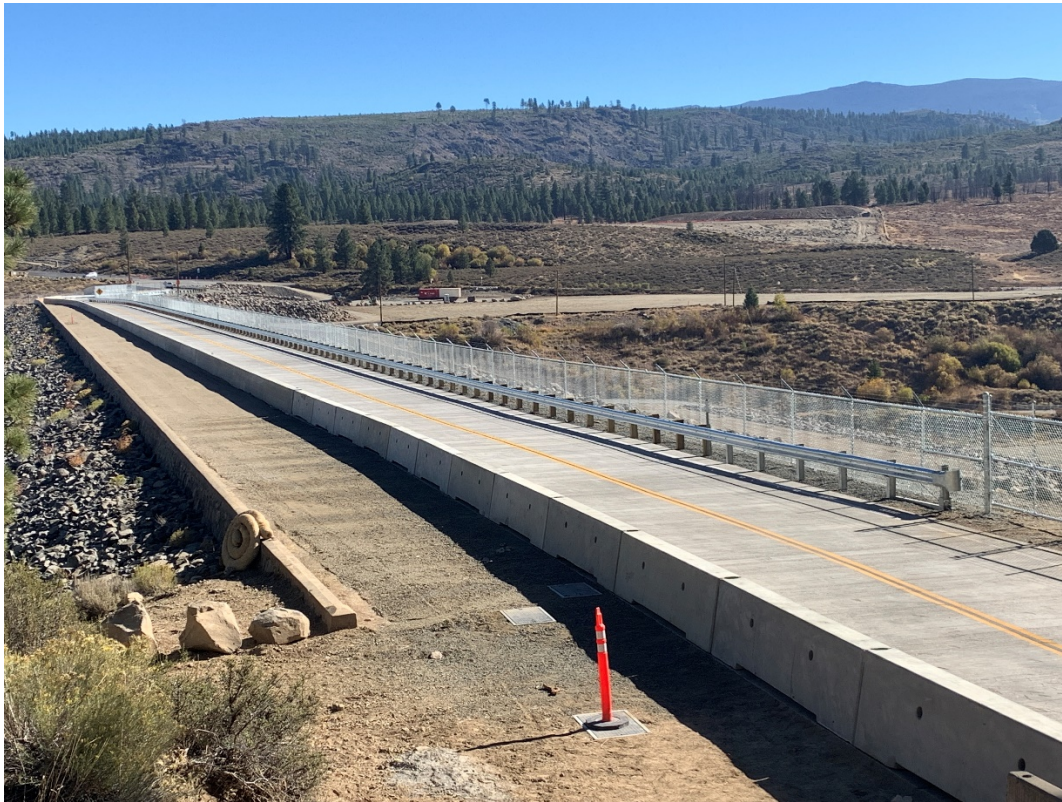
Completed Boca Dam Reservoir Road

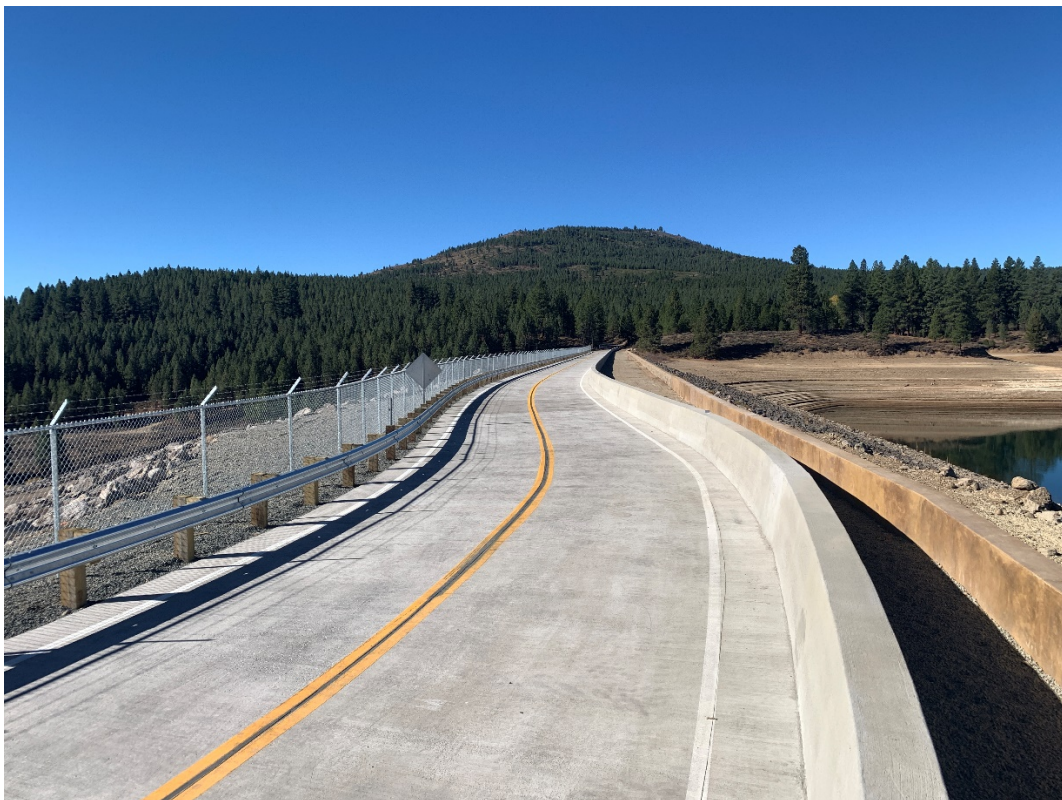
Completed Boca Dam Reservoir Road, photo 2
