#### Assessment Units for Steelhead

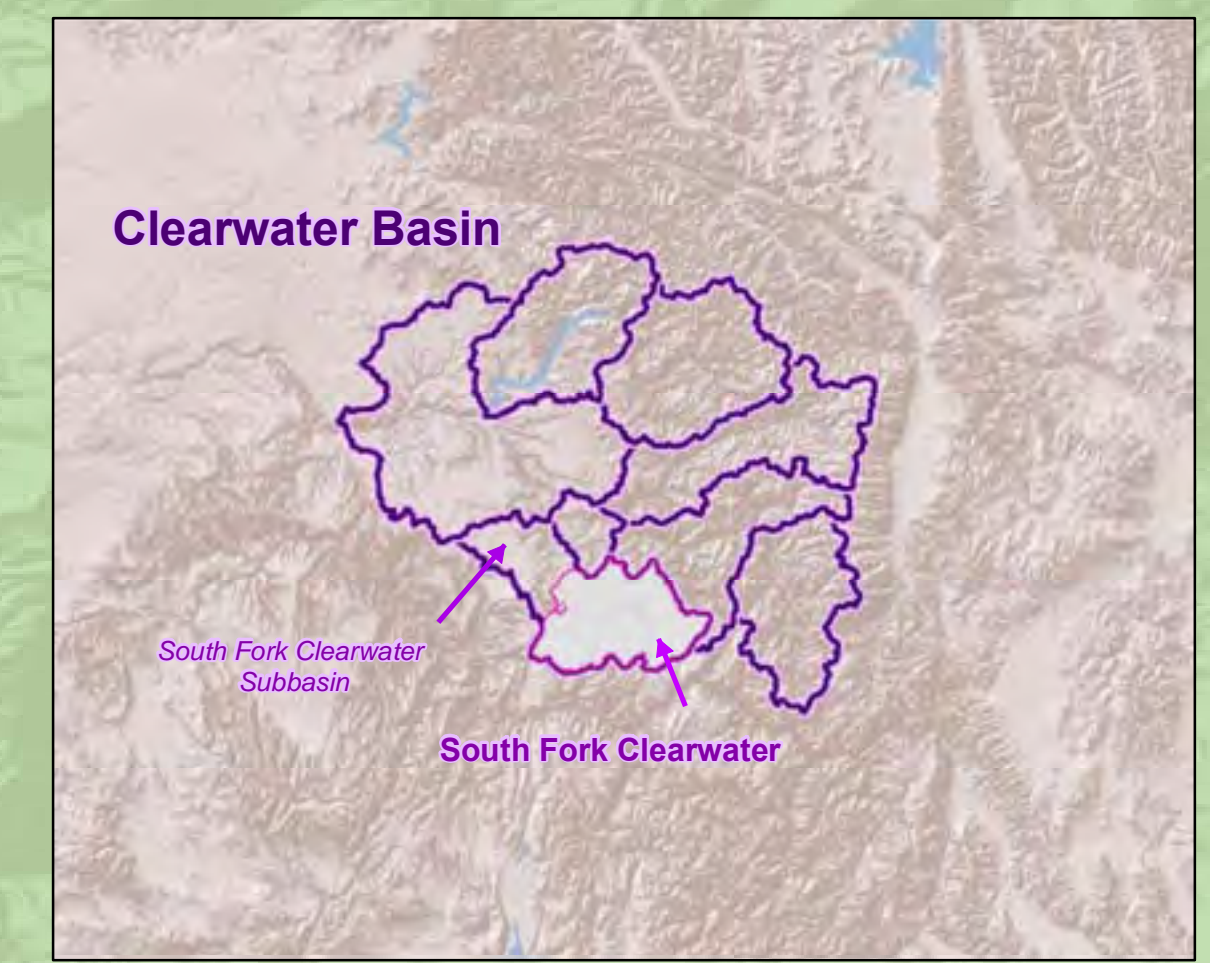
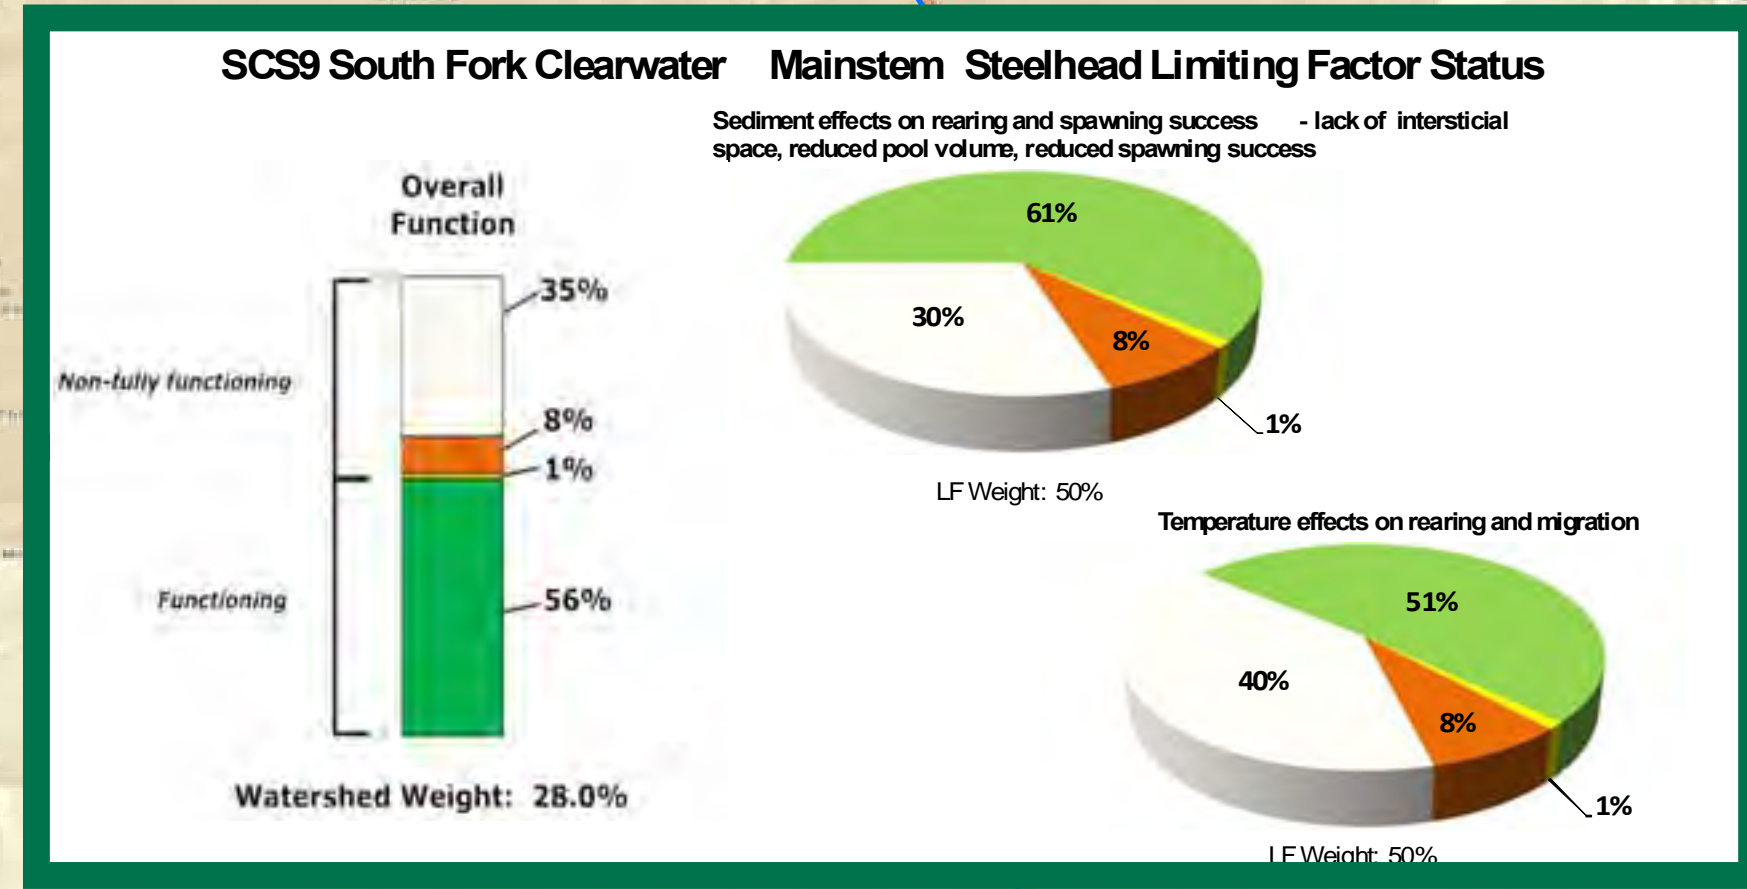
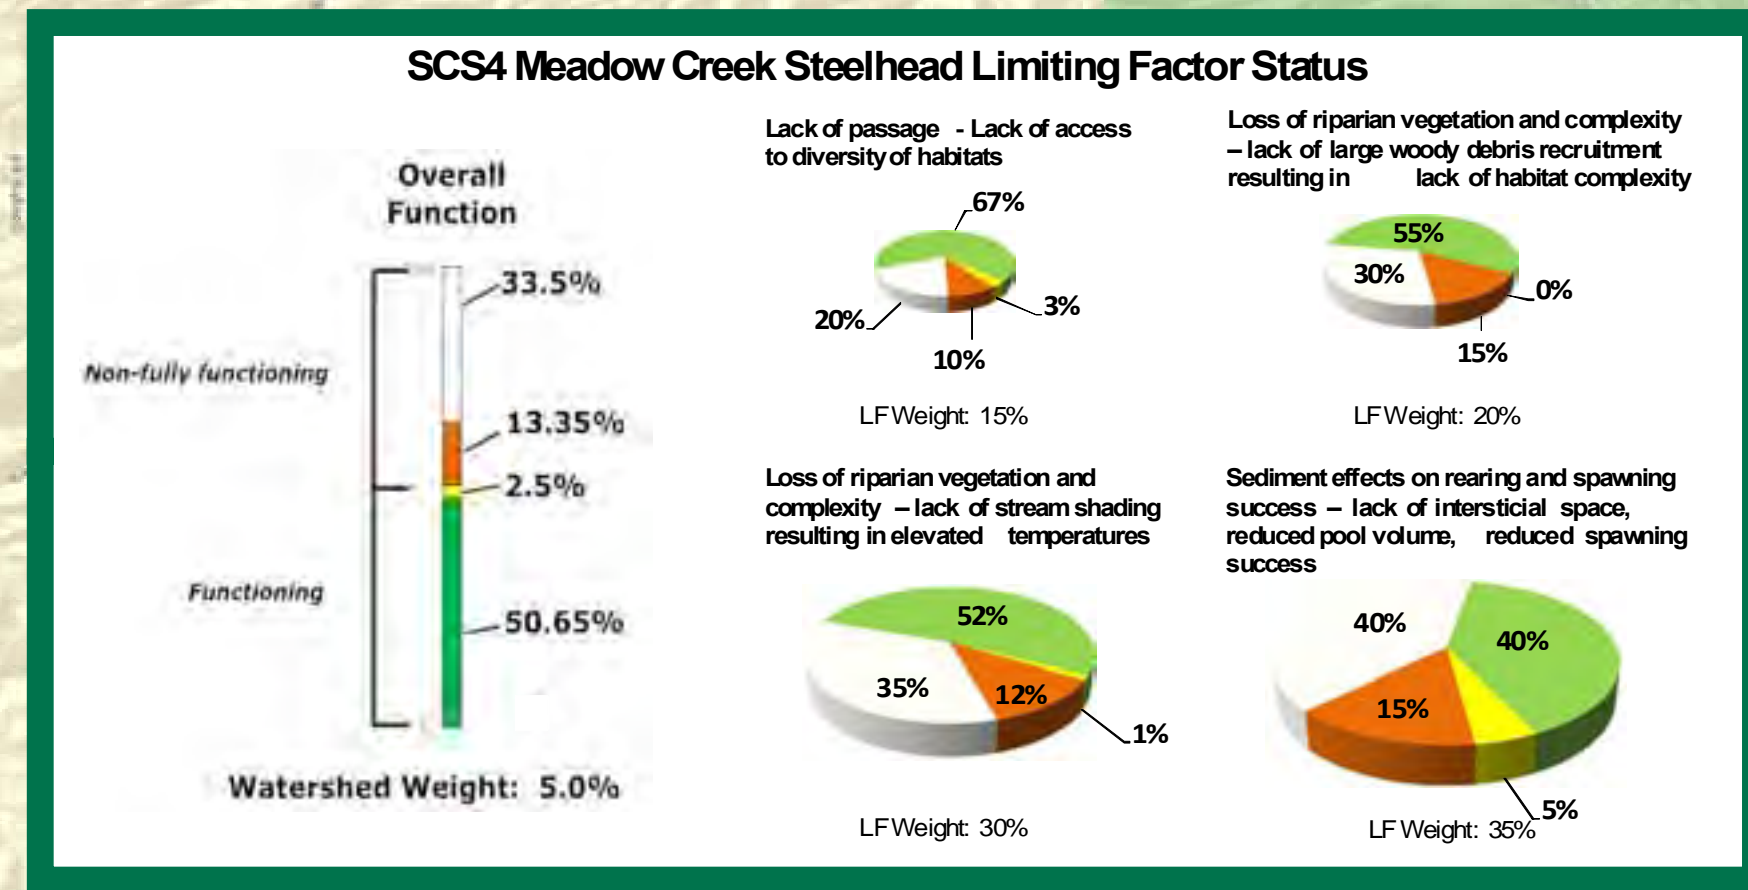
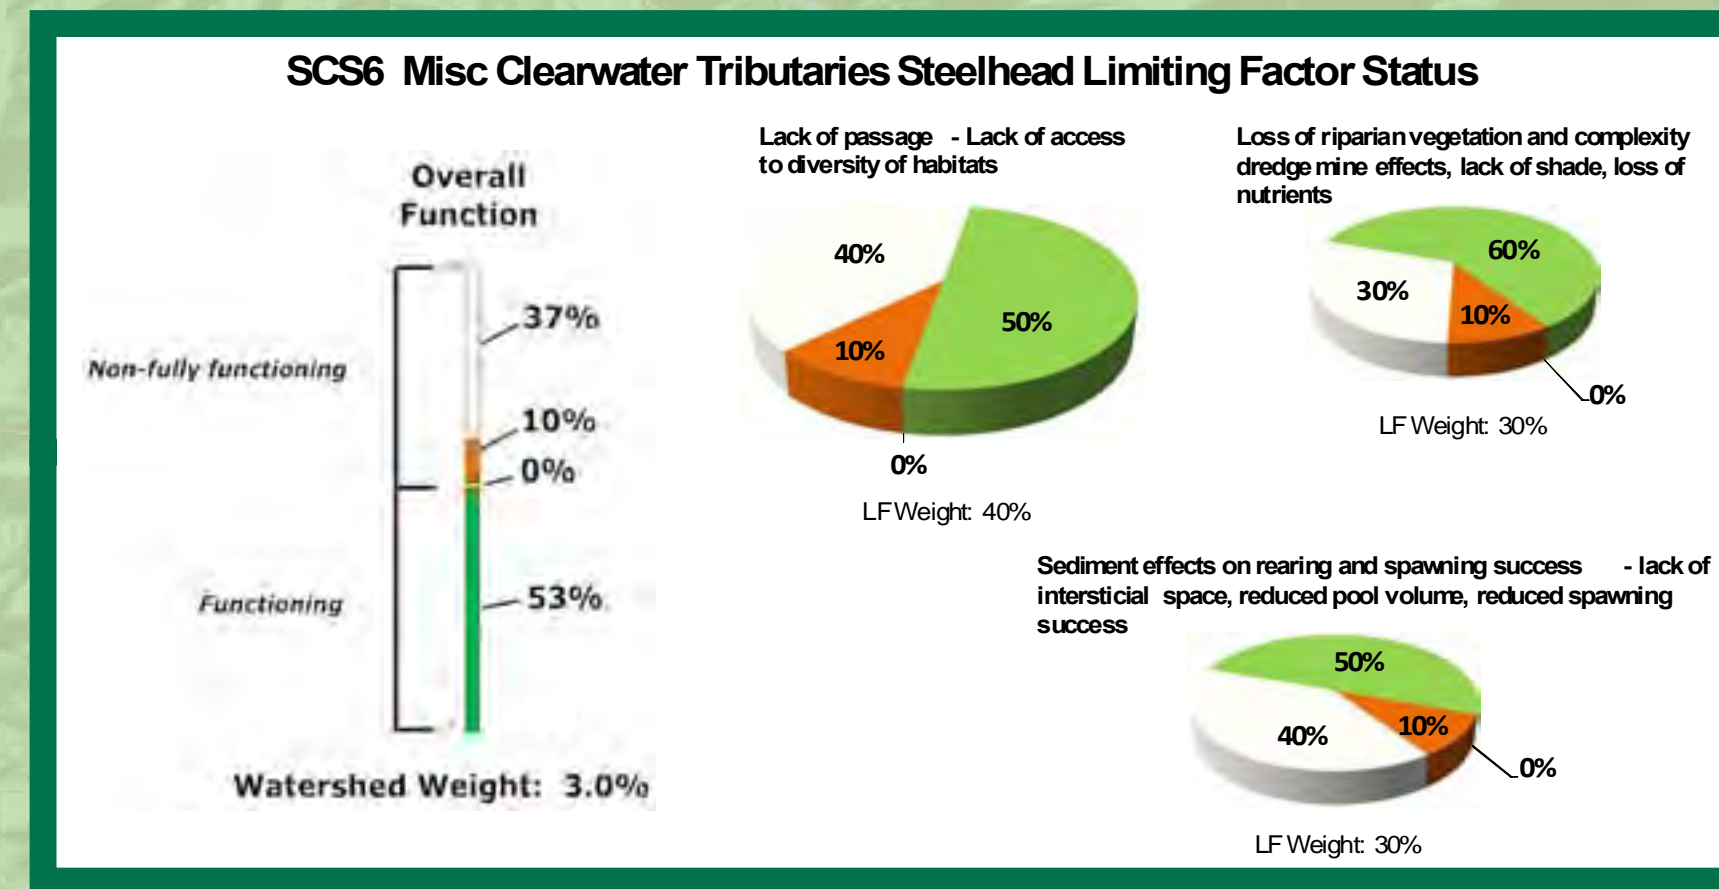
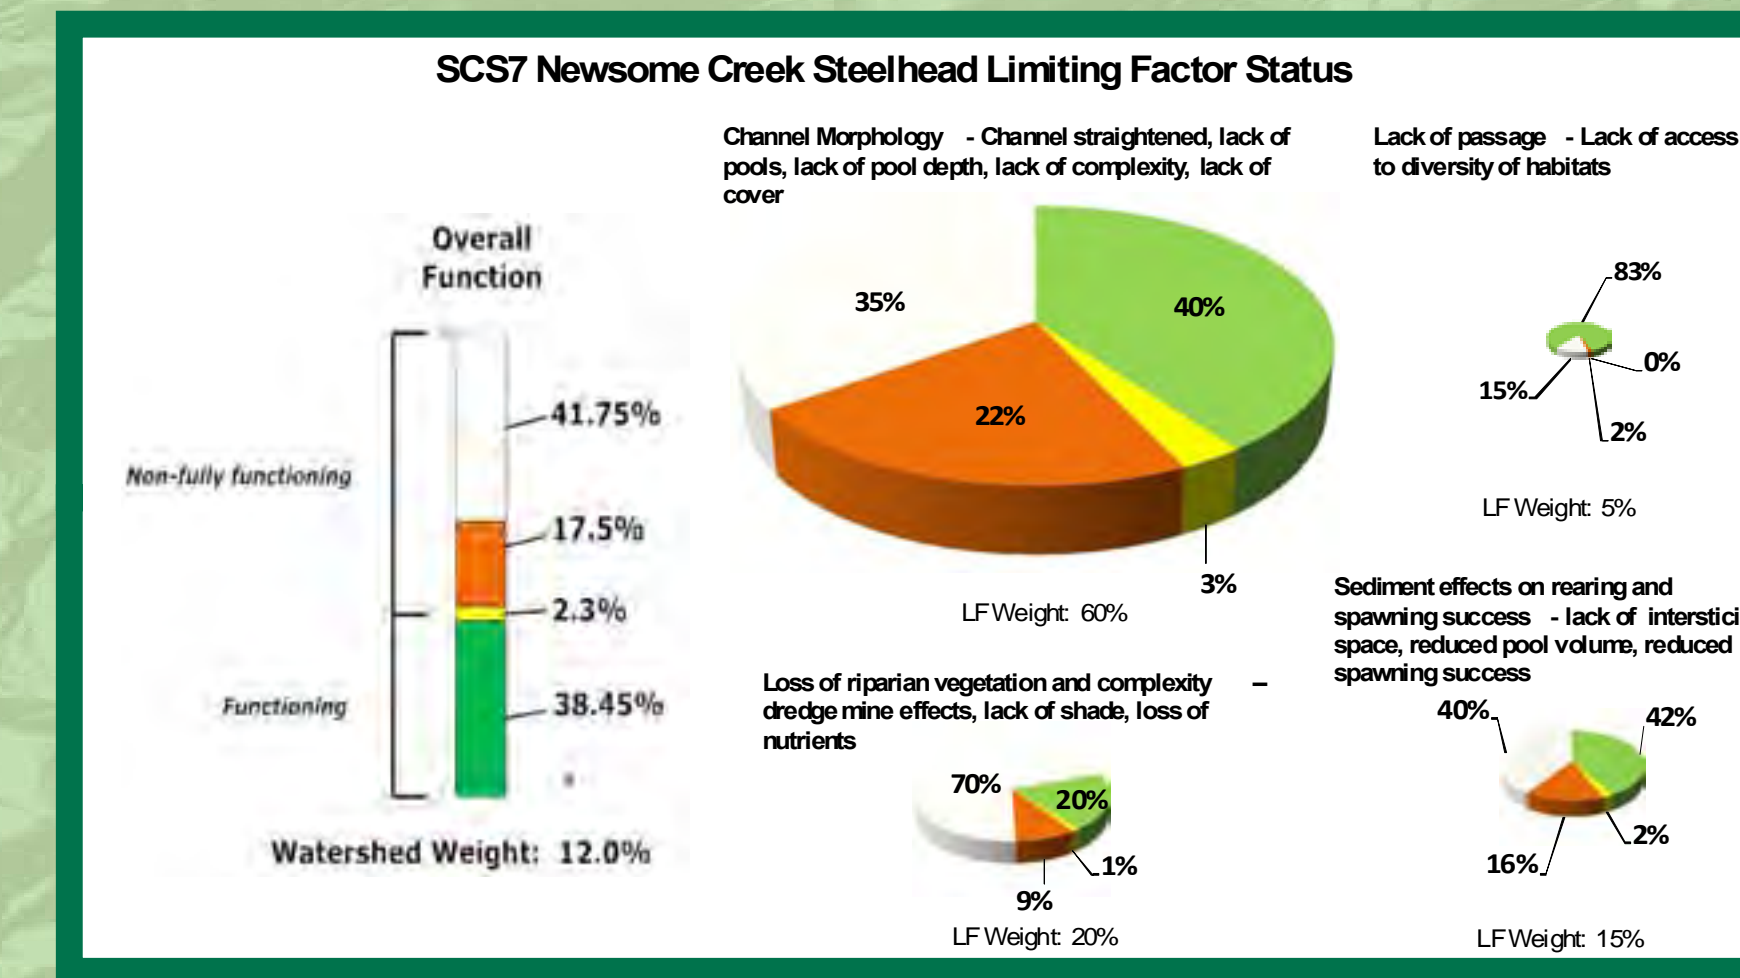
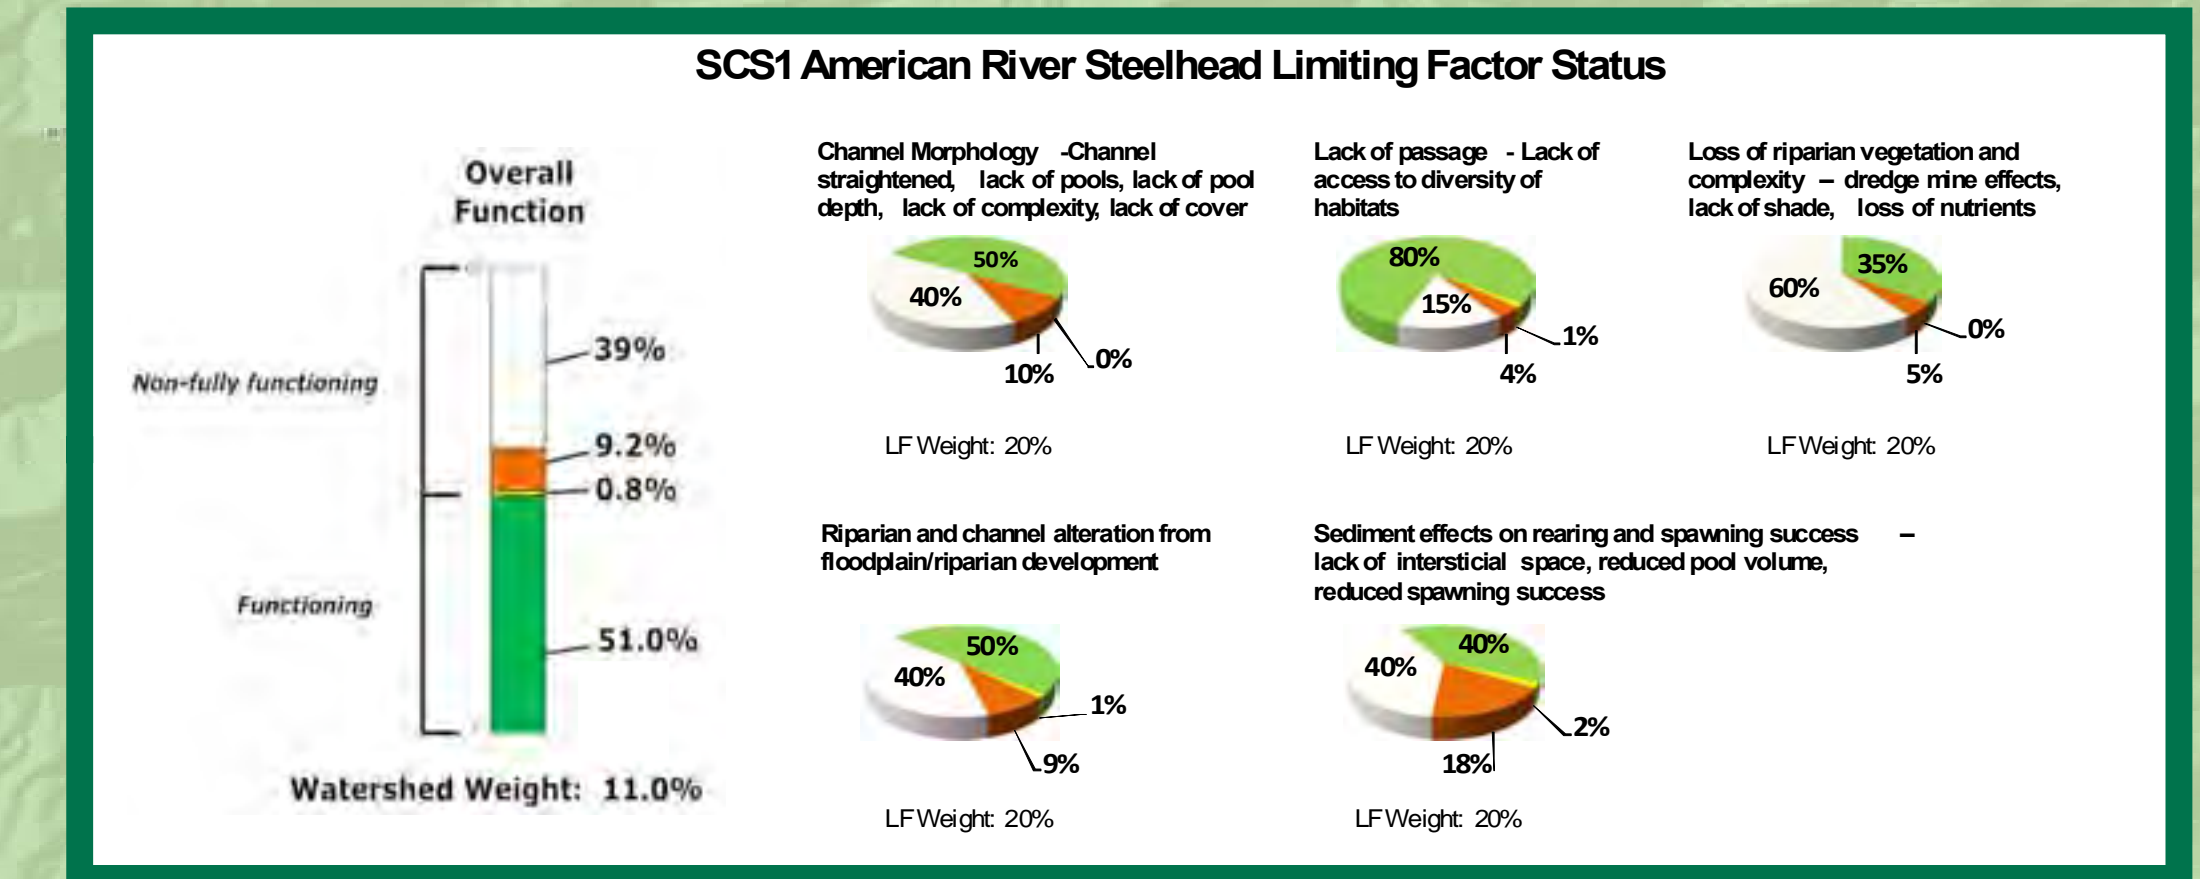
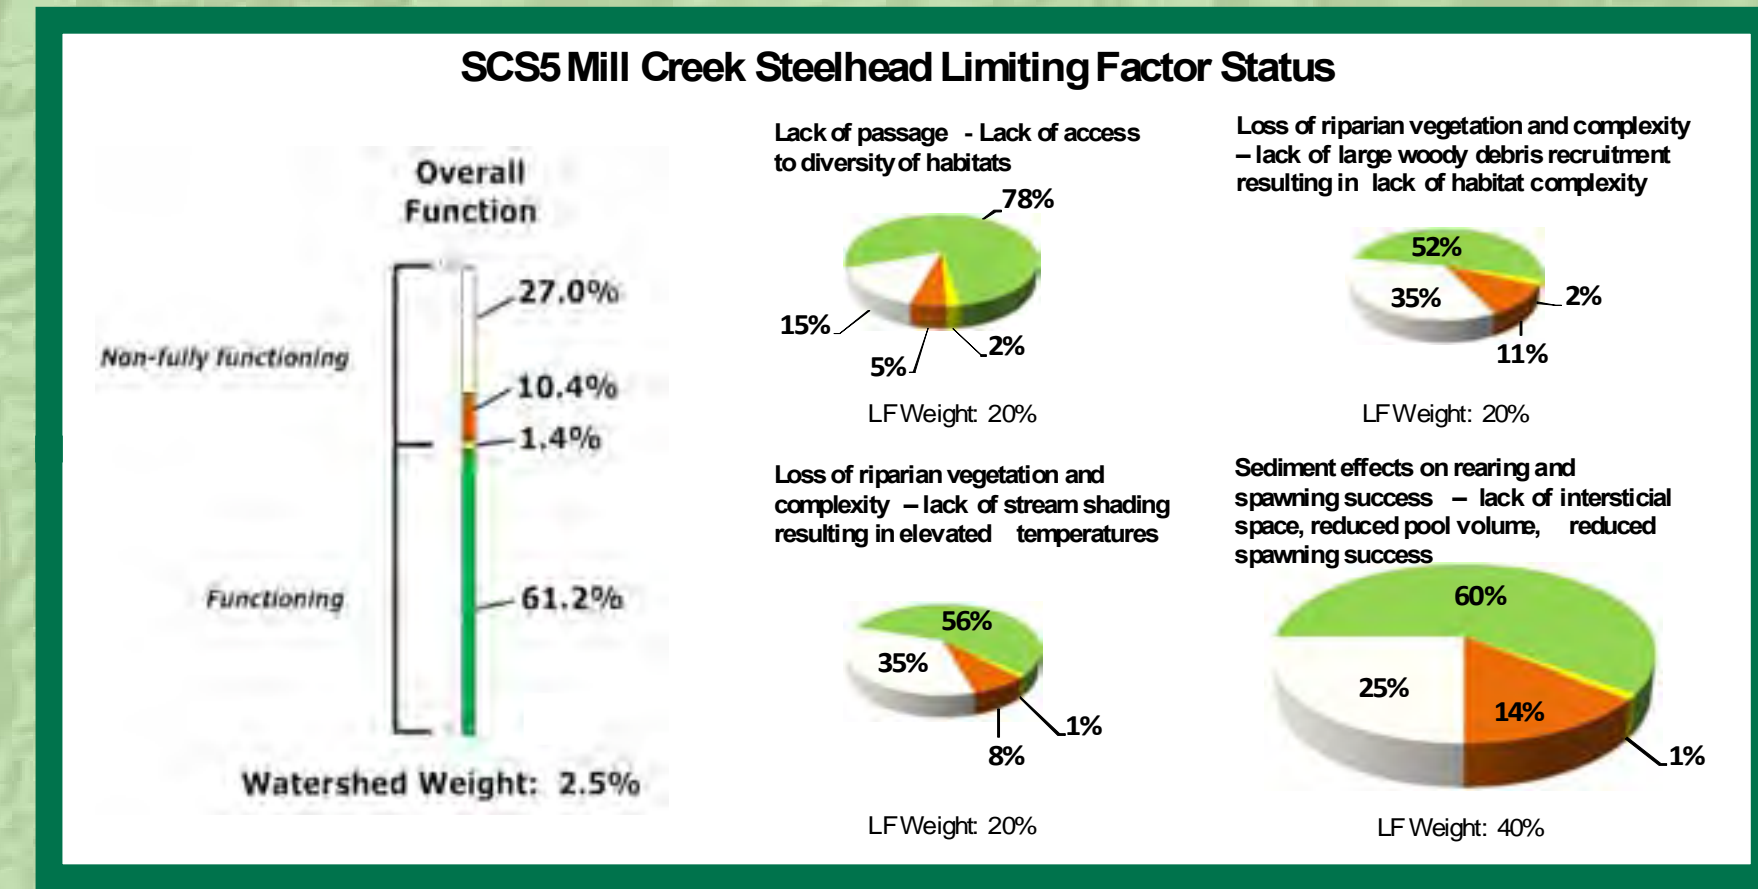
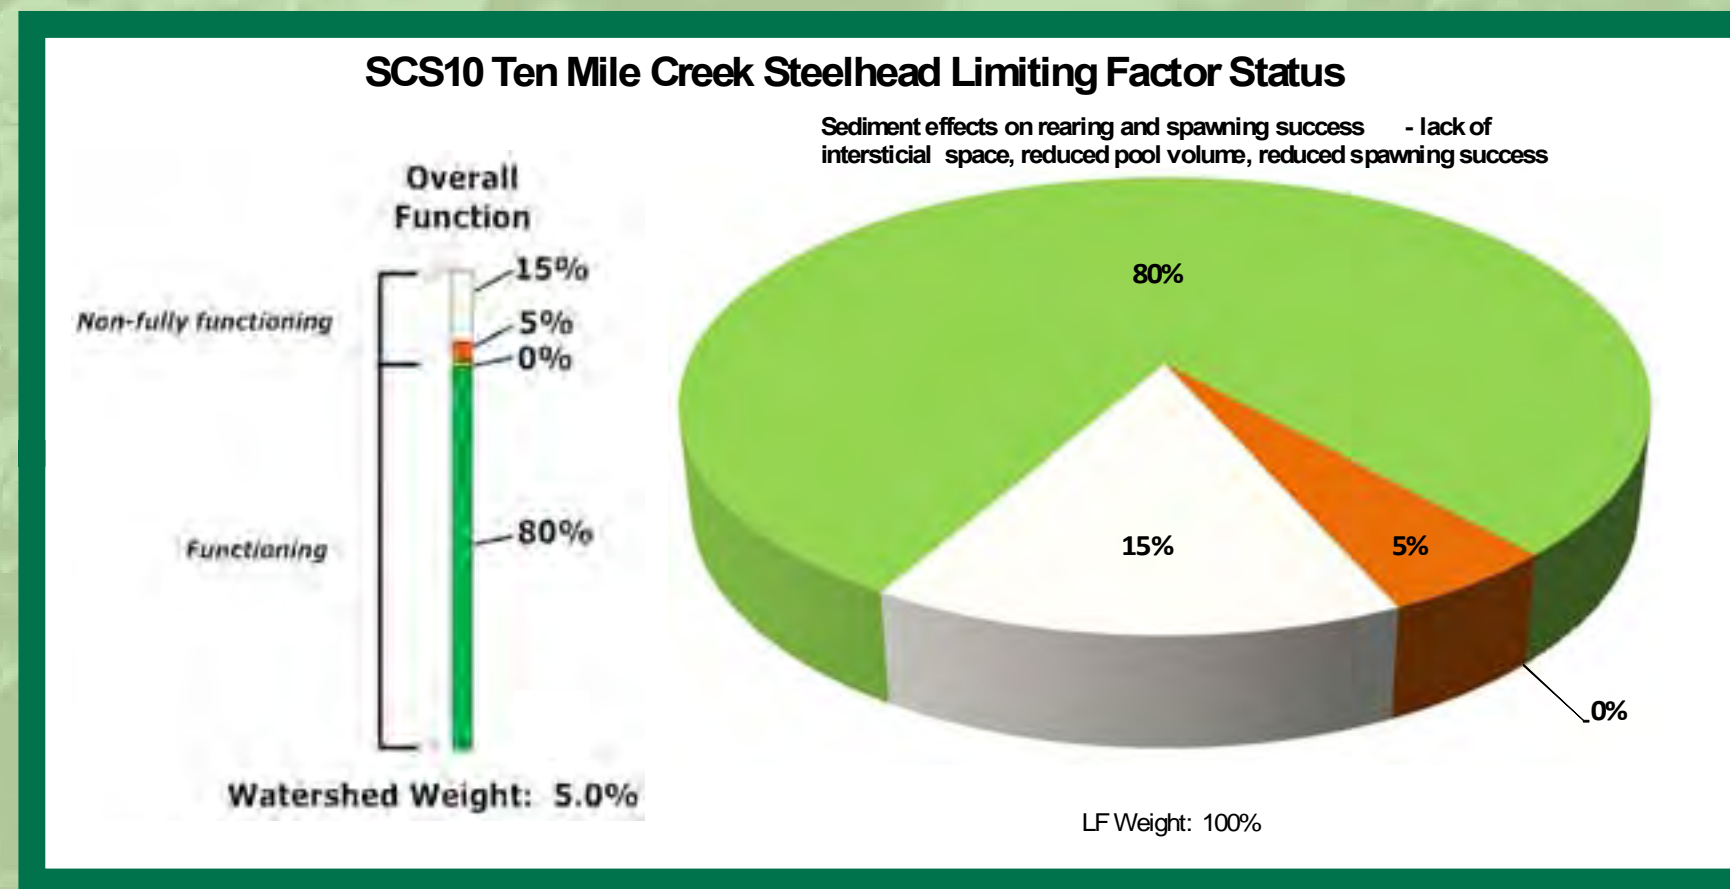
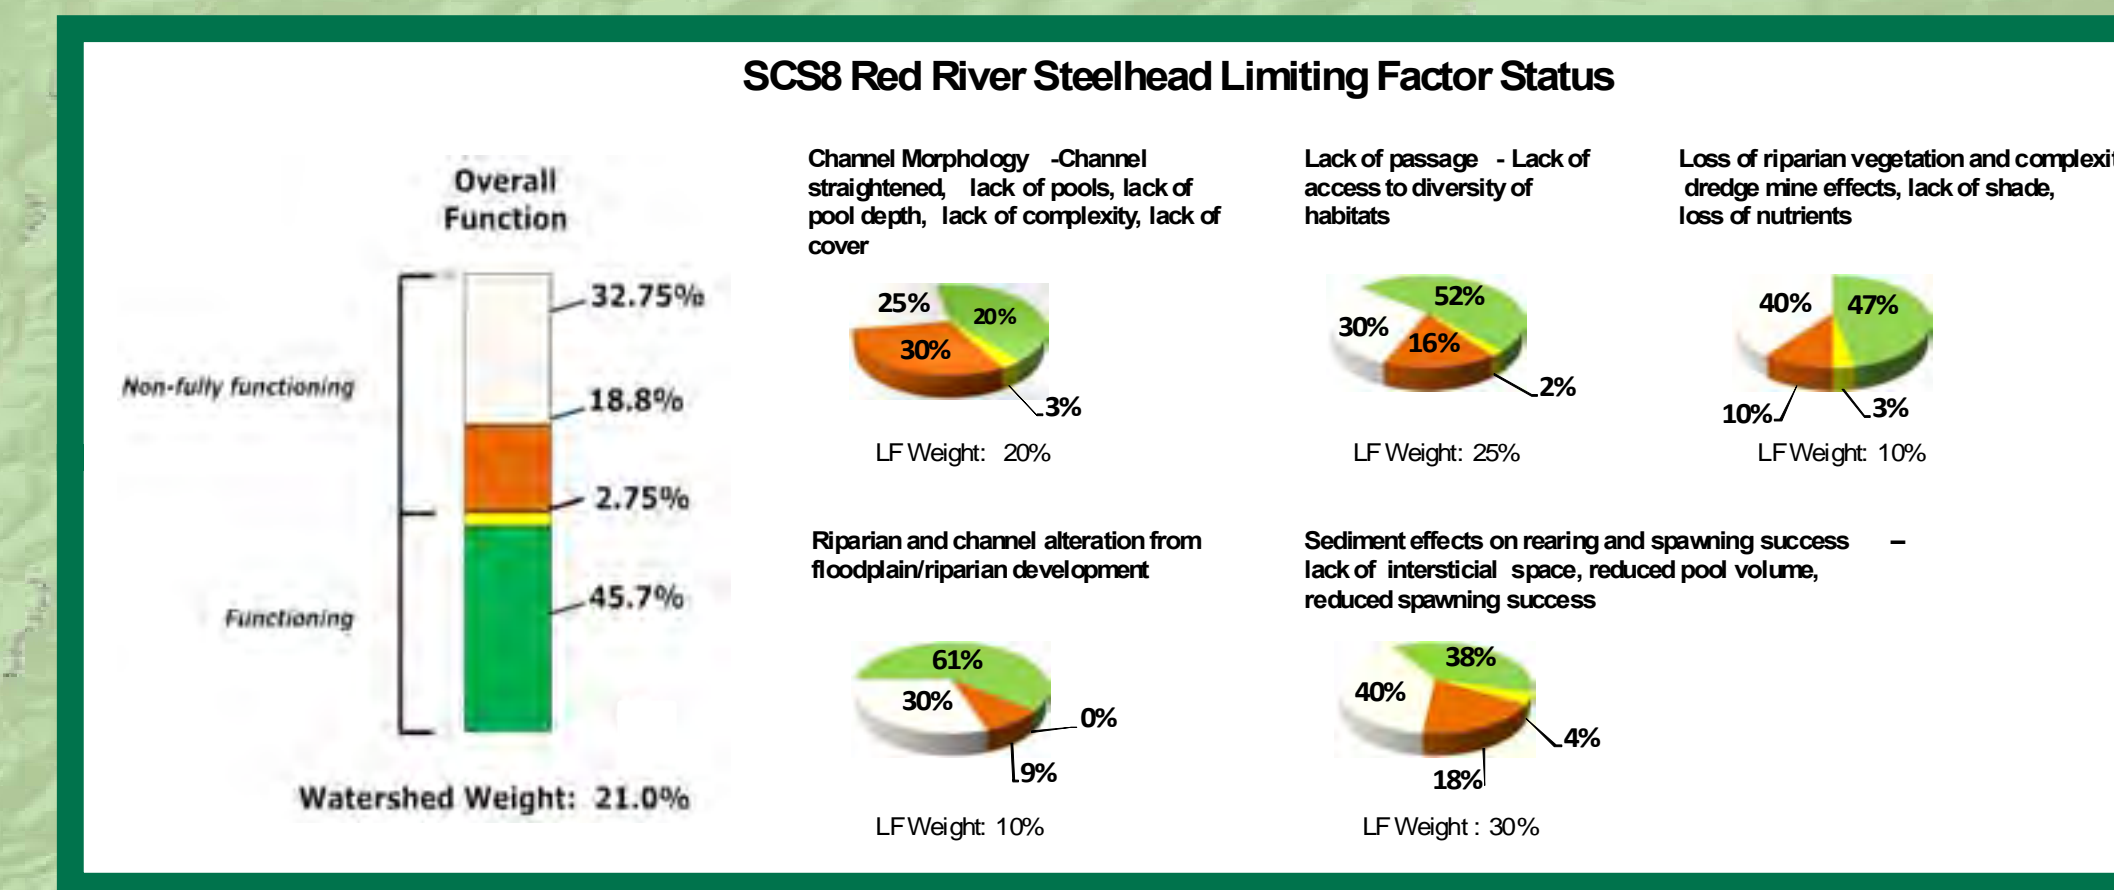
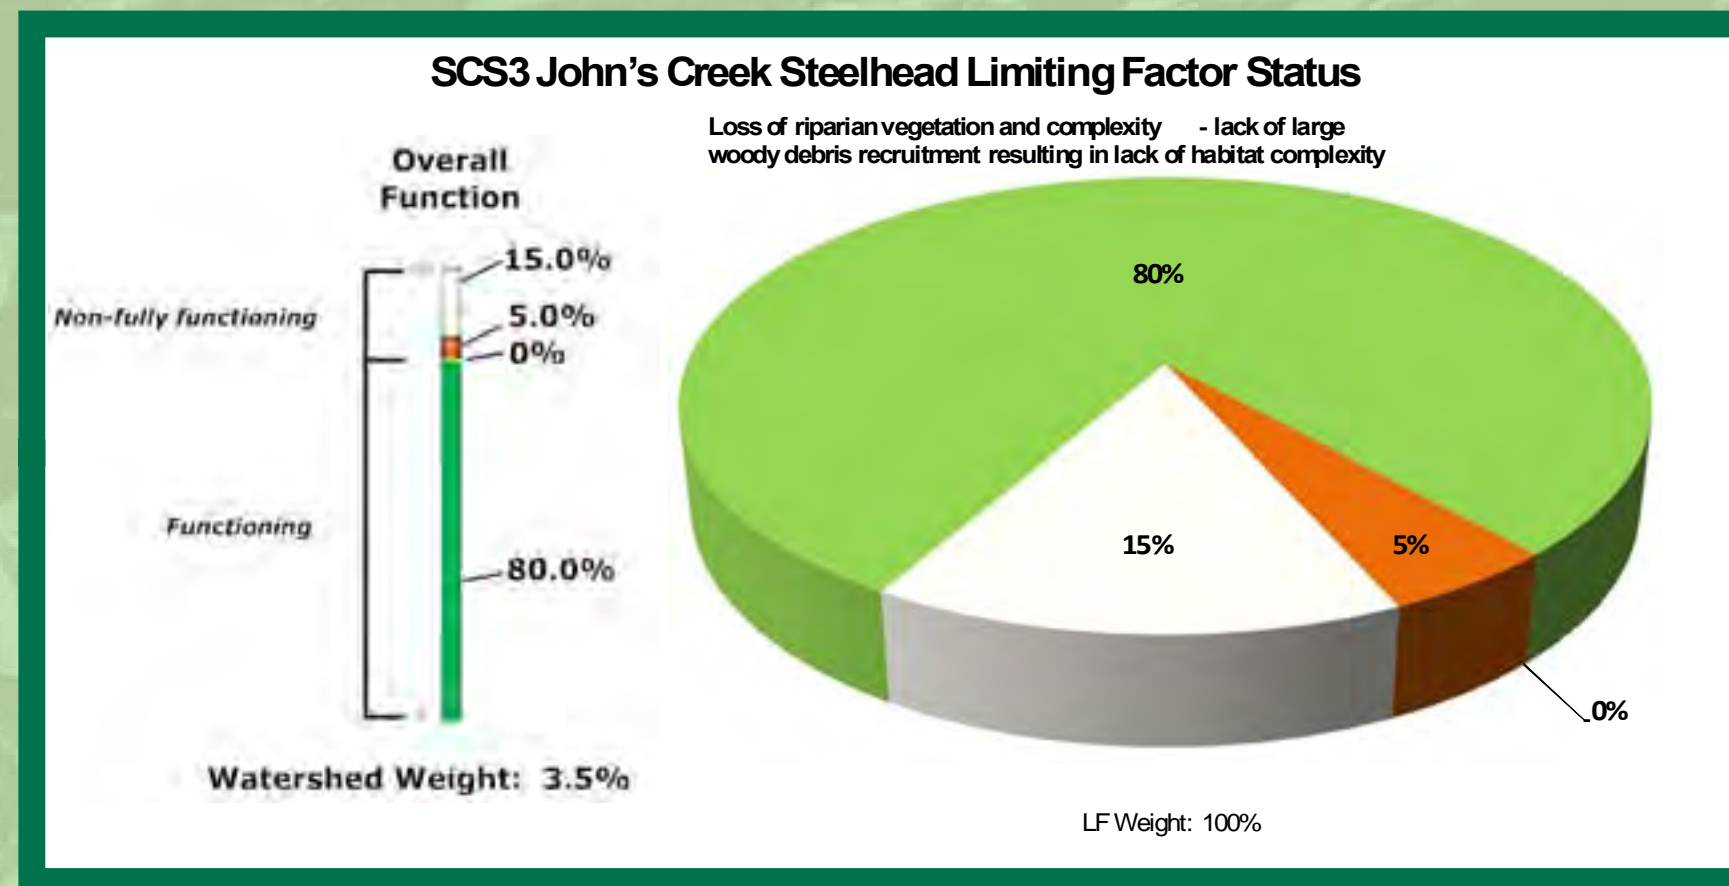
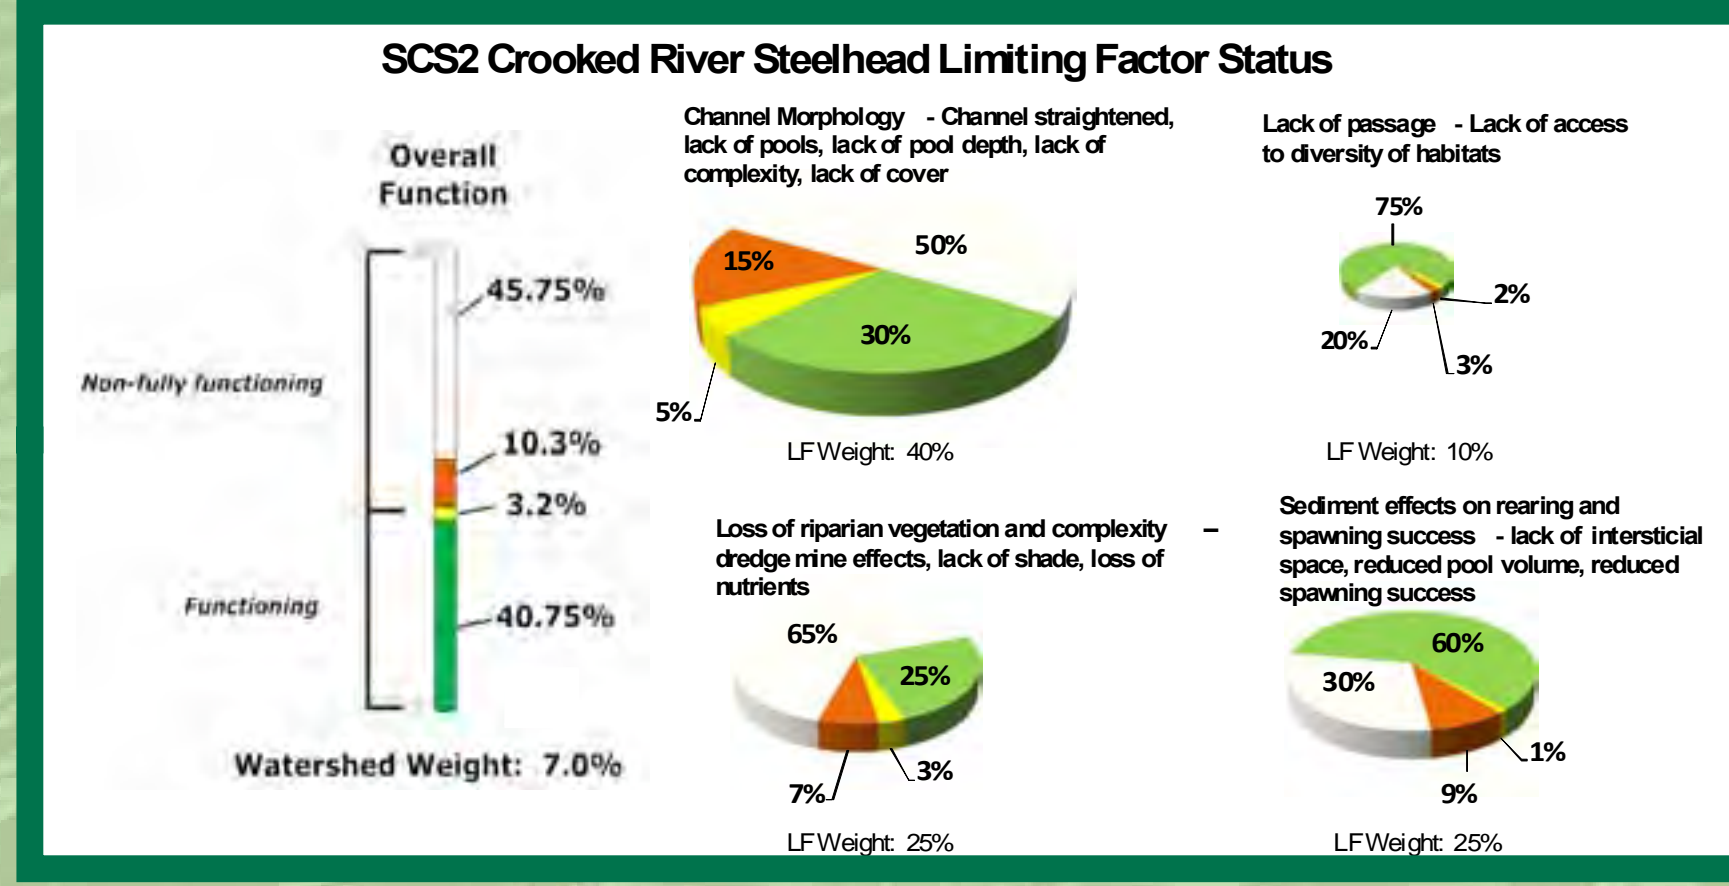
**Pies and Charts:**  
Pies and bars were generated from estimates of the habitat condition of key limiting factors associated with habitat actions planned to be completed for the FCRPS BiOp through 2012. The pies and bars only represent conditions for the term of the FCRPS BiOp (2007-2018), do not include conditions associated with habitat actions completed by other parties within this time period, and, therefore, may not represent the status of these key limiting factors for other than FCRPS BiOp purposes.

**Details:**  
Stacked bars and values of Overall Function (%) represent differences between functioning (green) and non-fully-functioning (red) key limiting factors aggregated for each assessment unit.

**Size of each pie is relative to the Intrinsic Potential of each Assessment Unit within the population as defined by Recovery Plans by the Interior Columbia Basin Technical Recovery Team. The intrinsic potential weighting factor (Watershed Weight) is denoted below each pie.**

**Pie slices and values indicate the relative proportion of each limiting factor that comprise the non-fully-functioning (red) part of the bar. Zero values indicate a limiting factor was identified for FCRPS BiOp purposes, but habitat condition values have not yet been assigned.**
