**UPPER GRANDE RONDE RIVER  
TRIBUTARY ASSESSMENT  
GRANDE RONDE RIVER BASIN  
Tributary Habitat Program, Oregon**

**U.S. Department of the Interior  
Bureau of Reclamation  
Pacific Northwest Region  
Boise, Idaho**

**January 2014**

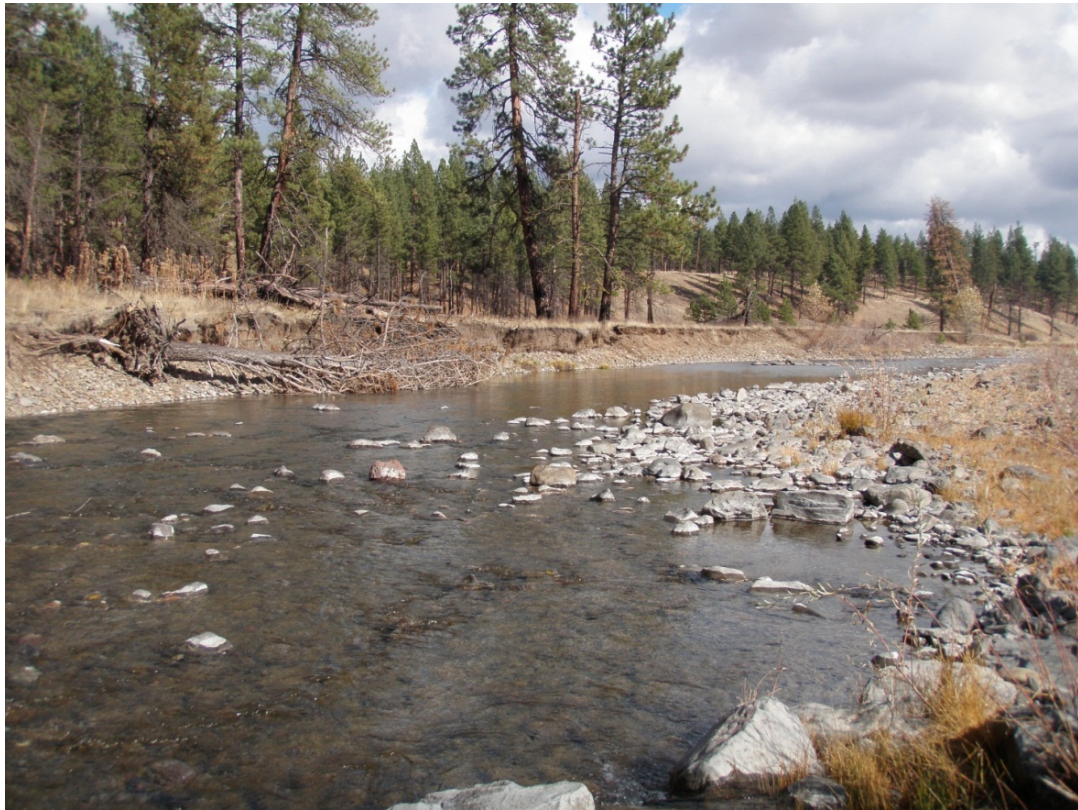
**Figure 9.** Representative bank conditions within the upstream three response reaches on the Upper Grande Ronde River.

Within the response reaches the banks range from vertical to gently sloped. Bank material includes alluvial gravel with sand and cobble overlain by a layer of floodplain silts and sands that varies in thickness (Figure 9). Within the Starkey and Birdtrack/Longley reaches where the channel is located along the edge of the valley, bedrock outcrops and/or colluvium comprise the left bank. In the Hampton reach, the right bank is a 2 to 3 foot terrace comprised of alluvial material while in the downstream half of the reach the left bank is comprised of coarse fill material used to construct the historic railroad grade along the toe of the hillslope.

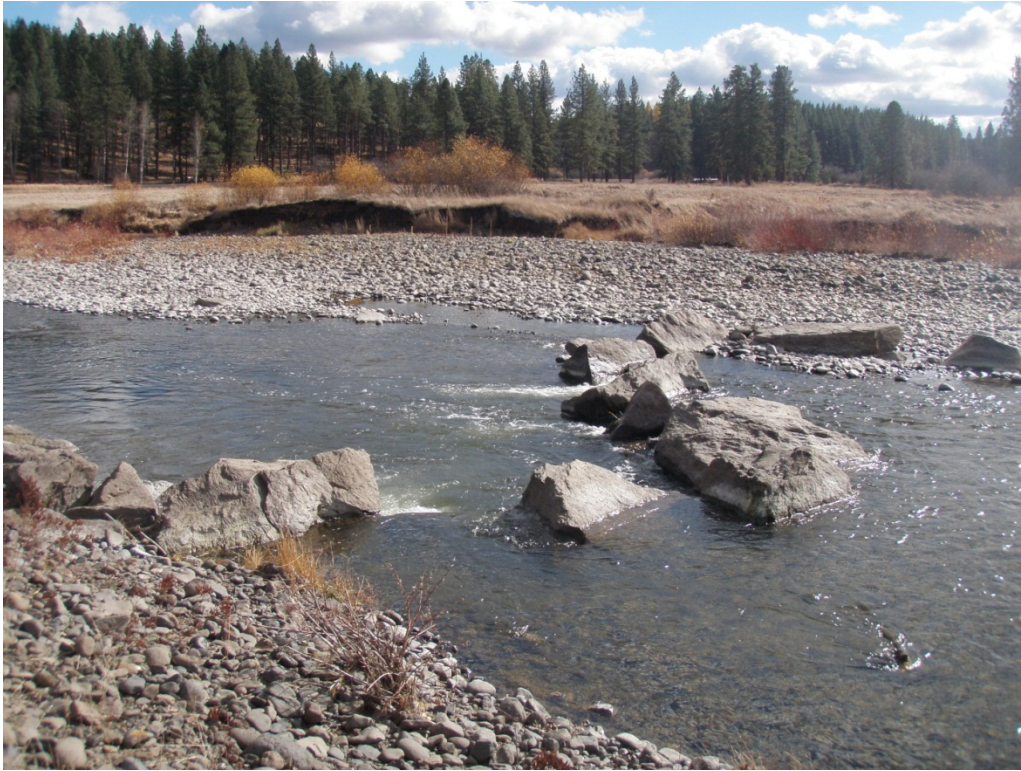
**Figure 11. Instream rock structure in the Birdtrack/Longley reach.**

Within the Birdtrack/Longley reach very little LWM is present to act as a forcing agent. The river flows against bedrock and or colluvium associated with the left valley wall at several locations within the upstream section of the reach. In the downstream end of the reach from RM 143.8 to RM 143.3 the Bear Creek/Jordan Creek alluvial fan forms a 2 to 3-foot terrace that narrows the active floodplain. As within the Starkey reach, sediment accumulations in the form of lateral and point bars act to concentrate flow at low flow which increases local low flow depths. Anthropogenic forcing agents within the reach include several boulder clusters, vortex weirs, and rock/log barbs (Figure 11).

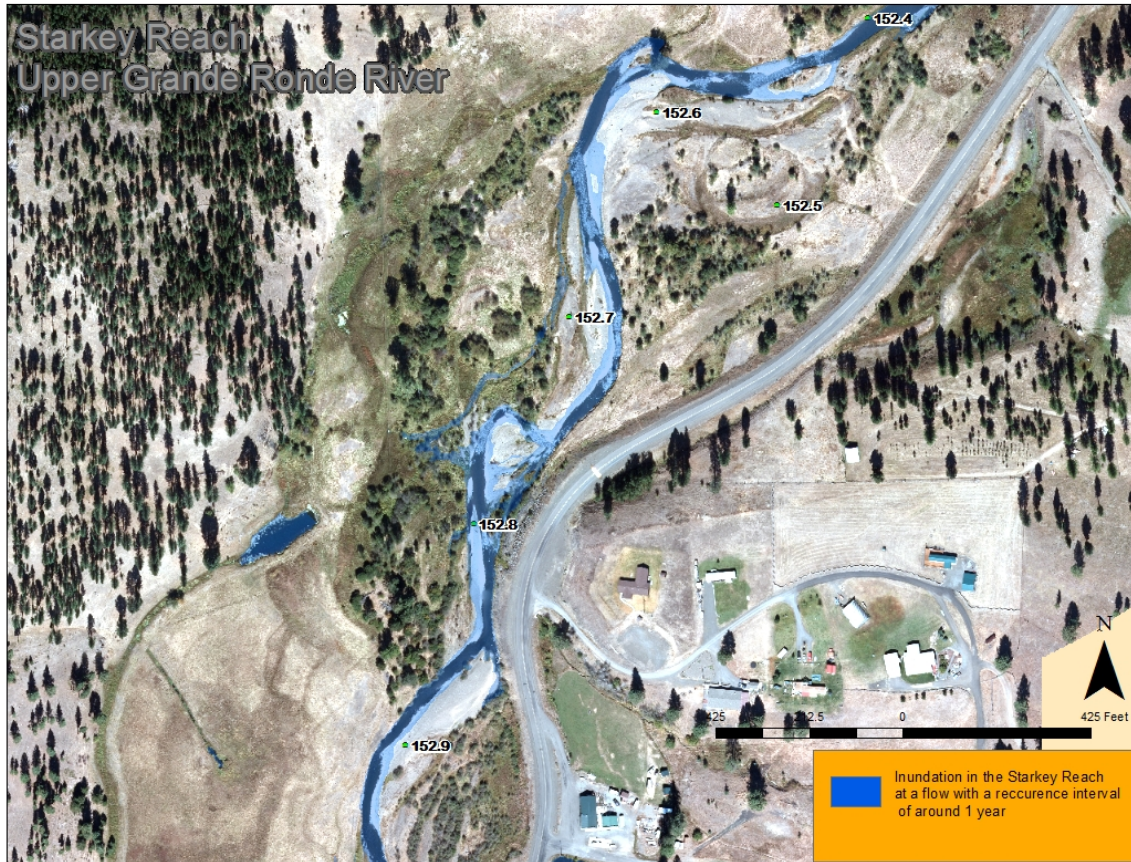
**Figure 12. Activation of an intermittent side channel within the Starkey reach during a flow with a return interval of approximately 1 year.**

In the Starkey reach, there are various natural off-channel features visible in the LiDAR imagery. At the flow associated with the edge of water data, there are some intermittent floodplain side channels, but the predominant side channel type is back bar side channels within the active channel width (Figure 12). Most of the activated floodplain side channels were connected at the upstream and downstream ends. Others were connected at the

downstream end providing alcove habitat. Additional hydrologic and hydraulic analysis is needed to estimate the area of floodplain that is inundated and/or the length of side channel that is activated at a range flows.

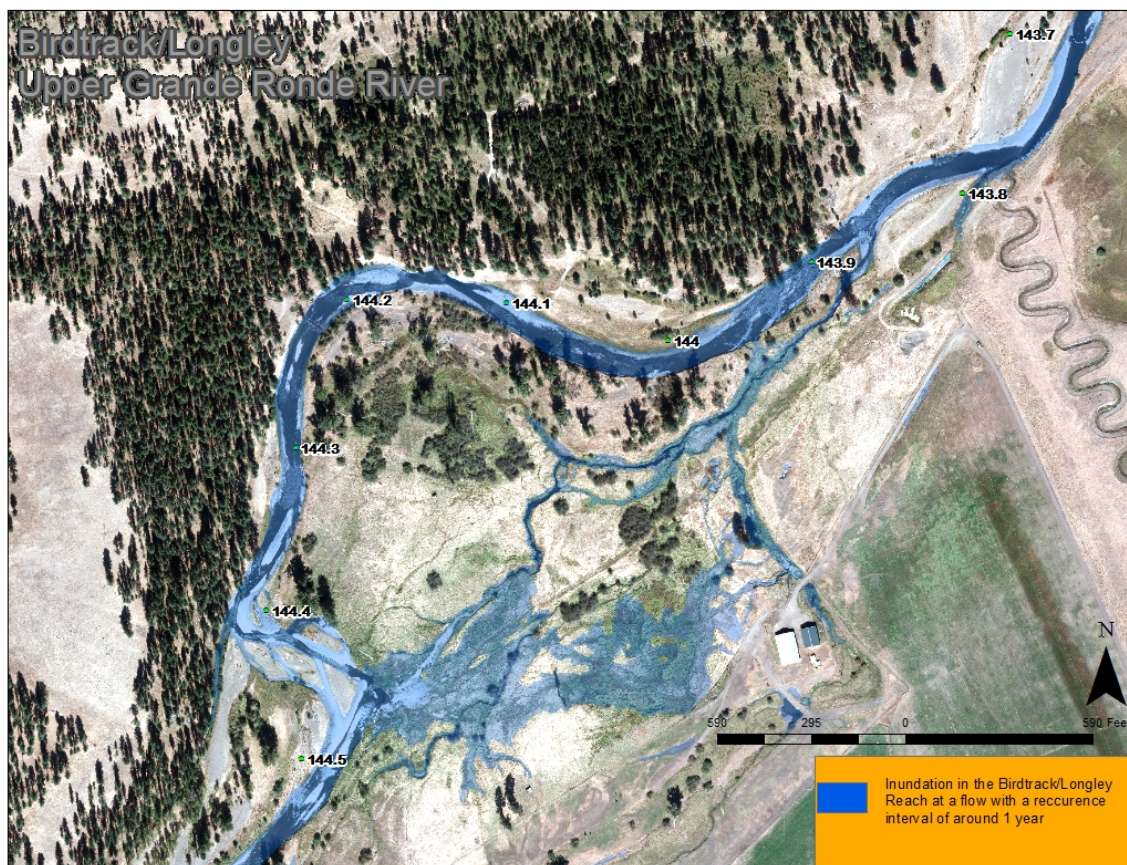
**Figure 13. Floodplain inundation associated with flow with a recurrence interval of approximately 1 year within the Birdtrack/Longley reach.**

In the Birdtrack/Longley reach, approximately 11 acres of off-channel floodplain was inundated at the flow with a recurrence interval of approximately 1 year. The lineal side channel distance of that area is estimated to be roughly 5,000 feet. Similar to the Starkey reach, the activated floodplain side channels within the Birdtrack/Longley reach had

upstream and downstream connections (Figure 13). There were also several bar side channels within the active channel, particularly in the upstream end of the reach (Figure 13). Additional hydrologic and hydraulic analysis is needed to estimate the area of floodplain that is inundated and/or the length of side channel that is activated at a range flows.

The most prevalent anthropogenic feature within the floodplain in the Birdtrack/Longley reach is over 9,500 feet of non-continuous historic railroad grade. A section of the railroad grade has been removed, allowing inundation of the floodplain noted in Figure 13 (Childs 2013).
