**Draft Environmental Assessment
Marble Beach Bank Stabilization
Lake Roosevelt, Grand Coulee Project, Washington**

U.S. Department of the Interior
Bureau of Reclamation
Pacific Northwest Region
Boise, Idaho

July 2018

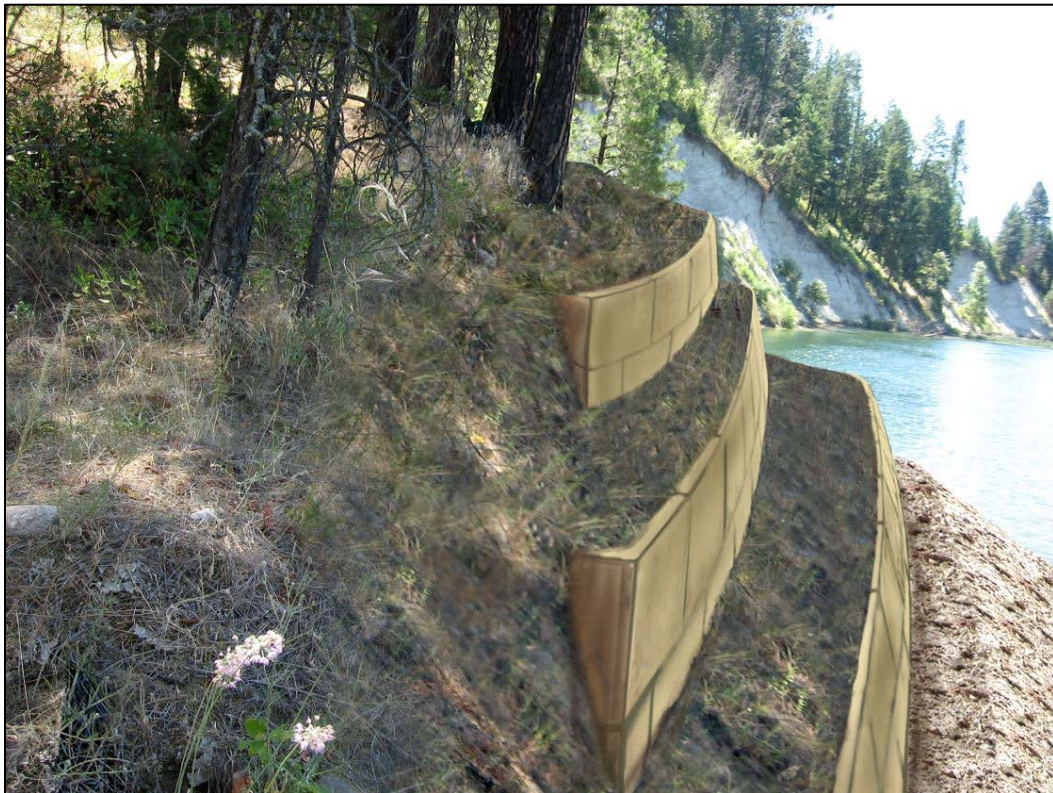
Figure 1-2. Schematic depiction of southern portion of proposed retaining wall

Reclamation proposes to stabilize the shoreline and halt bank erosion at the Marble Beach Project site through the installation of a retaining wall using concrete blocks that would be reinforced with surface-treated riprap (Figure 1-2). Project staging would occur approximately 4 miles downstream of the project site at the NPS-managed China Bend boat launch (Figure 1-1).

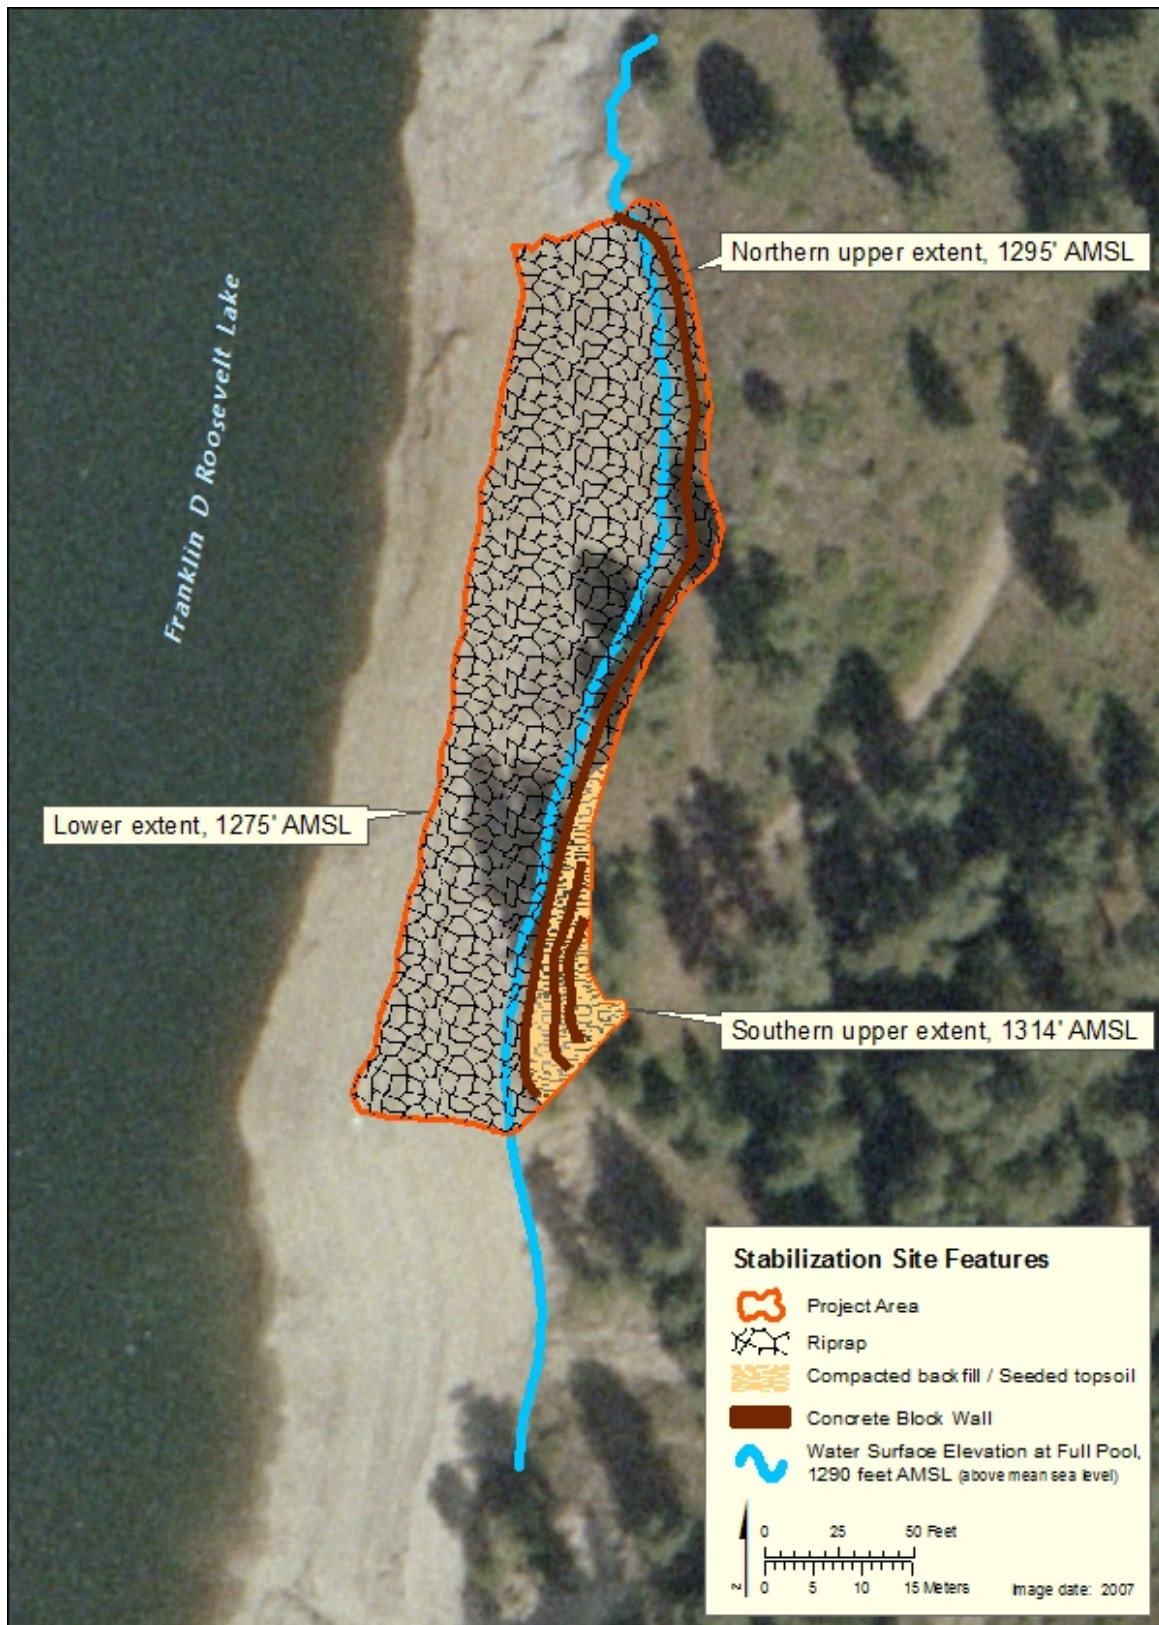
Figure 2-2. Marble Beach stabilization site

The top of the stabilization structure would extend horizontally from elevation 1295 feet above mean sea level to 1314 feet, and have a maximum total overall length of approximately 330 feet. The bottom elevation (lower extent) of the stabilization structure would be at 1275 feet. The width of the area to be protected would range from 50 to 100 feet, for a total stabilization area of 20,200 square feet (about 0.5 acres; Figure 2-2).

The bank stabilization structure would consist of different gradations of imported rock, fill, concrete blocks (such as ecology blocks), and seeded topsoil. The northern extent of the top of the bank stabilization site has relatively flat topography which extends about 240 feet south (downstream). A single layer of concrete blocks (tier 1) would be placed along this 240-foot stretch and have riprap backfill (Figure 2-2). The topography steepens for the remaining portion of the project area moving south (about 76 feet). Within this 76-foot section, the first tier of concrete blocks would continue to be placed, and compacted gravel backfill would be placed behind the blocks. The first tier would vary in height, from one concrete block layer to three concrete block layers, depending on the existing bank height. The compacted backfill behind the first tier of concrete blocks in the southern portion of the project area would serve as the foundation for two additional tiers of concrete blocks. The top of each of the three tiers would be seeded with native grasses for the 76-foot stretch (Figure 2-2); where there is only a single tier, there would be no seeded topsoil due to the presence of riprap. A wide layer of 24-inch riprap would be placed below the entire length of the first concrete block tier down to 1275 feet in elevation. A single layer of 36-inch riprap would be placed at the bottom of the stabilization structure as an anchor. Further details of the bank treatment are described in Section 2.2.2.

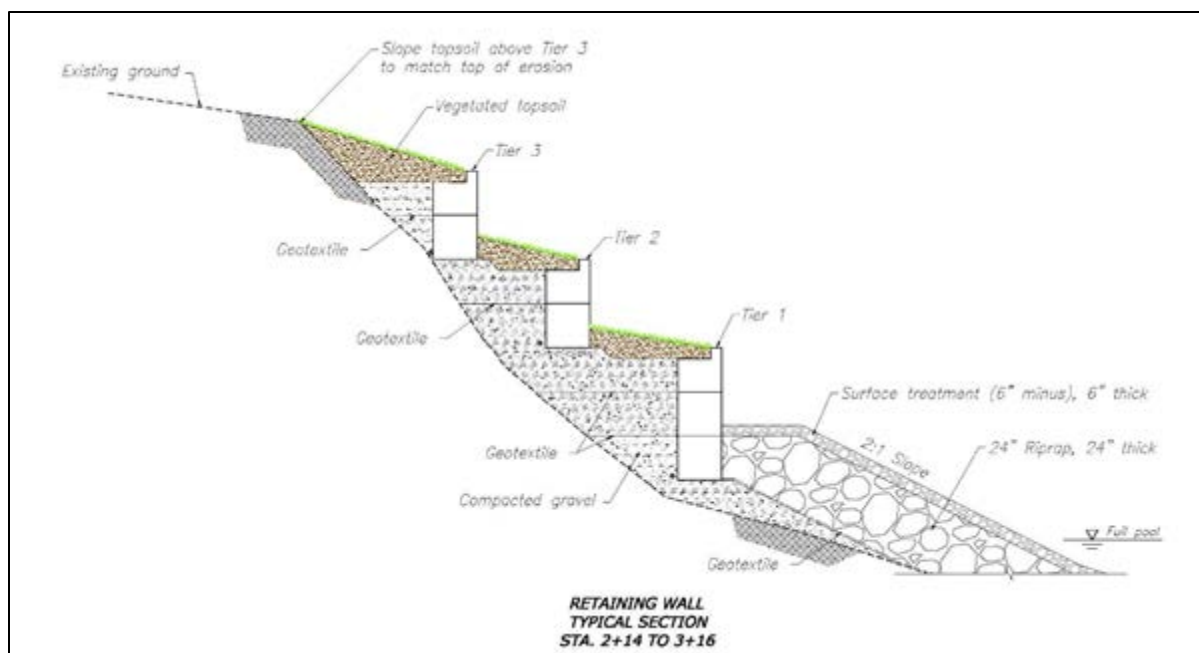
Figure 2-3. Cross-section drawing of the three-tiered retaining wall at the southern portion of the stabilization site

- Construct the 330-foot long, concrete-block retaining wall. The total wall height would be 4 feet, with up to 3 feet visible.
 - A compacted gravel base would be used as the foundation for the tier of concrete blocks to provide a stable and level course. The top of the gravel bedding would be at 1293 feet elevation.

- Riprap, combined with a gravel filter base layer and surface treatment (riprap holes filled with small aggregate rock), would be placed in front of the retaining wall between elevations 1294 and 1275 feet to protect the remaining portion of the project area shoreline.

- Topsoil seeded with native grass would be placed on top of the tiers for the portion of the stabilization structure containing three tiers (Figure 2-3) as the tiers are finalized. The topsoil would be placed from the back edge of the concrete block up to 12 inches of the face of the next concrete block layer. Upon the initial seeding, the contractor would water the seeded topsoil using an existing Reclamation water right.

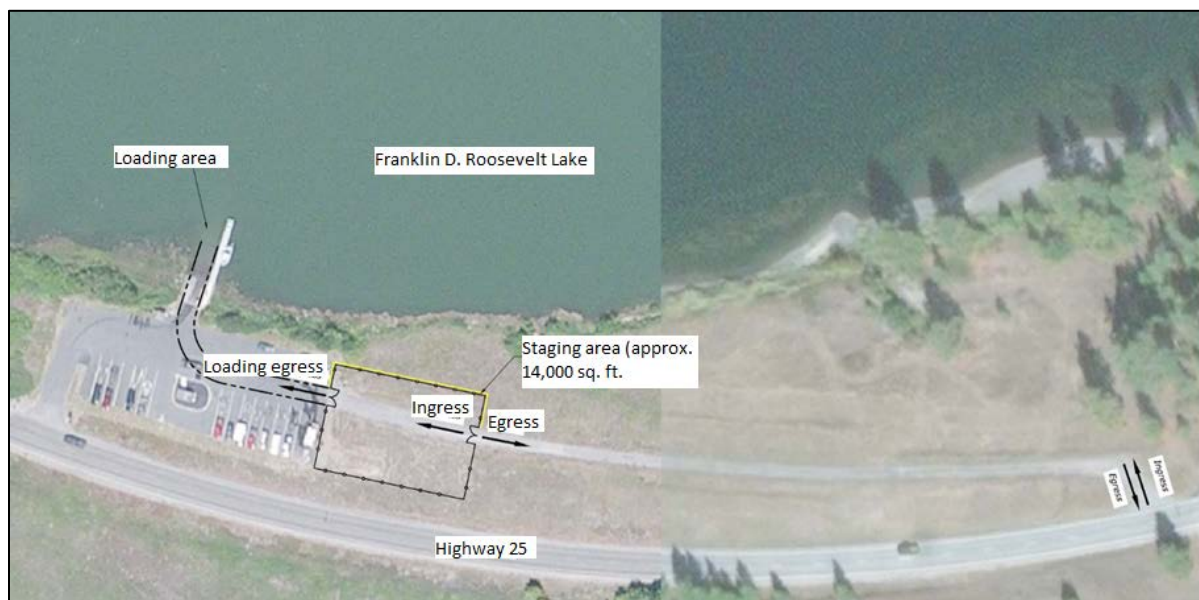
Figure 2-4. Staging area at China Bend Boat Launch

The staging and loading areas would be located at the NPS-managed China Bend Boat Launch (see Figure 2-1 and Figure 2-4), approximately 4 miles downstream of the project site. This site consists of a boat launch, boat dock, parking area, and toilets. China Bend is open year-round; however, the boat launch is accessible only at lake levels above 1277 feet (around mid-June through January).

The general location of the loading area, where the barge would land and launch, is shown on Figure 2-4. The exact location would vary within this area, depending on weather conditions and water surface elevation, and would be selected by the barge operator. Depending on the equipment used by the contractor, barge size, and materials being loaded, the barge would make two to four trips per day from the loading area to the stabilization site: one in the morning to load materials, and at least one mid-day to replenish materials. After-hours during the construction period, the barge would anchor at a small cove downstream from the staging area, or as directed by the NPS.

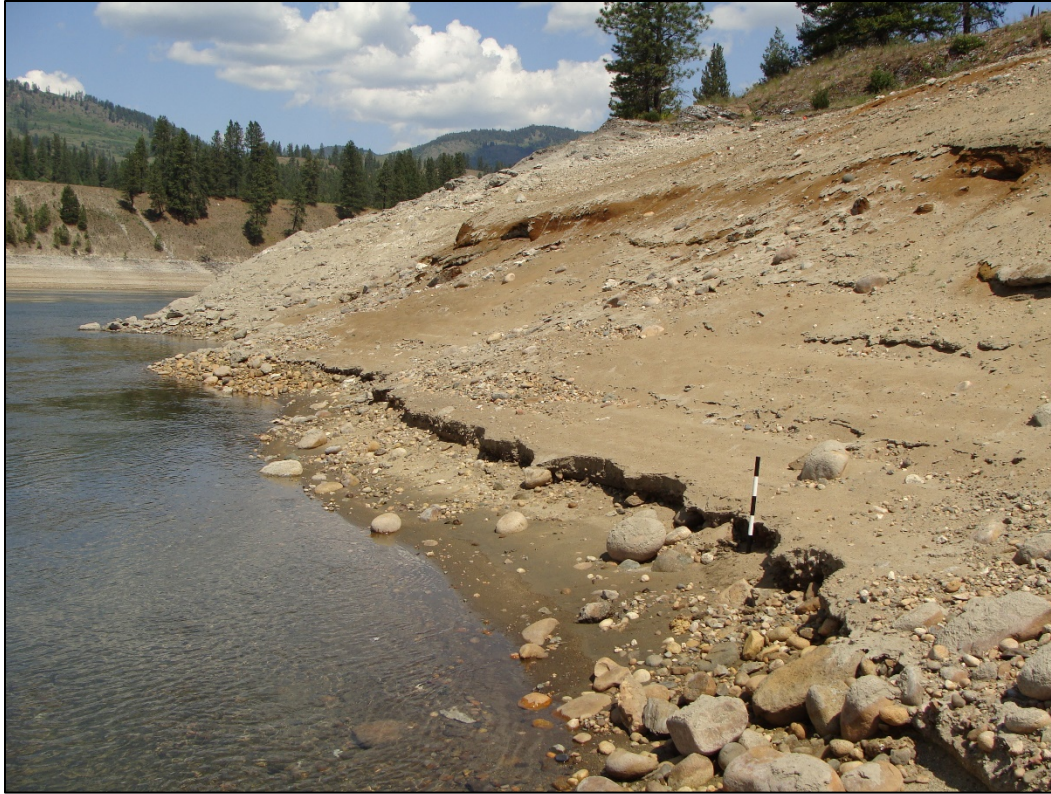
The top of the terrace at Marble Beach ranges from elevation 1295 to 1314 feet above mean sea level. The material consists of fine-grained sand and silt with fine gravel and cobbles. The material at the toe of the terrace (lowest elevation 1275 feet) is composed of gravelly sandy loam with rock outcropping and cobbles (USDA NRCS 2017, Figure 3-1). The bank material has little shear strength and is easily erodible. Wave action from wind and recreational boating has caused substantial erosion and some bank slumping at the contact between the two terrace materials.

Figure 3-1. The material at the Marble Beach stabilization site consisting of gravelly sandy loam with rock and outcropping and cobbles.

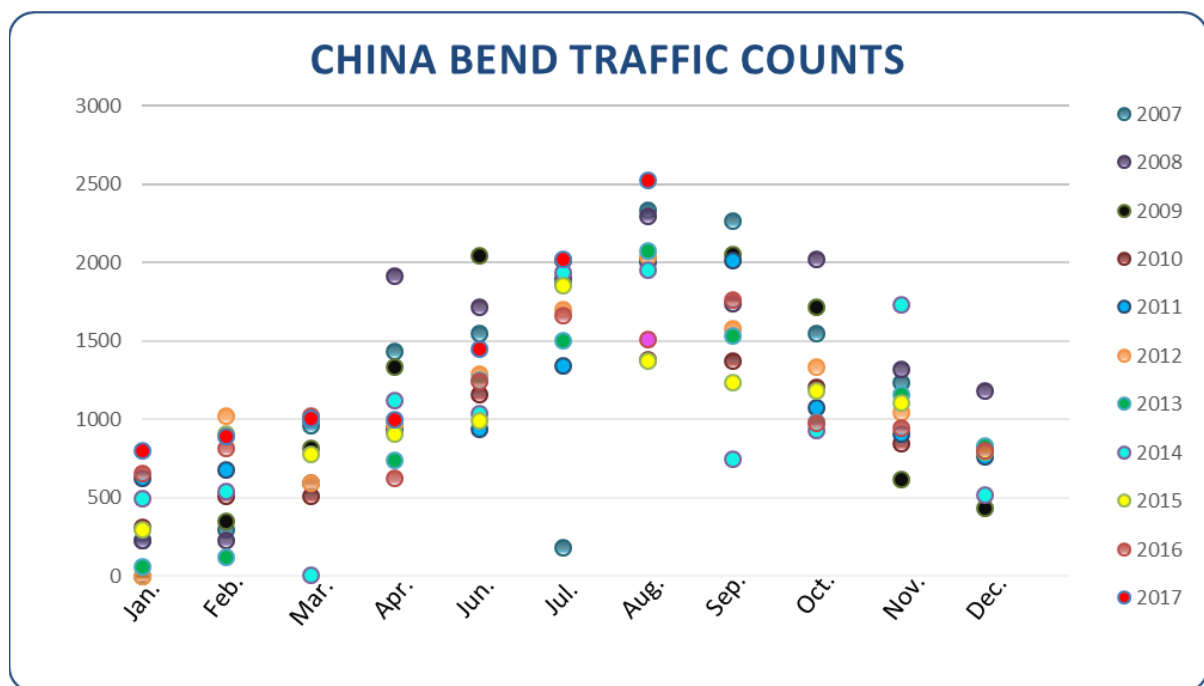
Figure 3-2. Traffic control counts at China Bend

Traffic counts are used to extrapolate visitor use numbers and track user trends at China Bend over time. Traffic counts provided by the NPS (Edwards 2017) demonstrate use trends between 2007 and 2017 (Figure 3-2). Traffic counts have shown that visitation at China Bend has remained relatively stable. In 2017, there was a spike in the total number of vehicles entering the site. July, which marks the peak of the season, received 2,531 vehicles, an increase from the previous 3-year average of 1,613. This spike may be related to the new sturgeon harvesting season. On an average year in July (based on the previous 3-year average), there would be about 52 vehicles daily, if visitation was evenly dispersed throughout the week; however, more visitation is anticipated on the weekends than during weekdays. The annual average number of vehicles for the past 10 years is 14,821.

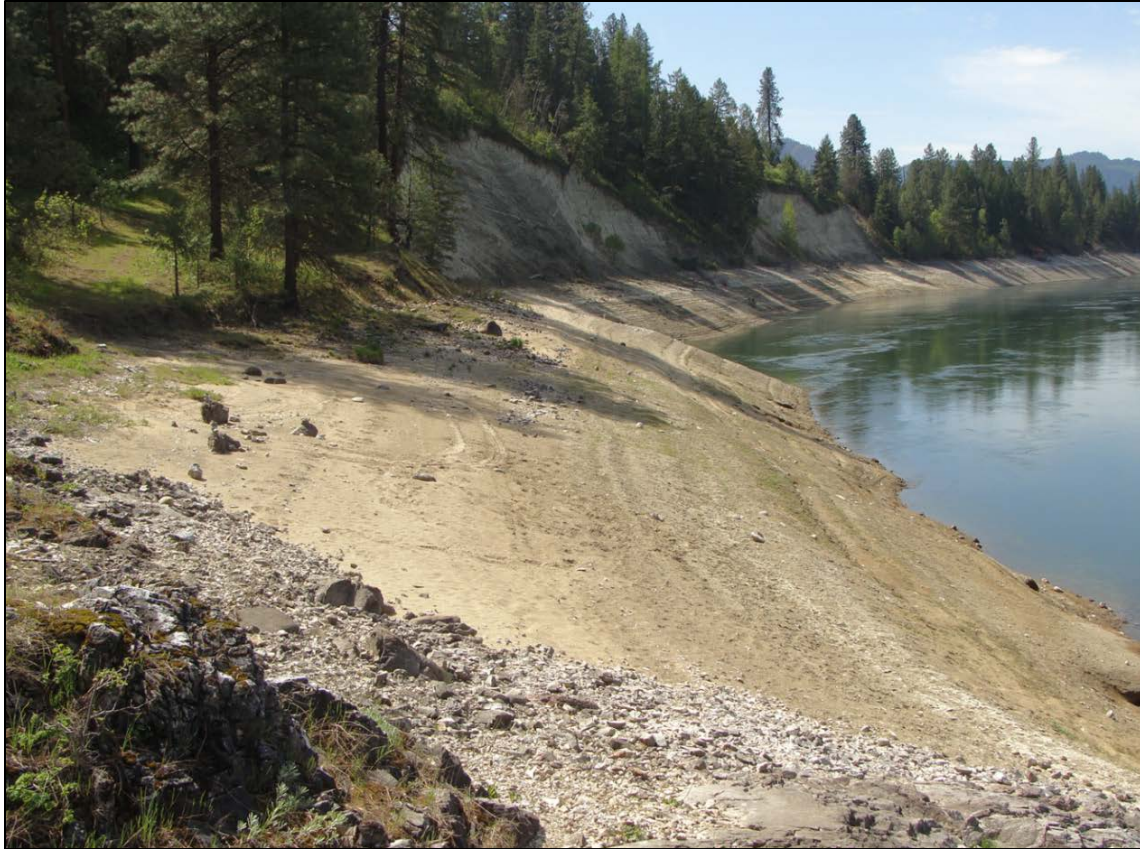
Photograph 3-1. Landscape view of Marble Beach during low water levels

The landscape views of Marble Beach change seasonally based on water levels. At lower water levels, the exposed beach provides opportunities for visitors to engage in swimming, water play, and picnicking. The beach consists of gentle slopes seen in the foreground, interspersed with rock outcrops and the occasional low-growing vegetation. The steep banks and jagged, horizontal lines of the cliff interrupt the scene and create a dramatic backdrop, which is further accentuated by the vertical lines and darker color of the coniferous forest found along the ridgeline (Photograph 3-1).

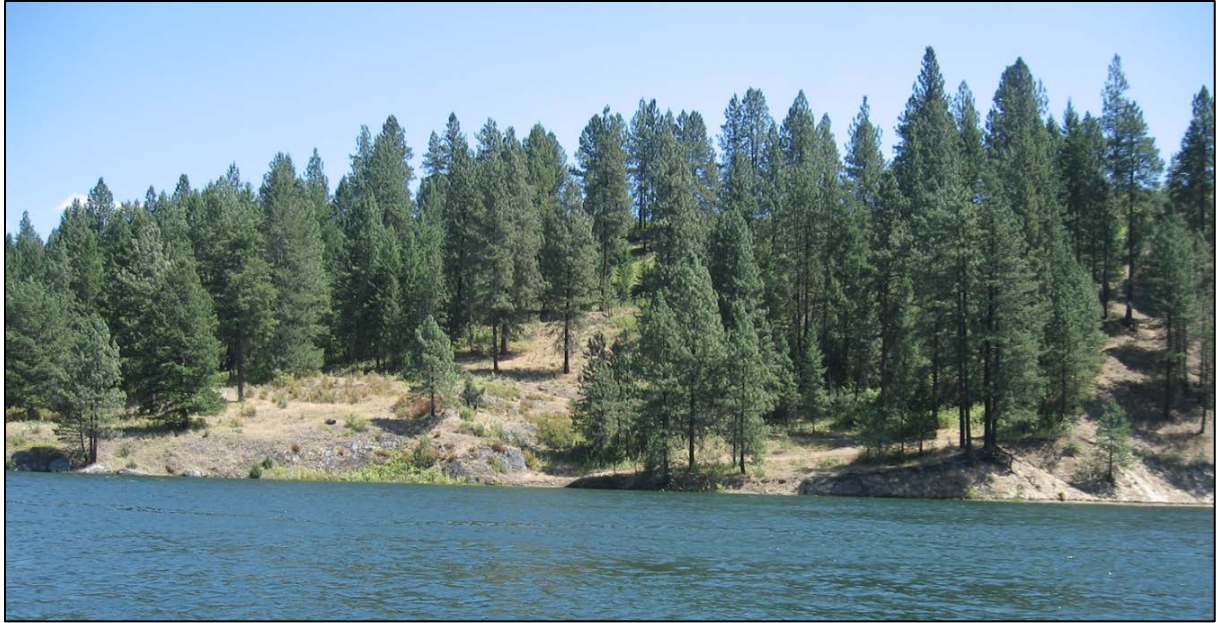
Photograph 3-2. Landscape view of Marble Beach during high water levels

As the water levels increase, the shoreline is no longer marked by the sandy soils and gentle slopes; the water level expands towards the top of the ridgeline creating a radically different view. Rock outcrops lie scattered throughout an undulating surface that rises in elevation as it moves into the background. The coniferous forest now plays a primary role in the natural landscape (Photograph 3-2).

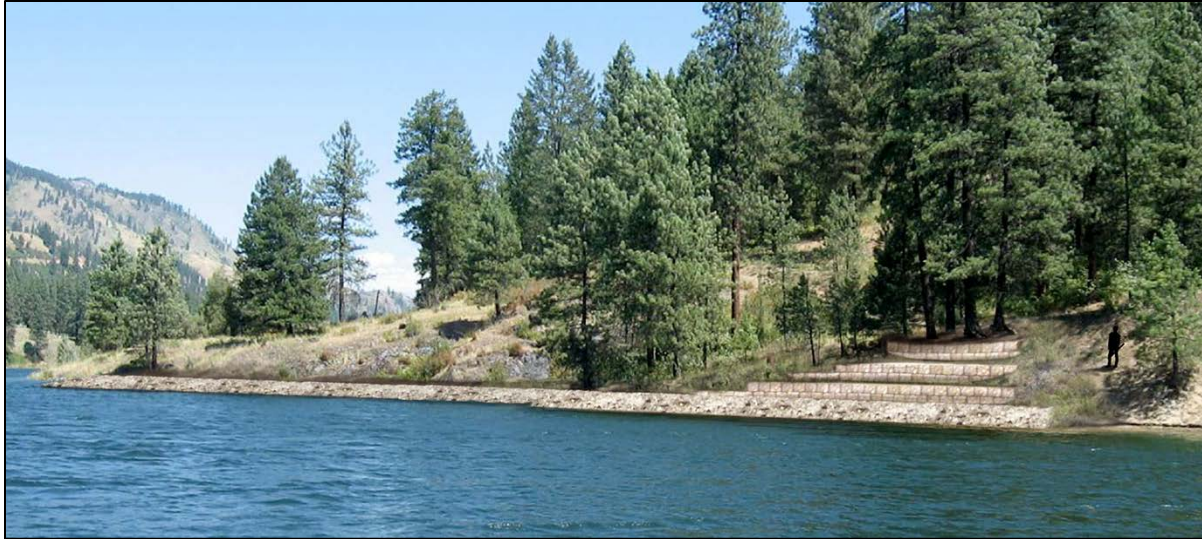
Figure 3-3. Conceptual diagram of the stabilization site with tiered retaining wall and surface-treated riprap

Bank stabilization would extend horizontally at the top of the existing slope for an approximate length of 330 feet. Stabilization would include reinforcing the lower portion of the shoreline with surfaced treated riprap and constructing a shorter three-tiered terrace (see Section 2.2.2 and Figure 3-3). The tops of the three-tiered terrace would be revegetated with native grasses, further blending the project into the natural surroundings. Construction activities would result in short-term visual impacts that would cease upon construction completion.
