Improving Public Safety of Large Wood Installations

Designing and installing safer large wood structures

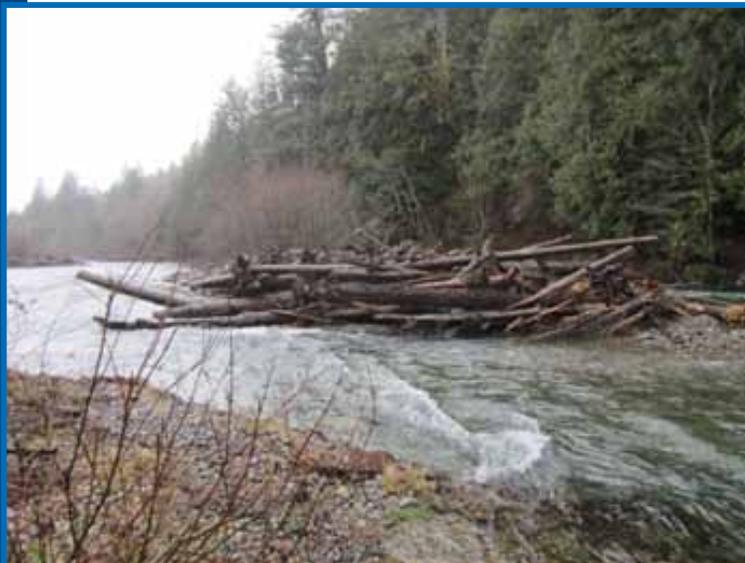
A multilog large wood structure placed in the center of the Green River, a tributary of the Colorado River.
