## Placing Half Log Structures in Reservoir Drawdown Zones to Help Endangered Fish

*Constructing onsite habitat structures in reservoir drawdown zones for endangered fish*

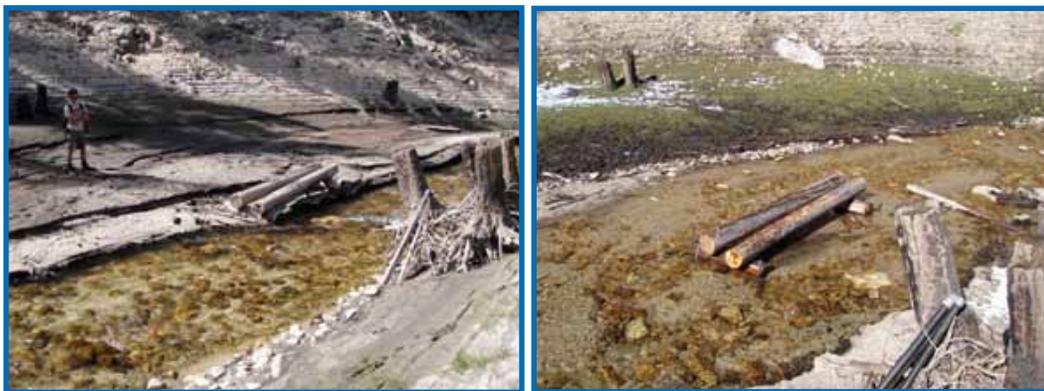
*Habitat structure in Trail Creek, a tributary to Deadwood Reservoir, Valley County, Idaho. Initial placement (left) and 1 year later (right).*

Prototype log structures were developed consisting of two “feet” and a “deck” that was secured to the top of each foot. To evaluate the most durable and functional design, each structure varied slightly.

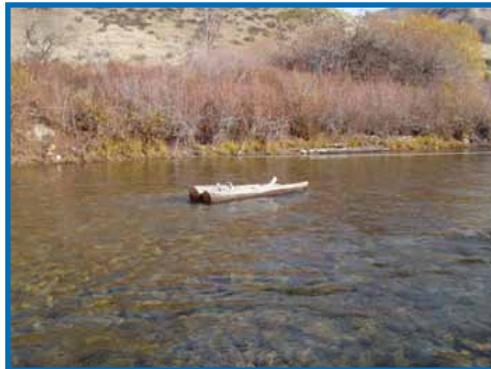
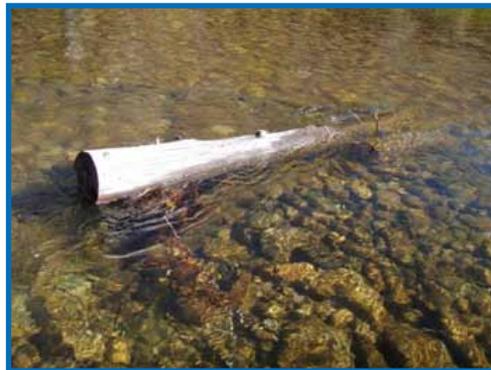
Picture of habitat structure in Middle Fork of the Boise River, Idaho. Initial placement (top) and 1 year later (bottom).

Four of the six habitat structures remained intact after 1 year; however, only two remained in the wetted channel and were functional. (The deposition of sand and fine sediment within the delta causes the channel to change course year to year; two structures became buried in sediment.)

The initial evaluation demonstrated that each structure provided some type of cover including one or more of the following: overhead, shading, velocity, or depth. Initial results varied depending on water velocity and attributes of the existing channel.
