Underwater Corrosion Condition Assessment of Hydraulic Steel Structures

Exploring state-of-the-art technologies available for underwater corrosion condition assessment of hydraulic steel structures

Research Bulletin
Science and Technology
Program
4279

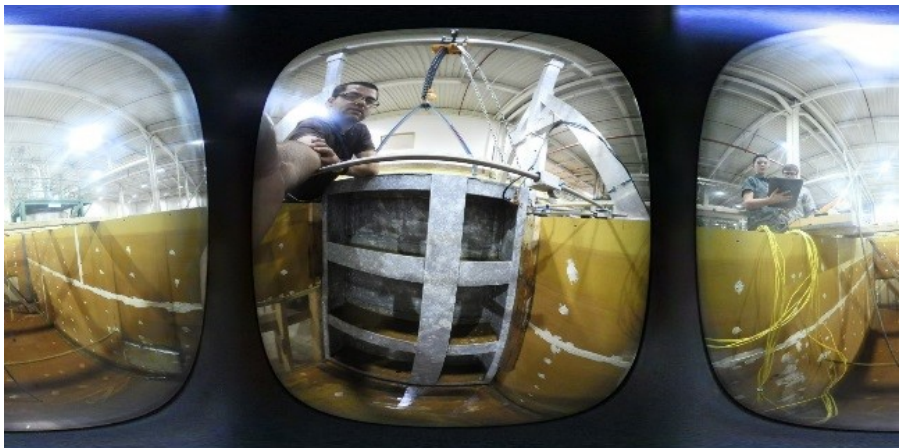
Reclamation researchers perform 360° image capture of fabricated test gate for use in photogrammetric analysis and camera evaluation.

Photogrammetry would be most useful and accurate with a reference point for the steel surface and corrosion product coloring.
