S&T Project 8141: Hoover Dam Powerplant Noise Control Research – Survey Results Post Controls Install

**Final Report No. ST-2021-PROJECT ID 8141-REPORT NUMBER 01
NCE Report #2021-006**

NCE Report 2021-006

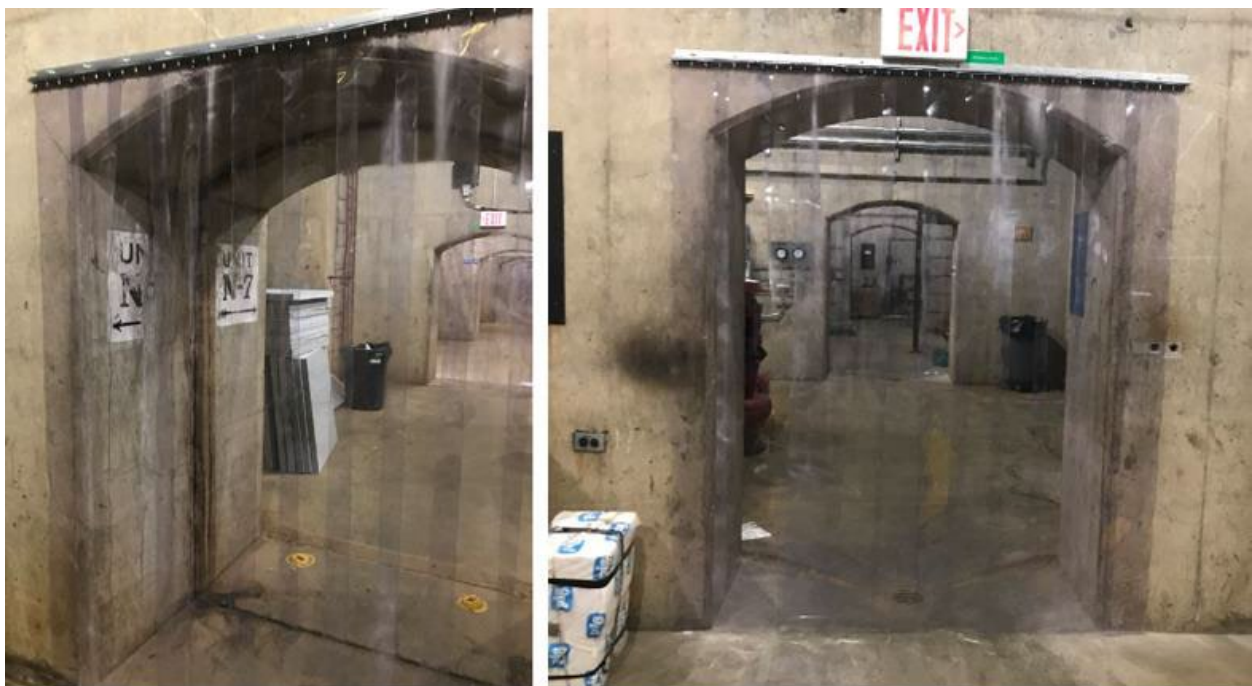
Figure 1. Flexible acoustic strip curtains installed in openings along Eductor Gallery corridor on Level 1

Figures 1 and 2 show the flexible strip acoustic curtains that were installed in all the openings between the bays of the Eductor Gallery as well as in the opening from the draft tube corridor on the Eductor Gallery side of Level 1. Figure 3 shows absorption panels that were installed in the draft tube corridors, both the main corridor leading between the Eductor Gallery and the Butterfly Gallery as well as the access corridors leading up the draft tube.

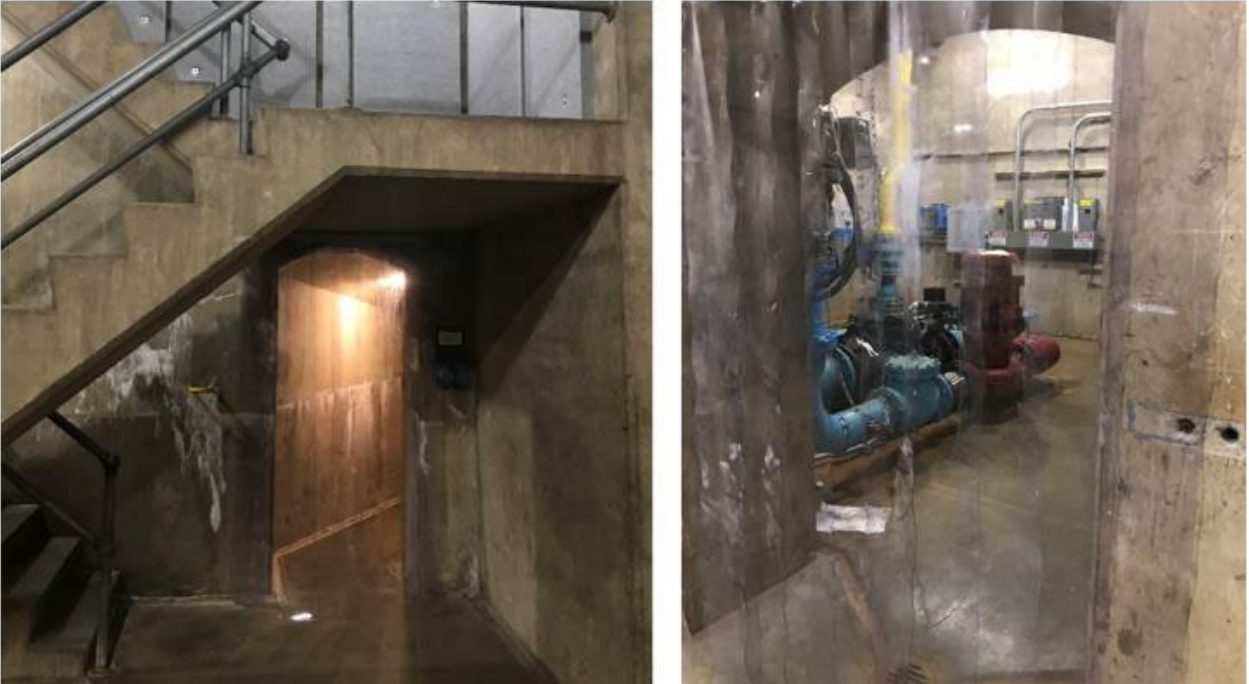
Figure 2. Flexible acoustic strip curtains in openings to eductor bay and draft tube corridor on Level 1

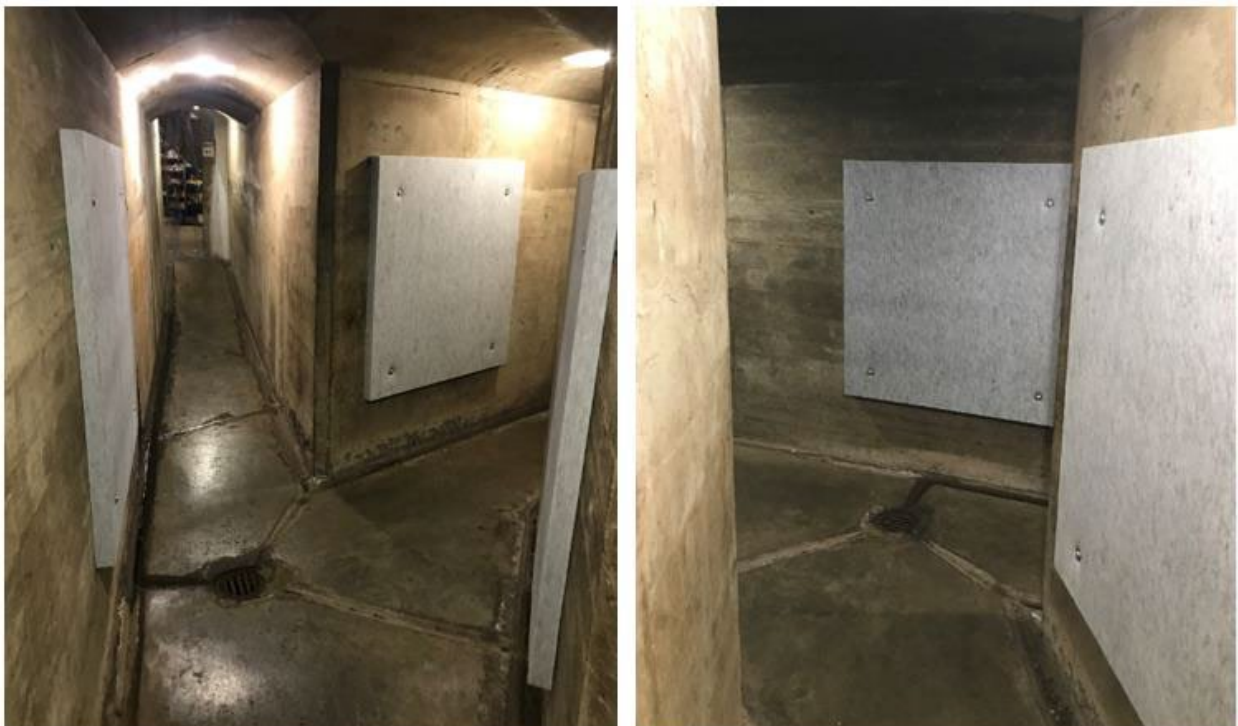
Figure 3. Absorption panels installed on surfaces in draft tube corridors on Level 1

Inside the draft tube corridors, the absorption panels that were installed resulted in a 4-7 dB reduction in noise levels for areas where conditions could be compared between tests. Noise levels were still very high ranging from 90-95 dB(A) near operating units for both wings. Only a relatively small surface area of these corridors was actually treated and, if deemed necessary, noise levels could still be significantly reduced by adding more absorption material. In a highly reverberant space such as this, a coverage of at least 50 percent of the total surface should be the target.

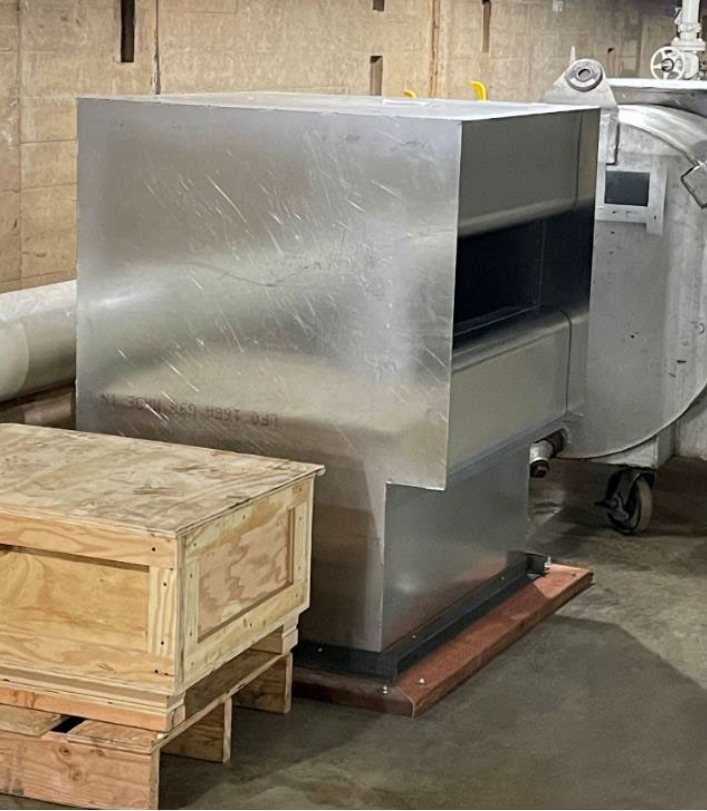
Figure 4. Acoustic silencers over vents from Eductor Gallery to Level 2 Pipe Gallery

On the level 2 Pipe Gallery, there were a number of open vents that lead directly down to the Eductor Gallery. High noise levels in the Eductor Gallery were contributing to the overall noise levels in the Pipe Gallery through these vents. To reduce this noise, silencers were designed and installed over these vents as shown in Figure 4.

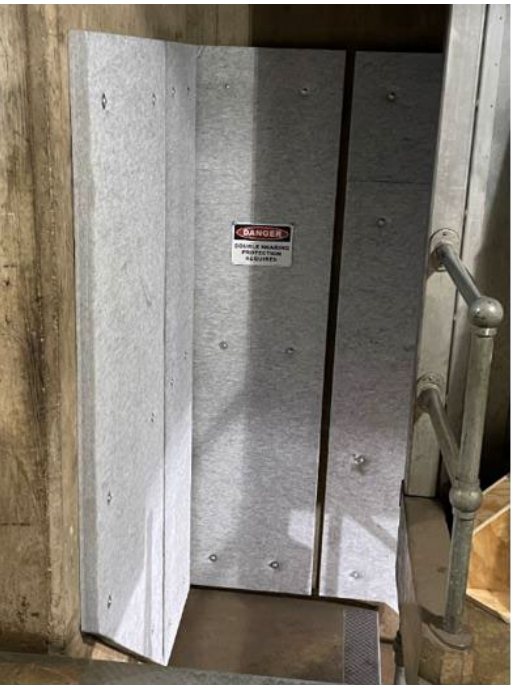
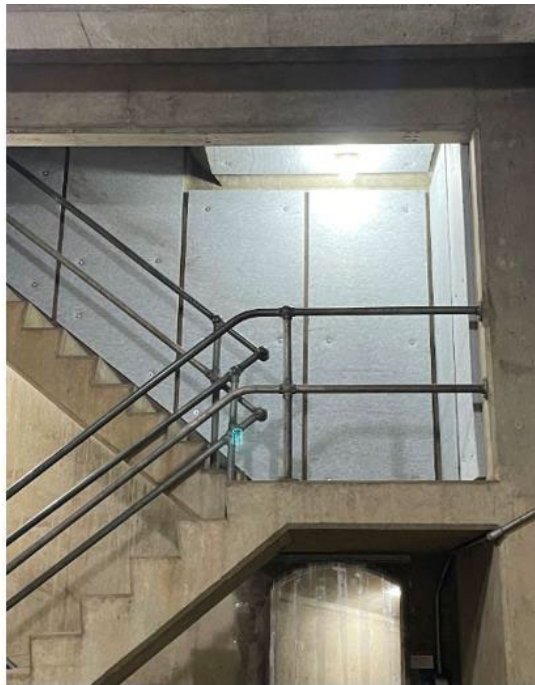
Figure 5. Acoustic absorption panels installed on stairwell from Eductor Gallery to Level 2 Pipe Gallery

Noise from the Eductor Gallery was also travelling up the staircases to the Level 2 Pipe Gallery. To reduce this noise, absorption panels were installed on the hard surfaces in the stairwells (Figure 5). Figure 6 shows these same absorption panels which were installed in the openings leading from the Turbine Gallery to the Governor Gallery in order to reduce noise entering the Governor Gallery from the Turbine Gallery.

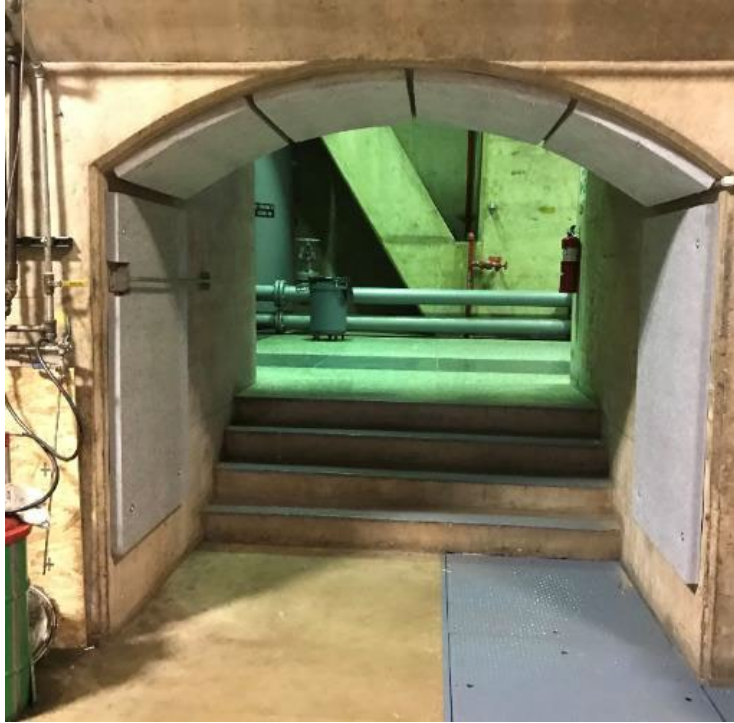
Figure 6. Acoustic absorption panels installed in opening from Governor Gallery to Turbine Gallery

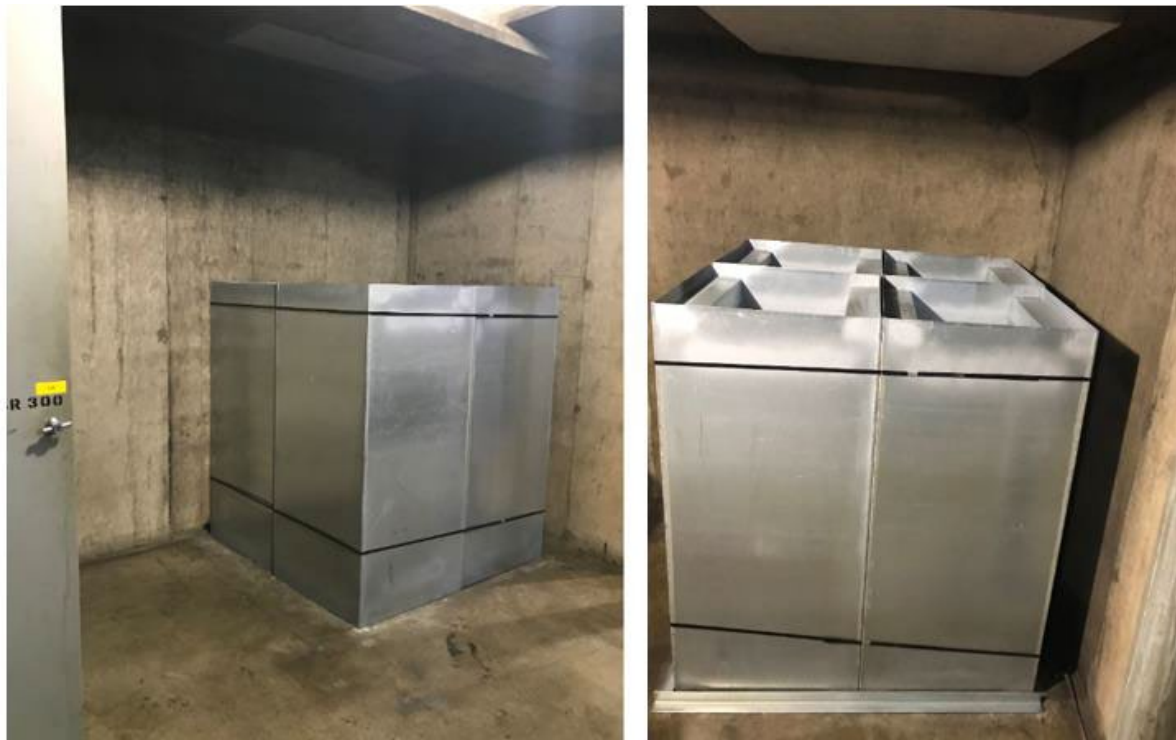
Figure 7. Acoustic silencers installed over fan exhaust vents in Cable Gallery

Noise levels in the Cable Galleries between Levels 2 and 3 were very high because of acoustical energy entering the Cable Gallery through vents in the floor leading to the lower levels. Figure 7 shows silencers which were designed and installed over these vents to reduce Cable Gallery noise.

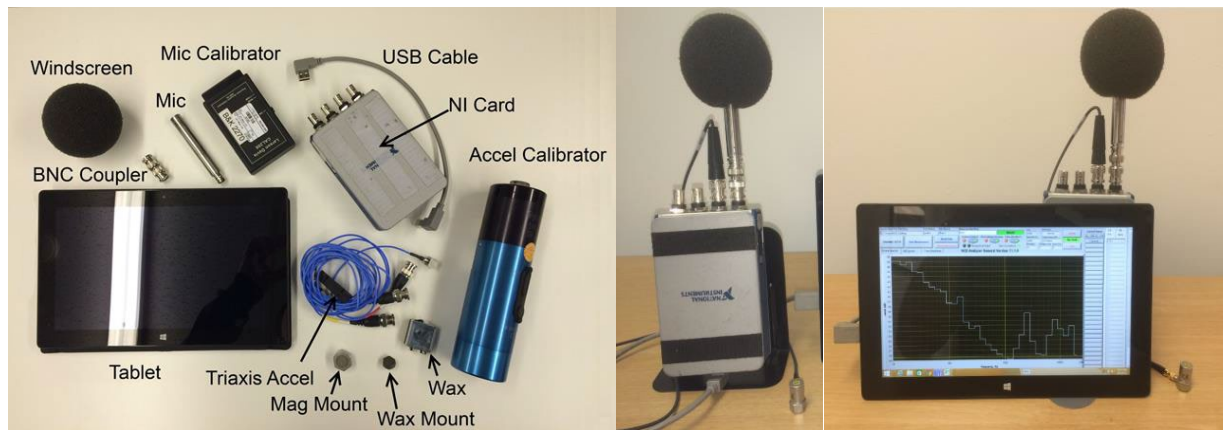
Figure 8. National Instruments/LabVIEW walk around data acquisition system

Noise data was acquired using a hand-held walk around spectrum analyzer (Figures 8 and 9). Acoustic measurements were obtained using laboratory quality microphones from PCB. All instrumentation was under calibration from a certified laboratory and in addition, at each facility, end-to-end calibrations were performed to verify sensitivity values of the measurement transducers through the complete measurement chain. The field measurements included storage of raw time data as well as narrowband and one-third octave band (TOB) analysis at multiple locations in each powerplant.

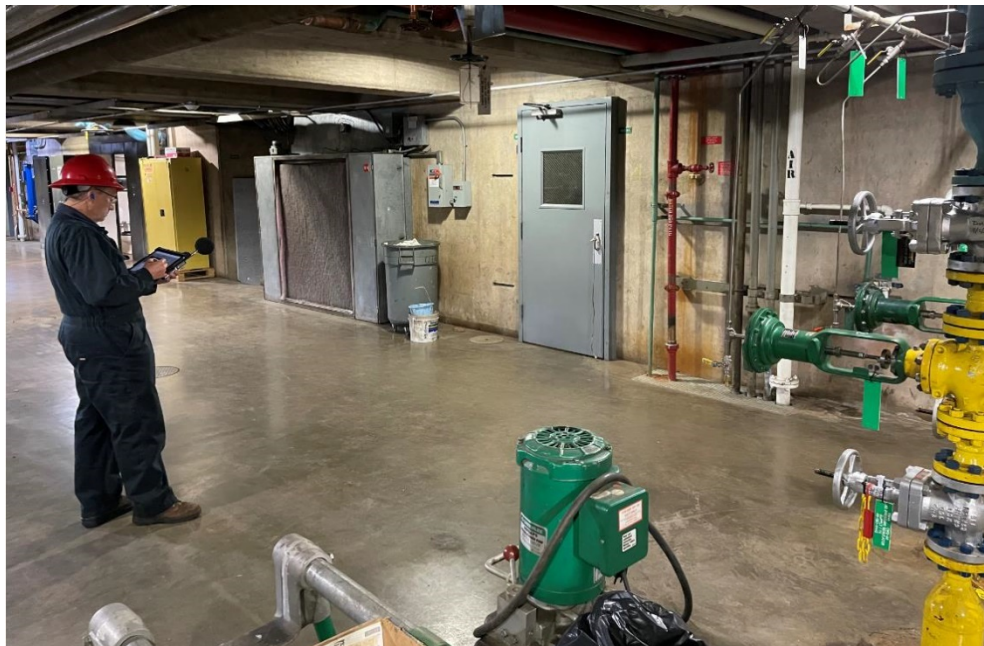
Figure 9. Typical walk around measurement using hand-held system

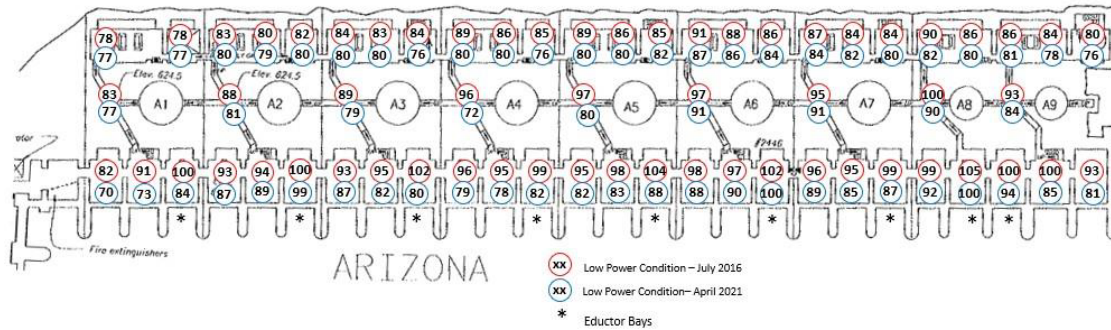
Figure 10: Arizona Plant noise levels (dBA) on Draft Tube Level (Level 1) for low power condition

Figure 10 shows the measured noise levels on the draft tube level for the Arizona Powerhouse in the low-power test condition. For the units that were operating, the loads were comparable. The difference is in the units which were not loaded. In the July 2016 test, all units which were not under load were in condense mode, which means they were spinning, and the eductors were operating. In the April 2021 test, those units, except for unit 2 which not under load were off and not spinning. For the eductor bays, noise levels for the July 2016 test were very high in every bay because the eductors were all operating, ranging from 99-102 dB(A). Noise levels in these same bays during the April 2021 test, where the unit was either operating or in condense mode except for unit 1, were still very high. This is to be expected since there was no treatment applied to the space. It is unclear why the noise level in the unit 1 eductor bay dropped. Noise levels in the bays adjacent to the eductors did see a drop in noise levels which was anywhere from 3-6 dB higher than before treatment.

Inside the draft tube corridors, noise levels were lower by anywhere from 4 to 17 dB, but again, since the units were actually spinning in the July 2016 test, the drops for this condition were most likely not due only to the treatments. For the two comparable locations, in the corridor on the opposite side of unit 1 (from unit 2), and between units 1 and 2, there was a drop of 6-7 dB. Similarly, for the Butterfly Gallery side, drops in noise levels from 2-4 dB were seen outside units 2 and 6 where the conditions were comparable. Noise levels in the other areas on this side were lower in most other locations, but again, most likely due to the non-loaded units being off as opposed to being in condense mode.

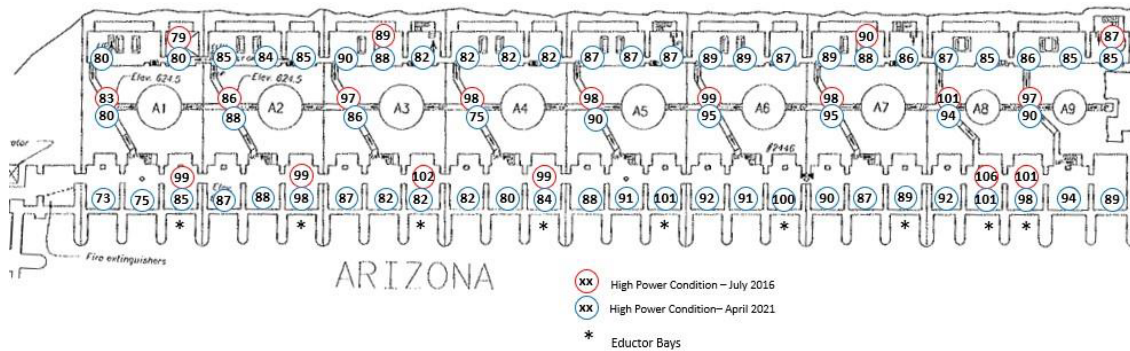
Figure 11: Arizona Plant noise levels (dBA) on Draft Tube Level (Level 1) for high power condition

Figure 11 shows the measured noise levels on the draft tube level for the Arizona Powerhouse in the high-power test condition. For units A1 and A5 through A9, conditions for both tests were virtually the same. Because of the conditions during the July 2016 test, there were only a limited number of points taken on this level at the high-power condition. For the points in the draft tube corridors where comparable conditions existed, noise levels after treatment were reduced by 4-7 dB. On the Eductor Gallery side, there were no comparable measurements for the bays adjacent the eductor bays. Noise levels in these areas were all still above 85 dB(A) during the April 2021 test near operating units, ranging from 88 to 92 dB(A). In the Governor Gallery, comparable noise levels were reduced by 2 dB, but again, near operating units, noise levels were still above 85 dB(A) ranging from 85 to 89 dB(A).

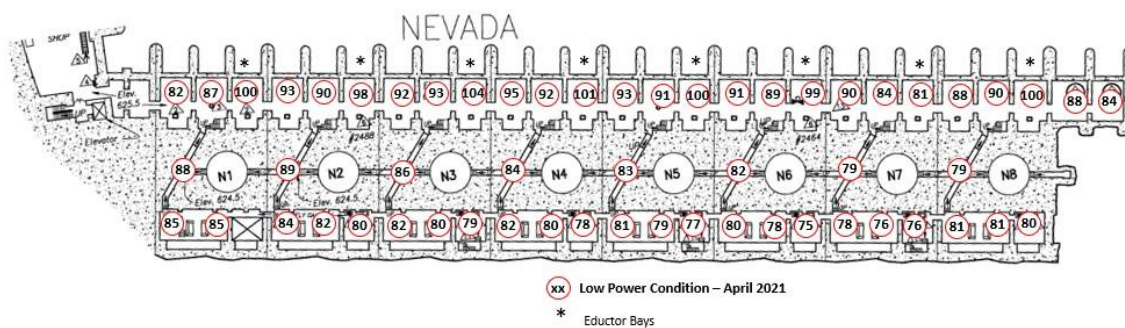
Figure 12: Nevada Plant noise levels (dBA) on Draft Tube Level (Level 1) for low power condition

Figures 12 and 13 show the measured noise levels for the Nevada plant draft tube levels for the low power and high-load conditions during the April 2021 tests after the installation of noise controls. Data was not acquired in the Nevada during the July 2016 testing. As can be seen, for the low-power operating condition, noise levels in the Eductor bays where the units were operating, or condensing (eductors operating) were consistent with the levels on the Arizona side and ranged from 98 to 102 dB(A). In the bays directly adjacent to the operating eductor bays, noise levels ranged from 87-93 dB(A). Noise levels in the rest of the bays, except for one location near unit 7, were all above 85 dB(A). In the Governor Gallery, for this operating condition, noise levels were all at or below the 85 dB(A) targets with the highest levels near operating unit 1 at 85 dB(A). For the high-power operating condition where all units were operating (except for unit 7), as expected, noise levels in the draft tube corridors between two operating units increased significantly, now ranging from 84-94 dB(A). Eductor Gallery noise levels were very similar to the low power condition with all

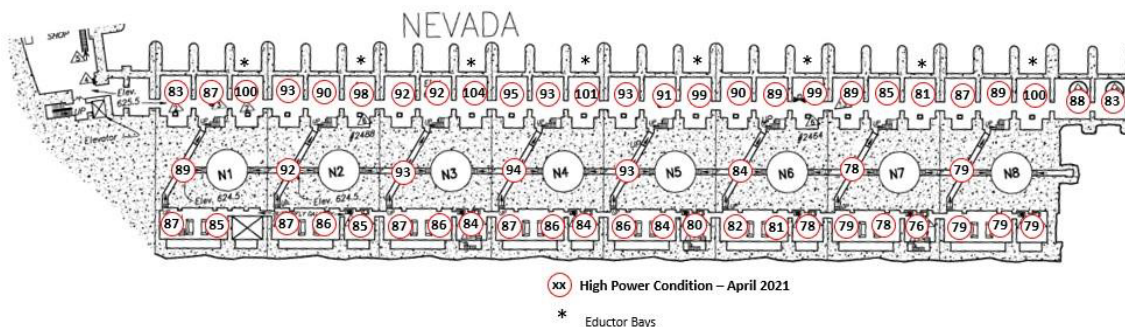
Figure 13: Nevada Plant noise levels (dBA) on Draft Tube Level (Level 1) for high power condition

bays being above the 85 dB(A) targets except for the very end bays by units 1 and 8. Governor Gallery noise levels increased slightly with many locations still at or below the 85 dB(A) targets but now a number of locations near operating units were in the 86-87 dB(A) range.

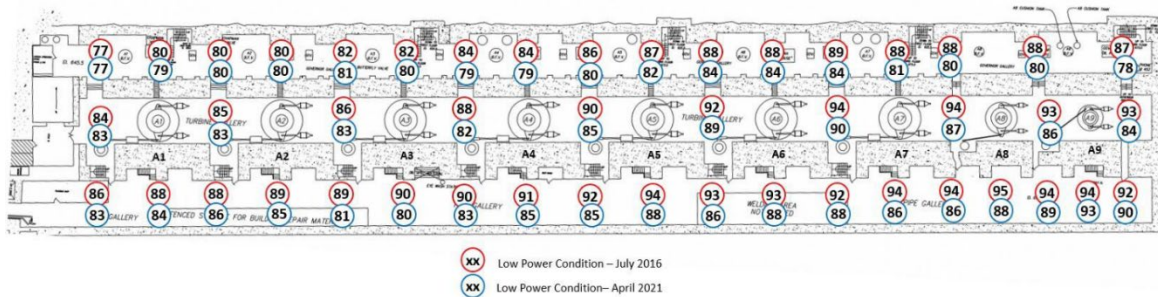
Figure 14: Arizona Plant noise levels (dBA) on Turbine Pit Level (Level 2) for low power condition

Figures 14 and 15 show measured noise levels on the Turbine Gallery level (Level 2) for the low power and high-power conditions in the Arizona plant. Absorption panels were installed in the arches of the openings between the Turbine Gallery and the Governor Gallery. In the Pipe Gallery, silencers were installed over the vents on the floor that were open directly to the Eductor Gallery below. Absorption panels were also installed on the walls of the stairwells leading down to the Eductor Gallery. In the Governor Gallery, noise levels were very comparable between the July 2016 and the April 2021 tests for the low-power condition. Near the operating units where noise levels inside the Turbine Gallery were similar between both tests, noise levels in the Governor Gallery were also similar. In other areas inside the Turbine Gallery, such as near units 2 through 5 which were off, turbine pit noise levels were 3-7 dB lower in April 2021 compared to July 2016, and the Governor

Gallery noise levels outside those units were also comparably lower. In the Pipe Gallery, noise level reductions in several areas were as high as 6-10 dB. This area is not really affected by turbine pit noise because of the doors to the turbine pit but is more influenced by noise from the Eductor Gallery below as well as the Fisher valves and generator cooling units. Throughout the Pipe Gallery noise levels were lower at all locations with reductions ranging from 1 to 10 dB. For the locations near the units which were operating in both tests (units 1, 6 and 8), noise levels were 2-8 dB lower after controls were installed. Except for the very end of the Gallery near unit 9, where levels of 90 & 93 were observed, the highest levels throughout the rest of the Gallery after controls installation was 88 dB(A). Before the controls were installed, the highest level was 95 dB(A) and the majority of the measurements ranged from 90-95 dB(A).

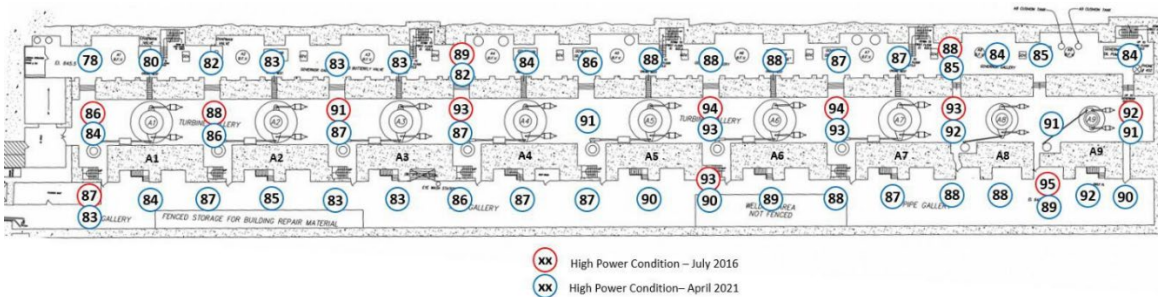
Figure 15: Arizona Plant noise levels (dBA) on Turbine Pit Level (Level 2) for High power condition

For the high load condition, except in the vicinity of units 3 & 4 which were off in the April 2021 test, noise levels inside the turbine pit were comparable between the tests. Again, due to limited availability of this condition in July 2016, only a few points on this level at this condition were measured prior to controls installation. In the Governor Gallery, between units 7 and 8, a 3 dB reduction was observed after controls installation. A 7 dB reduction was seen between units 3 and 4, but this is believed to be due to units 3 & 4 not operating in the April 2021 test. Overall, noise levels in the Governor Gallery were 85 dB(A) or below except between units 5 through 7 where the levels ranged from 86-88 dB(A). In the Pipe Gallery, measurements in the July 2016 test were all taken around operating units and for these locations, reductions of 3-6 dB were observed after controls were installed. Noise levels throughout the Pipe Gallery ranged from 83 to 90 dB(A) where before the installation, levels as high as 95 dB(A) were measured.

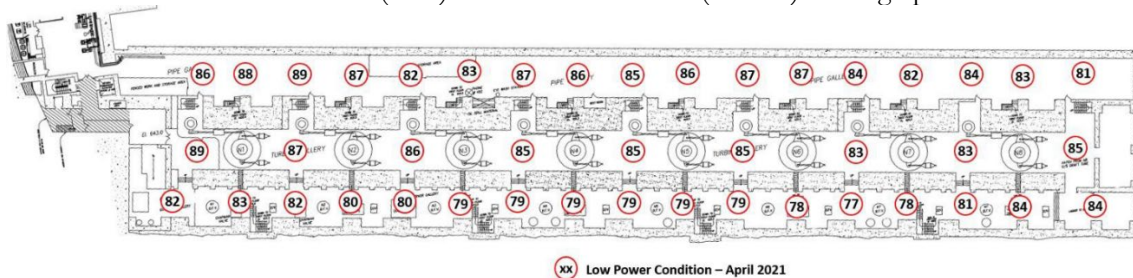
Figure 16: Nevada Plant noise levels (dBA) on Turbine Pit Level (Level 2) for low power condition

Figures 16 and 17 show the noise level measurements taken on the Turbine Gallery level for the Nevada plant for low-load and high-load conditions. Again, no measurements were taken on the Nevada side during the pre-controls July 2016 test. Noise levels in the Turbine Gallery ranged from 83 to 89 dB(A) for the low-load condition. In general, noise levels in the Turbine Gallery were comparable to the Arizona side with expected variations due to slightly different operating conditions (units in condense mode vs off). In general, around Unit 1, which was operating for tests in both plants, levels were slightly higher on the Nevada side, but probably due to Unit 2 operating in condense mode in the Nevada plant and being off in the Arizona plant. Near Unit 5 which was in operation on the Nevada side, noise levels on either side were 85 dB(A) whereas on the Arizona side, noise levels near

operating Unit 6 ranged from 89-90 dB(A). Pipe Gallery noise levels were lower in the Nevada plant with all measurements for this condition being below the 85 dB(A) targets, ranging from 78 to 84 dB(A).

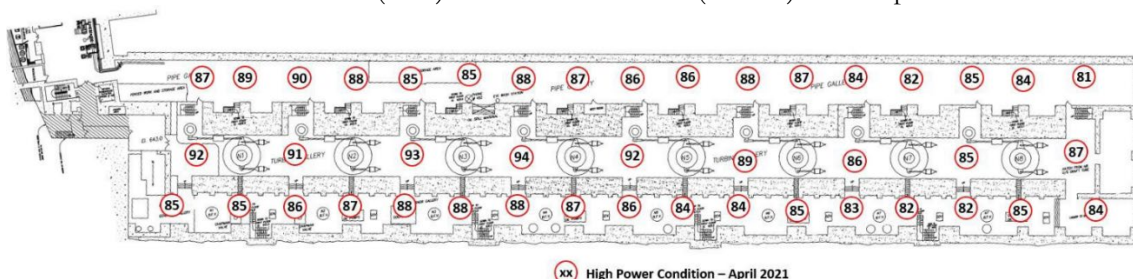
Figure 17: Nevada Plant noise levels (dBA) on Turbine Pit Level (Level 2) for high power condition

For the high-load For the high-load condition, Turbine Gallery noise levels were very comparable to the Arizona wing. Around operating units, noise levels were 91-94 dB(A). In the Governor Gallery, noise levels for this condition again were comparable to the Arizona side. Noise levels outside the openings for operating units ranged from 85-90 dB(A) with the only levels below 85 dB(A) near unit 7 which was not operating. In the Pipe Gallery, noise levels seemed slightly lower than in the Arizona wing, ranging from 84 to 88 dB(A) except near non-operating unit 7, where levels ranged from 82-83 dB(A).

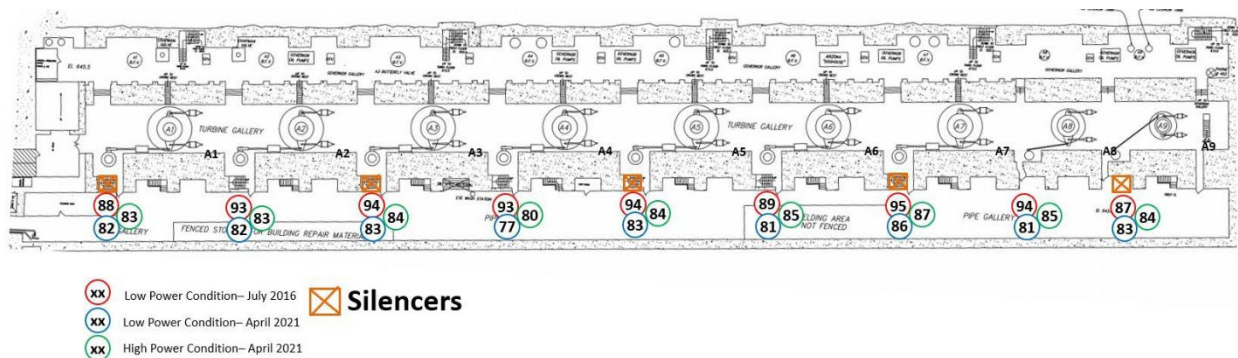
Figure 18: Arizona Plant noise levels (dBA) in Cable Gallery (Level 2-1/2)

Figures 18 and 19 show the measured noise levels in the Cable Gallery for both plants. On the Arizona side, before installation of noise controls, noise levels for the low power condition ranged from 87-94 dB(A). After the silencers were installed over the floor vents, noise levels dropped 4 to 11 dB, now ranging from 77 to 83 dB(A) with only one location near unit 7 reaching 86 dB(A). For the high-power condition, noise levels were only slightly higher with all locations at or below the 85 dB(A) criteria except for an 87 dB(A) reading near unit 7. On the Nevada side, all locations for the low-power condition were below the 85 dB(A) targets. For the high-power condition, most locations were below the 85 dB(A) target with only 2 locations near units 1 and 2 above the target ranging from 86-87 dB(A).

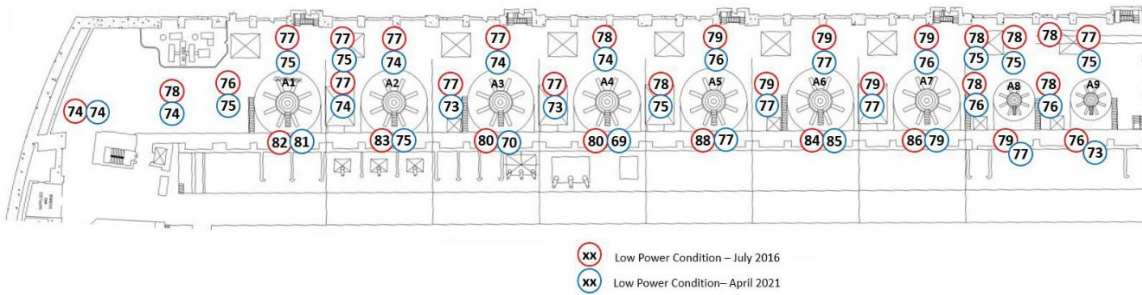
Figure 20: Arizona Plant noise levels (dBA) on Main Generator Floor and CO2 Gallery (Level 3) for low power condition

Figures 20 through 23 show the noise levels on the main generator floor (Level 3) for both plants at the low-power and high-power load conditions. There were no controls installed on this floor. All noise levels are below the 85 dB(A) targets for both conditions and the noise levels are comparable between the July 2016 and the April 2021 tests with the slight differences most likely due to the difference in operating conditions with several generators in condense mode in 2016 vs off in 2021. There were a few locations in the CO2 Gallery

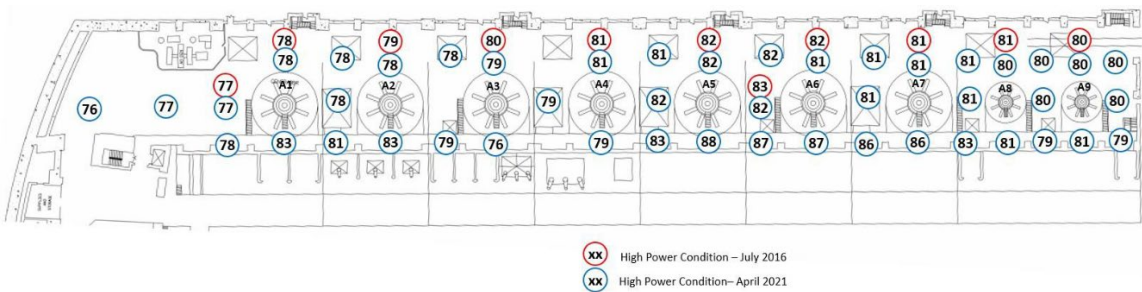
Figure 21: Arizona Plant noise levels (dBA) on Main Generator Floor and CO2 Gallery (Level 3) for high power condition

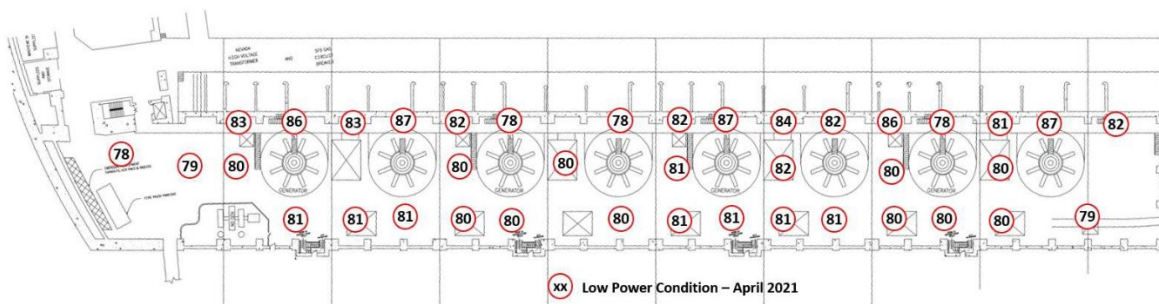
Figure 22: Nevada Plant noise levels (dBA) on Main Generator Floor and CO2 Gallery (Level 3) for low power condition

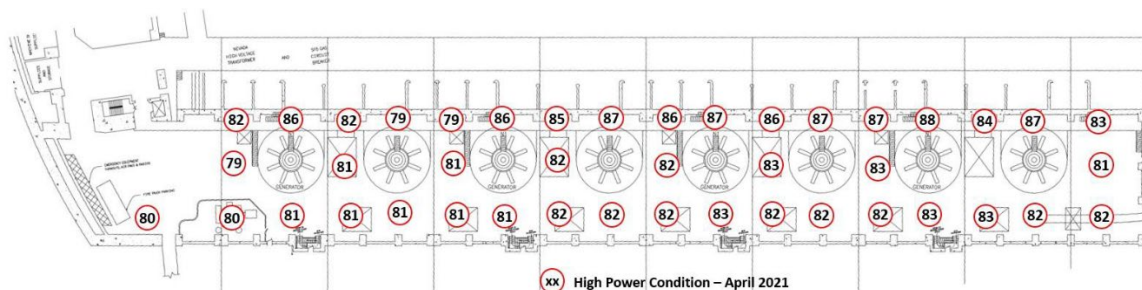
Figure 23: Nevada Plant noise levels (dBA) on Main Generator Floor and CO2 Gallery (Level 3) for high power condition

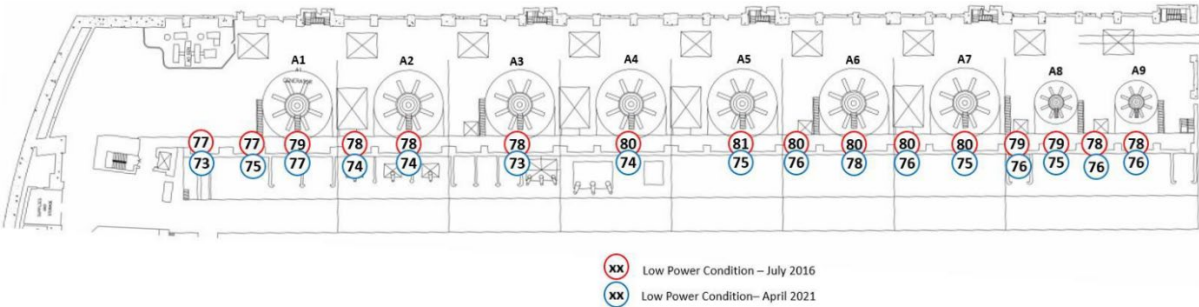
Figure 24: Arizona Plant noise levels (dBA) on Generator Top Level (Level 4) for low power condition

Figures 24 through 27 show the measured noise levels at the generator top elevation (Level 4) for both the Arizona and Nevada plants for the low-power and high-power loading conditions. As can be seen, all noise levels for these locations are below the 85 dB(A) for both conditions. The measured noise levels on the Arizona side are again comparable between the 2016 and 2021 tests with the differences most likely attributed to generators in 2016 being in condense mode as opposed to being off in the 2021 test.

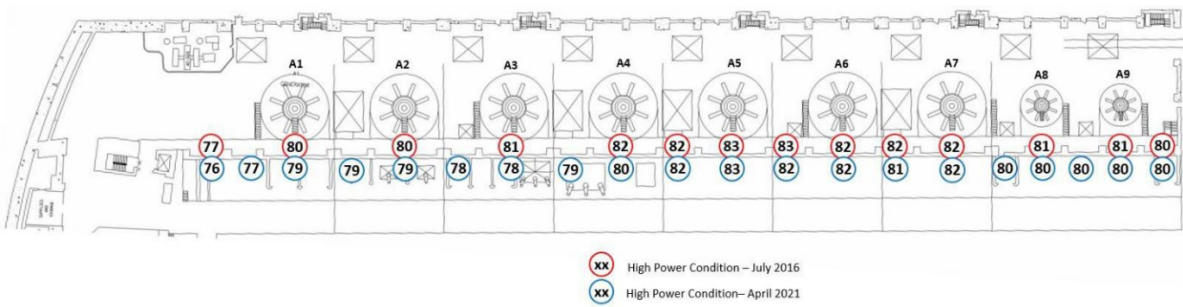
Figure 25: Arizona Plant noise levels (dBA) on Generator Top Level (Level 4) for high power condition

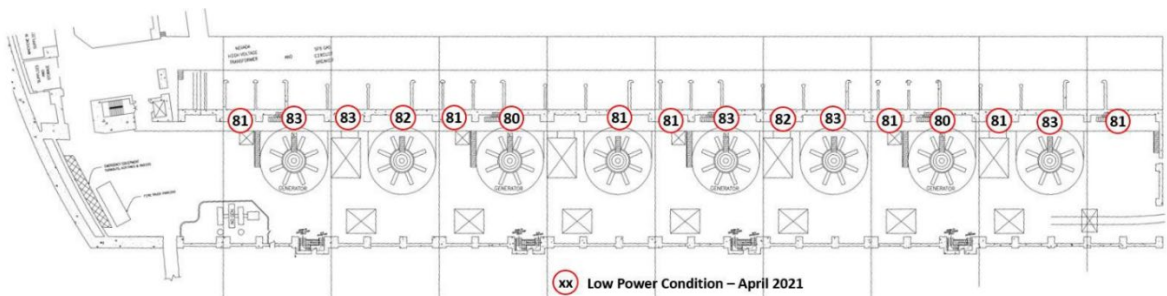
Figure 26: Nevada Plant noise levels (dBA) on Generator Top Level (Level 4) for low power condition

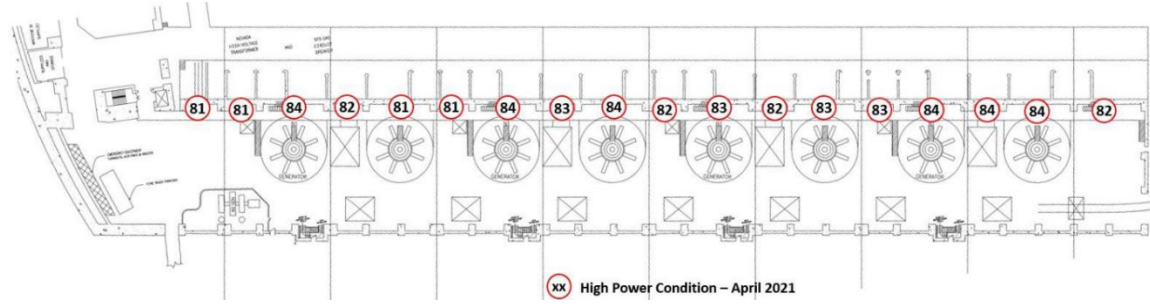
Figure 27: Nevada Plant noise levels (dBA) on Generator Top Level (Level 4) for high power condition

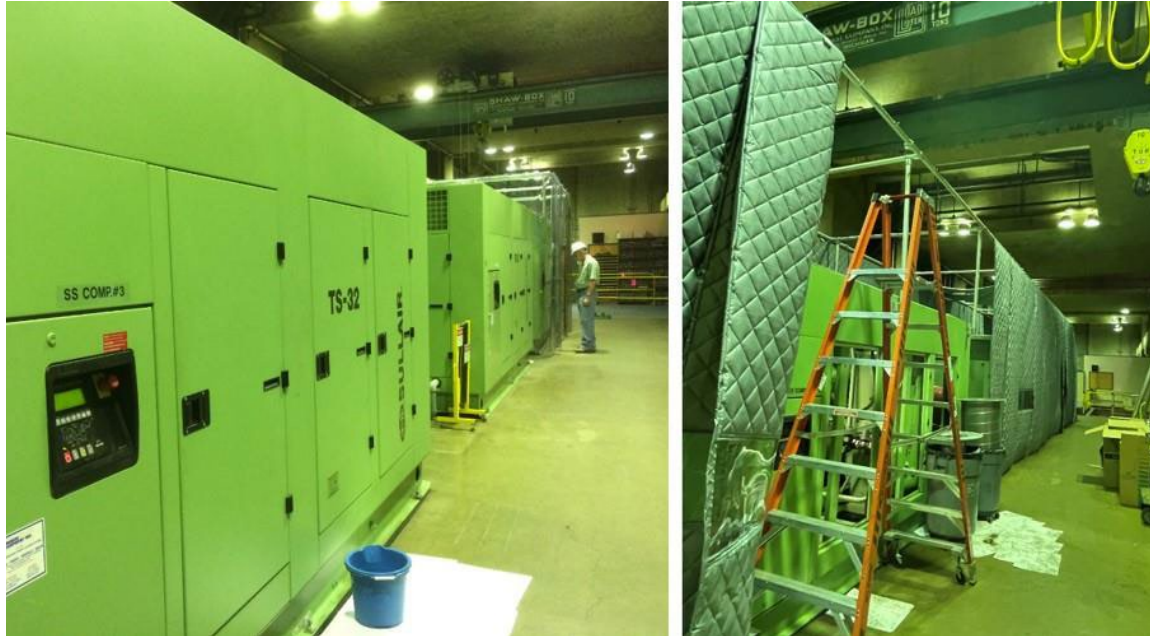
Figure 28: Before and after pictures around compressors (Level 2) showing controls

Noise measurements were taken around the compressors on Level 2 in the central plant area between the Arizona and Nevada plants in July of 2016. With only one compressor operating, noise levels ranged from 84 dB(A) to as high as 91 dB(A). As can be seen in Figure 28, there were very little noise attenuation around the compressors. The compressor housings did have some insulation and Compressor 1 did have some clear acoustical strip curtains around it, but the curtains were not sufficiently heavy to block any significant sound and they were not sealed around the compressors which allowed most of the acoustical energy into the plant area. Acoustic blankets were installed around the units, as can be seen in Figures 28 and 29.

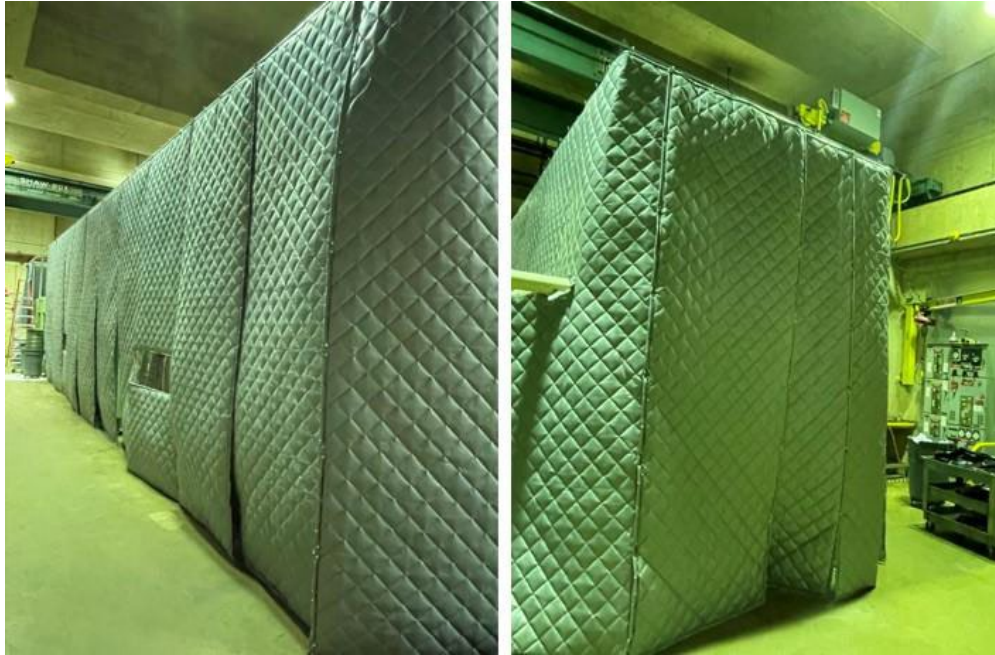
Figure 29: Acoustic blankets installed around compressors

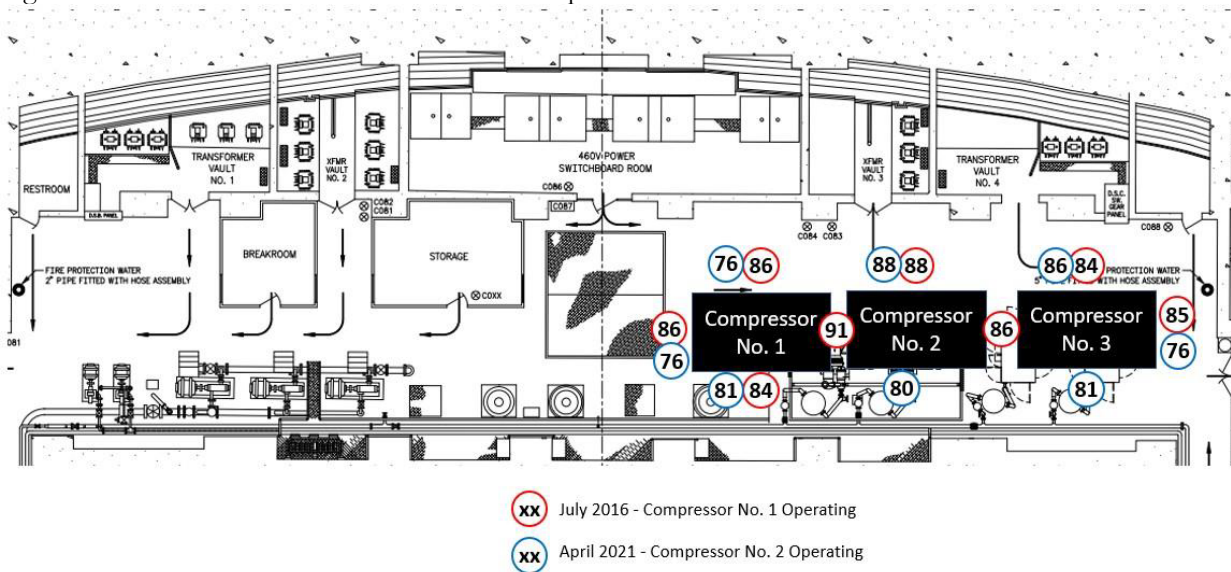
Figure 30: Noise levels (dBA) in central area around compressors (Level 2)

Unfortunately, when measurements were being acquired during the April 2021 test, work was being performed on Compressor 3 and gaps in the blankets were present. Figure 30 shows measurements acquired during both tests. As can be seen, noise levels near the side of Compressor 2, which was the only one operating during the April 2021 test, were similar to the July 2016 measurements because the acoustic blankets were not closed. On the back side of the compressors, where the blankets were sealed, the noise level, even right next to the operating compressor was 80 dB(A) compared to a comparable measurement of 84 and 86 dB(A) next to compressor 1 during the July 2016 test. On the end of Compressor 3, after the blankets were installed, the noise level measured was 76 dB(A) compared to 85 dB(A) during the July 2016 test, even though the operating compressor (No. 2) was closer to this point than the July 2016 test when Compressor 1 was operating.

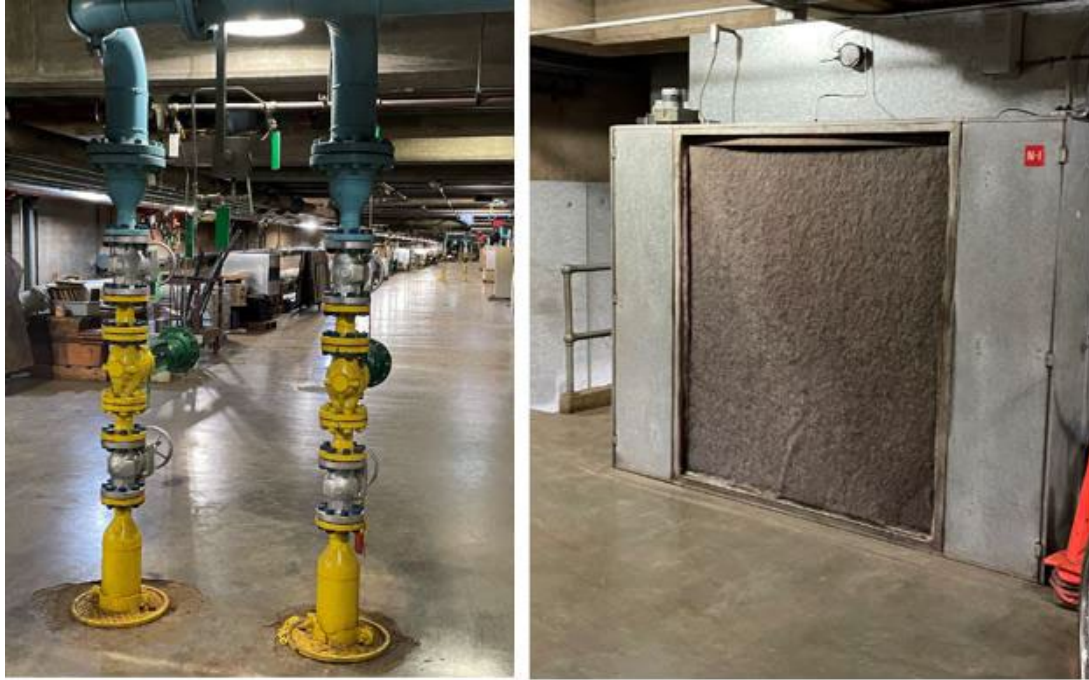
Figure 31: Fisher valves and generator cooling air exhaust

The silencers which were installed on the floor vents and the absorption panels installed in the stairwells leading to Level 1 significantly reduced noise levels in the Pipe Gallery by treating the highest sources. However, noise levels at many locations near operating units are still above the 85 dB(A) targets reaching as high as 88 dB(A) in the Nevada Wing and as high as 92 dB(A) near Unit A9 in the Arizona Wing. The sources of these continued high noise levels are the Fisher Valves and air flow from cooling air exhausts (Figure 31). It is believed that of these two sources, the Fisher Valves are the highest contributor to current noise levels and additional engineering controls should be explored. Possible controls which could eliminate at the source could include noise attenuators such as Fisher Whisper trim cage, vent diffusers, and noise attenuation trim. In addition to these primary options, these valves and associated piping could be wrapped with cladding material which is of the same construction as the acoustic blankets used to enclose the compressors. If additional reduction in noise levels is still needed after this treatment, then control options to reduce noise from the exhaust opening can be explored.

Pipe Gallery - It is believed that the Fisher Valves are the highest contributor to current noise levels and additional engineering controls should be explored. Possible controls which could eliminate noise at the source could include noise attenuators such as Fisher Whisper trim cage, vent diffusers, and noise attenuation trim.
