# RECLAMATION

## Fiberglass Pipe Literature Review

Research and Development Office  
Science and Technology Program  
Interim Report ST-2016-9777-01

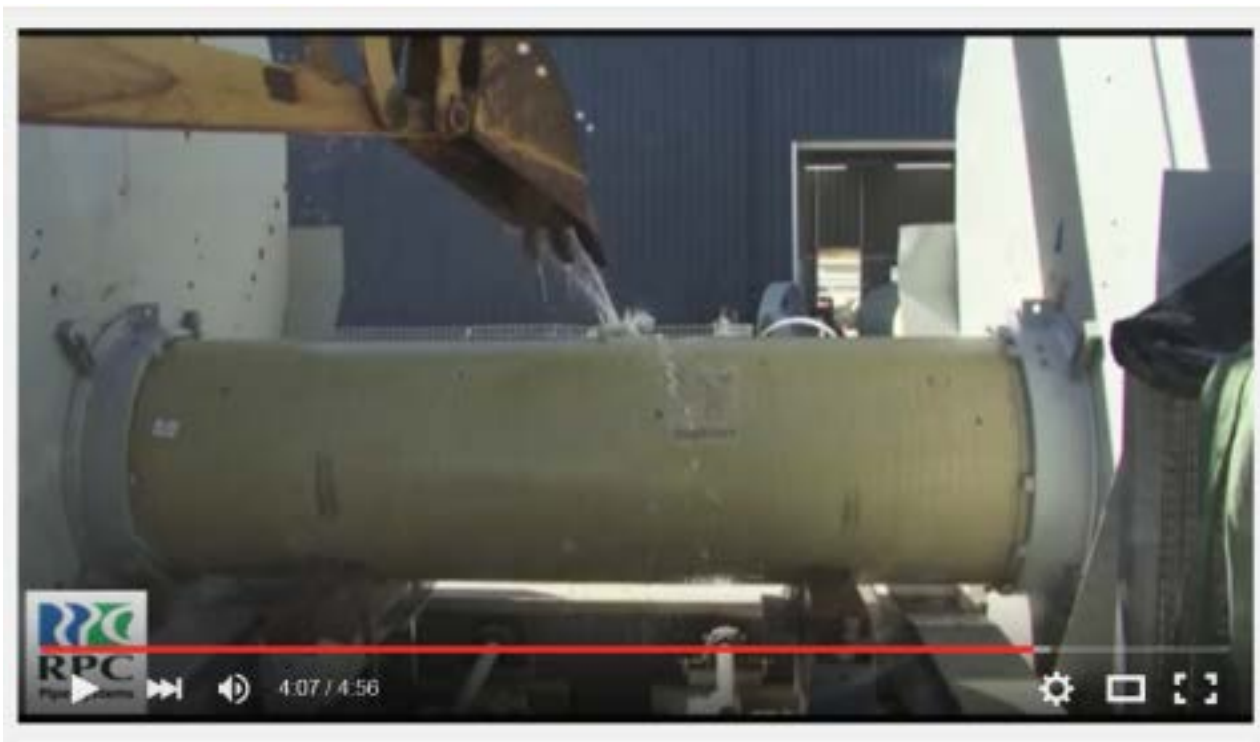
Figure 2 – Screenshot of Backhoe Impacting RPM Pipe

1. Flowtite video ([www.youtube.com/watch?v=G2Z\\_S2rhTU](http://www.youtube.com/watch?v=G2Z_S2rhTU)) [15] shows a backhoe bucket repeatedly impacting a 30-inch fiberglass pipe pressurized to 232 psi (1600 kPa). After about a dozen blows, the impacts from the backhoe cause structural damage to the pipe wall and the pipe begins to leak significantly at the impact site. The pipe leaks but does not fail catastrophically. The impact demonstration is impressive, but not readily quantifiable.

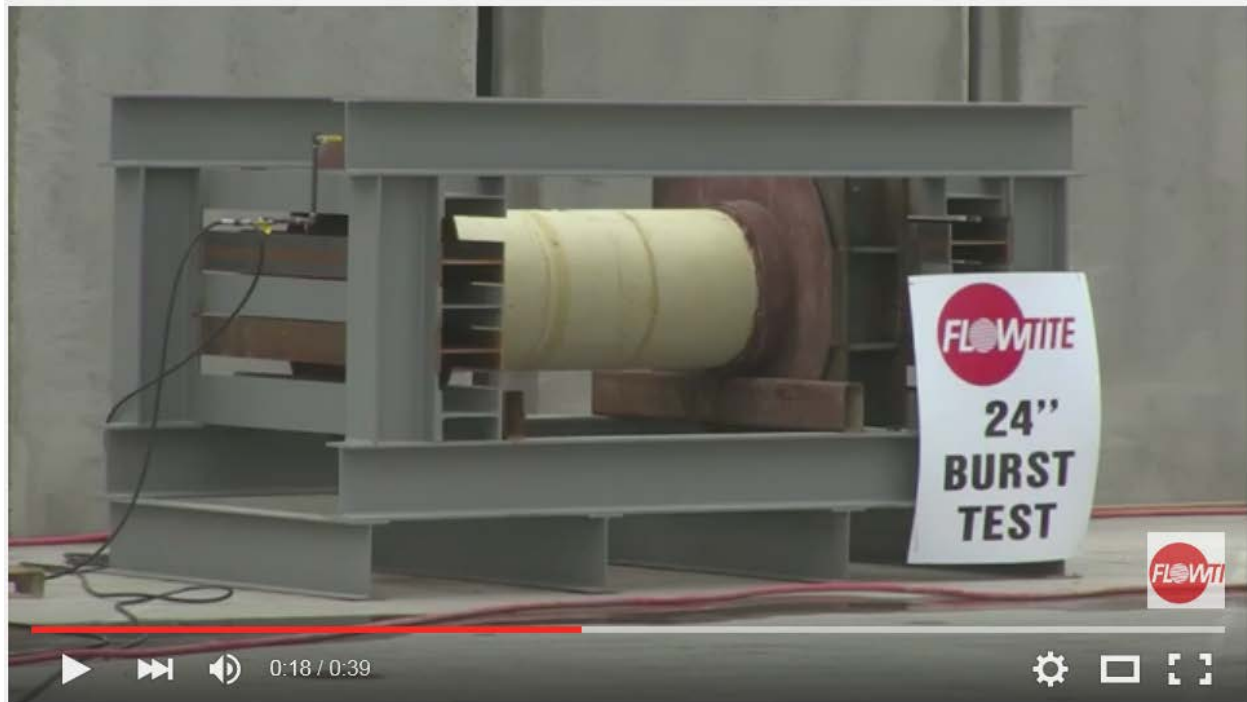
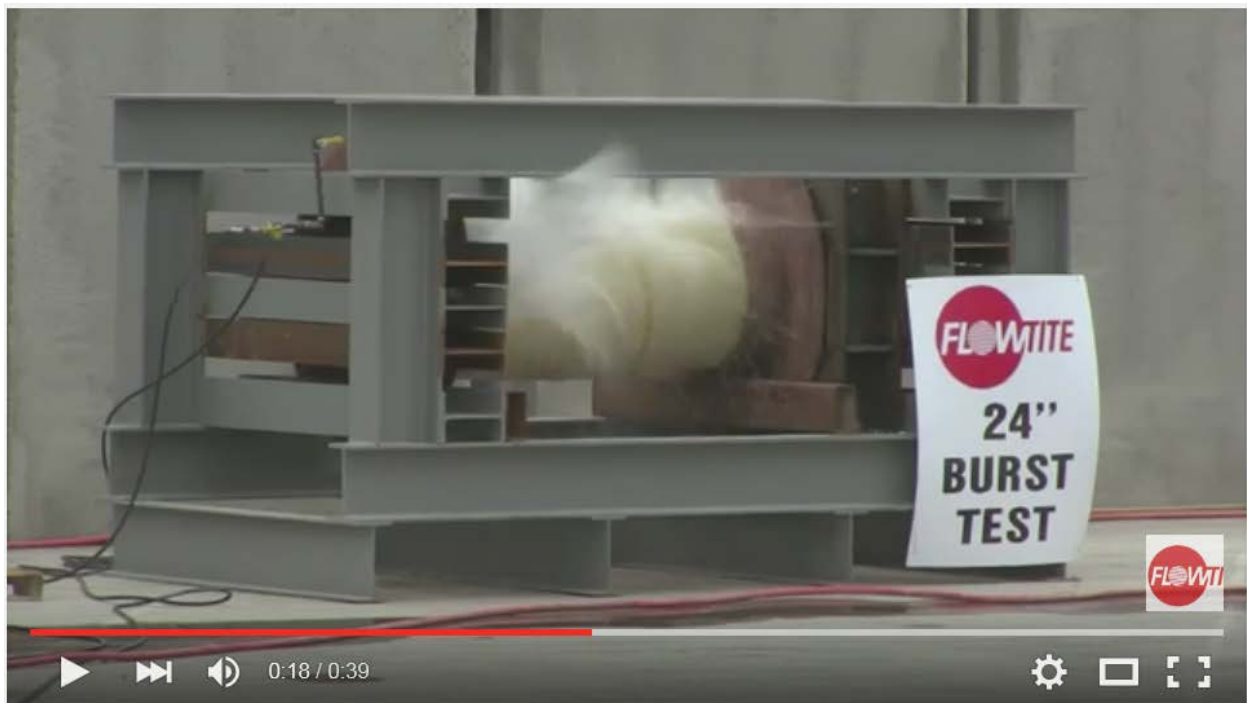
4. Flowtite video [www.youtube.com/watch?v=nQ4xSn4A0iw](https://www.youtube.com/watch?v=nQ4xSn4A0iw) [18] shows a burst of 1375 psi on a 150 psi 24-inch FRP Flowtite pipe, demonstrating a ratio of 9.2 (1375/150) between quick burst and rated pipe pressure. In the video, the failure appears to initiate at the left-hand seal, suggesting the true burst strength is higher than the demonstrated 1375 psi.

Figure 6 –Laboratory burst test on 24-inch RPM Pipe. Failure initiates at left end cap.
