Research Update

Summer 2015
Bulletin 2015-07

This research project examined Aqualastic® spray-applied polyurea to repair degraded roller compacted concrete (RCC) canal lining.

Polyurea Holds a Canal Together

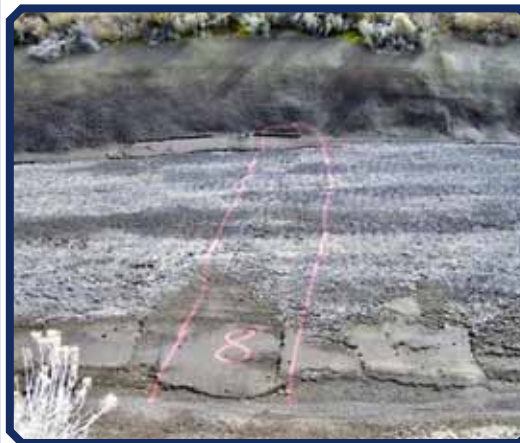
Before: Deteriorating lining from dozer tracks and previous patchwork at the toe of the slopes is typical in this area of the North Unit Main Canal, Oregon.

The North Unit Irrigation District in Madras, Oregon, partnered to provide a test bed in the North Unit Main Canal. The canal is dewatered every winter and is subject to freeze-thaw damage. The RCC lining also had dozer trackmarks left in the concrete from construction, which are prone to cavitation damage during the irrigation season.

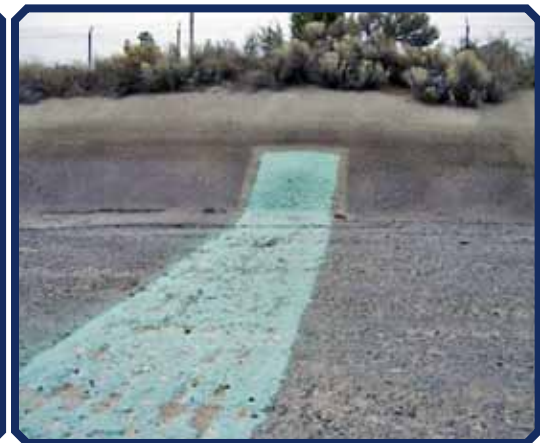
After: The test section after one irrigation season and one winter season. Adhesion to the concrete substrate is excellent and there is no cavitation damage on the coated section.

The test sections have had two irrigation seasons and one winter season to date. The test sections are doing well—no new cavitation damage, freeze-thaw damage, or direct sun exposure damage. Basic adhesion tests showed that the method of surface preparation did not show appreciable difference in the adhesion of the polyurea to concrete, based on attempts to pry the material's leading edge.

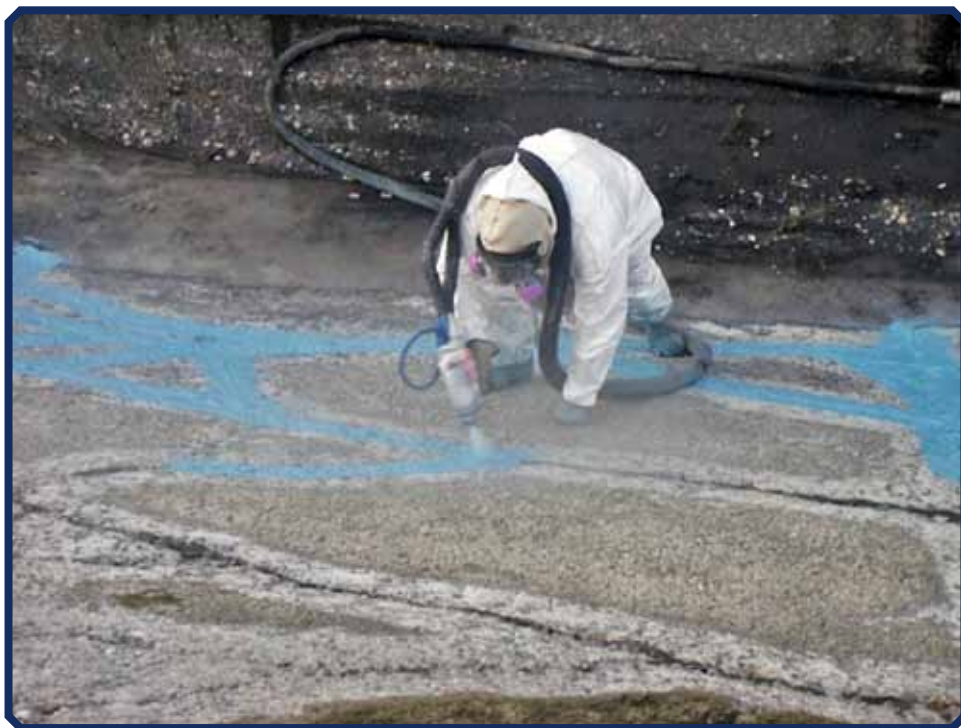
Typical equipment used to apply Aqualastic® in cracks at Roza Canal, Washington, during annual maintenance. (Note that this was not part of the test research project.)
