UV Control of Biofouling in Generator Cooling Systems

UV Reduces Maintenance Costs Associated with Biofouling in Generator Cooling Systems

Research Bulletin Science and Technology Program 1712

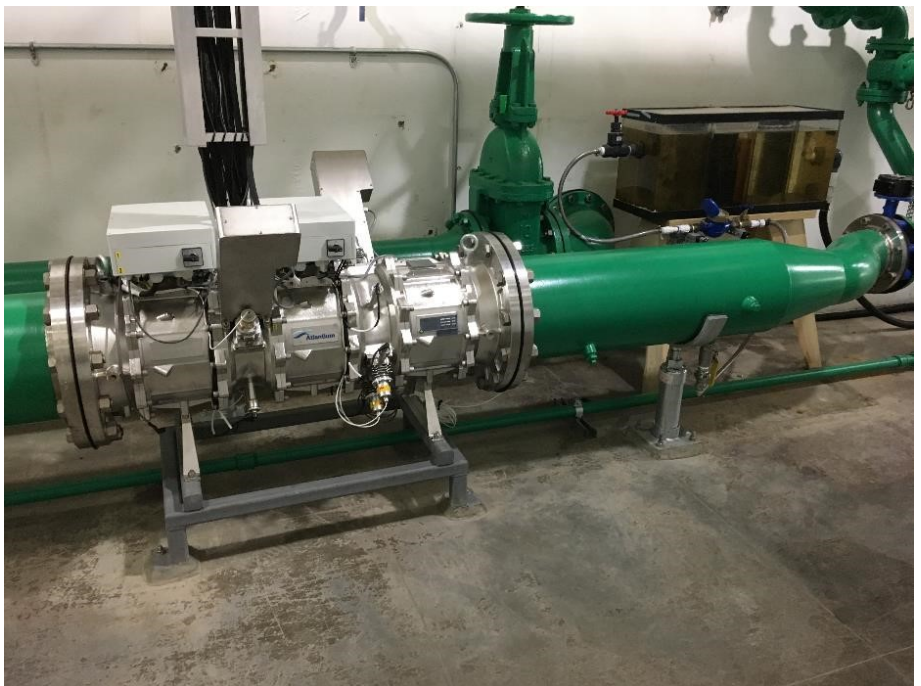
HOD UV unit installed at Parker Dam for reduction of biofouling the generator cooling systems.

The following study was conducted over a two-year period and was designed to evaluate the effectiveness of the HOD UV systems at Parker Dam for settlement reduction of multiple biofouling species.

The impact of HOD UV on biofouling was monitored by measuring the combined dry weight of dreissenid mussel, freshwater sponge, colonial hydroid, and bacterial settlement on plates in bioboxes downstream of the HOD UV units and comparing the results with data collected from an identical biobox upstream of the HOD UV.

The Parker Dam facility manager confirmed that biofouling-related maintenance of the coolers was reduced by 75 percent after the first year of HOD UV operation and eliminated in the second and third years after implementation, resulting in an estimated savings of \$80,000 per year.
