H-5 LEVEE CLOSURE SYSTEMS

H-5.1 Key Concepts

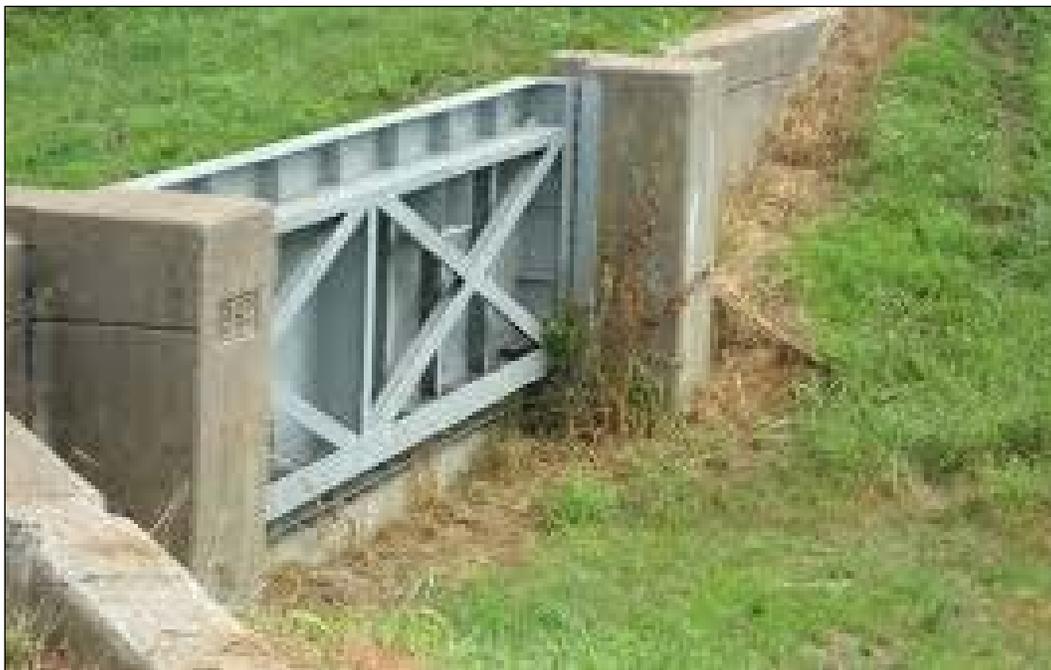
Figure H-5-1.—Example of levee/floodwall closure structure.

Levee closure systems are usually temporary structures that are put in place at openings along the embankment/floodwall to provide flood protection when the river/stream is elevated. The openings are typically for vehicular, rail, or pedestrian access through the embankment/floodwall when the river/stream is at normal levels (non-flood). A simple example of a levee/floodwall closure is shown on figure H-5-1 which shows a small gate structure used for pedestrian access.

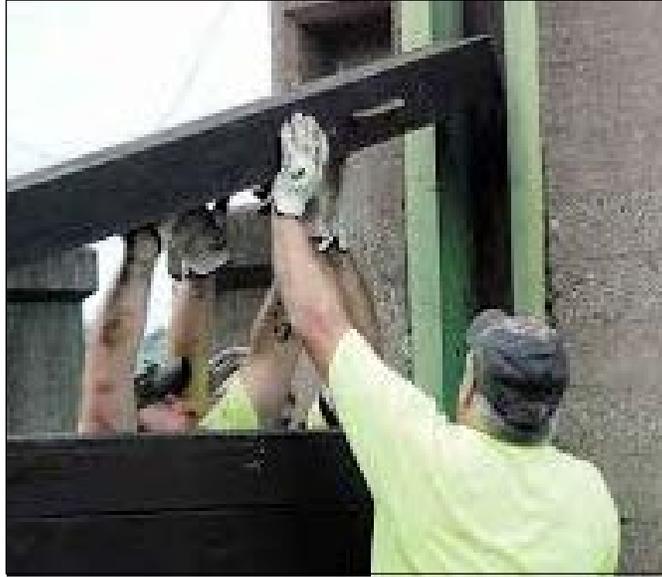
Figure H-5-2.—Setting stoplog closure.

For the purposes of this closure type, the term bulkhead and stoplog are assumed to have the same meaning and are used interchangeably. A bulkhead/stoplog closure is one of the simpler closure types used for embankment/floodwall closures. It usually involves a vertical slot that has been formed into the adjacent concrete section part of either the closure structure or floodwall itself. The stoplogs are then simply lifted into place and vertically stacked upon one another until the desired height is reached for the closure. Figure H-5-2 shows a stoplog closure being placed by maintenance personnel. Bulkhead/stoplog closures are typically used only when the opening itself isn't too wide (less than 8 feet or so) for pedestrian or single lane vehicular/bike access. Wider openings require a supporting structure, such as a frame or vertical post, and are considered under the post/panel closure style.

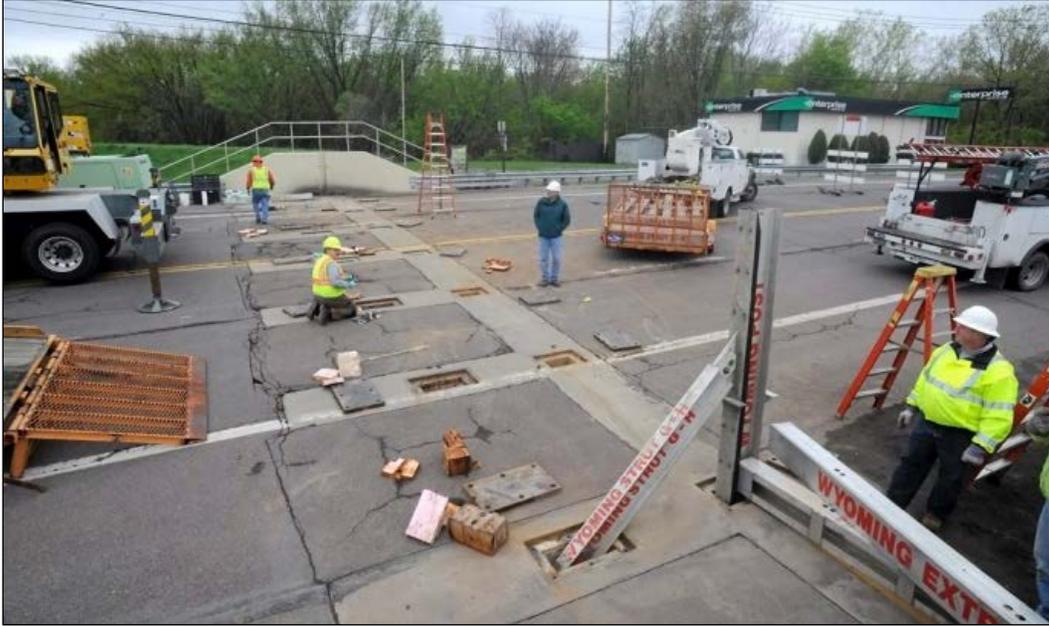
Figure H-5-3.—Installation of post/panel closure utilizing vertical support posts.

Post and panel style closures are similar to bulkhead/stoplog closures except the panels (vertical or horizontal alignment) require the use of structural support other than the adjacent wall section in order to span a wider opening. The support structure usually comes in the form of a vertical post with accompanying foundation slot or a structural frame. Examples of both of these are shown on figure H-5-3 (vertical post) and figure H-5-4 (structural frame), respectively.

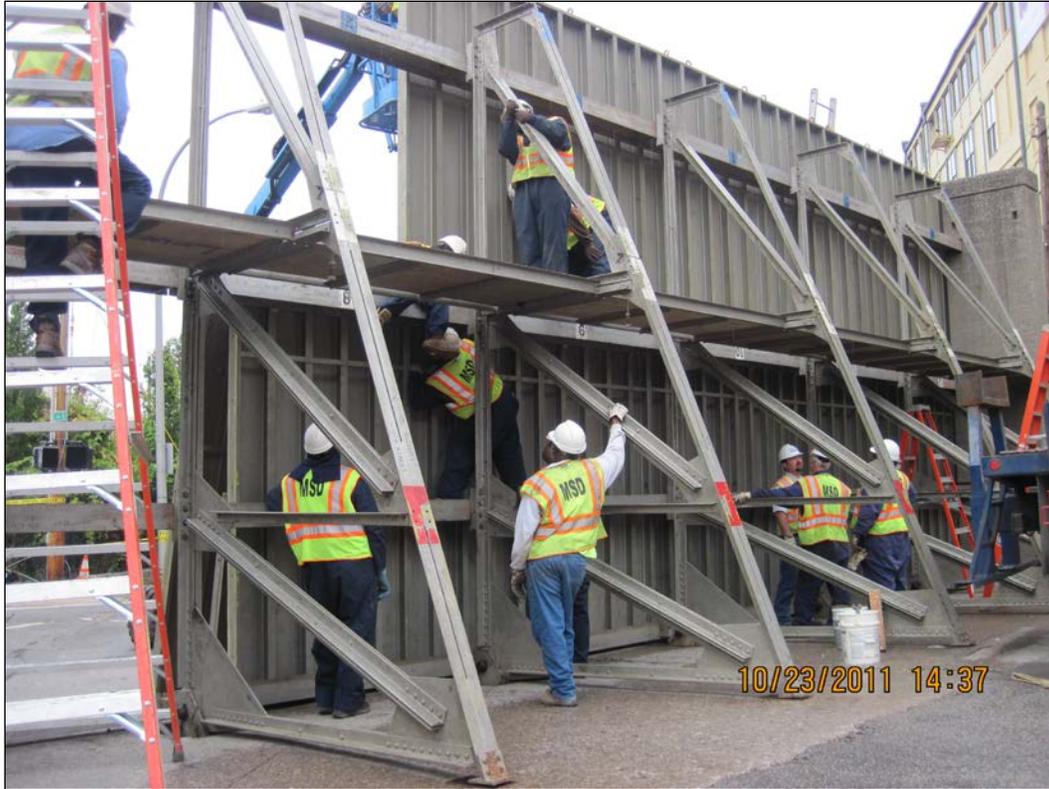
Figure H-5-4.—Setting a post/panel closure with supporting frame.

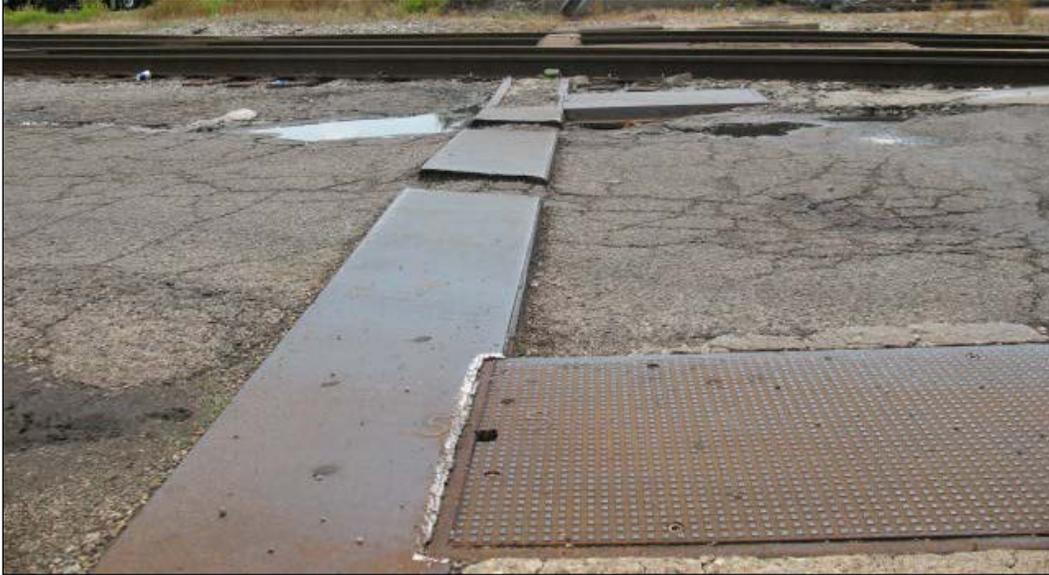
Figure H-5-5.—Deteriorated bearing sill for combination railroad and road closure.

Another significant concern with respect to both stoplog and post/panel closures is the condition of the bearing sill. There are many instances where the sills have been severely damaged from a combination of traffic, weathering, and road changes/maintenance. Figure H-5-5 shows a deteriorated sill structure for a combination railroad and road post/plane closure. There have been numerous cases where it has been so long since the closure was set that the bearing sill has been paved over and is no longer visible. The condition of the bearing sill should be included as part of the overall assessment of the closure superstructure when assessing the risk of these features.

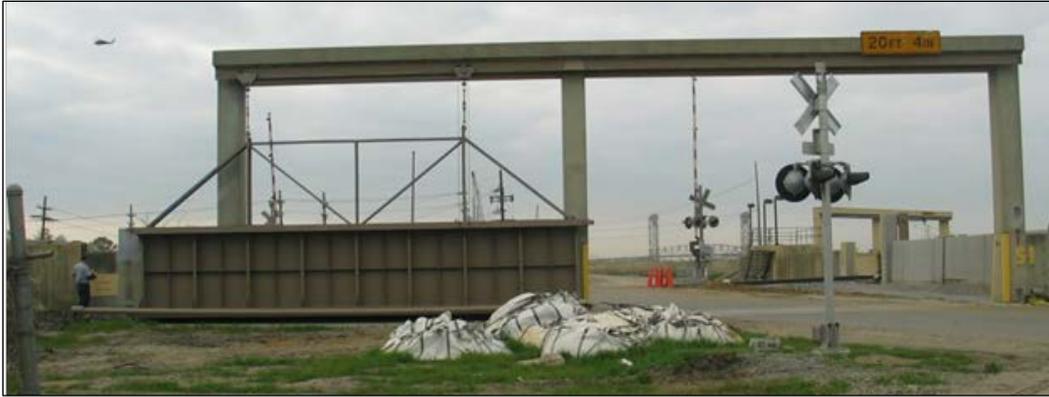
Figure H-5-6.—Overhead trolley rolling gate closure for floodwall.

Moveable gate closures are usually the simplest type of non-culvert closure to set. They are gate structures that are moved into place by either manual or mechanical means. The gates are permanently attached to the closure superstructure (adjacent closure wall section) in the recessed or open position and then simply moved into place ahead of the rising floodwaters. Once moved into their final position (recessed or closed), they are secured by some type of locking mechanism so they don't move. There are a variety of styles of moveable gate closures (overhead trolley rolling, roller, and swing gates are typical). An example of each type is shown on figures H-5-6 through H-5-8.

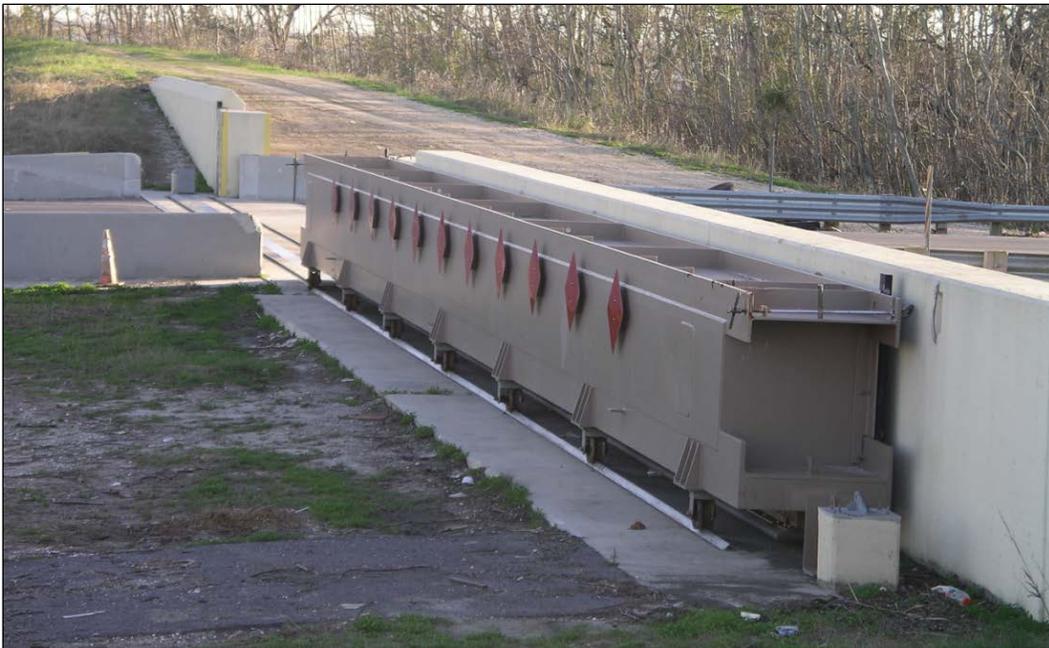
Figure H-5-7.—Roller gate at levee road crossing.

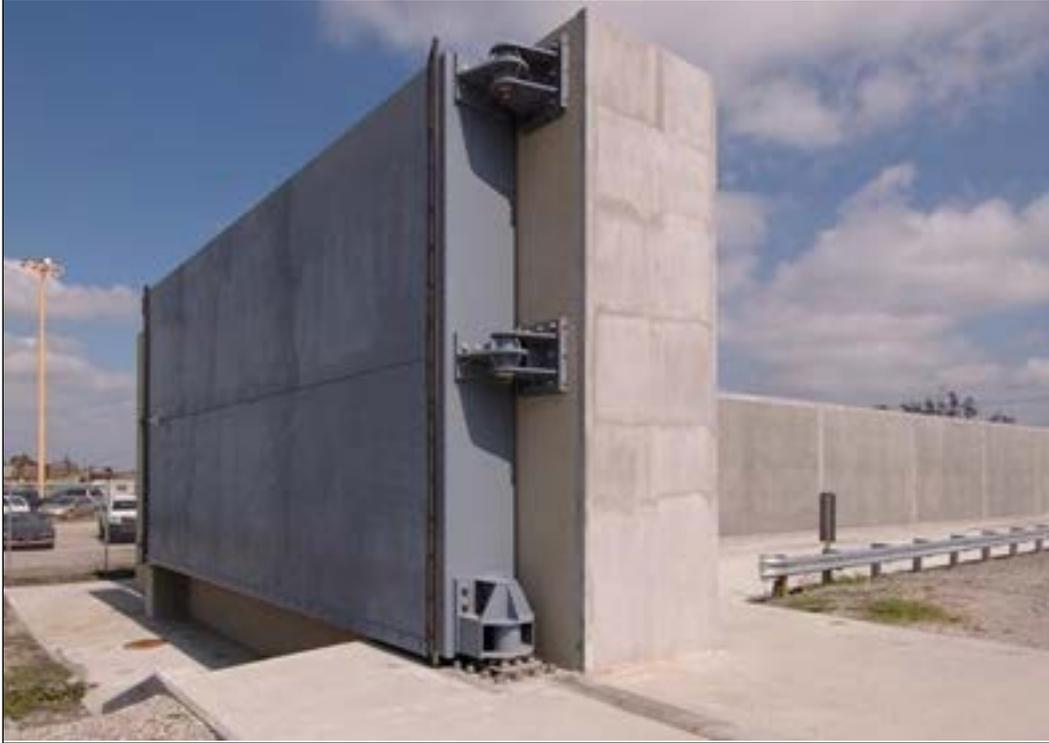
Figure H-5-8.—Swing gate closure.

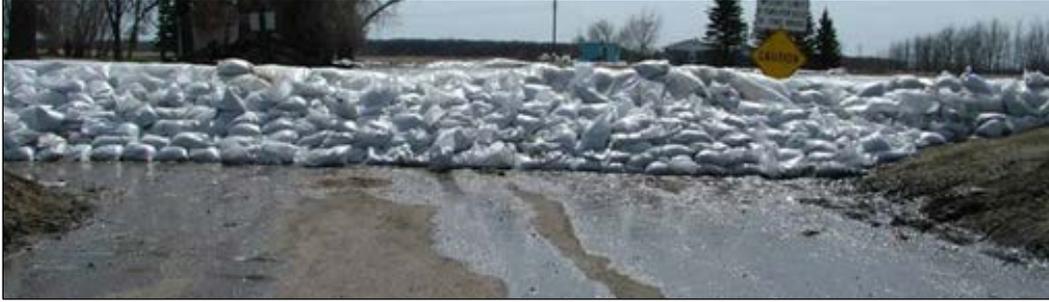
Figure H-5-9.—Sandbag closure at road crossing.

Sandbag closures are likely the most common type of access closure in existence due to their low cost of implementation and simplicity; however, their use has limited applications. Sandbag closures should only be used when the height of the closure (elevation from base of sandbags to the top) is no more than 4 feet and there is ample time to set the closure. There has to be enough time and enough workers/volunteers to fill the bags, move them to the site, and then set them in place. A typical sandbag closure is shown on figure H-5-9.

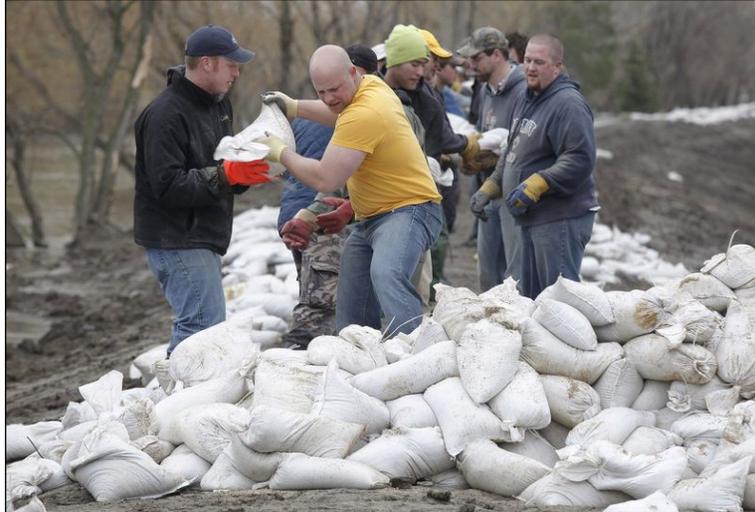
Figure H-5-10.—Incorrect placement of sandbags.

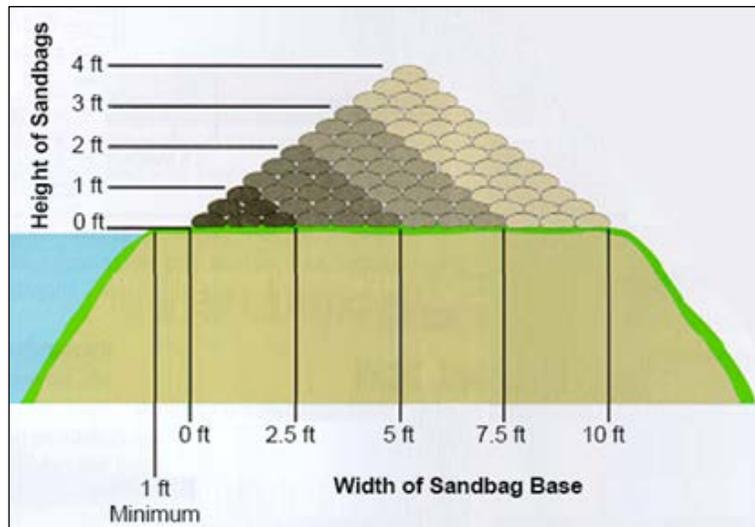
Figure H-5-11.—Sandbag placement guidelines.

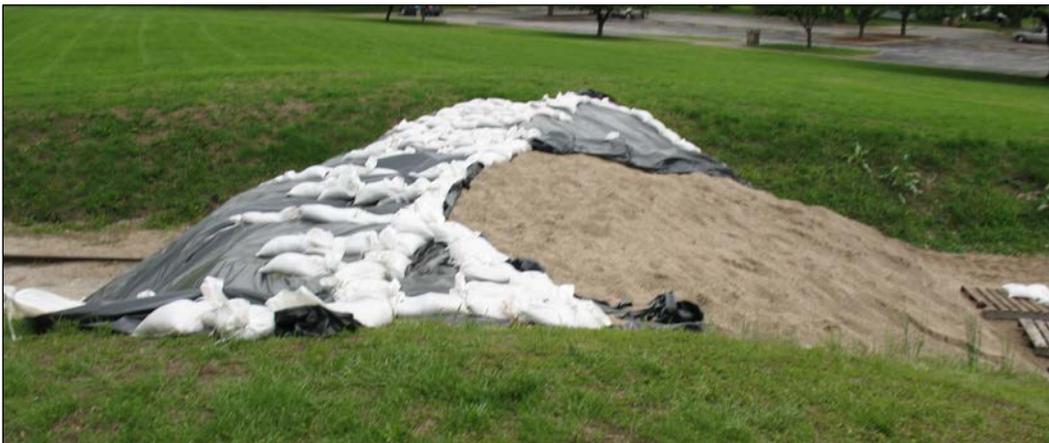
Figure H-5-12.—Soil pile with plastic sheeting closure.

The final type of non-culvert closure considered within this document is soil pile with plastic sheeting and/or soil baskets. Both of these involve moving soil into place to provide a water barrier. Soil piles covered with plastic can provide sufficient weight and a good enough water barrier for providing temporary closure (figure H-5-12). An alternative option is utilization of an engineered container system, referred to as soil baskets, one type of which is shown on figure H-5-13. Soil pile/baskets can be a cost-effective way to set a temporary closure, but caution is warranted. First, heavy equipment should not be placed on a levee when it is saturated. This could cause the levee to fail or be seriously damaged under the additional weight. Soil piles or baskets usually involve the use of heavy construction equipment to move the soil in place in an efficient manner. The required equipment and potential for damaging the levee should be considered when assessing the risk of placing these type closures. Another issue of concern is when soils used to set the closure are taken from the landside slope of an adjacent levee section. This is not recommended and can weaken the levee section where the soil is taken by shortening the seepage path or causing an unstable slope.

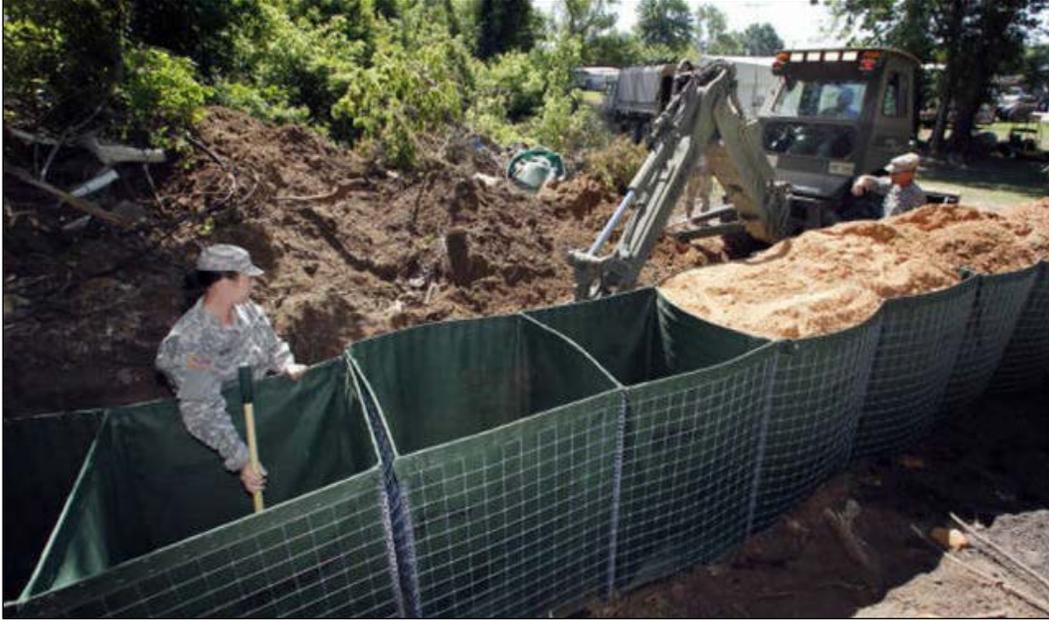
Figure H-5-13.—Soil basket flood barrier under construction.

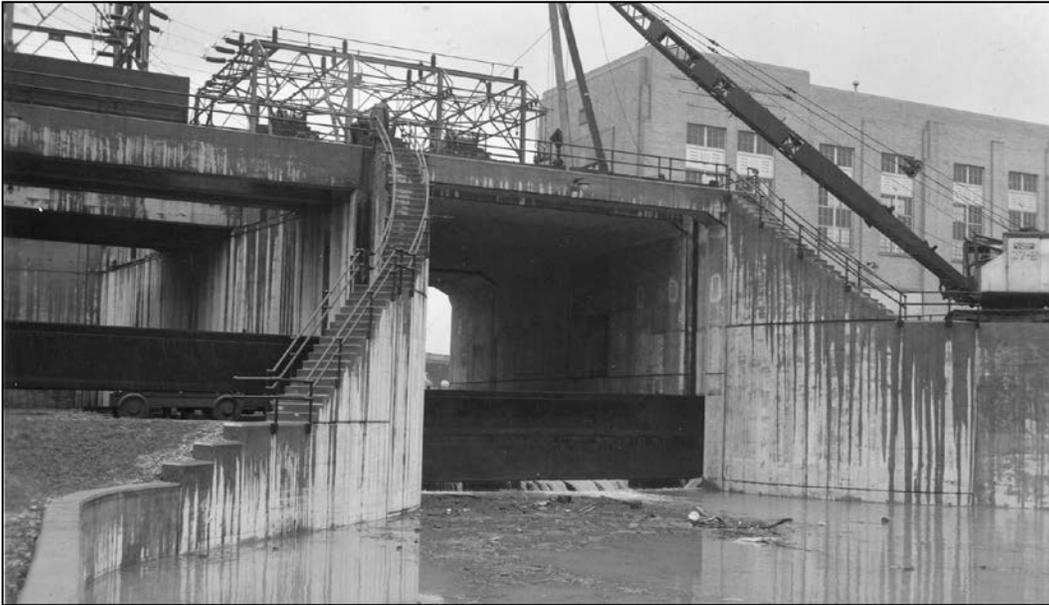
Figure H-5-14.—Mill Creek Pump Station closure bay.

These type of closures are significant structural members that are designed to shut off flow through very large openings at high capacity pump stations. These closure structures are typically large steel gates/bulkheads that are designed as an integral part of a gravity monolith section. They are usually associated with flood protection systems in highly urbanized areas where high capacity pump stations are utilized for the removal of interior drainage. When the river is low, the opening allows gravity flow to remove interior water through the closure bay. When the river is elevated, the large gates/bulkheads are lowered into place and interior drainage is removed via pumping operations. Figure H-5-14 shows the original completed construction of the Mill Creek Pump Station closure bay in Cincinnati, Ohio. Note the section where the large steel bulkheads are lowered into place through the use of a crane and the adjacent area where the bulkhead are stored.

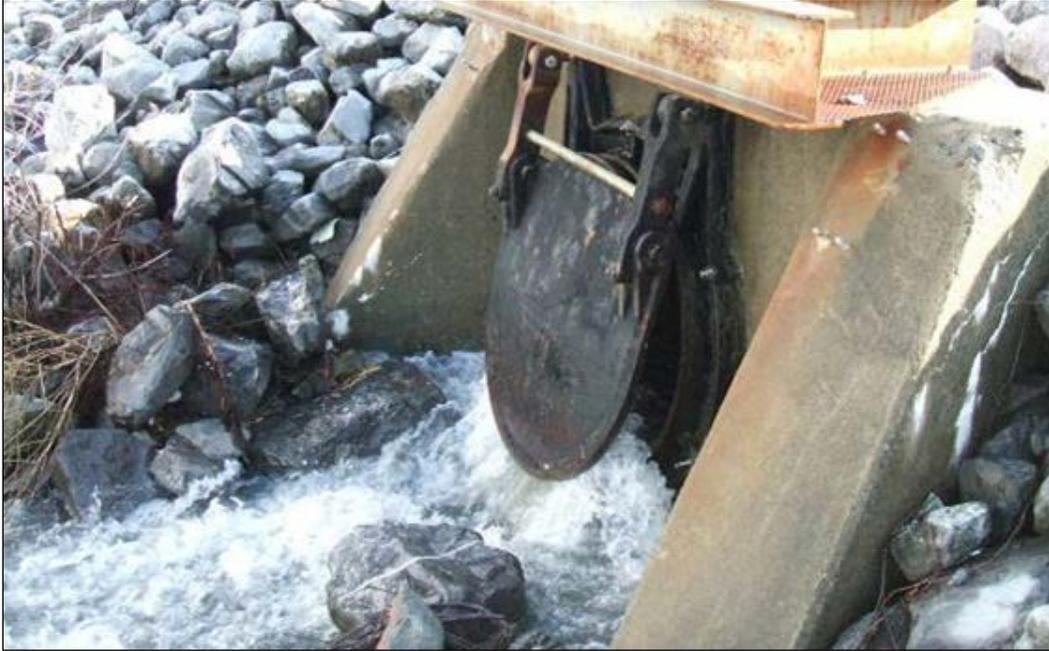
Figure H-5-15.—Culvert flap gate closure.

One of the more common types of closures for culverts is flap gates. They are very popular because of their relatively low cost, automatic functionality, and wide range of sizes. Flap gate closures are placed at the outlet end of the culvert and are designed to remain shut at all times; thus, when the river rises above the outlet end of the pipe, it will seal against the end of the pipe and keep water from entering the culvert. When the river is low, their simple design allows interior drainage to discharge through the outlet end by applying a small amount of water pressure from flowing water to “crack” the bottom of the flap gate open, as shown on figure H-5-15. Once the flow subsides, the valve is designed to close back against the vertical face of the culvert. Sometimes the flap gate may be ‘propped’ open to ensure an obstruction doesn’t block the flap gate in the closed position, such as shown on figure H-5-16. When this type of system is used, it is important to realize the flap gate must be manually shut ahead of rising floodwaters otherwise unrestricted flow through the culvert will occur and flood the interior.

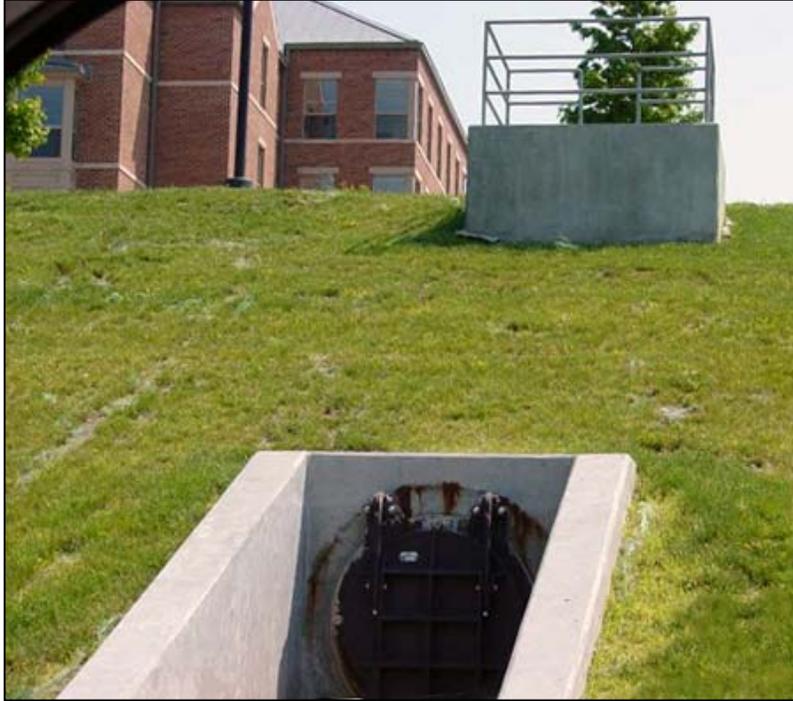
Figure H-5-17.—Culvert with flap gate and sluice gate closure.

Vertical sluice gate closures are another popular means to shut off flow through a culvert. Most sluice gate closures consist of vertical steel gates that are lowered into place by turning a screw stem attached to the sluice gate. Pulley systems are also used in some instances to lower and raise the sluice gate. Sluice gates are installed either at the outlet end of the culvert (as shown on figure H-5-18) or within a gate well somewhere along the length of the pipe (such as figure H-5-19). In both situations, someone must lower the gate into place either manually or with the assistance of mechanical equipment. Sluice gates constructed within a gate well are typically placed on the riverside slope of the levee near the crest in order to gain easy access to the gate well. As noted previously, they are used many times in conjunction with flap gates to provide two means to shut off river flow through the culvert.

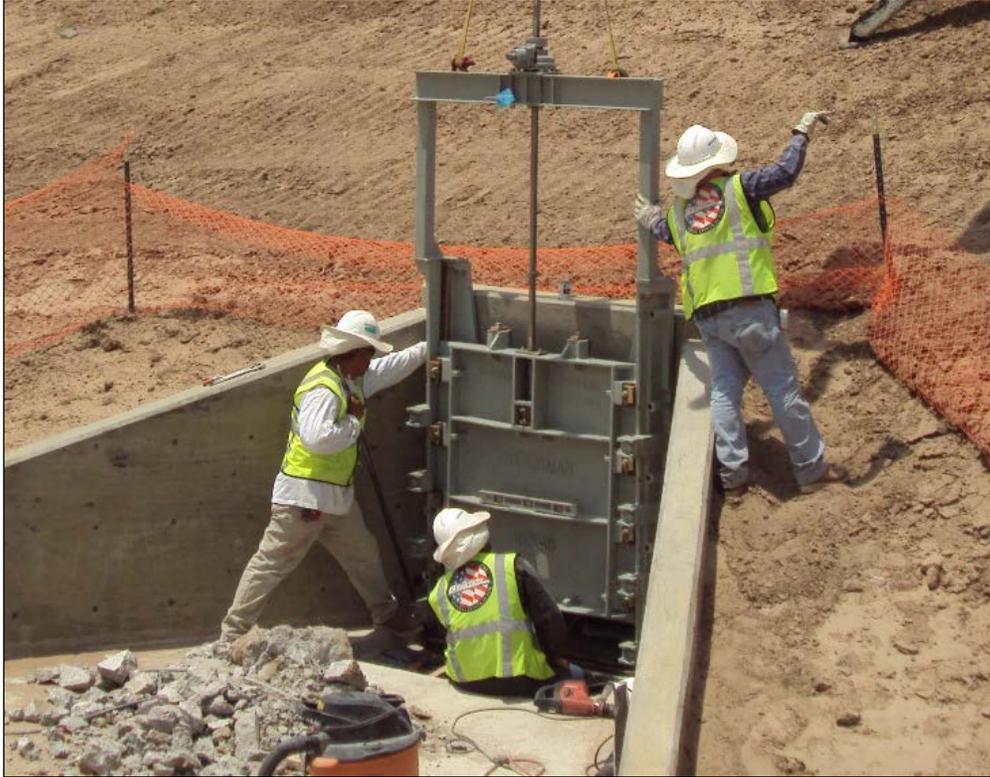
Figure H-5-18.—Sluzice gate being constructed at outlet end of culvert.

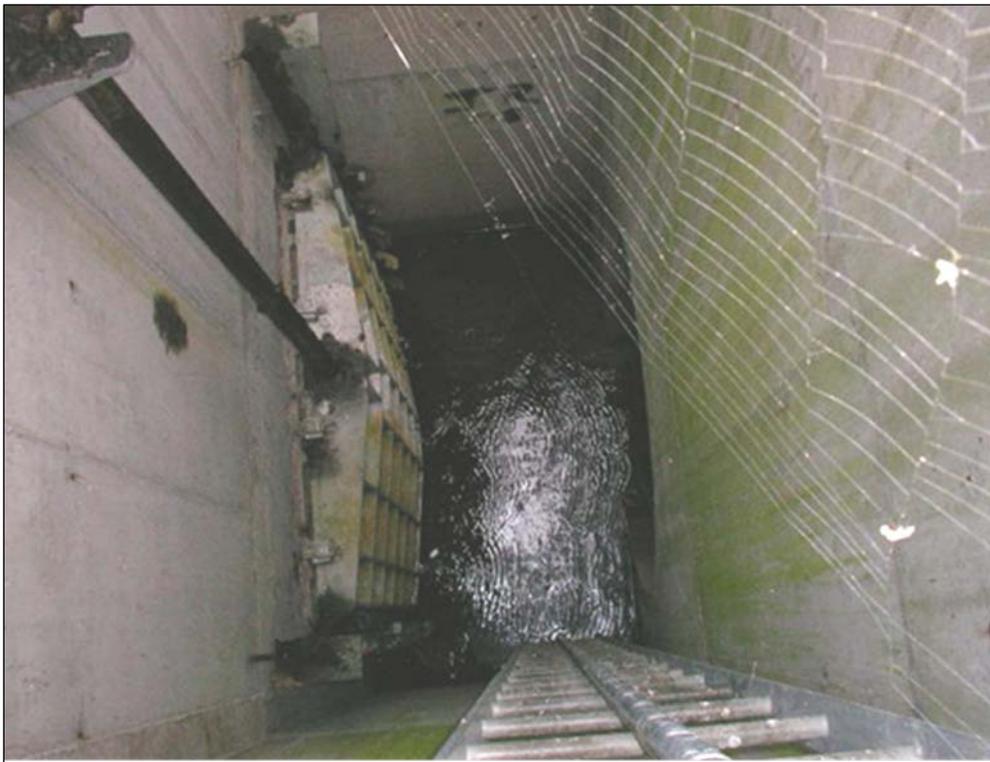
Figure H-5-19.—View of sluzice gate looking down from top of gate well.

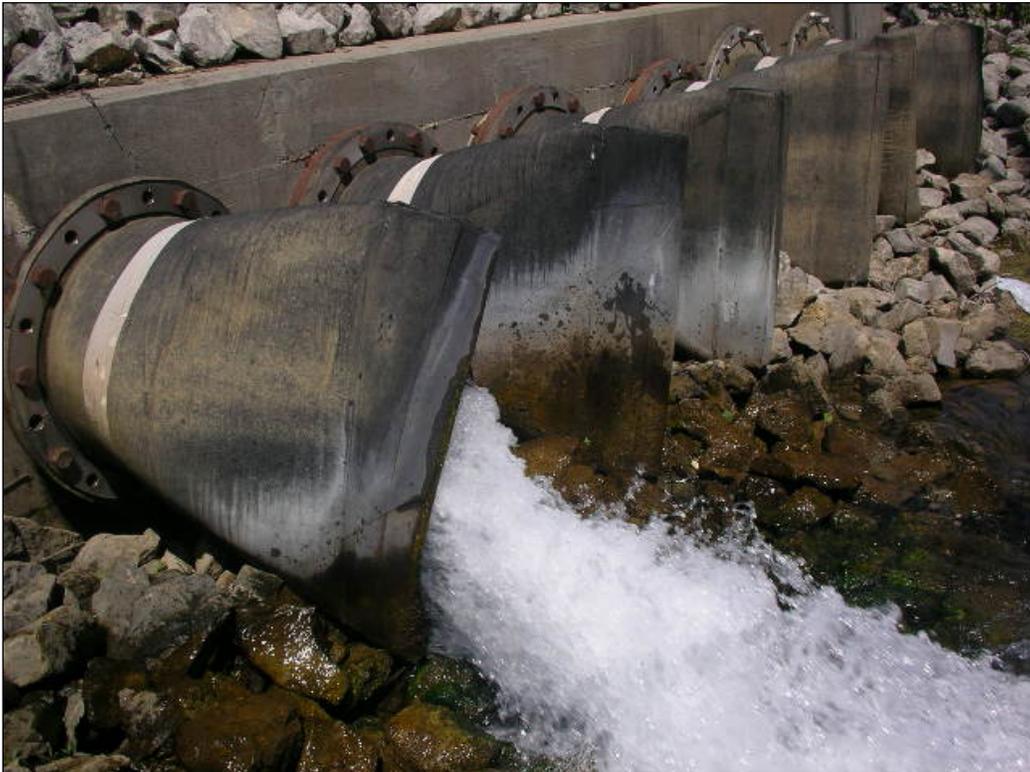
Figure H-5-20.—Duck bill at outlet end of culvert.

Duckbill valves are one piece elastomeric devices that act as a check valve (only allow one way flow). They are attached to the outlet end of the culvert to prevent backflow through the pipe. They are referred to as duckbill valves because they resemble the bill of a duck (see figure H-5-20). Duckbill valves are designed so they are closed when no flow through the pipe is present. Once the culvert starts to receive interior flow, the vertical seal will open under pressure allowing water to drain out of the duckbill and culvert. It usually takes 1-2 inches of water above the invert of the culvert in order to crack open the seal of the valve. It is designed to re-seal once the interior water is drained sufficiently. When the river level rises on the exterior of the culvert, the vertical seal is designed to keep exterior water from entering the pipe. Duckbill closure devices have been used successfully in many installations and are a popular option when the theft of flap gates is a recurring problem and in areas where corrosion of steel products could be a significant issue. Generally speaking, they require no maintenance and are quite cost effective compared to other closure features.

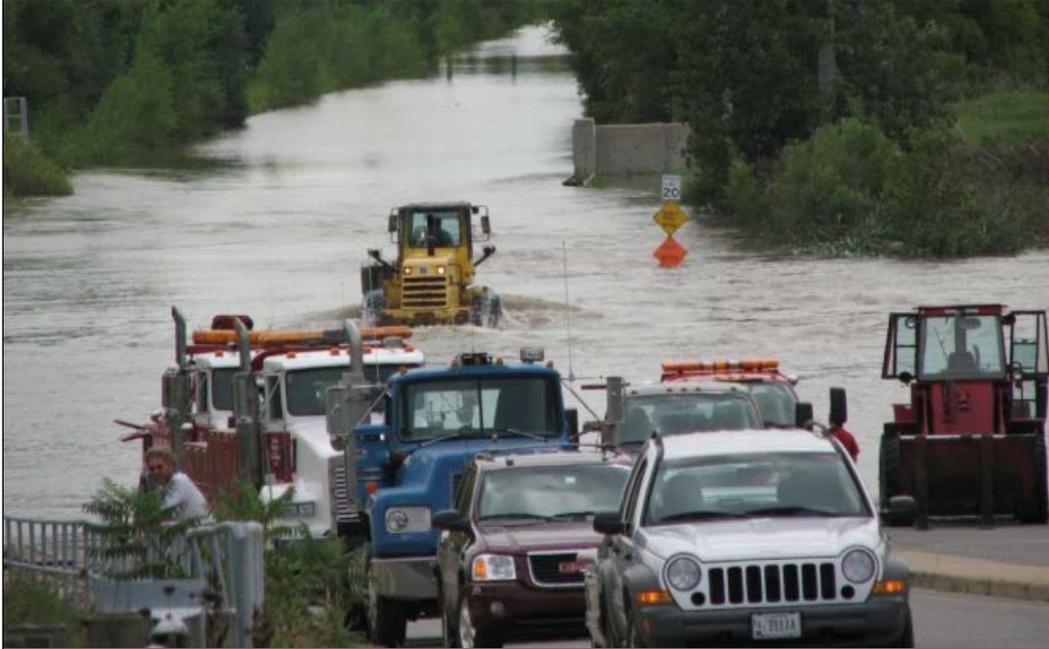
Figure H-5-21.—Flooding of Gary, Indiana, at Chase Street post/panel closure.

The Gary North Local Flood Protection Project is a federally-constructed, locally operated/maintained levee segment located along the Little Calumet River in northern Indiana. The segment is approximately 8.4 miles long (8.0 miles of levee embankment, 0.4 mile of floodwall). It is located in a heavily industrialized area. There are a total of seven different non-culvert closure systems within this segment (six sandbag and one post/panel closure). The single post/panel closure was designed to close off flow from entering through Chase Street. According to the post flood report, the local sponsor lacked experience in both the planning and setting of the post/panel closure. It was noted they weren't sure when to start setting the closure and how it was to be put together in a timely manner. During the 2008 flood as the Little Calumet River was rising, the local sponsor was unable to set the post/panel closure and in a last ditch attempt tried to provide closure by placing a sand pile with plastic across the closure. This was unsuccessful as water poured into the interior through the Chase Street closure opening as the river rose above the sill elevation. This resulted in flooding of the interior, as shown on figure H-5-21 where the closure is visible in the background. Consequences were limited primarily to economics as the interior flooding through the closure resulted in road damage and portions of the interstate being closed for a period of time (see figure H-5-22).

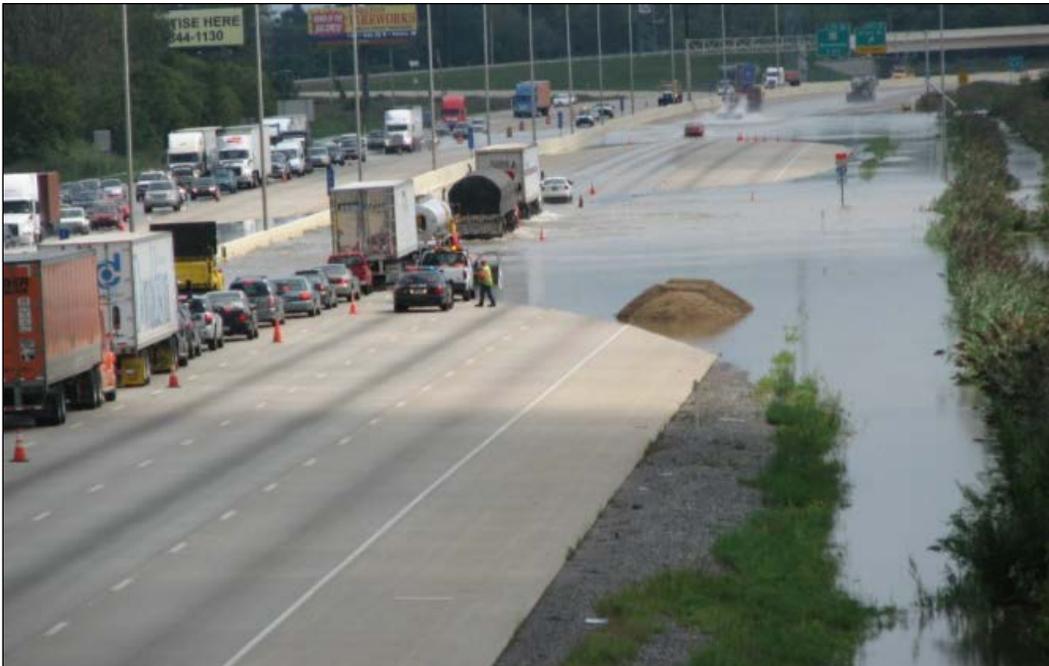
Figure H-5-22.—Flooding of interstate in Gary, Indiana, due to failure of post/panel closure.

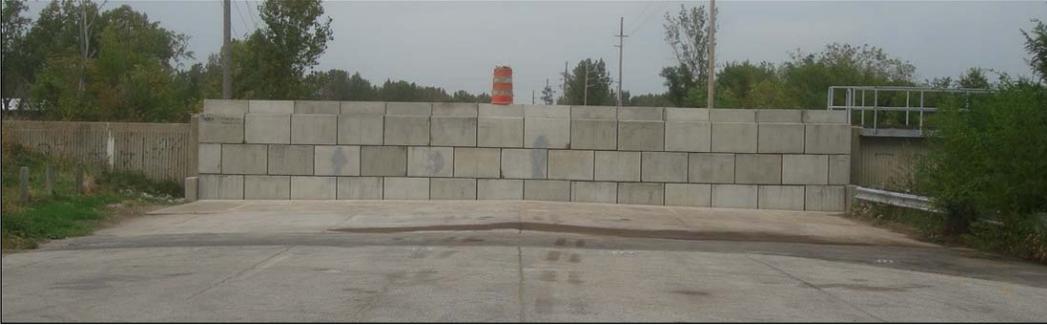
Figure H-5-23.—Semi-permanent concrete block wall at Chase Street (Gary, Indiana).

closure at Chase Street would have little overall effect on traffic patterns. The local sponsor, working with an independent engineering firm, opted for large, removable concrete blocks to seal the closure, as shown on figure H-5-23. These could be moved in an emergency, but it is unlikely they will ever be moved unless access to the area needs to be provided in the future.

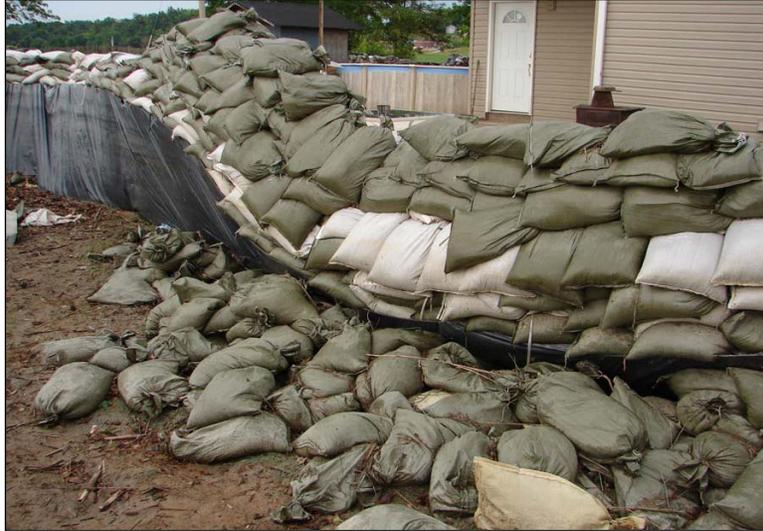
Figure H-5-24.—Failure of soil basket system (Winfield, Missouri).

Winfield Pin Oaks Levee (Winfield, Missouri) is a locally constructed, locally operated/maintained levee that is active within the USACE Public Law (PL) 84-99 program. The PL 84-99 program is a program that allows the federal government to repair levees after flood damages as long as the levee is operated and maintained to a set of standards. The Winfield Pin Oaks Levee is located along the Mississippi River in Missouri just north of St. Louis. During the 2008 flood, the exterior levee protecting the agricultural area breached prior to overtopping along the southeastern section. The town of Winfield is a small community located within the northwestern part of the interior area about 2 miles inland from where the breach had occurred. In an attempt to protect the town from on-coming floodwaters, a combination earthen berm and soil basket levee was quickly constructed around the town with the use of National Guard troops. As the floodwaters reached the soil baskets and started to buildup, seepage started to emanate from under the soil baskets at the location of an 18-inch iron pipe that hadn't been noticed previously. A secondary line of soils baskets was immediately placed landward in the area around the leaking pipe; however, the soil supporting the baskets quickly saturated and failed under the weight of the soil baskets that were topped with sandbags (see figure H-5-24).

While this wasn't a closure system failure, it was a failure of a soil basket system that is commonly used for levee closures. The cause of the failure was the leaking pipe below the soil baskets that wasn't noticed and saturated the soil supporting the baskets.

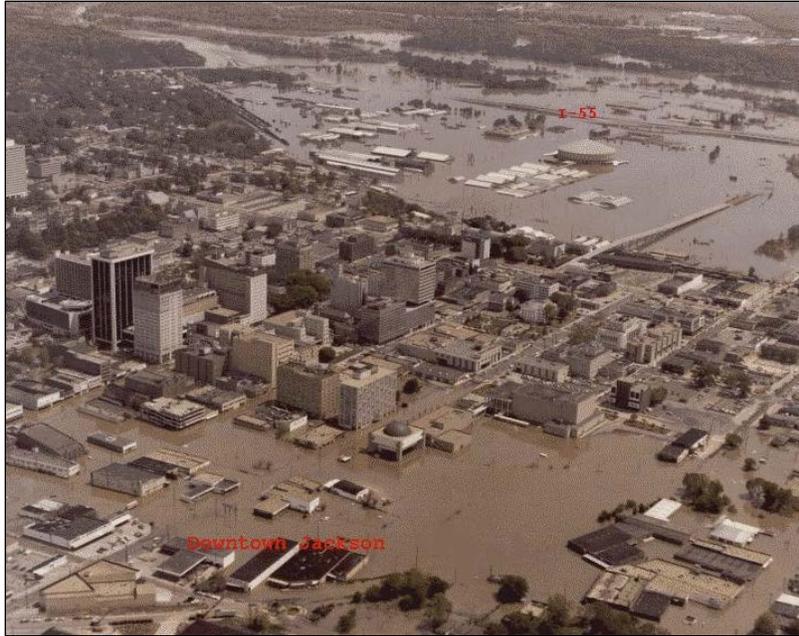
Figure H-5-25.—Flooding of Jackson, Mississippi, 1979.

The Jackson Fairgrounds Levee is a federally constructed, locally operated/maintained levee located in Jackson, MS along the Pearl River. During a 1979 flood event, water from the Pearl River initially flooded the interior when it entered through an open street closure that was designated to be closed utilizing sandbags. According to the post flood report, there was confusion and overall lack of coordination between the various local and federal agencies as to who was responsible for setting the closure. While USACE was concentrating on keeping water from going over the levee embankment section, floodwaters flowed through the open roadway closure and began flooding the interior. The local agency responsible for operation and maintenance of the system didn't set the closure because they stated it wasn't shown as a requirement in the plans and operations manual; thus, neither group took the initiative to protect the interior from flooding by setting the closure resulting in significant interior flooding and economic damages as shown on figure H-5-25. This event resulted in a congressional investigation to determine what actions caused the flooding and how it could be avoided in the future (United States Comptroller General Office 1979). The lack of setting the closure was determined to be one of the main causes of interior flooding along with performance issues associated with the sewer system.

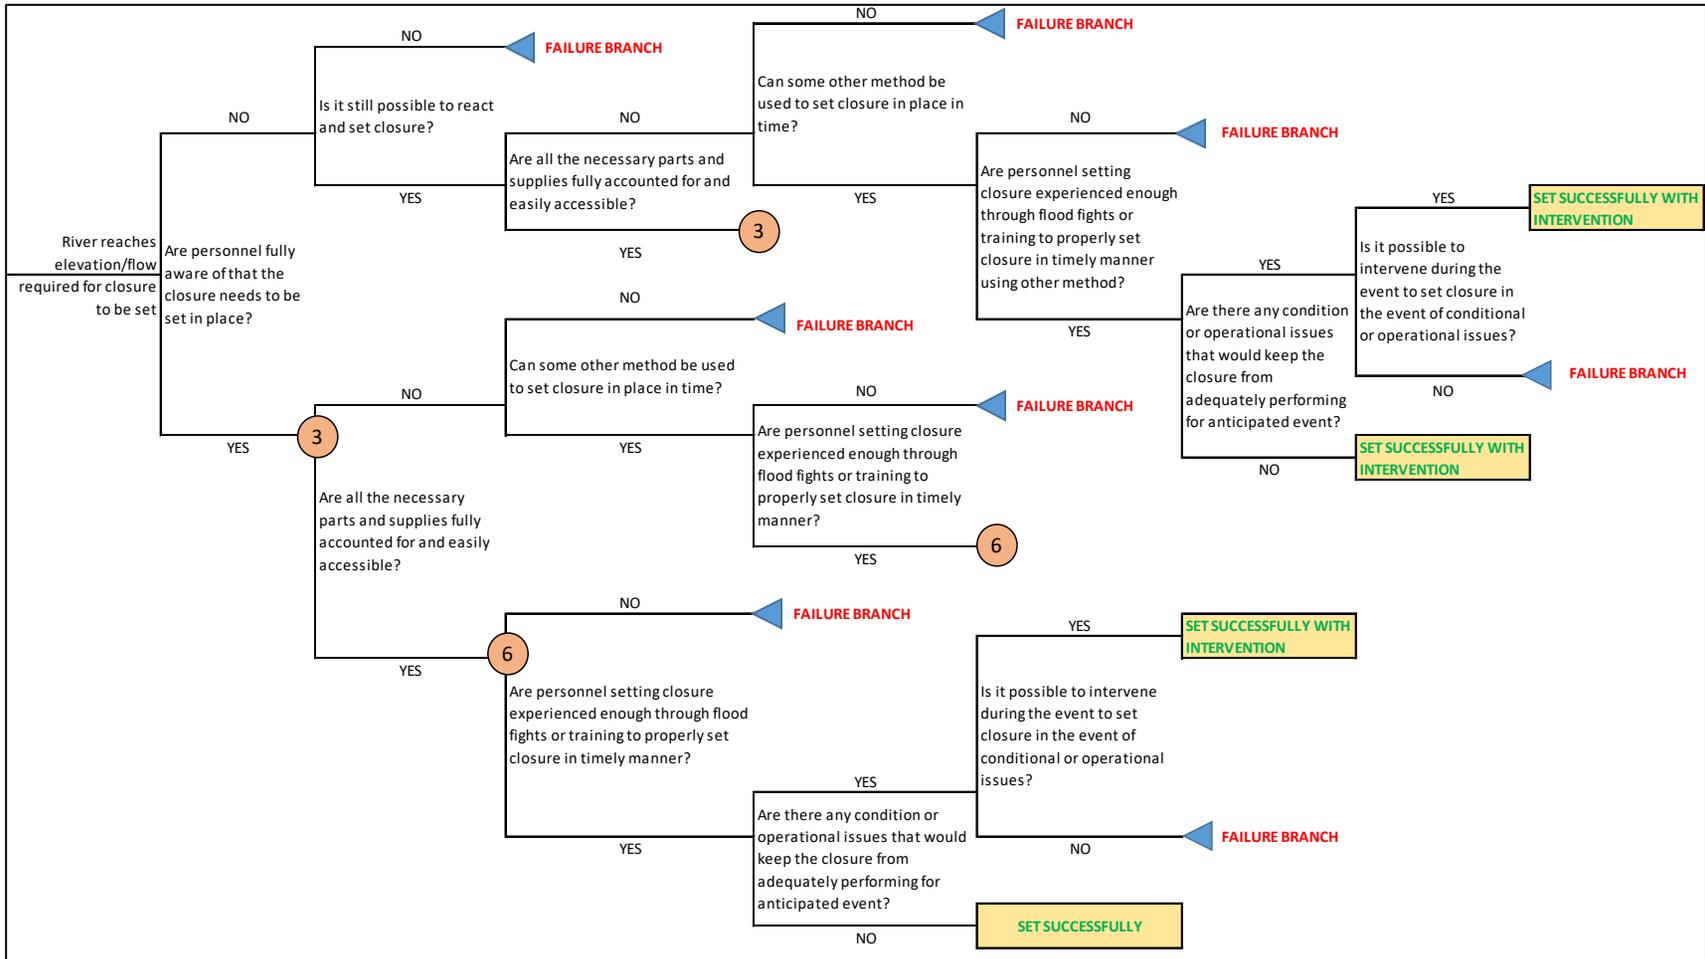
Figure H-5-26.—Generic event tree for levee closure system.

A generic levee closure systems event tree is shown on figure H-5-26. While each type of closure varies, the event tree is intended to reflect the potential paths to failure for most types of closures. There are a few types of closures where this type of event tree isn't applicable, such as culvert flap gate and duck bill closures, because they are designed to perform automatically on their own. Additionally, some of the branches may not be applicable for every type of closure such as ensuring all necessary parts and supplies are available, which wouldn't be required for simple moveable gate closure systems.

A few notes of clarification are provided herein with respect to the event tree on figure H-5-26. Nodes 3 and 6 at the end of a few branches have been shown since they are repetitive branches meaning when you see node 3 at the end of the branch you would follow the path associated with node 3. The same is true when 6 is shown at the end of the branch. This was done in an effort to simplify the tree for this narrative. Also, estimating the probabilities for each tree should be done through elicitation. It is recommended that individuals with a good working knowledge of the levee and closure systems be involved with the elicitation. This could be as a 'voting' member helping establish the event tree estimates or providing key background information and answering technical questions from the panel estimating the values.
