A STUDY OF THE HYDRAULIC CHARACTERISTICS OF
AN UNREINFORCED CONCRETE PROTECTIVE HOOD
FOR CANAL LINING UNDERDRAIN FLAP VALVES OF THE
WELLTON-MOHAWK CANAL--GILA PROJECT, ARIZONA

Hydraulic Laboratory Report No. Hyd.-270

Laboratory Report No. 270
Hydraulic Laboratory
Compiled by: J. C. Schuster
Reviewed by: J. W. Ball and
W. C. Case

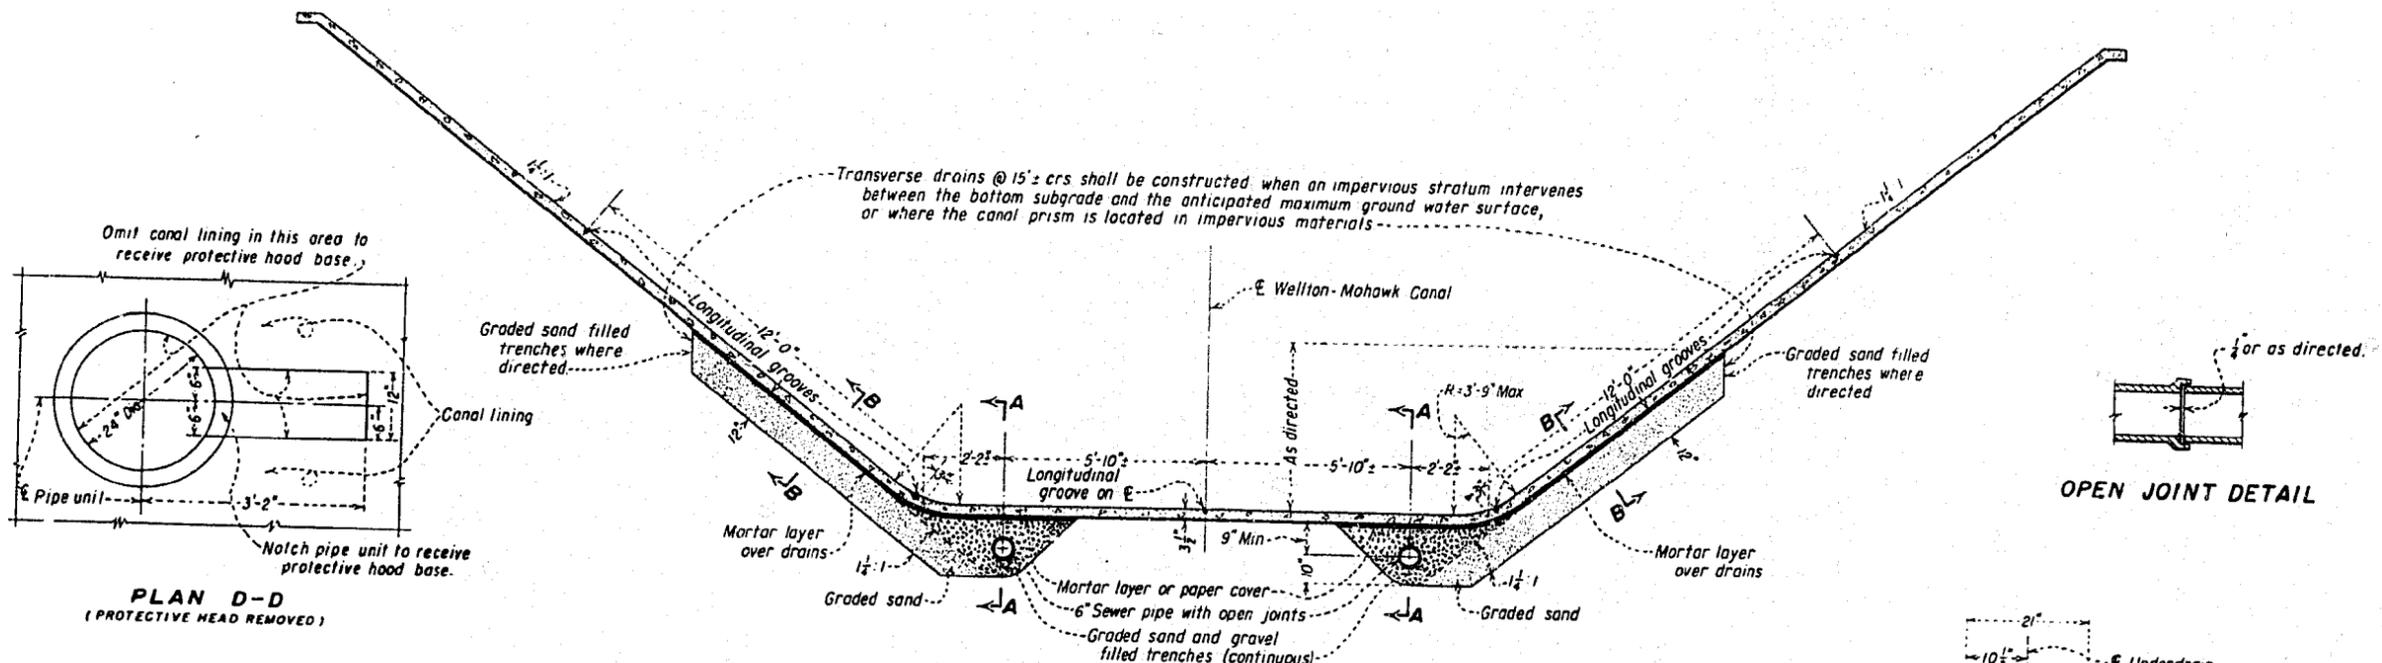
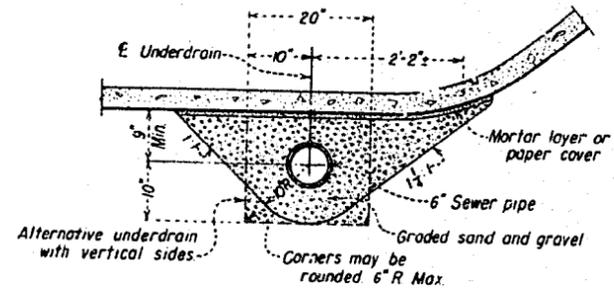
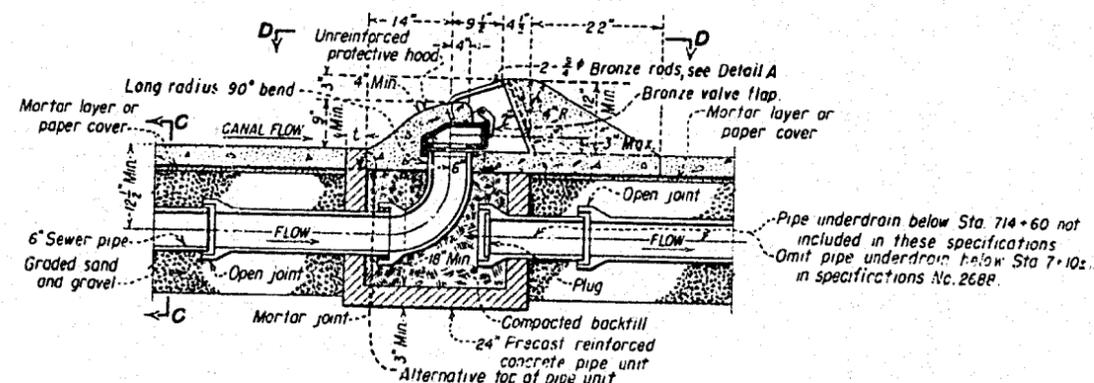
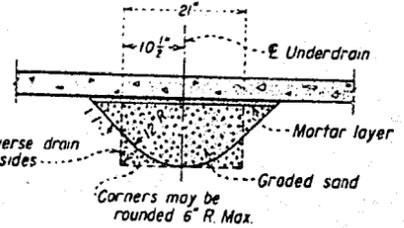
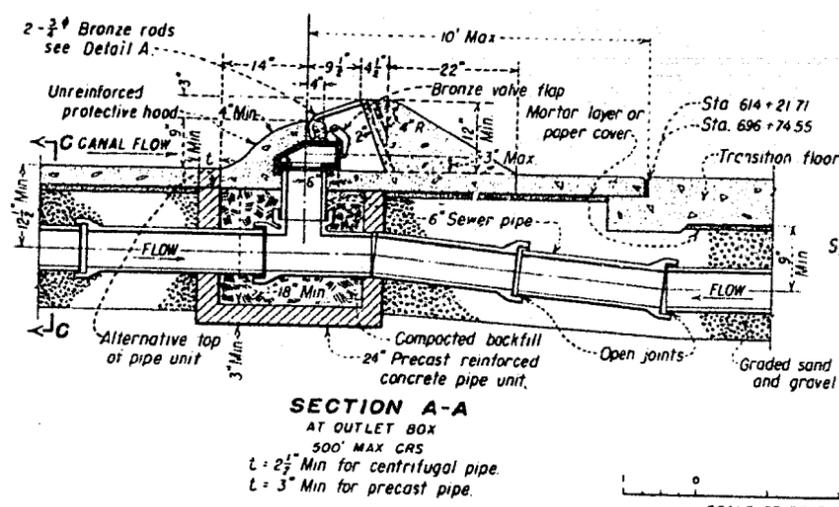
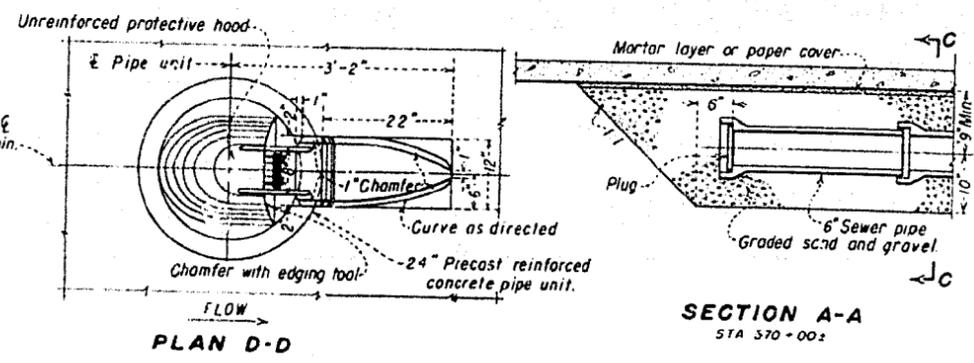
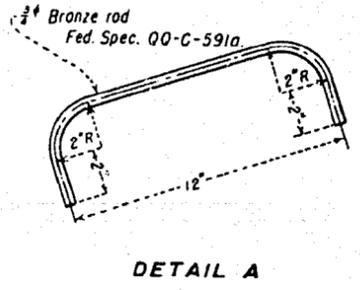
UNITED STATES
DEPARTMENT OF THE INTERIOR
BUREAU OF RECLAMATION
GILA PROJECT - ARIZONA
WELLTON - MOHAWK DIVISION
WELLTON-MOHAWK CANAL - STA'S 1+84 TO 7+14 AND 570+00 TO 714+60
CONCRETE CANAL LINING
TYPICAL PIPE UNDERDRAINS

TRANSVERSE SECTION - CANAL LINING

1. The two-piece hood developed by the laboratory study (Figure 2) will fulfill the requirements listed above. It will keep the flap valve operable at water velocities as low as 1 foot per second, which is about one-third of the average velocity expected in the Wellton-Mohawk Canal.

1. Use the two-piece hood (Figure 2) for the protection of the flap valves in the Wellton-Mohawk Canal.
2. Finish the concrete hood surfaces as smoothly as possible to aid in the passing of biological growth which is carried by the canal water.
3. Smoothly blend the two bronze rods, which bridge the two pieces of the divided hood, into the concrete surfaces to aid in the passing of biological growth.
4. Mark the location of the protective hoods on the canal bank to guard against hood and valve damage by canal cleaning equipment.

A sketch of the two-piece hood was given to the Canals Division for their consideration in planning the final design (Figure 2).

Two-piece hood--Final design. The final design, prepared by the Canals Division to include structural features, included a chamfer to the upstream deflector face, two 3/4-inch bronze rods in place of three, and a 30° slope to the downstream face of the deflector to facilitate passing of a drag chain. A 1:4 scale model of the final design was constructed (Figures 11A and B).

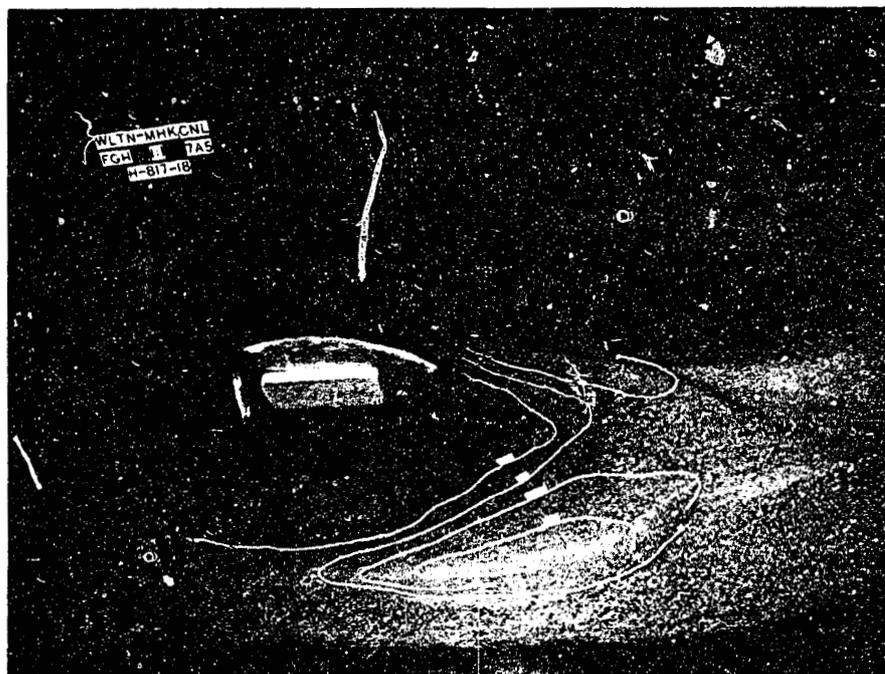
B. Scour pattern of circular hood with deflector operated 1-hour at 1.0 foot per second water velocity. Slot 2 inches high, 5-1/8-inch entrance (7/8-inch reinforcing bar), and 6-inch exit.

After a test like that on the unslotted hood, it was found that the scour along the face containing the valve had moved downstream approximately 6 inches beyond the previous scour (Figure 8B). The sand moved through the slot and was deposited along the entire length of the 6-inch exit, but without completely filling the 2-inch height. It had been thought that the sand moving through the slot might be removed by the water causing the main scour downstream of the hood. In place of this action, the sand moved downstream and to the left, being deposited in a ridge approximately 2 inches high, as shown in Figure 8B. The general appearance of the scour pattern for this hood was good, but two objections to the hood were apparent: (1) the slot beneath the deflector may become plugged, which would reduce the extent of the scour across the valve face; and (2) its shape (with the deflector) would be conducive to the accumulation of biological growth.

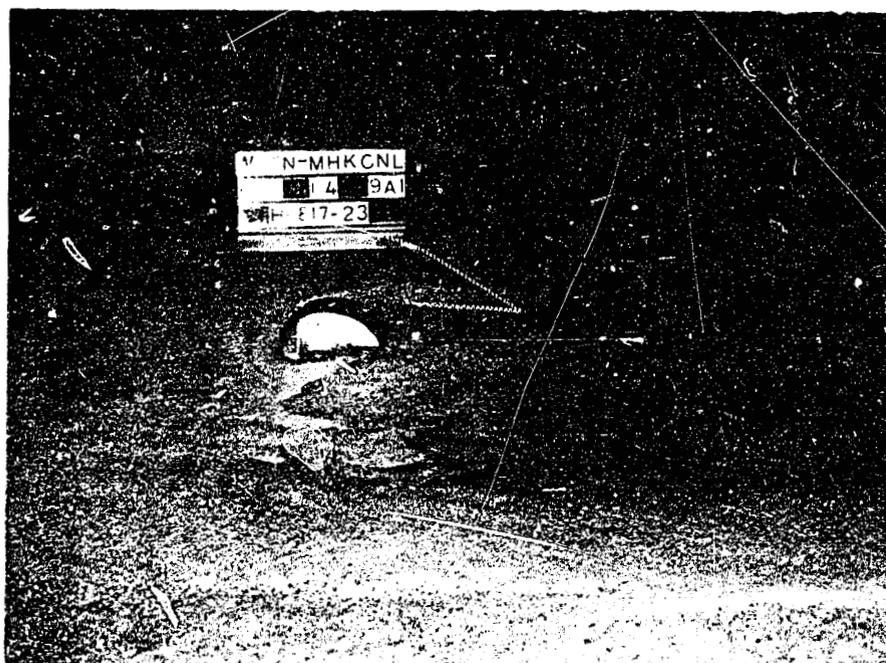
B. Scour pattern of 1:4 scale circular hood with deflector operated 1-hour at 0.97 foot per second water velocity. Slot closed beneath deflector.

similarity of scour patterns of the full scale and model hoods. Again a uniform sand depth of $3/16$ inch was used. As shown in Figure 9A, the model scour across the face containing the valve was not as complete as that in Figure 8B, but in general the similarity was good. With good similarity established, the slot beneath the deflector of the 1:4 model was closed (objection 1 above) and the scour pattern obtained (Figure 9B). There was a small deposit of sand directly in front of the valve. With the exception of this deposit, the scour pattern was practically the same as in Figure 9A.

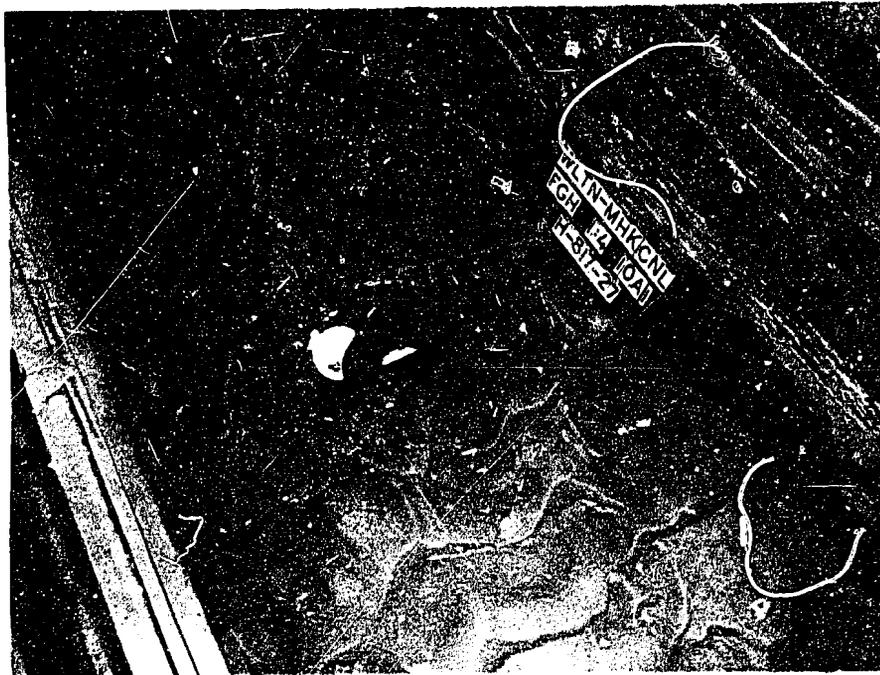
A. Scour pattern of 1:4 scale original hood operated with continuous sand movement for 1-hour at 0.97 foot per second water velocity.

same conditions of time (1 hour) water velocity (0.9 foot per second), and sand depth (approximately 1 inch). The test results are shown on Figures 11 and 12. The deposit against the flap of the original hood was higher than in previous tests. Note that the scour pattern retains a similarity to previous tests with the hood in this position. During the operation of the circular hood, the sand waves moved under the deflector, along the face containing the valve, and the area in front of the valve never completely cleared as in previous tests, although the pattern of scour was essentially the same. The sand in the area between the two pieces of the final hood design was completely removed.

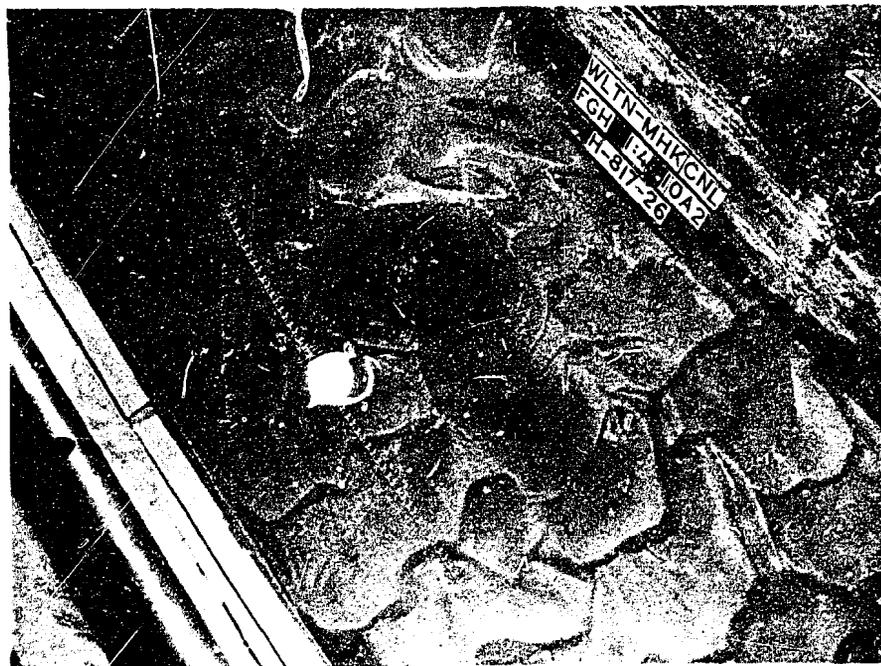
B. Scour pattern of 1:4 scale circular hood operated with continuous sand movement for 1-hour at 0.97 foot per second water velocity.
