HYDRAULIC MODEL STUDIES OF SUPERIOR-  
COURTLAND DIVERSION DAM, HEADWORKS AND  
SLUICeway STRUCTURES--PROGRESS REPORT  
NO. I ON GENERAL STUDIES OF HEADWORKS  
AND SLUICeway STRUCTURES

Hydraulic Laboratory Report No. Hyd.-275

MARCH 22, 1950

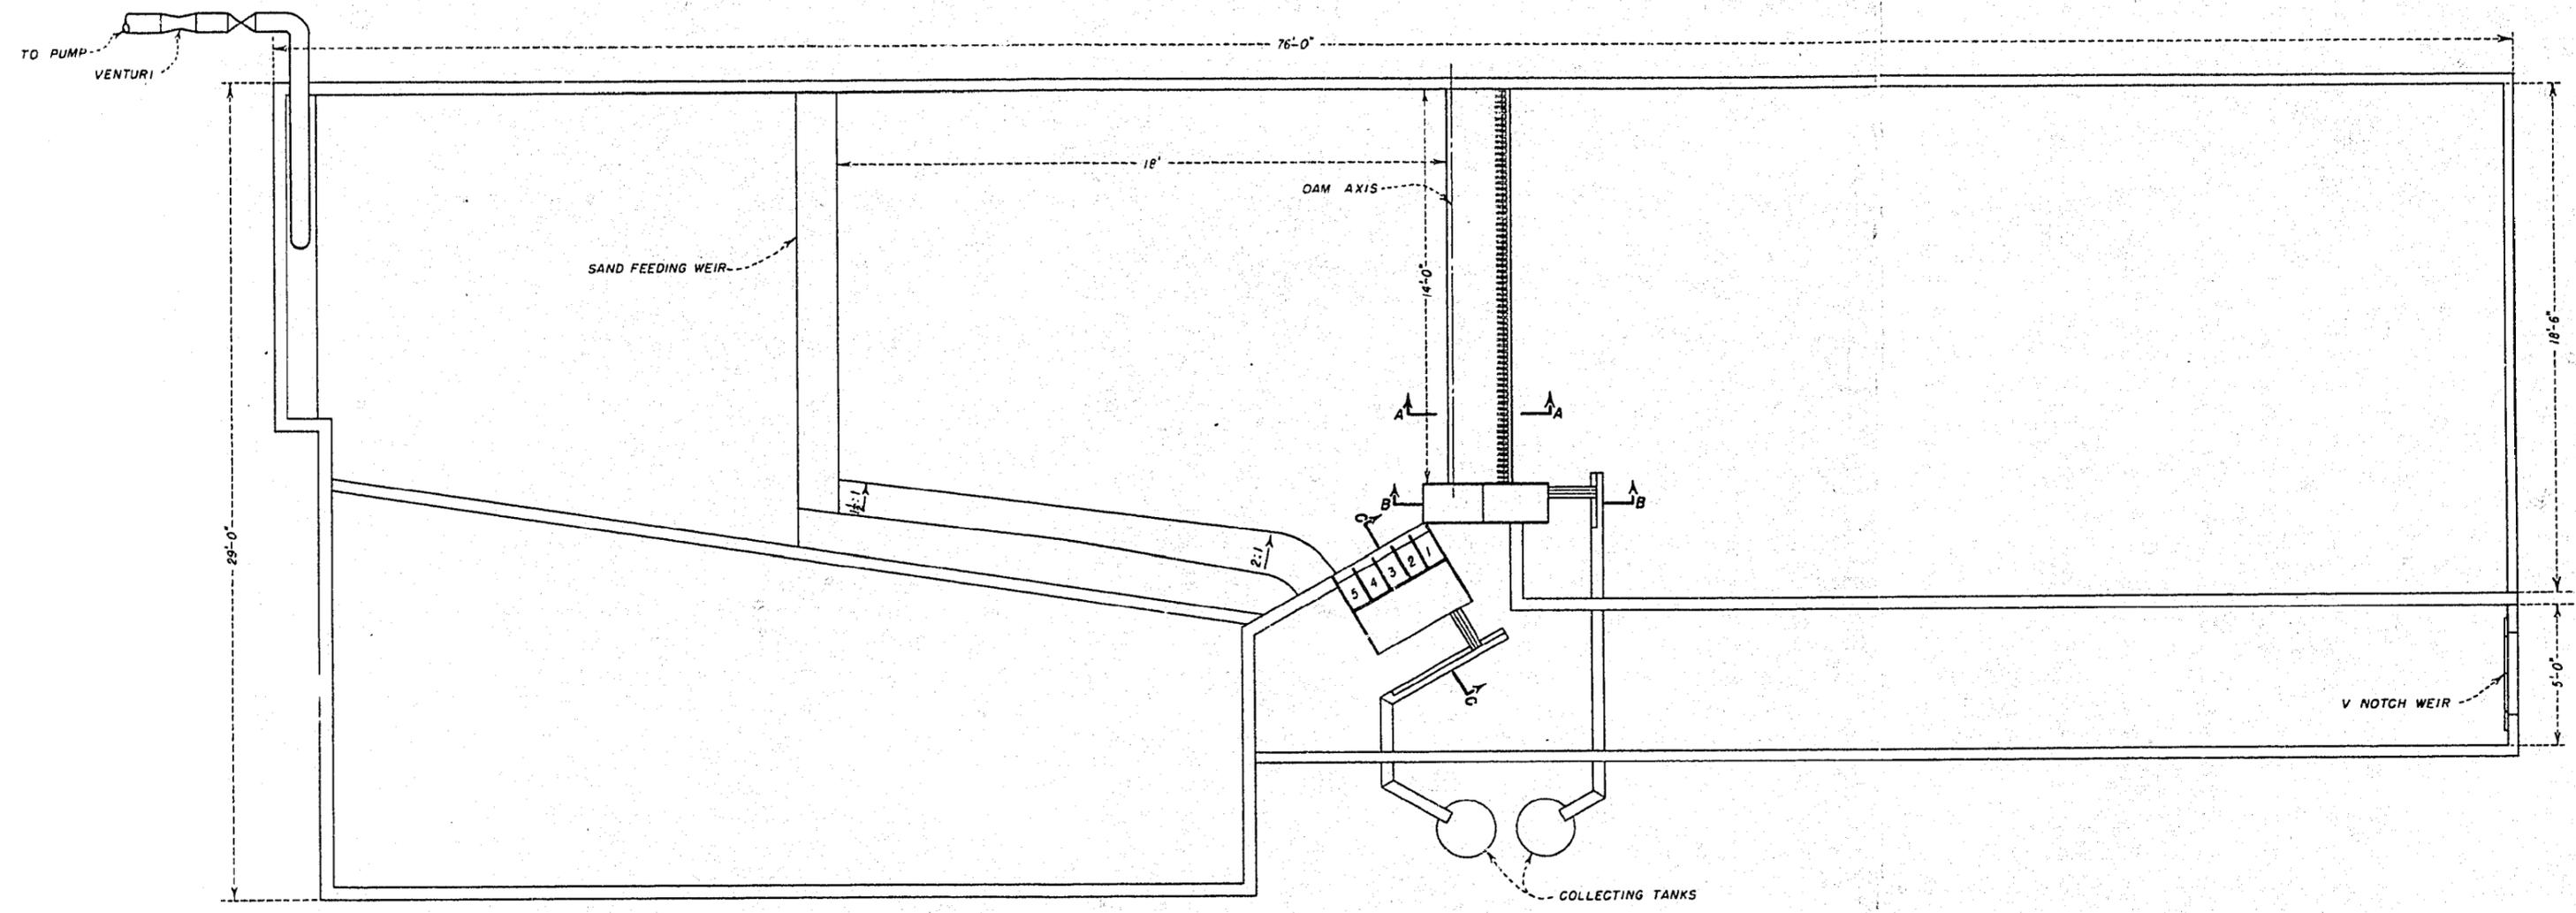
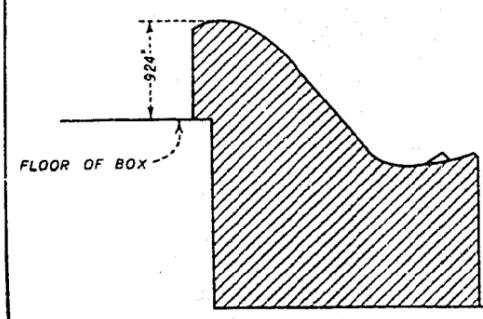
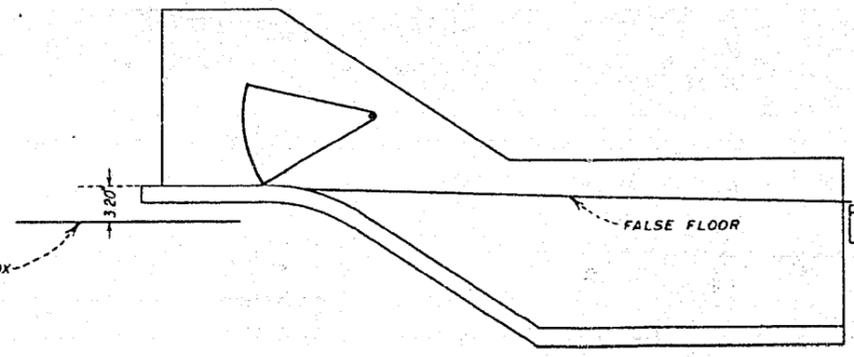
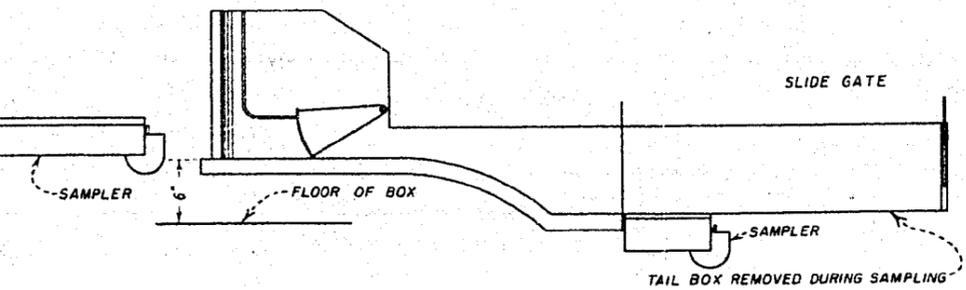
UNITED STATES DEPARTMENT OF THE INTERIOR BUREAU OF RECLAMATION	
<b>HYDRAULIC MODEL STUDIES</b> <b>SUPERIOR-COURTLAND DIVERSION DAM</b> <b>MODEL LAYOUT-ORIGINAL DESIGN</b>	
DRAWN.....	SUBMITTED.....
TRACED.....	RECOMMENDED.....
CHECKED.....	APPROVED.....
DENVER, COLORADO - JULY 11, 1948

Since it was necessary to obtain good movement of the sand used in the bed with relatively small discharges, as large a model as practicable was deemed necessary to obtain satisfactory results. Space in the Hydraulic Laboratory approximately 30 by 70 feet was available. By utilizing this entire area, it was found that a 1:15 undistorted scale could be used which would include an area sufficient to cover one-half of the diversion weir, the Courtland Canal headworks and sluiceway, and approximately 400 feet of the upstream and downstream river channel. The general layout of the model is shown in Figure 4.

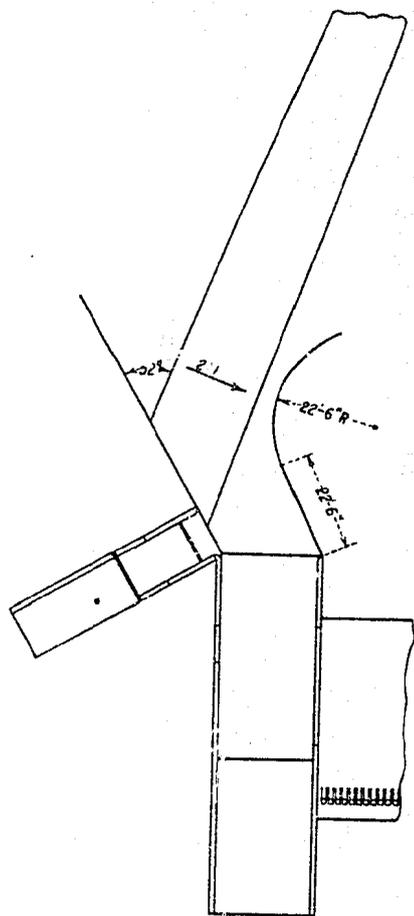
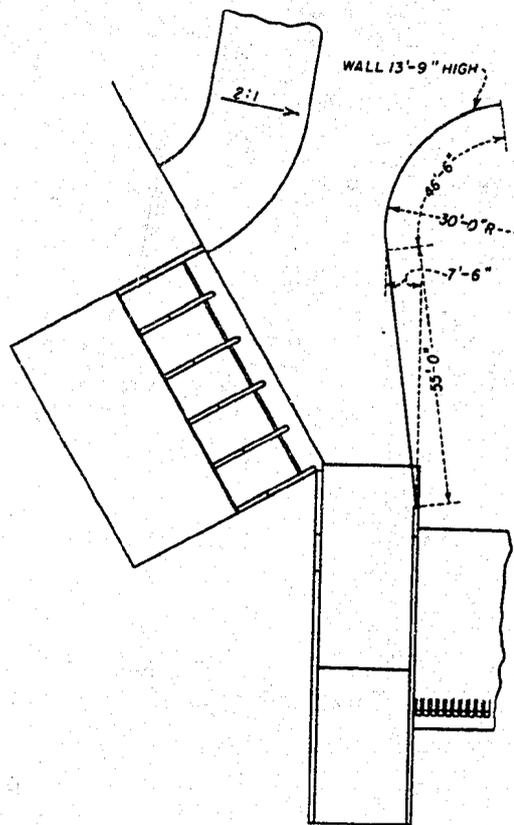
SUPERIOR HEADWORKS

COURTLAND HEADWORKS

UNITED STATES DEPARTMENT OF THE INTERIOR BUREAU OF RECLAMATION <b>HYDRAULIC MODEL STUDIES</b> <b>SUPERIOR-COURTLAND DIVERSION DAM</b> <b>RECOMMENDED DESIGNS</b>	
DRAWN . . . . .	SUBMITTED . . . . .
TRACED . . . . .	RECOMMENDED . . . . .
CHECKED . . . . .	APPROVED . . . . .
DENVER, COLORADO—JAN. 18, 1930

The various designs tested are shown in Figures 5, 6, and 7. The original design for the Courtland headworks and sluiceway gave a ratio of  $\frac{C_s}{C_h} = 0.68$  for the standard prototype discharge used: 400 cfs through the headworks and 200 cfs through the sluiceway. Changes No. 1 to 3 were unsuccessful and showed no improvement over the original design. This was partly due to the greater turbulence created in front of the headworks. This turbulence caused a larger percentage of the bed load to be picked up and carried through the headworks as suspended load. Change No. 4 using a divide wall between the overflow weir and the sluiceway proved to be the most favorable, resulting in a ratio of  $\frac{C_s}{C_h} = 6.63$ . Further tests with this type of wall involving changes in alignment of the bank of the pool excavation, length of wall, and wall location failed to show any further improvement in its desilting characteristics. Figure 5 shows the recommended design.

From the results of these tests the arrangement of the divide wall and excavation embankment shown on Figure 5 was recommended as the most favorable design for the Courtland diversion. Two further test runs were made on this design. One using only 150 cfs for sluicing which gave a  $\frac{C_s}{C_h}$  ratio of 1.52 and the second in which the sluicing water was cut to 90 cfs with the total flow of 600 cfs remaining the same. This final run gave a  $\frac{C_s}{C_h}$  of 0.94. Figure 18 shows the condition of the bed at the end of these two runs.

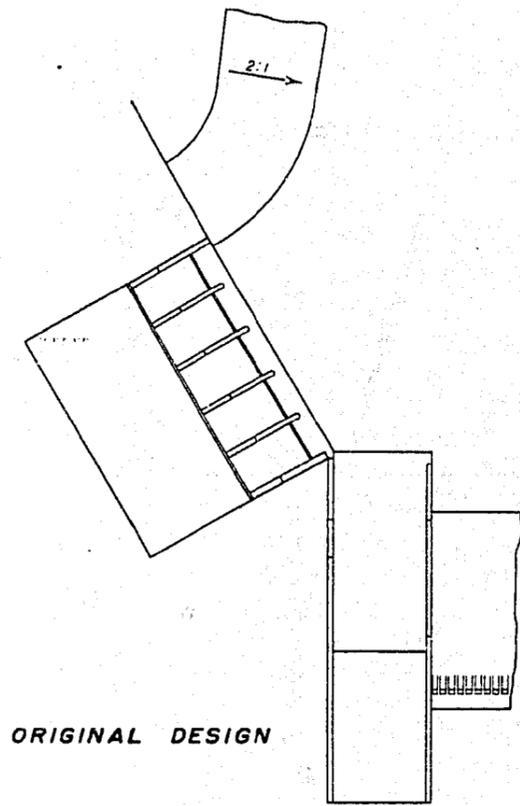
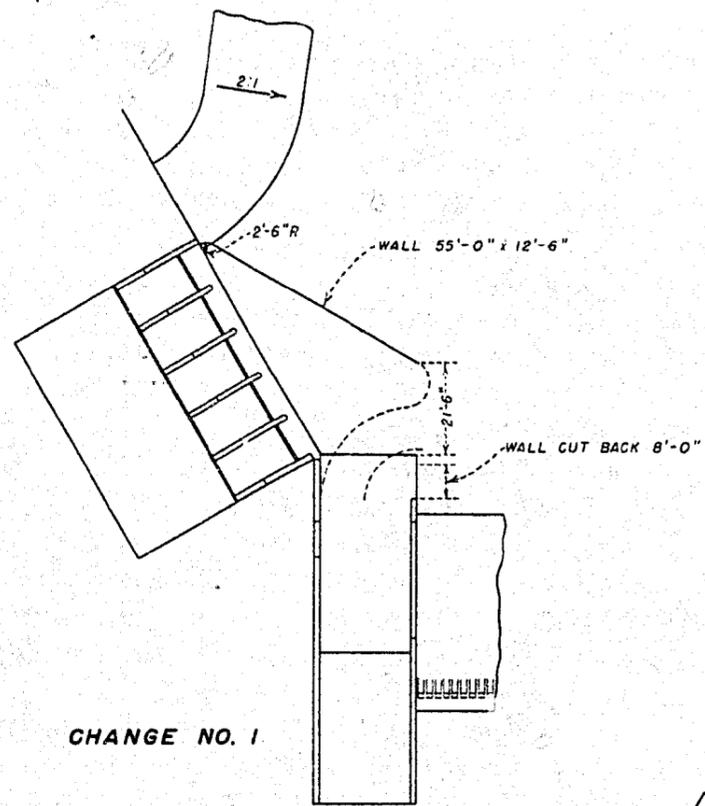
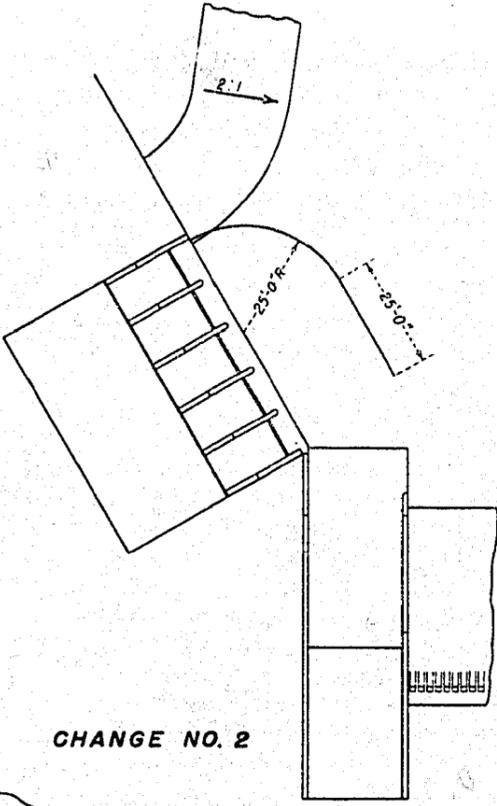
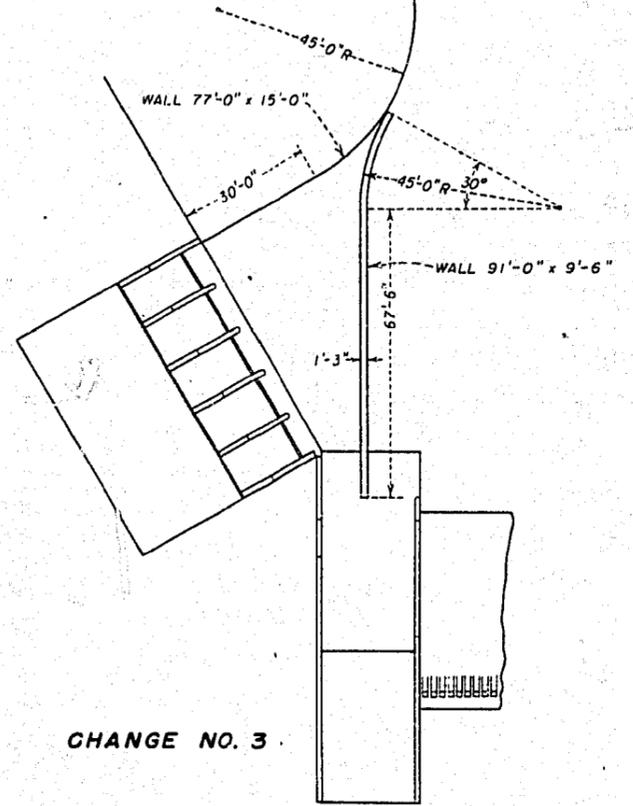
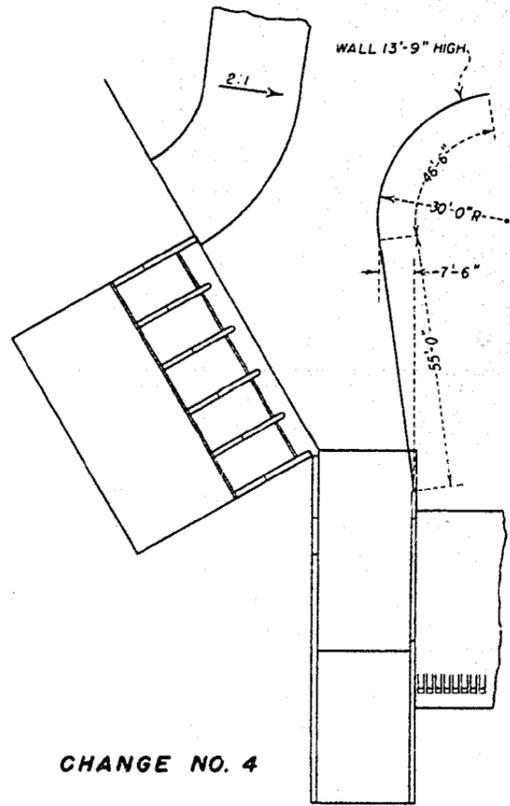
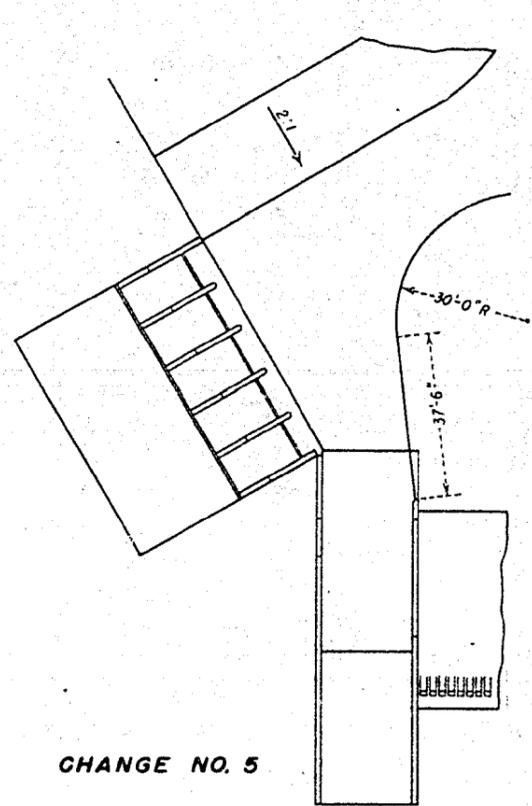
UNITED STATES DEPARTMENT OF THE INTERIOR BUREAU OF RECLAMATION	
HYDRAULIC MODEL STUDIES SUPERIOR-COUNTLAND DIVERSION DAM DESIGNS TESTED-COURTLAND HEADWORKS	
DRAWN: W.M.P.	SUBMITTED: .....
TRACED: E.J.H. - P.V.	RECOMMENDED: .....
CHECKED: .....	APPROVED: .....
DENVER, COLORADO - JULY 18, 1948

A guide wall 55 feet long and 12 feet 6 inches high was then installed as shown in Change No. 1, Figure 6. The bed was set at elevation 1632.0 feet between the guide wall and the headworks. The remainder of the bed in the model was left as it was at the end of the previous run. The pier between the sluiceway and the overflow weir was also cut back 8.0 feet to eliminate the large draw-down it caused when the sluice gate was full open.

A new guide wall, Change No. 2, Figure 6, was then tried. This wall was built to operate submerged allowing the water to be diverted to flow over the top. Various wall heights were tried. It became apparent that when the elevation of the top of the wall was lowered sufficiently to allow the full flow of the headworks to pass over it, the sand bed upstream from the wall built up to an elevation sufficient to allow the bed load sand to also pass over the wall. A horizontal lip extending upstream from the face of this guide wall was tried in an attempt to keep the sand from flowing over the top. This lip showed a slight improvement over the other arrangement but the improvement was insufficient to warrant further tests. A vertical guide wall was also tried in place of the sloping bank. Figure 14A shows the model at the completion of the test with this arrangement.

Change No. 3, Figure 6, was the last of the upstream guide walls to be tried. The curved wall extending from the upstream edge of the headworks had its top above water and replaced the sloping bank of the pool excavation. The straight wall across the face of the headworks was a submerged weir with a 1-inch lip extending outwards from its face. The wall extended to the upstream face of the sluice gate.

The first such wall tried is shown as Change No. 4, Figure 6. On preliminary runs this arrangement showed a marked improvement over the original design so a complete run at the standard water and sediment discharges was made with samples being taken at regular intervals. During the early part of the run, the area in front of the headworks began filling with sand. During this time, however, the samples showed approximately equal concentrations in both the sluiceway and headworks. After a few hours of operation, the area in front of the headworks had filled to the level of the headworks sill, and a roller across the face of the sill began to form. This roller immediately began scouring a large hole in front of the headworks and carried the majority of the sand past the headworks to the sluiceway.

The guide wall was then extended to 67 feet 6 inches, Change No. 6, Figure 6. The flow conditions for this arrangement appeared to be approximately the same as that for Change No. 4. The roller action, however, was further upstream than previously noted and heavy concentrations passed through both Headgates 1 and 2. The bar across the face of the sluiceway also formed slightly further upstream, being located between Headgates 1 and 2. The restricted opening between the bank and divide wall caused an appreciable loss in head for the 600 cfs flow. Therefore, the wall was shortened to 52 feet 6 inches. The velocity of the water in front of the headworks was much lower and there was no indication of the roller. There was, however, a definite movement of sand across the face of the headworks toward the sluiceway. This set up showed enough promise to warrant a complete run. This run was made with the standard water and sand discharges and all headworks gates opened equally. When the model had reached equilibrium conditions the  $\frac{C_s}{C_h}$  ratio equaled 5.129. Figure 15B shows the condition of the sand bed at the completion of this run.

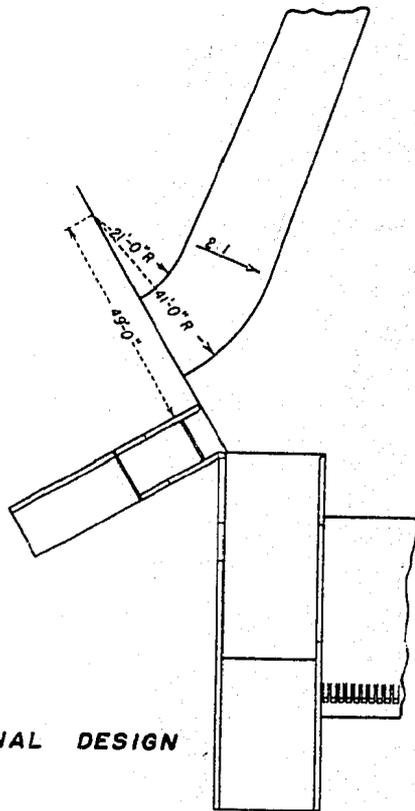
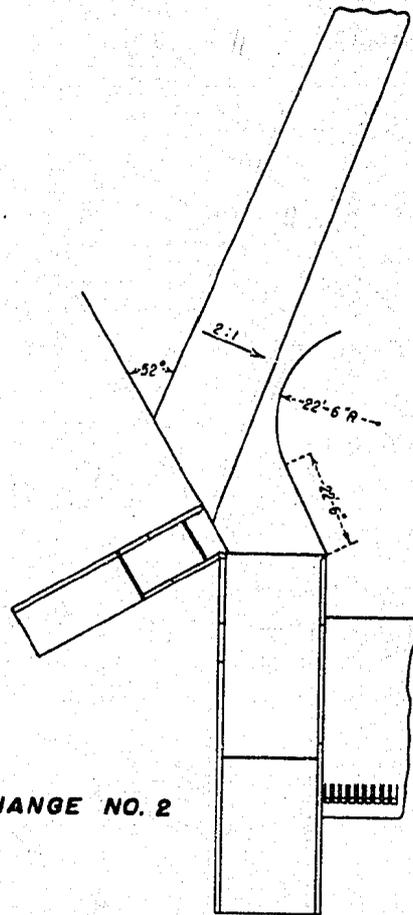
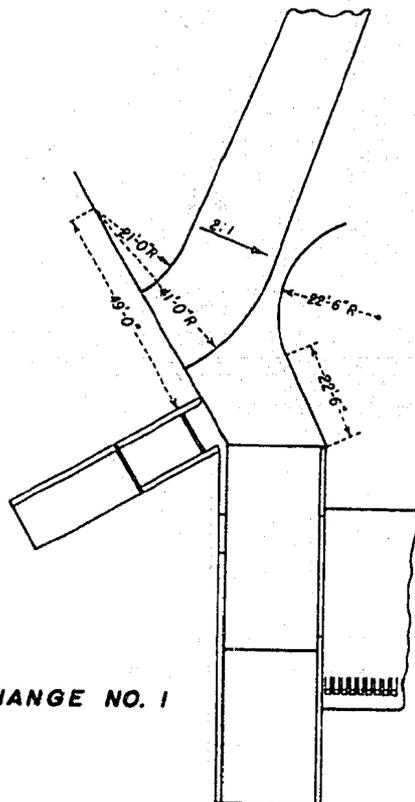
FIGURE 7

ORIGINAL DESIGN

CHANGE NO. 2

CHANGE NO. 1

UNITED STATES DEPARTMENT OF THE INTERIOR BUREAU OF RECLAMATION	
<b>HYDRAULIC MODEL STUDIES</b>	
<b>SUPERIOR-COURTLAND DIVERSION DAM</b>	
<b>DESIGNS TESTED-SUPERIOR HEADWORKS</b>	
DRAWN: P. E. S.	..... SUBMITTED .....
TRACED: E. J. M. - P. V.	..... RECOMMENDED .....
CHECKED: .....	..... APPROVED .....
DENVER, COLORADO - JAN. 19, 1920

Tests on the Superior Canal headworks were limited to designs similar to that proven best for the Courtland Canal headworks. These designs are shown on Figure 7 with the recommended design shown on Figure 5.

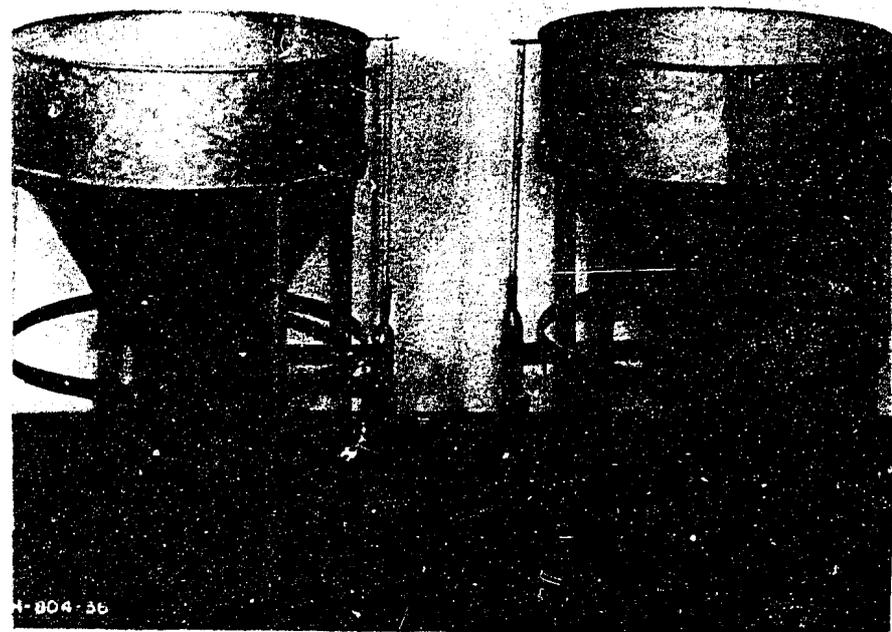
Headworks Collecting Trough

B. Measuring Tanks

SAMPLING APPARATUS

Samples of the water flowing through the sluiceway and headworks were taken at regular intervals by passing a collecting trough, Figure 9A, through the falling nappe. These samples were collected in tanks, Figure 9B, calibrated to read the amount of water in liters. The sand settled into glass funnels mounted at the bottom of the tanks. These funnels were graduated in grams of dry sand so the amount of sand could be read directly and the concentration computed without any further conversion of the data.

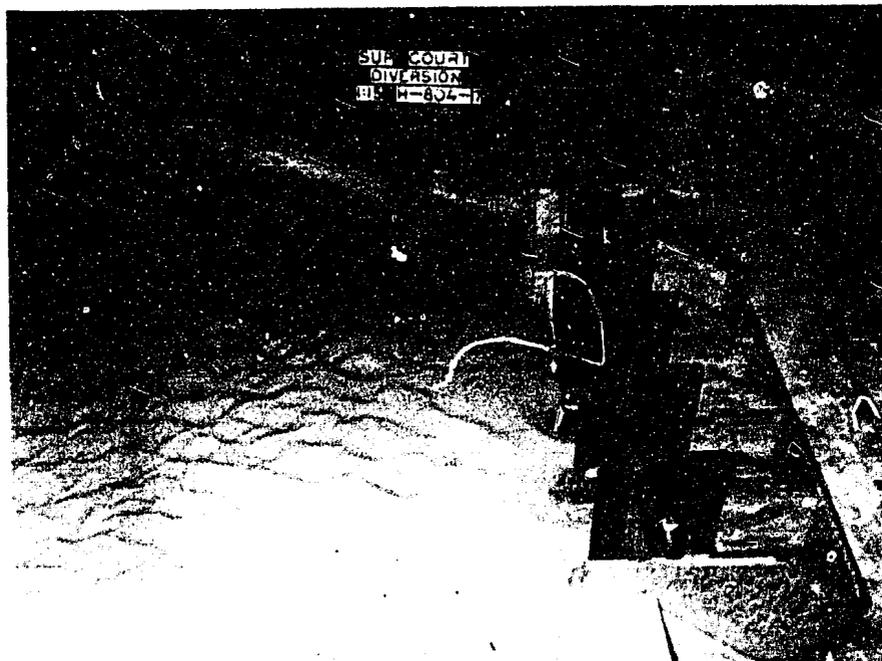
A. Before Test Run Number 1

B. After Test Run Number 1

COURTLAND HEADWORKS  
ORIGINAL DESIGN

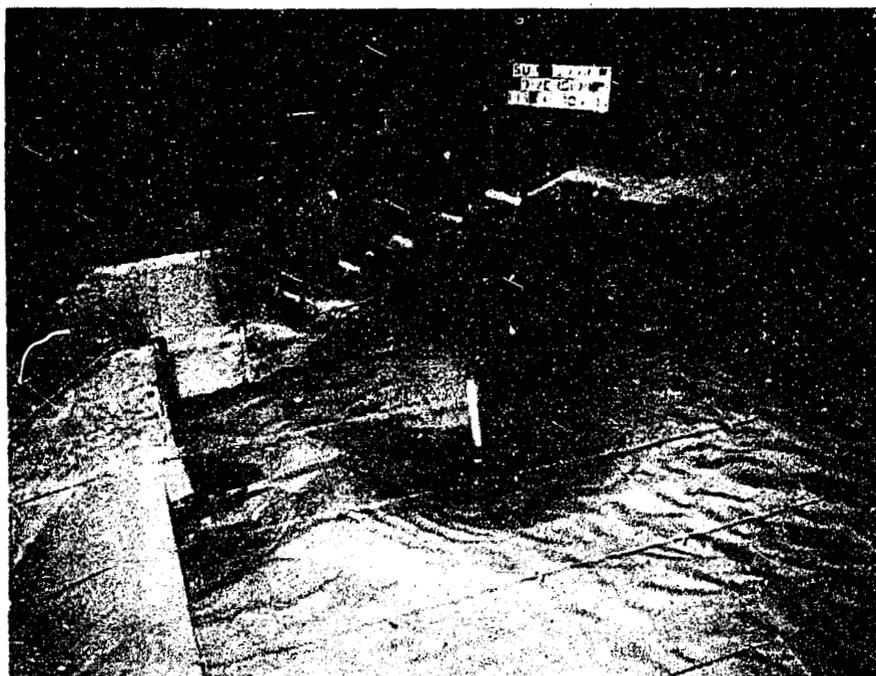
A. General view of bed after 3 hours run

B. Closeup of bed after 21 hours run

COURTLAND HEADWORKS  
CHANGE NUMBER 1

Photographs, Figures 13A and 13B, were taken during and at the end of this run. They show the heavy scour that occurred upstream from and around the end of the guide wall and the heavy deposit between the guide wall and the headworks.

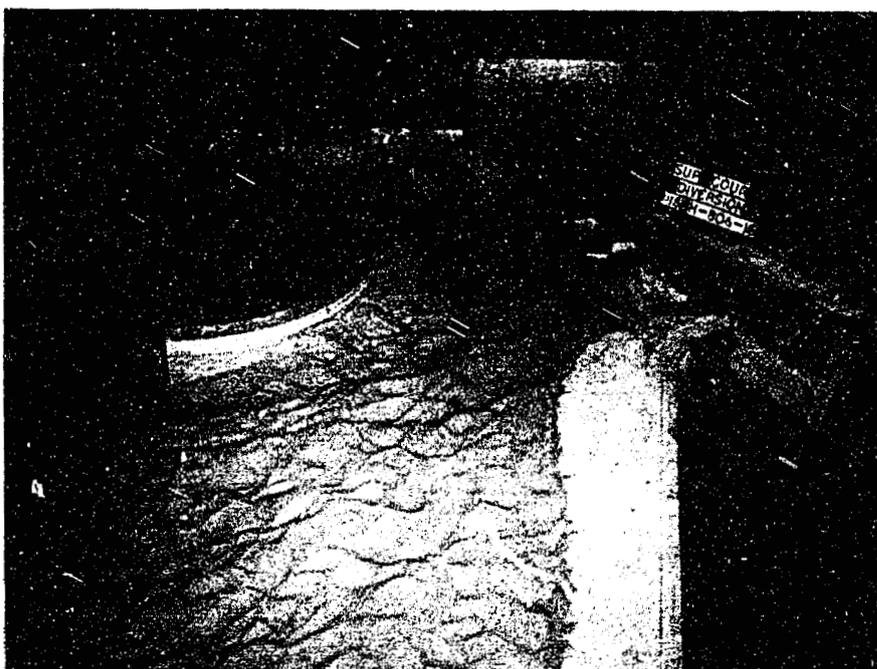
A. Closeup of bed after a short run  
Change Number 2

B. Closeup of bed after 15 hours run  
Change Number 4

COURTLAND HEADWORKS

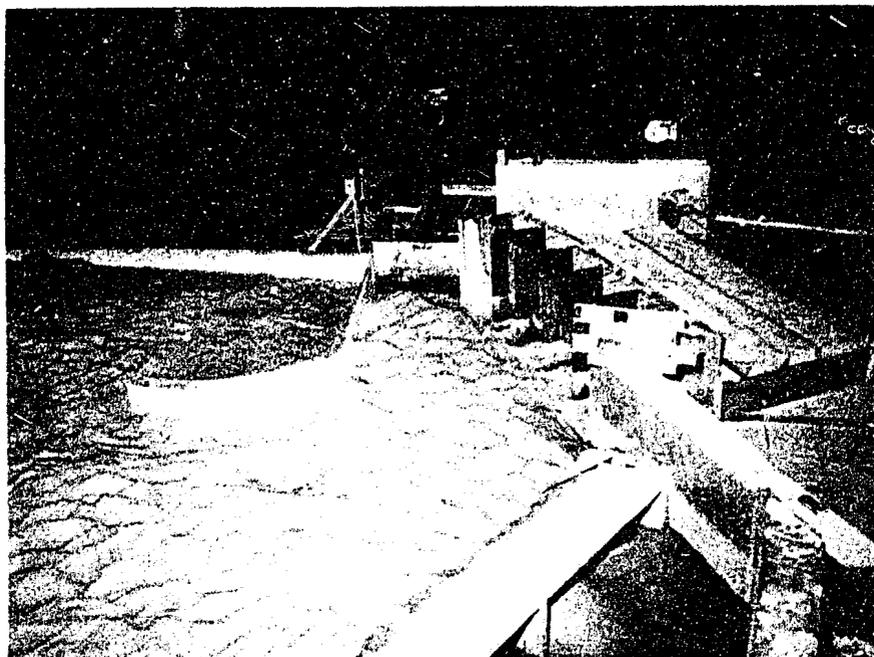
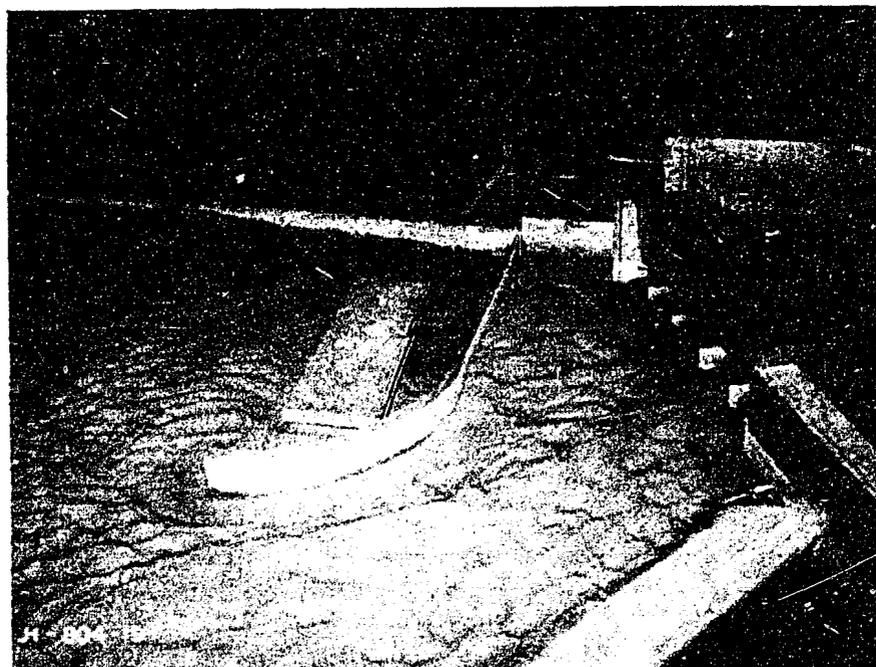
A. Closeup of bed after 6 hours run  
Change Number 5A

B. Closeup of bed after 20 hours run  
Change Number 6

COURTLAND HEADWORKS

The model was operated for a short time with Headgates 4 and 5 completely closed and the total diverted flow passing through Headgates 1, 2, and 3. This system of operation improved the sediment distribution. However, concentrating the flow too much by keeping some gates closed appeared to increase the turbulence in the flow through the headworks resulting in a higher concentration of sand being carried through as suspended load. Figure 15A shows the condition of the bed after these tests.

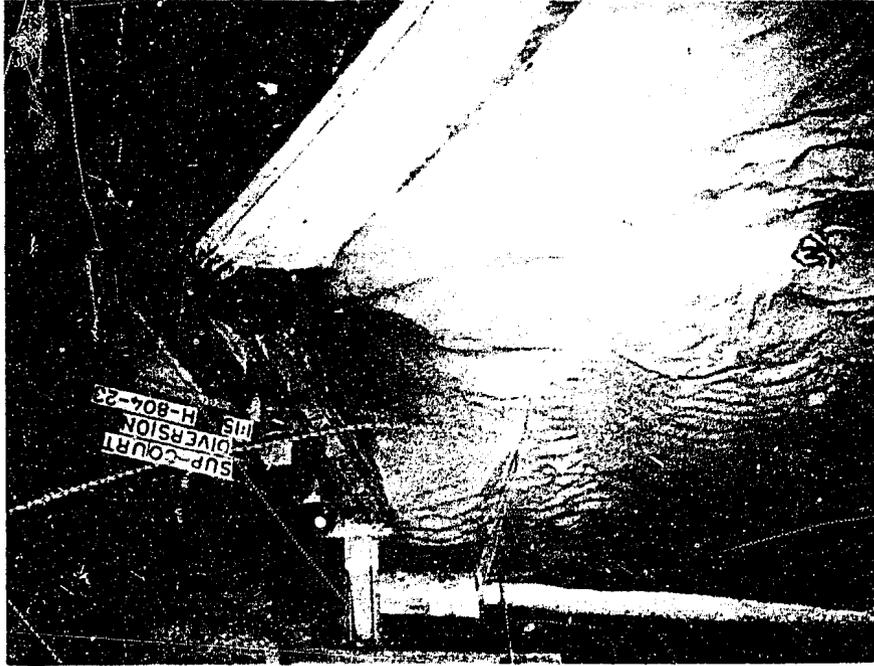
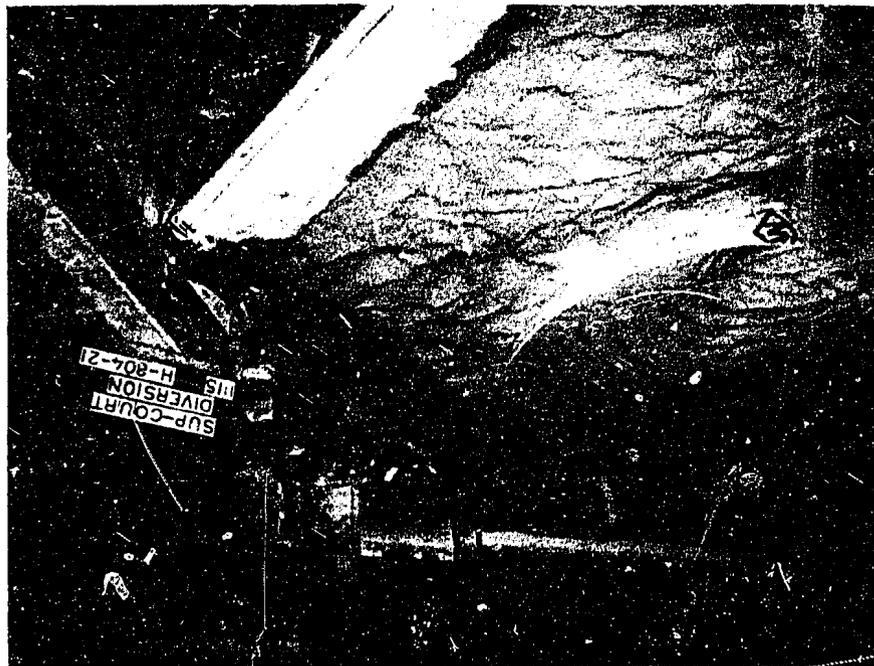
COURTLAND HEADWORKS  
CHANGE NUMBER 7  
VORTEX TUBE INSTALLED  
B. Using 10 ft. Sluicagate

A. Using 20 ft. Sluicagate

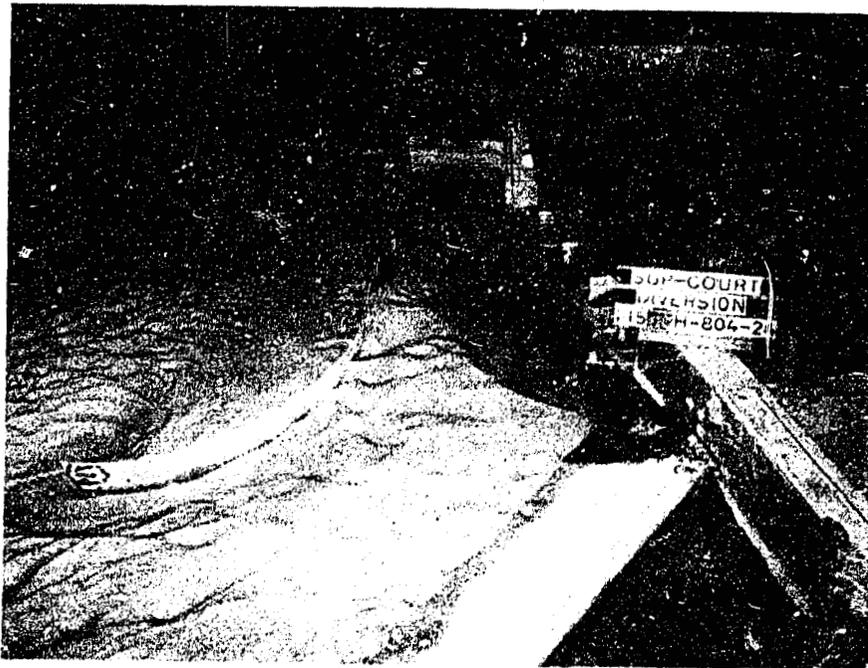
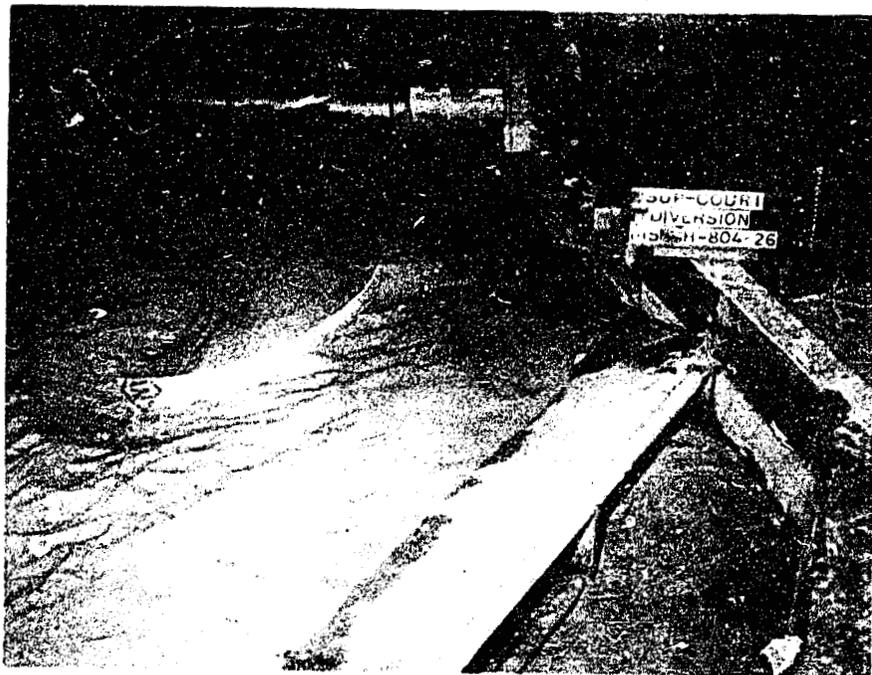
A. Using 20 ft. Sluiceway

B. Using 10 ft. Sluiceway

COURTLAND HEADWORKS  
CHANGE NUMBER 7  
VORTEX TUBE REMOVED

action was similar to that in the previous run but the sand distribution was not as satisfactory. The  $\frac{C_s}{C_h}$  ratio for the 20-foot sluice gate was 2.92 and for the 10-foot gate 5.83. Figures 17A and 17B show the condition of the sand bed at the end of the runs with the 20- and 10-foot gates, respectively.

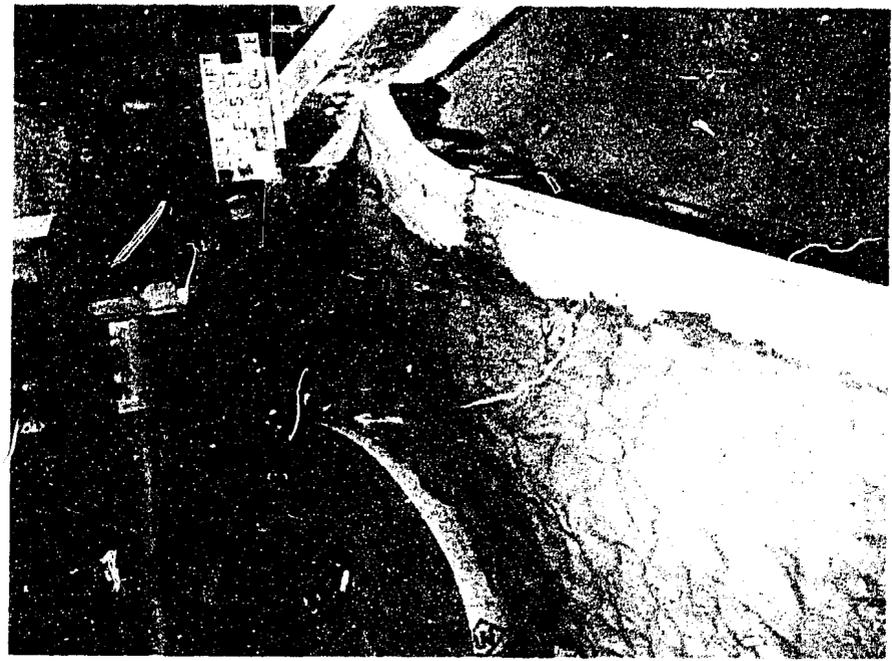
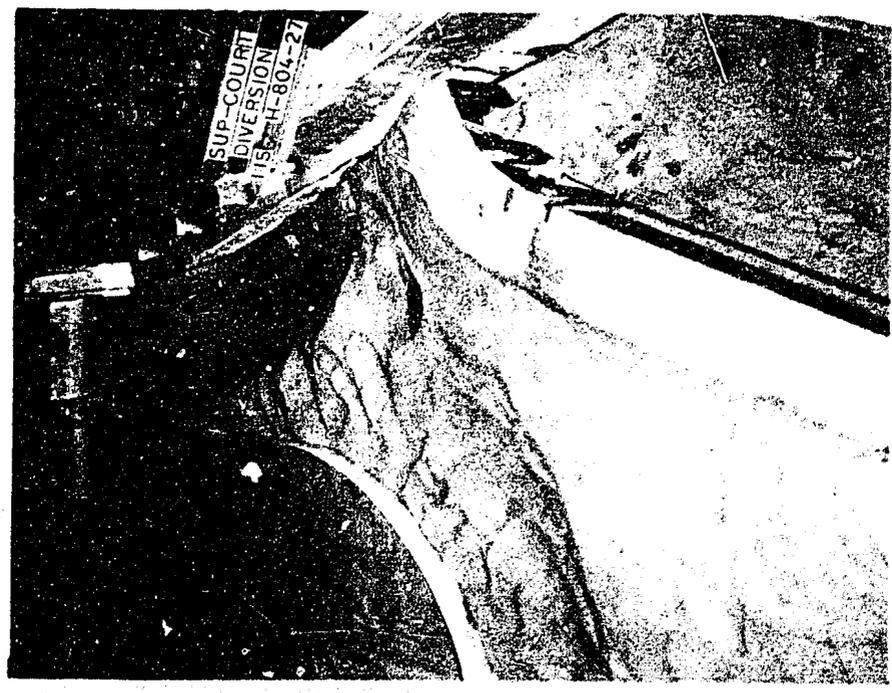
A. Using 25% of Total Discharge for Sluicing

B. Using 15% of Total Discharge for Sluicing

COURTLAND HEADWORKS  
RECOMMENDED DESIGN

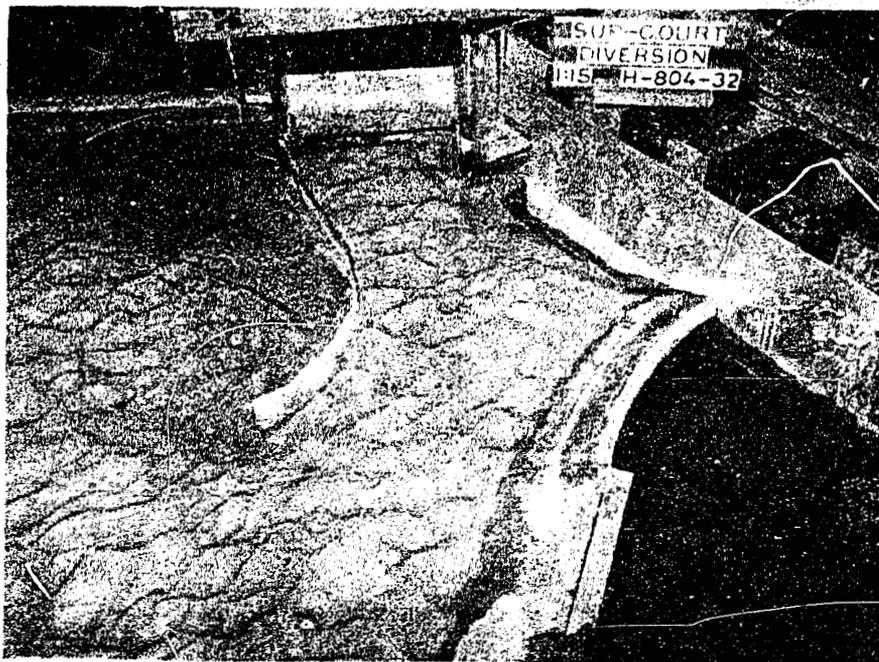
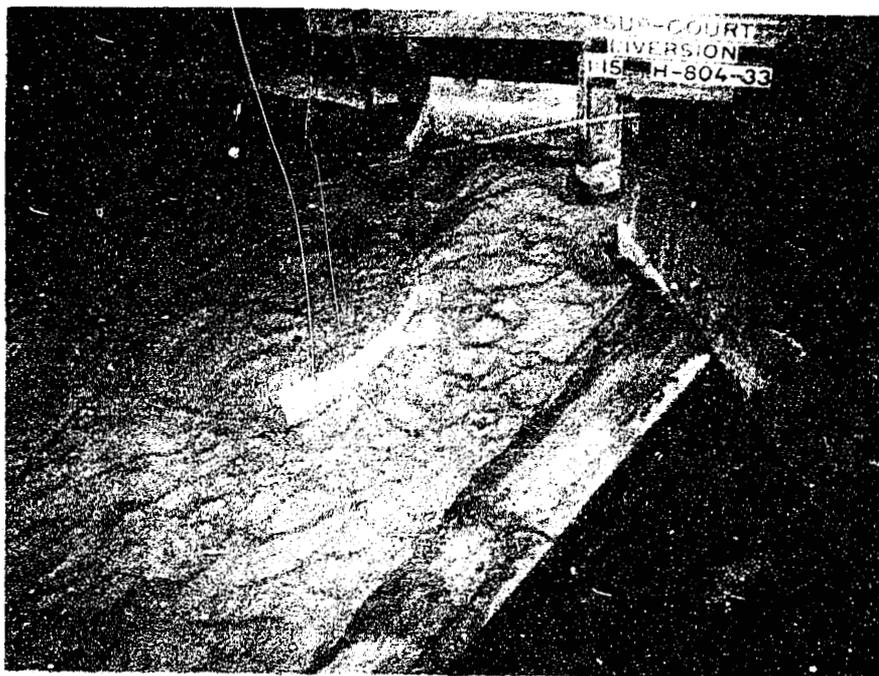
A. End of test run  
Change Number 1

B. During test run  
Change Number 2--Recommended Design

SUPERIOR HEADWORKS

This design showed some improvement over the original design, giving a  $\frac{C_s}{C_h}$  of 0.18. When the model was run at higher discharges, however, there was a pronounced wave formed where the main flow struck the headworks wing wall. To eliminate this condition the excavation bank was extended straight into the headwork wing wall, Change No. 2, Figure 7. This arrangement improved the condition in front of the wing wall and gave a  $\frac{C_s}{C_h}$  equal to 0.64. Figures 20A and 20B show the bed at the end of the run with Change No. 1 and during the run with Change No. 2 in place. The recommended design for the Superior headworks, Change No. 2, is shown in Figure 5. No further tests were run on this design.
