HYDRAULIC MODEL STUDIES OF THE SPILLWAY
TIBER DAM
MISSOURI RIVER BASIN PROJECT

Hydraulic Laboratory Report No. Hyd-288

March 24, 1952

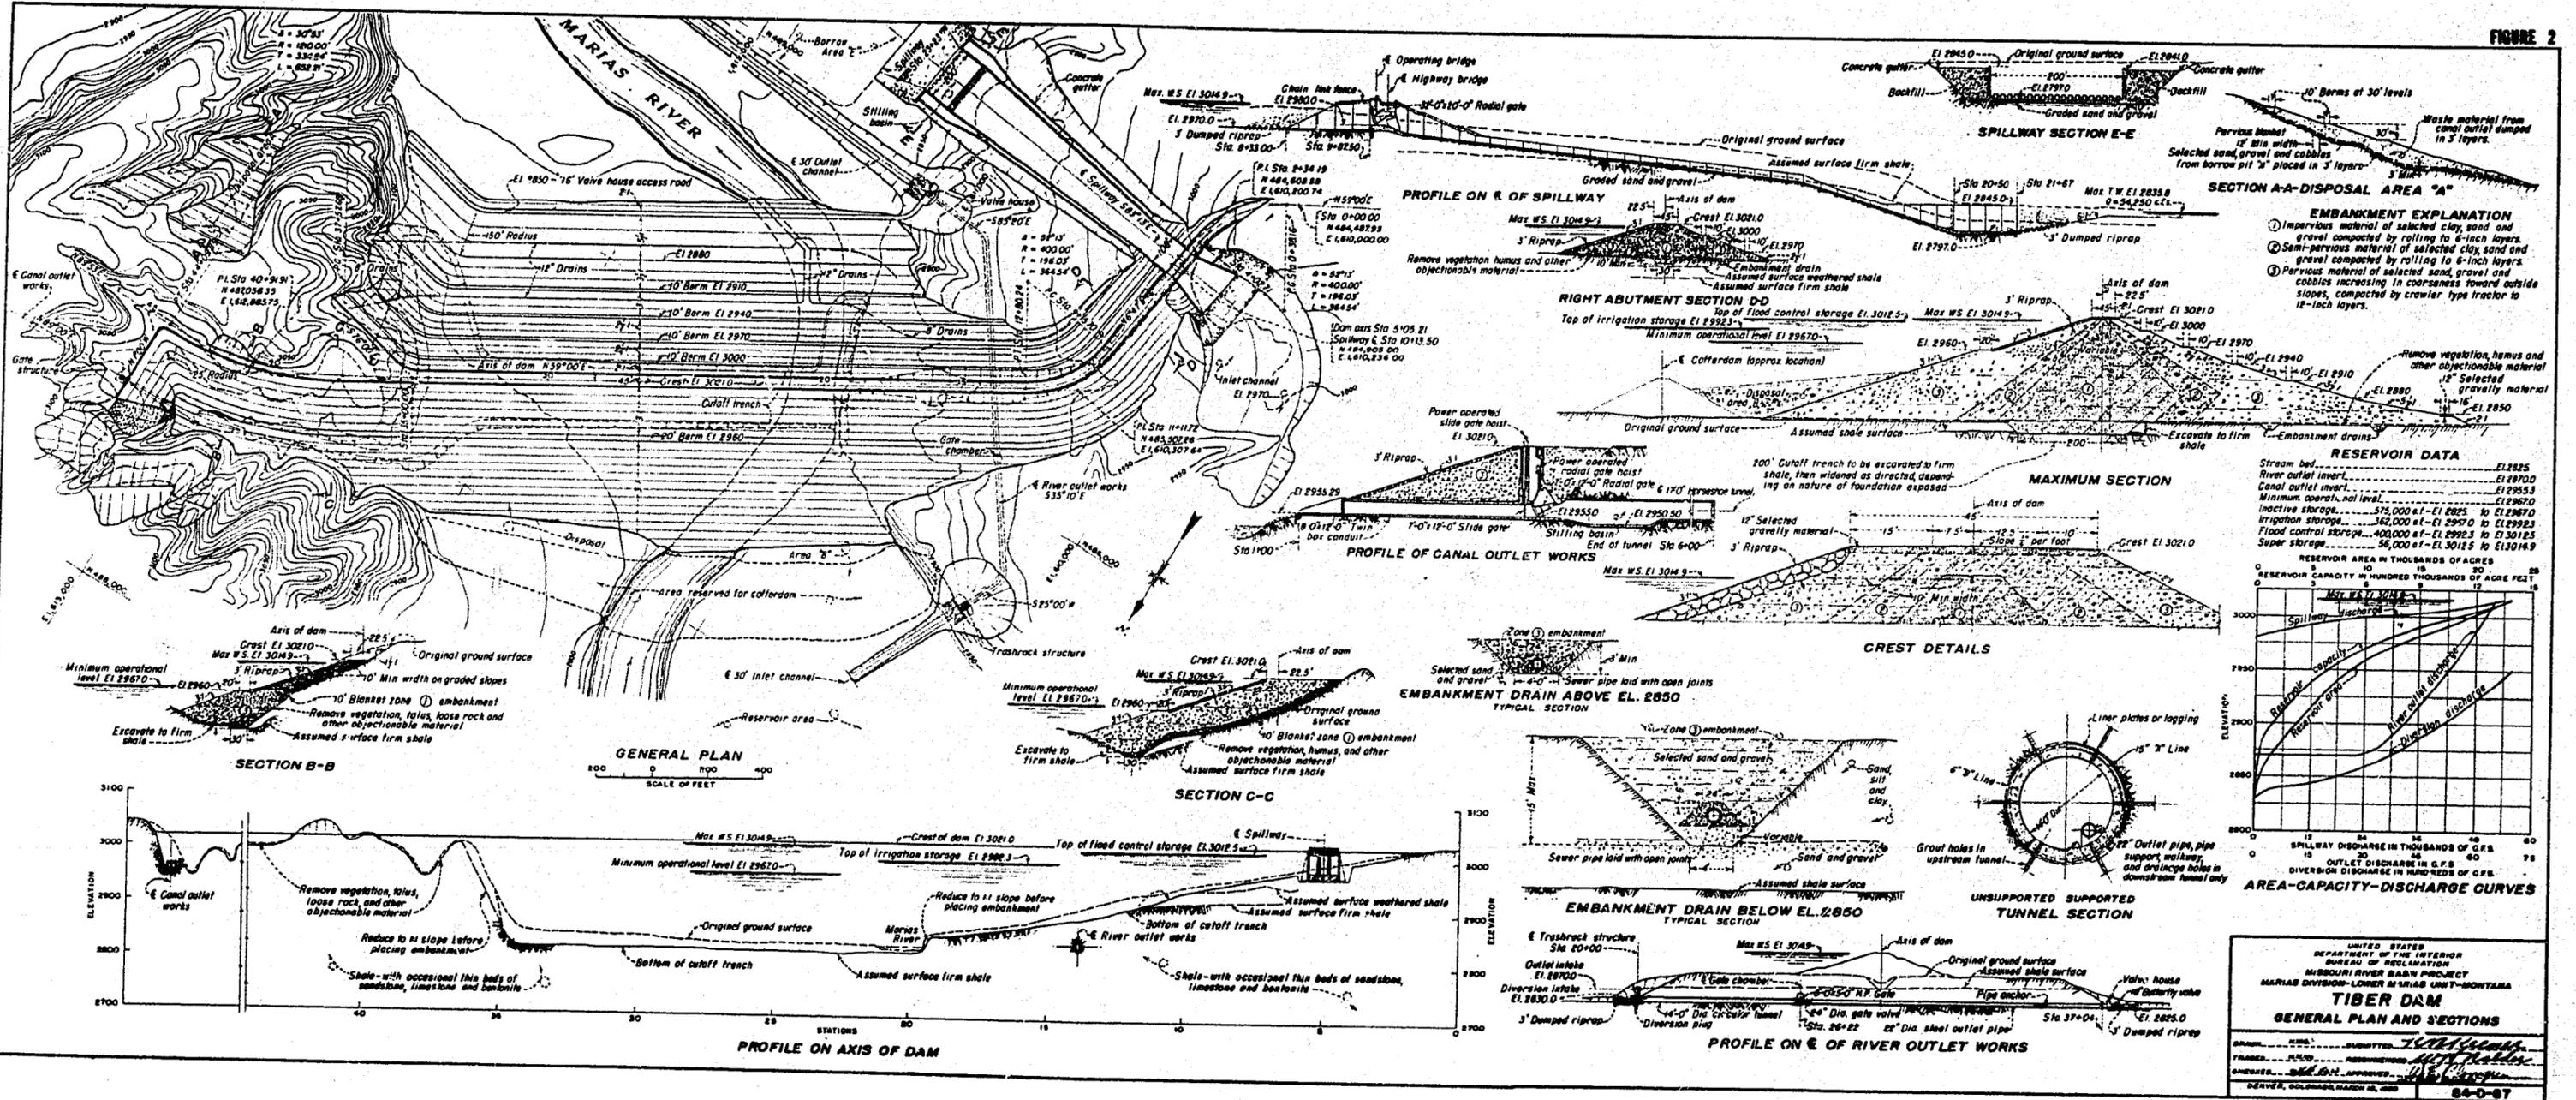
Tiber Dam is a part of the Missouri River Basin Project and is located on the Marias River approximately 15 miles south of Tiber, Montana, Figure 1. The dam, 182 feet high with a crest length of 4,200 feet, is an earth-fill structure, Figure 2. The reservoir, with a capacity of 970,000 acre feet, provides irrigation water for the Marias Project, an area situated 15 miles east of the dam.

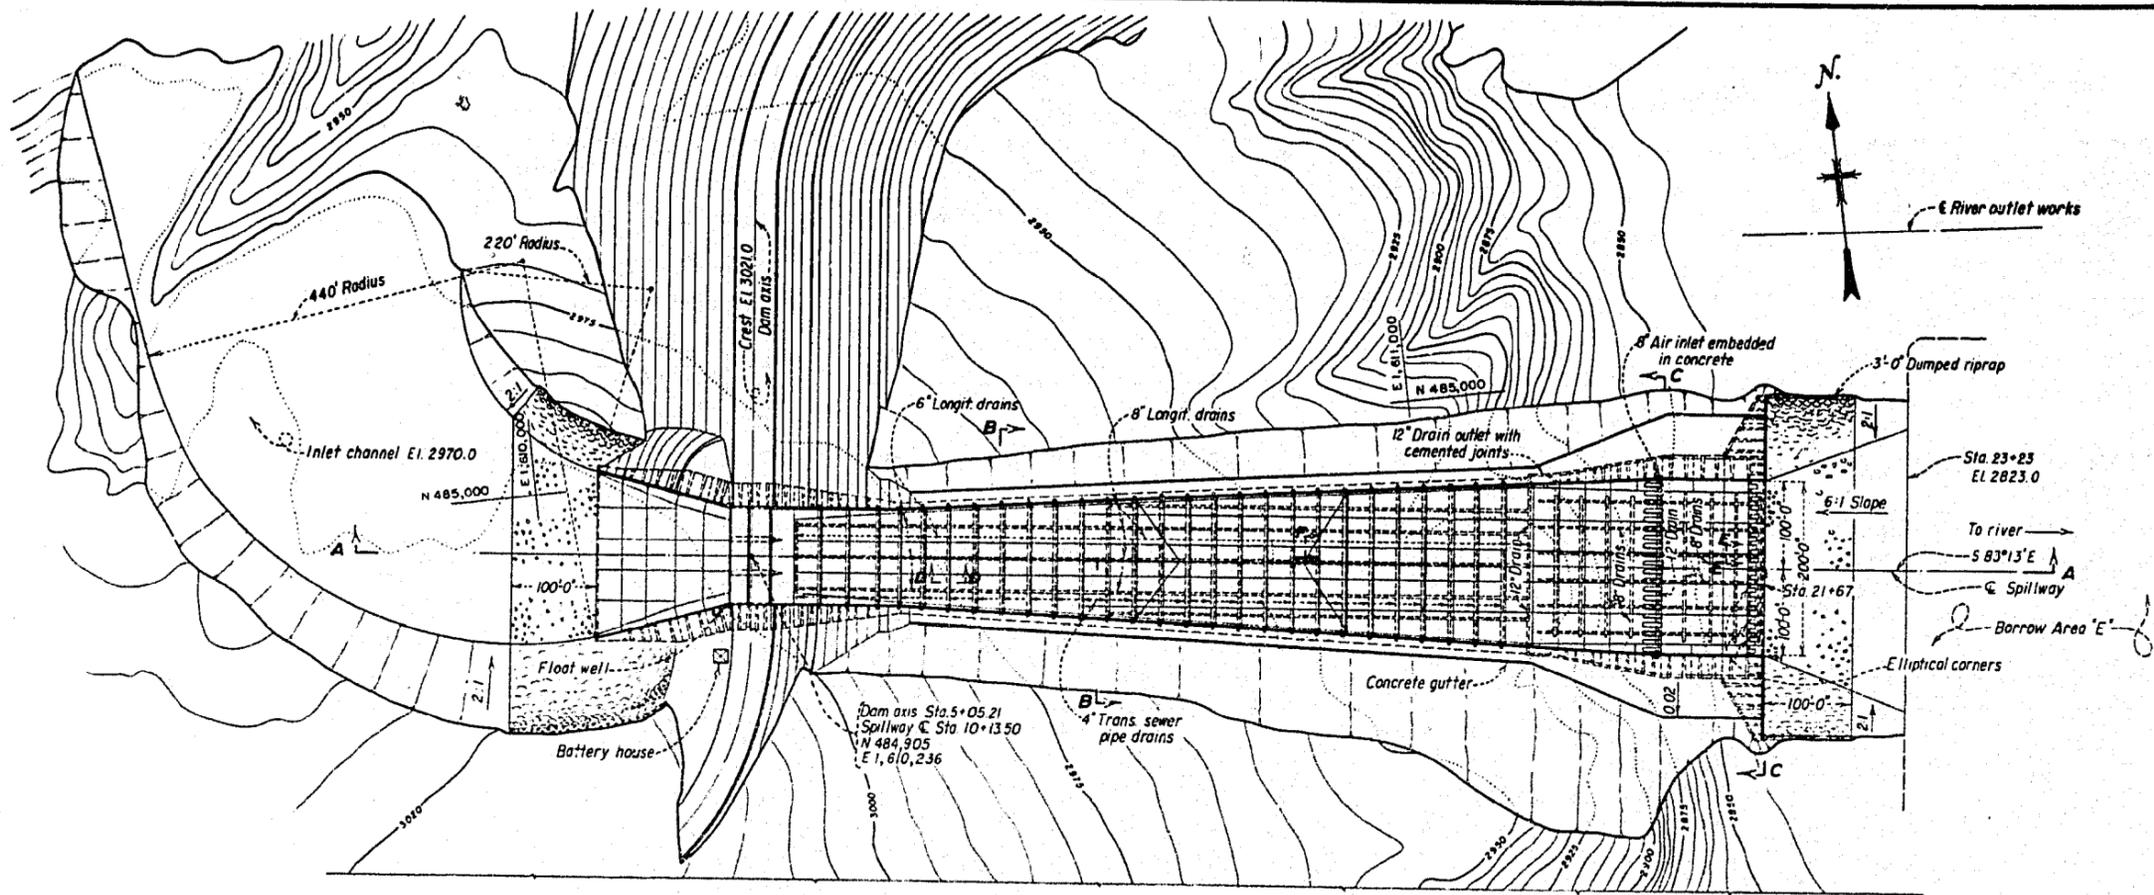
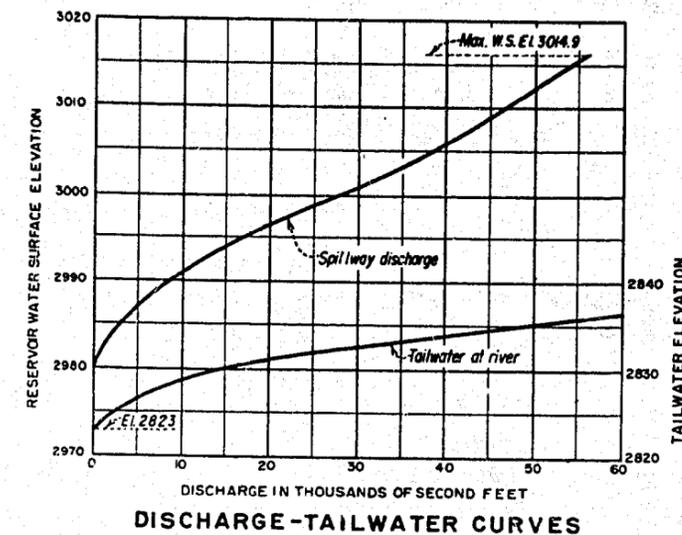
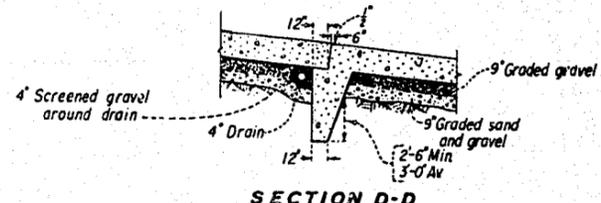
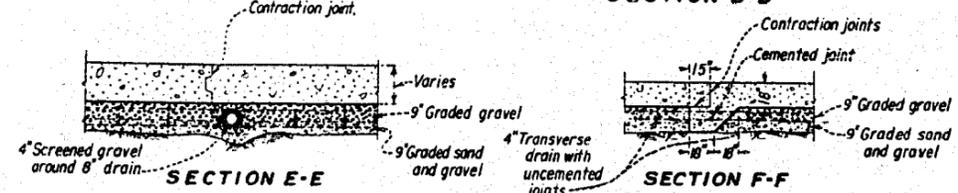
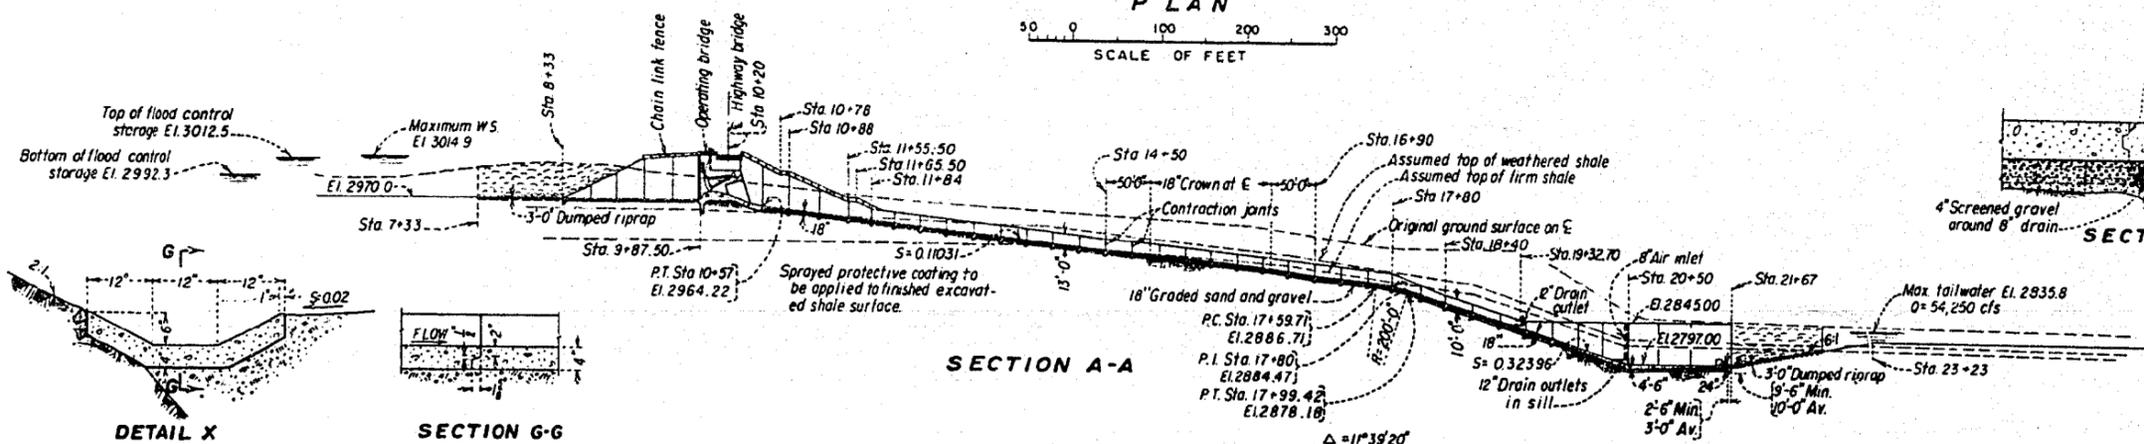
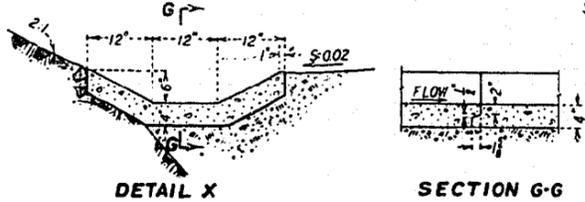
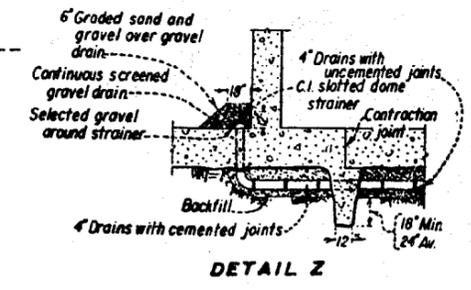
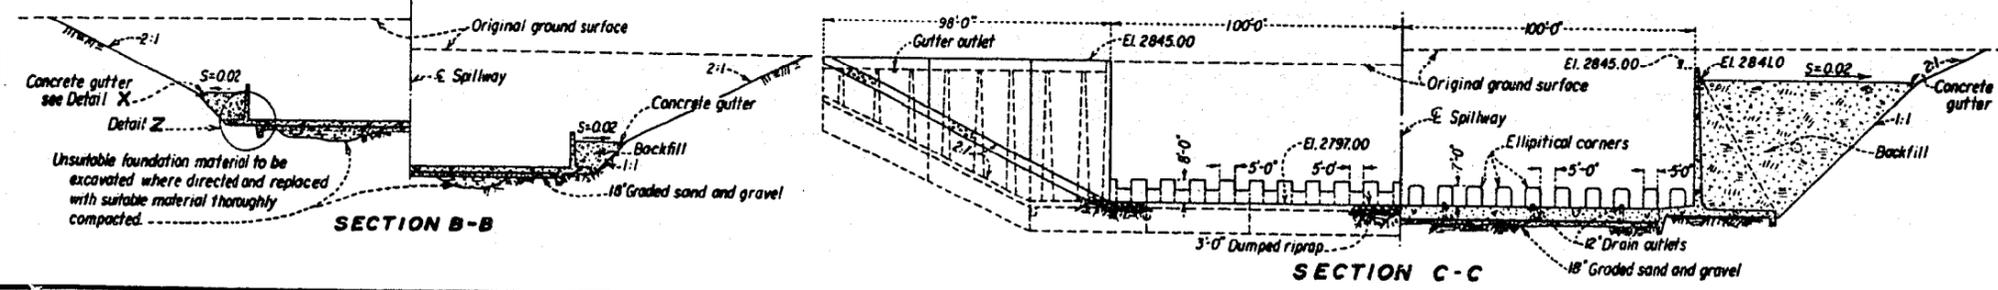
UNITED STATES
DEPARTMENT OF THE INTERIOR
BUREAU OF RECLAMATION
MISSOURI RIVER BASIN PROJECT
MARIAS DIVISION - LOWER MARIAS UNIT - MONTANA
TIBER DAM
SPILLWAY
PLAN AND SECTIONS

The flood control spillway at the right abutment is a concrete-lined open-channel structure, Figure 3. The overflow section at the upstream end of the spillway is controlled by three 32- by 20-foot radial gates resulting in a net crest length of 96 feet. A concrete curtain wall at the nose of the piers limits the gate openings to 20 feet and a seal prevents leakage of water between the gates and the curtain wall. The inclined chute section is 1,050 feet long, increasing in width from 108 feet at the crest to 200 feet at the stilling basin. The maximum discharge of 51,700 cfs results in a discharge of 258 cfs per foot of stilling basin width. The spillway drops 185 feet from the crest, elevation 2980, to the stilling basin, elevation 2797. A model built to a scale of 1:48 was used to study the hydraulic performance of the spillway structure.

Description. The approach channel to the entrance of the preliminary spillway was curved, Figure 3. The terminal 130 feet of the channel at elevation 2970 was lined with concrete and had converging side walls as shown in Figure 5A. The spillway chute, starting at the overflow section, was 108 feet wide for a length of 600 feet, Figure 6. For the remaining 450 feet of length, the chute diverged uniformly to a width of 200 feet at the upstream end of the stilling basin. The stilling basin was 200 feet wide throughout its length of 167 feet with the floor at elevation 2797.

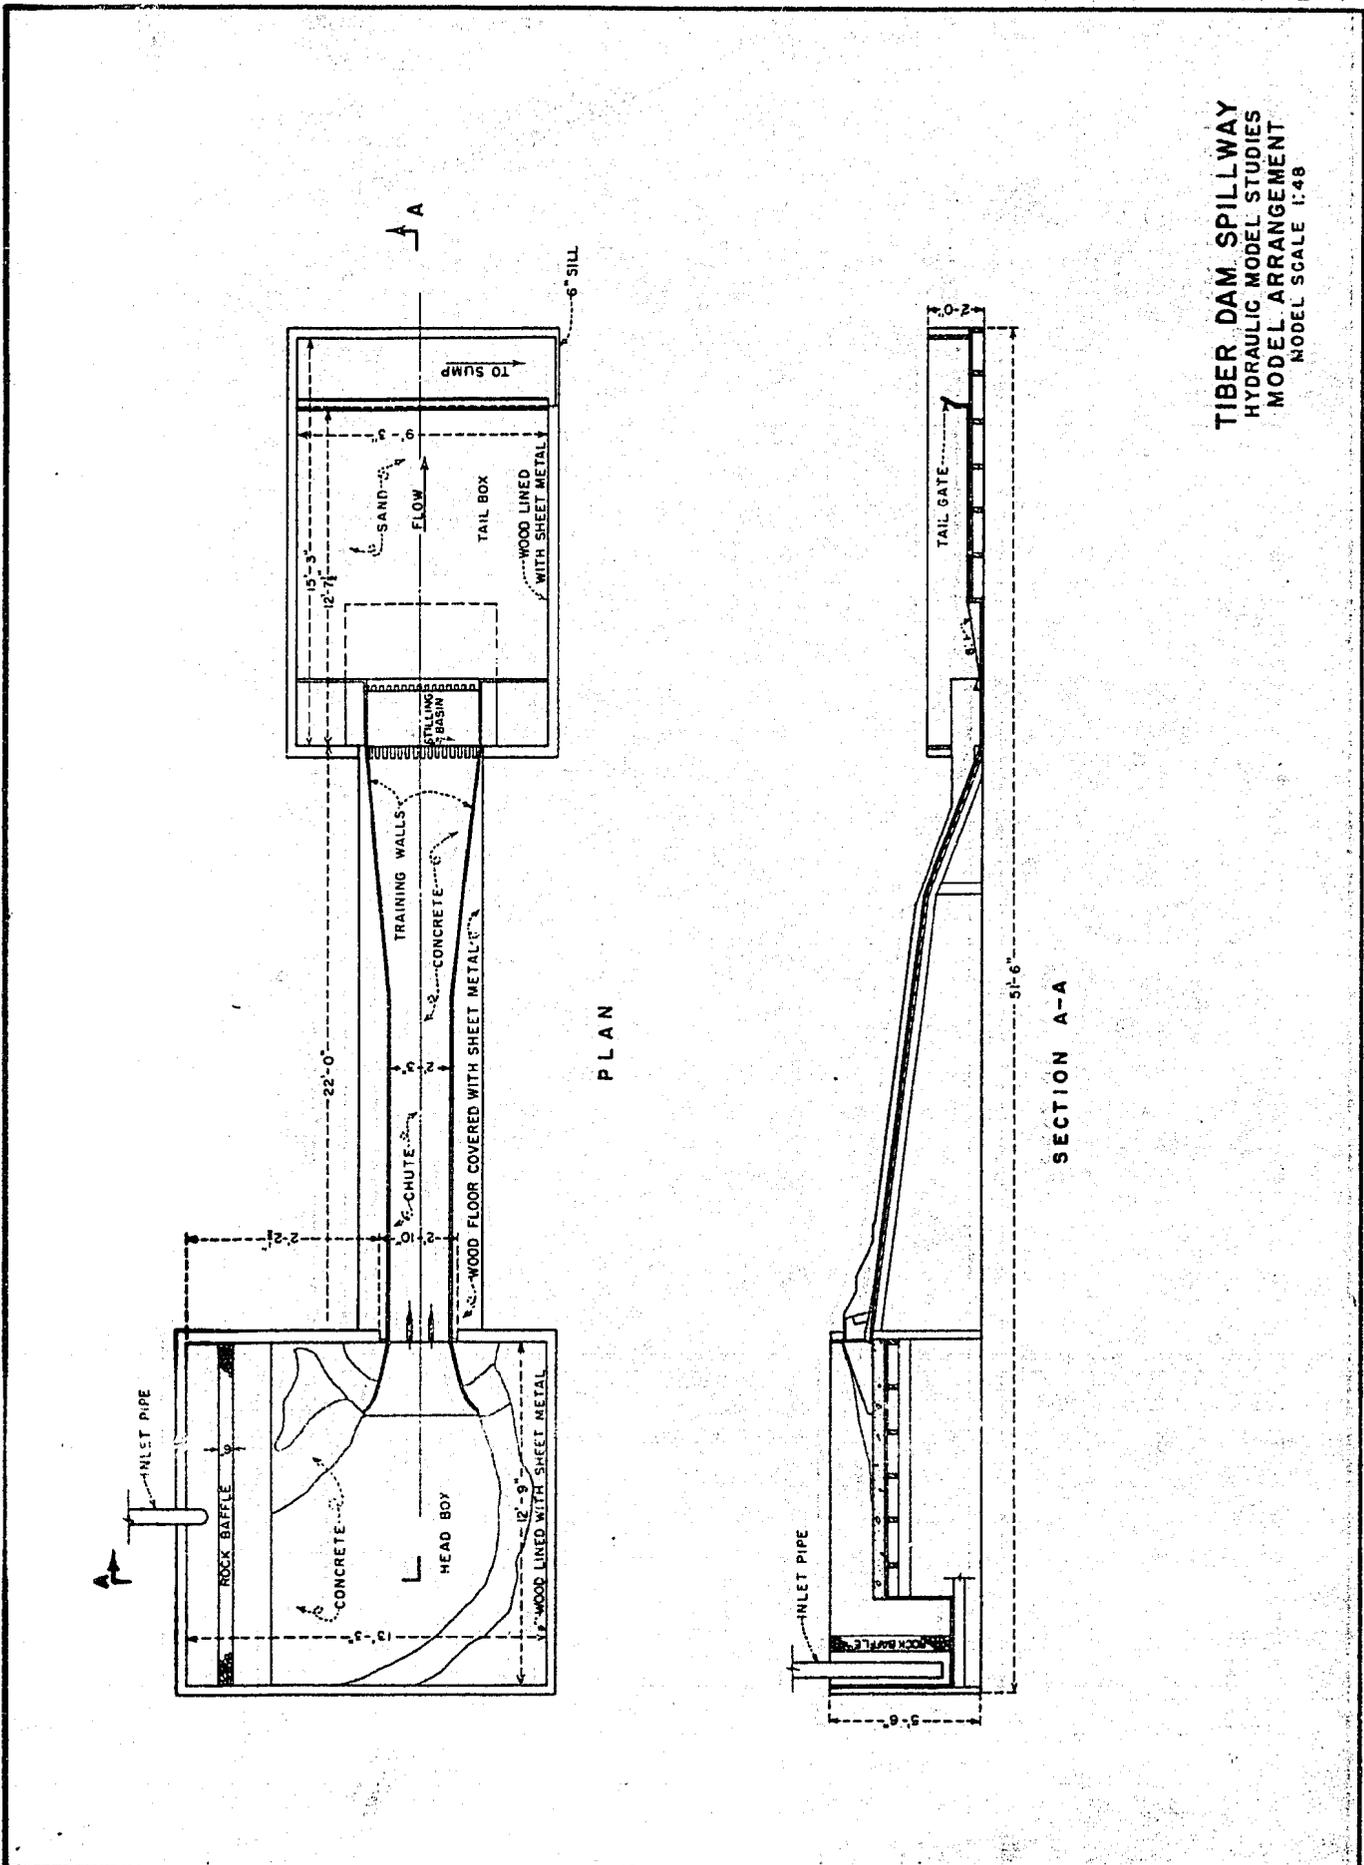
TIBER DAM SPILLWAY
 HYDRAULIC MODEL STUDIES
 MODEL ARRANGEMENT
 MODEL SCALE 1:48

The 1:48 scale model, Figure 4, represented a portion of the reservoir area, the spillway entrance, the spillway chute, the stilling basin, and a portion of the downstream river channel. The head and tail boxes were constructed of wood and lined with sheet metal. The head box was 13 by 13.5 feet and contained reservoir topography formed of concrete plastered on metal lath. The metal lath was supported by wooden forms cut to the shape of the contours in the area. A baffle 6 inches thick and filled with 1-1/2-inch rock was located at the upstream end of the head box to quiet the flow from the inlet pipe to simulate the placid characteristics of water in a reservoir. The overflow section of the spillway, built of concrete screeded to sheet-metal templates, was placed on the downstream side of the head box. The control structure consisted of three sheet-metal gates with two wood piers and a wood curtain wall. A row of piezometers was installed along the center line of the overflow section. A point gage was placed in the head box to measure the elevation of the reservoir water surface.

The spillway chute, beginning at the overflow section and continuing to the tail box, was supported by a wooden platform covered with sheet metal. The floor of the chute, like the overflow section, was formed of concrete screeded to metal guide strips placed parallel to the flow. The training walls were made of plywood and covered with sheet metal. Piezometers were installed along the center line of the steep downstream section of the chute. The upstream section of the chute was built with a slope of 0.1312 in the model instead of the prototype slope of 0.1107. This increase in slope was necessary to give correct velocity to the flow entering the stilling basin since the friction in the model could not be made small enough to correspond to the prototype.

The tail box was 9.5 by 15.5 feet and contained the stilling basin which was connected to the lower end of the chute. The remainder of the tail box was used to reproduce 450 feet of prototype river channel. The horizontal apron of the stilling basin was built of concrete screeded to metal templates, and the chute blocks and end sill were made of wood. The channel was formed of sand, of which all passed a No. 50 sieve and was retained on a No. 100 sieve. A tailgate on the downstream end of the box was used to control the tail-water elevation which was read directly in terms of prototype elevations from a staff gage in the channel.

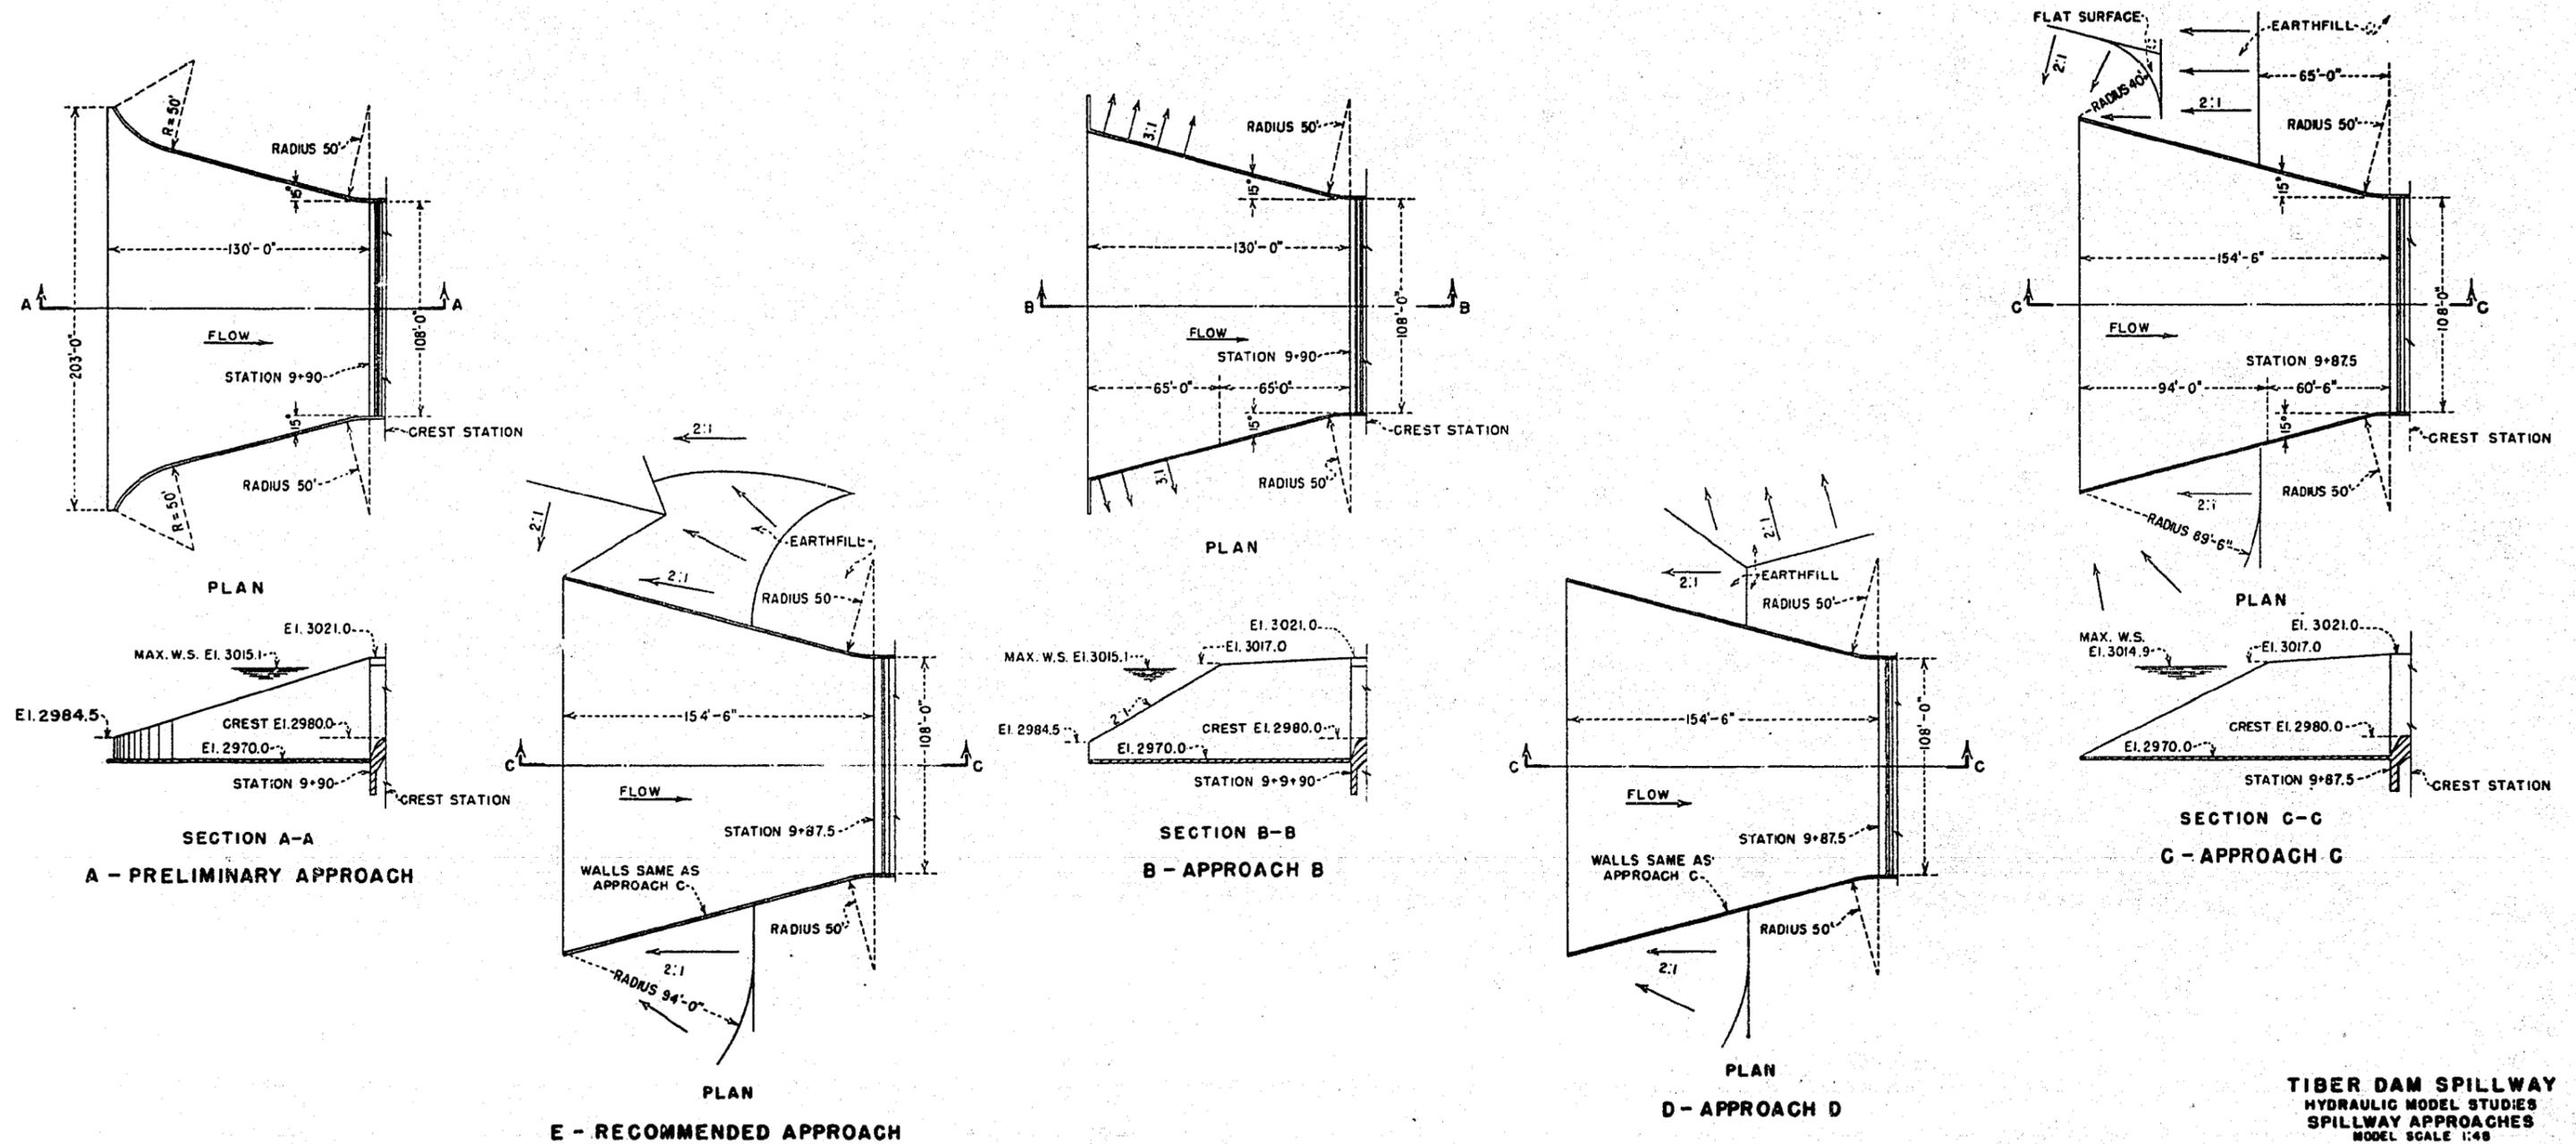
TIBER DAM SPILLWAY
HYDRAULIC MODEL STUDIES
SPILLWAY APPROACHES
MODEL SCALE 1:48

Approach studies. Approach B was the first alteration studied, Figure 5B. The modification consisted primarily in raising the height of the entrance walls as shown in the figure. The appearance of the water surface in the approach with a discharge of 51,700 cfs is shown in Figure 10A. There was some improvement over the conditions occurring with the preliminary entrance since the contraction covered less area and, being further upstream, caused less disturbance at the curtain wall.

Approach C was next tried, Figure 5C. The length of the paved section was increased 24.5 feet and the walls were lengthened a similar amount. In addition, backfill was placed to the top of the walls as shown in the figure. The contraction at the upstream end of the left wall was much less, Figure 10B, than occurred in the previous tests. The performance was considered satisfactory, but it was advisable to study similar but more economical arrangements which required less backfill.

For Approach D the same walls were used as for Approach C, but the backfill against the left wall was shortened, Figure 5D. The flow in the entrance area was smooth, Figure 11A, and there was less contraction at the left wall than had occurred with Approach C.

For Approach E, Figure 5E, the outer limit of the backfill at the left wall was placed on a curve since the corner used in Approach D would probably be damaged by large discharges through the spillway. The flow contraction at a discharge of 51,700 cfs, Figure 11B, was more pronounced than with the previous backfill arrangement, but the conditions of flow were considered satisfactory and this entrance was recommended for construction.

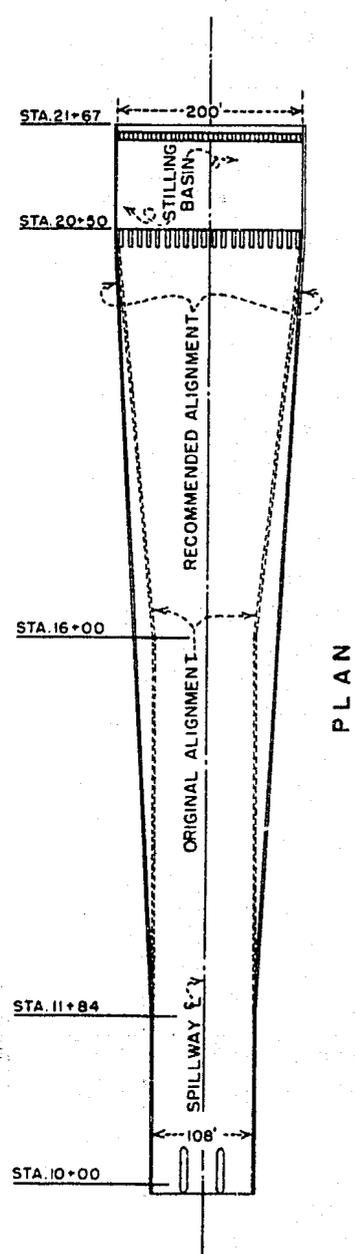
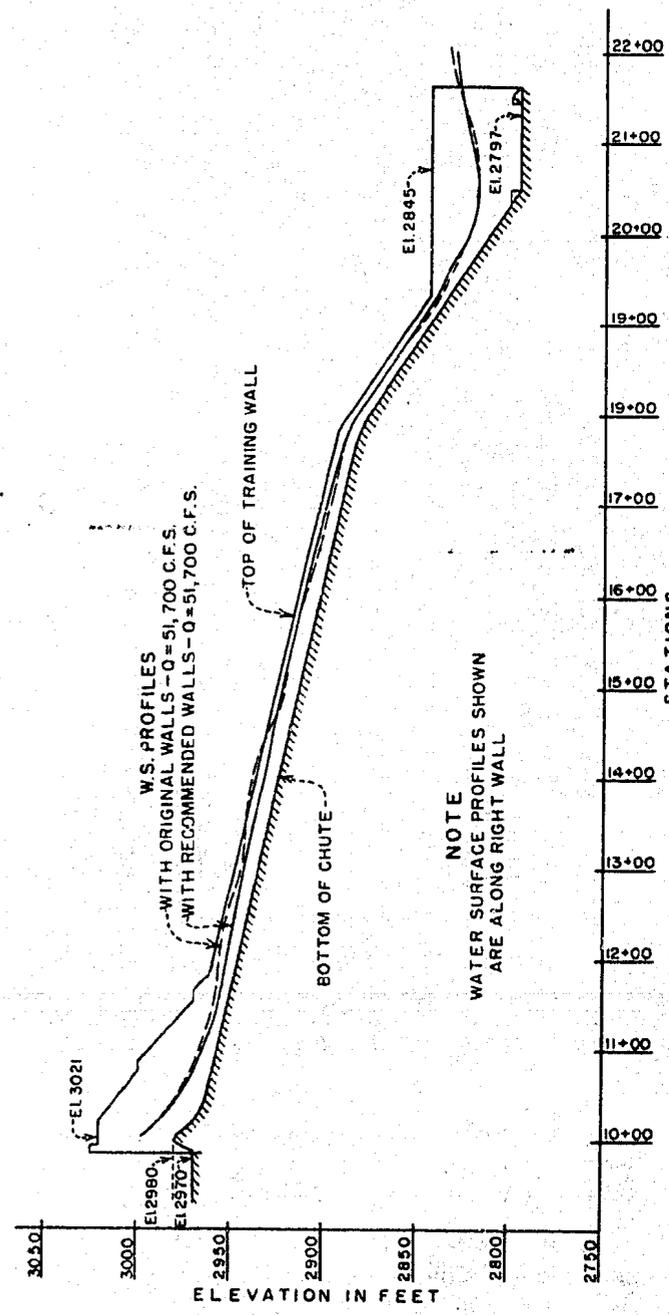
TIBER DAM SPILLWAY
 CHUTE TRAINING WALLS
 1:48 SCALE MODEL STUDY

W.S. PROFILES
 WITH ORIGINAL WALLS - Q = 51,700 C.F.S.
 WITH RECOMMENDED WALLS - Q = 51,700 C.F.S.

NOTE
 WATER SURFACE PROFILES SHOWN
 ARE ALONG RIGHT WALL

The studies with the two crowns did not prove successful in obtaining uniform flow distribution entering the stilling basin for all discharges, so the alignment of the training walls was modified, Figure 6. The point at which the training walls began to diverge was moved upstream 416 feet to Station 11+84. With the crown removed, the distribution of flow at the downstream end of the chute for the maximum flow of 51,700 cfs, Figure 17, was more uniform than occurred with the preliminary chute without a crown. The discharge, however, was still greater in the center of the basin than at the training walls.

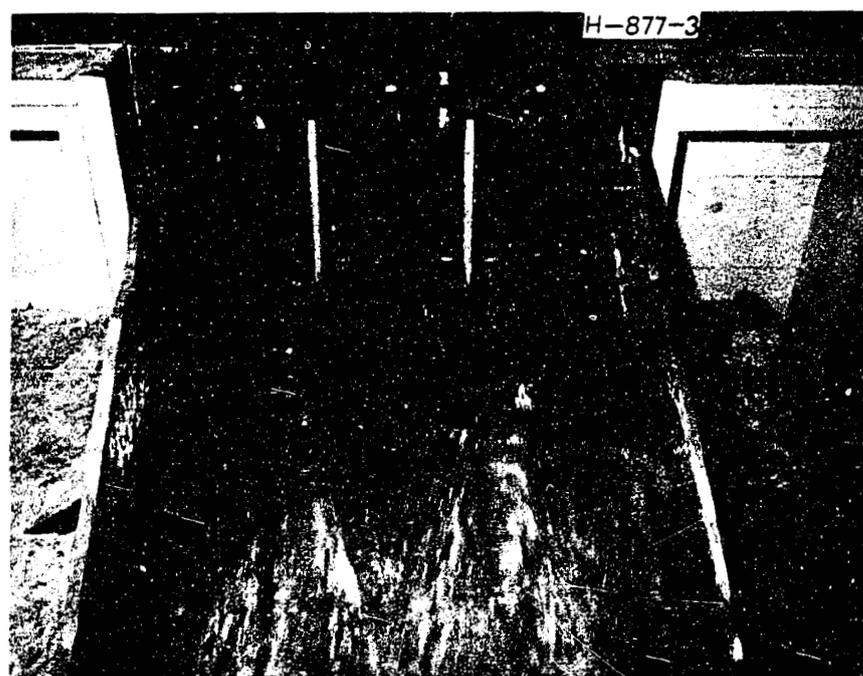
B. Overflow Section & Piers

The condition of the water surface downstream from the overflow section is shown in Figure 7B. The piers caused some disturbance in the flow which is indicated by the waves spreading down the chute from the tail of each pier. The disturbance downstream from the left pier, which is the more pronounced, was increased by the uneven flow originating at the left entrance wall previously shown in Figure 7A. As the waves from the piers spread down the chute, they impinged on the training walls, overtopping the left training wall at Station 14+00, Figures 6 and 8A. The training walls then reflected the waves toward the center of the chute, so that the flow upon reaching the stilling basin was concentrated in the center, Figures 8A and B.

Waves formed downstream from the preliminary piers, Figure 7B. Although this was not a serious disturbance, Pier No. 2, Figure 12B, was tested to determine the effect of the pier design on the wave formation. The longer pier reduced the waves, Figure 13, but the improvement did not justify the increased cost of the piers, so Pier No. 1 was retained.

Pier studies. Unusually large waves formed downstream from the preliminary piers, Figure 7B, as discussed under the operation of the preliminary spillway. This disturbance was not considered objectionable to the spillway performance, but Pier No. 2 was tested to improve the conditions, if possible. Pier No. 2, Figure 12B, was similar to the preliminary pier, but it had an additional 17-foot 9-inch tapered tail added to the downstream end. The tail reduced the disturbance because the depth of water was less at the tail of the longer pier than occurred with the preliminary pier. The improvement can be observed by comparing Figure 13 with Figure 7B. However, after considering benefits with the additional cost, the designers decided that the longer piers were not justified, so Pier No. 1 was used for prototype construction.

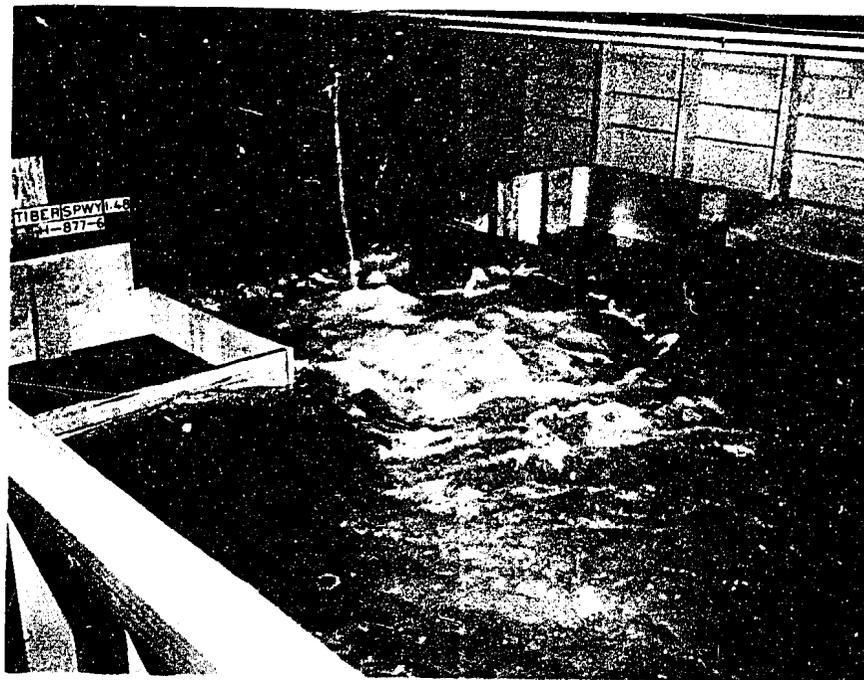
FIGURE 8

A. Spillway chute

B. Stilling basin

Discharge 51,700 c. f. s.

The water did not spread sufficiently in passing down the spillway chute, resulting in greater flow in the center of the stilling basin than at the sides. This was most pronounced at the maximum discharge of 51,700 cfs, Figures 8A and B. Tests were made to increase the spreading of the water by using crowns, Figure 14, which resulted in the center of the chute being higher than the sides for a portion of the chute length. With the preliminary chute, Crowns Nos. 1 and 2 gave uniform distribution of flow at the maximum discharge, but the flow was concentrated at the sides of the stilling basin for lower discharges. The recommended chute, Figure 6, had a more moderate divergence of the training walls than the preliminary. By using Crown No. 3 on the recommended chute, satisfactory distribution of flow occurred at all ranges of discharge, Figures 18A and B.

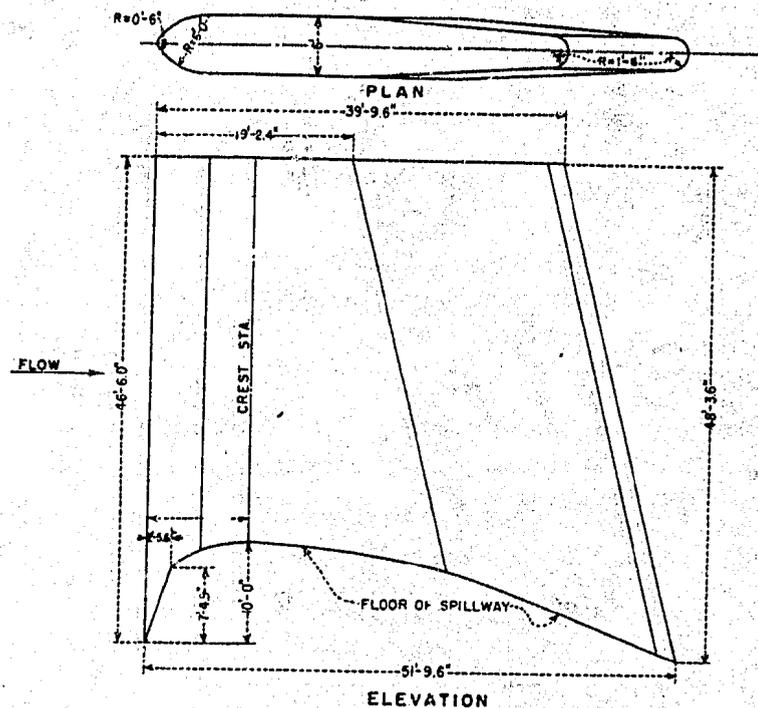
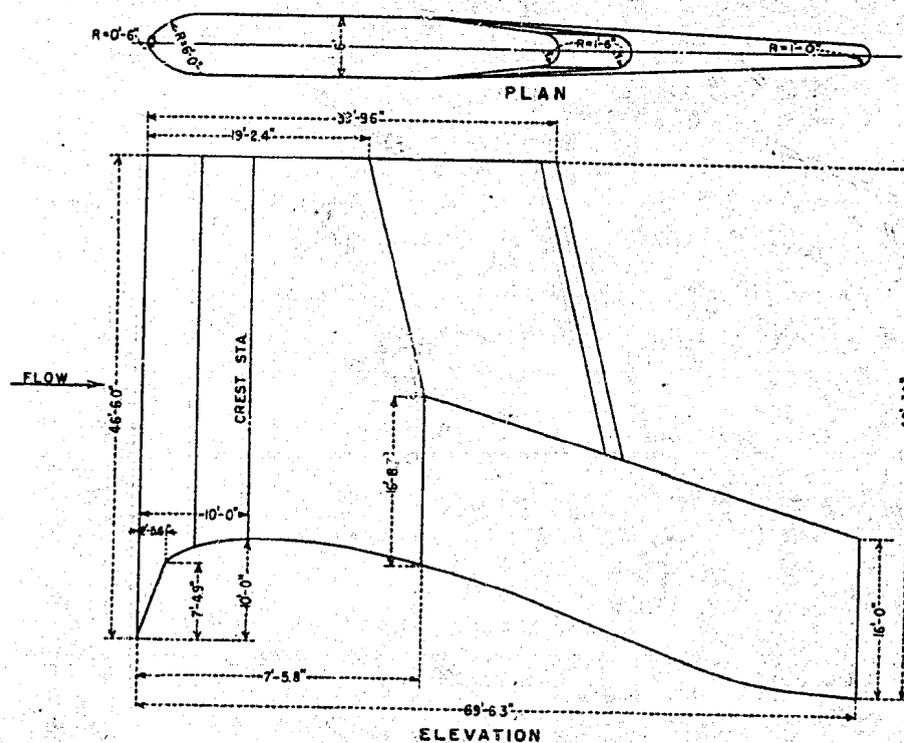
TIGER DAM SPILLWAY
 HYDRAULIC MODEL STUDIES
 PIERS
 MODEL SCALE 1:48

A. PRELIMINARY PIER NO.1

B. ALTERNATE PIER NO.2

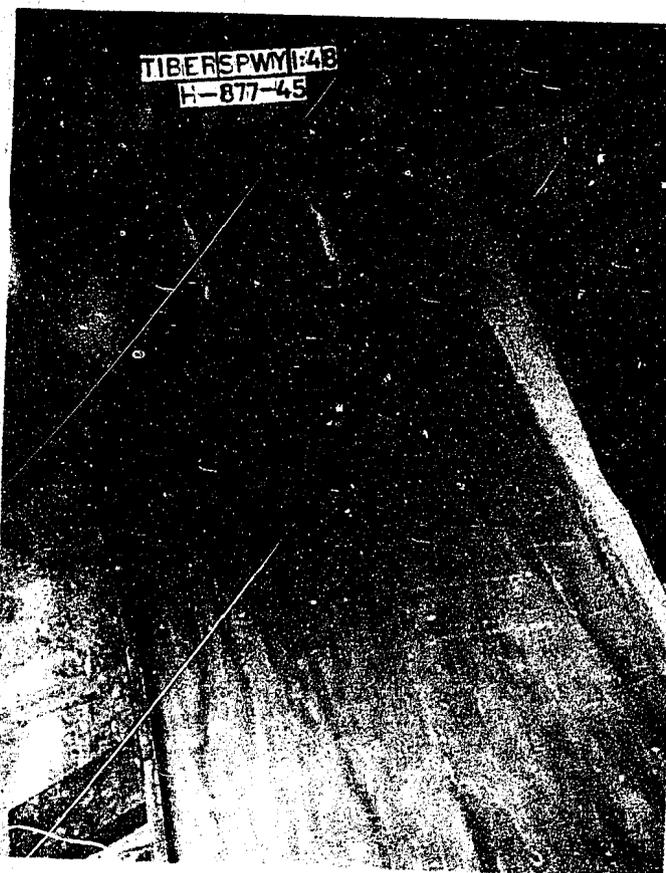
PIER NO. 2
TIBER DAM
1:48 Scale Model Study

Discharge 51,700 c. f. s.

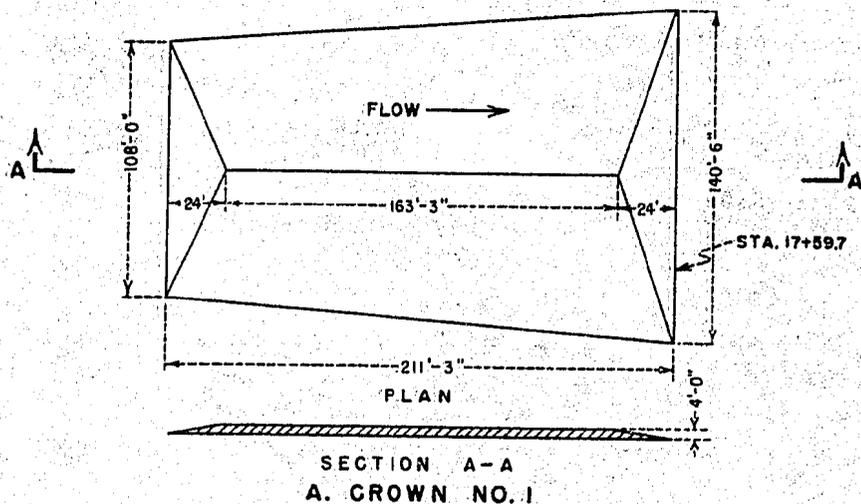
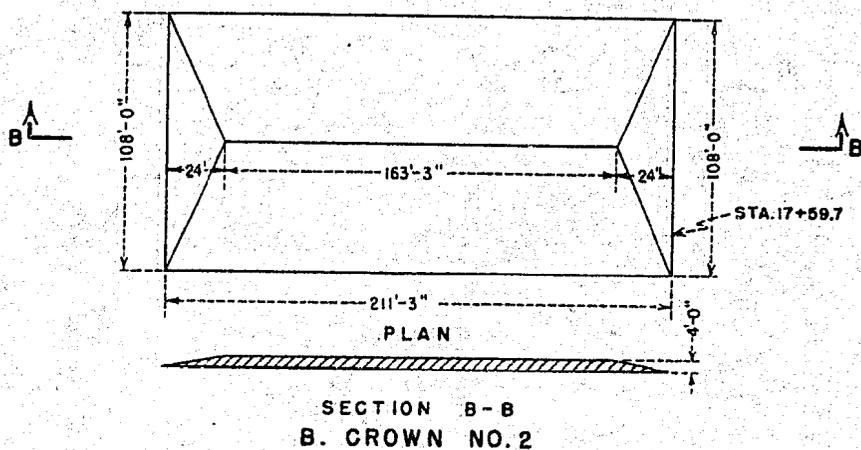
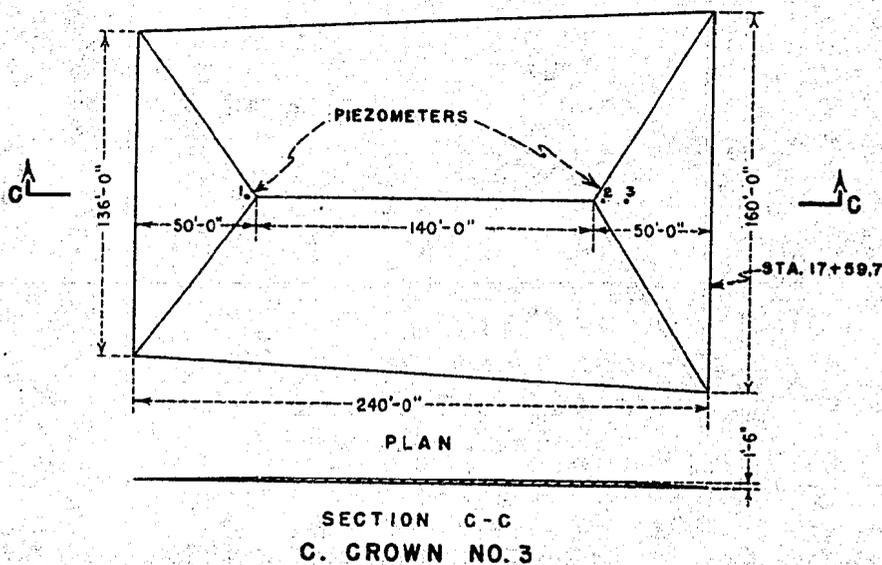
TIBER DAM, SPILLWAY
HYDRAULIC MODEL STUDIES
CHUTE CROWNS
MODEL SCALE 1:48

Chute studies. The next problem was to reduce the concentration of flow in the center of the downstream end of the chute which was objectionable at the higher discharges. Past experience had shown that by making the center of the chute higher than the edges the water would be forced to spread laterally. Such an alteration was made to the chute in the present study, Crown No. 1, Figure 14A. The distribution of the flow entering the stilling basin is shown in Figures 15A and B for discharges of 4, 150 and 51,700 cfs. The distribution was uniform at the maximum discharge, but at the lower flows the crown spread the water excessively, causing a concentration of water at the training walls.

Crown No. 2, Figure 14B, had 32.5 feet less width at the downstream end than Crown No. 1 to reduce the spreading action of the lower flows. The performance for discharges of 4, 150 and 51,700 cfs, Figures 16A and B, was unchanged from that occurring with Crown No. 1.

Crown No. 3, Figure 14C, with a center height of 1.5 feet and a length of 240 feet was next installed in the revised chute. The downstream end of the crown was at Station 17+59.7. The distribution of flow entering the stilling basin is shown in Figures 18A and B for discharges of 10,000 and 51,700 cfs. At the lower discharge the depth of flow was less in the center than at the sides, but the distribution was more uniform than had occurred in any previous test. Very uniform distribution resulted, however, at the maximum discharge. The water surface throughout the length of the chute was more uniform than in the tests with the preliminary chute. Since the performance of the chute arrangement was now considered satisfactory, tests were then conducted on the stilling basin.

Pressures and water-surface profiles. Pressures were obtained along the center line of the overflow section of the spillway. The lowest pressure that occurred, Figure 22A, was 1 foot of water below atmospheric when the gates were open 1 foot and the discharge was 3,200 cfs. Pressures were also measured on Crown No. 3 at the points indicated in Figure 14C. The lowest pressure obtained was 1/2 foot of water above atmospheric at Piezometer No. 2. These pressures are shown in the table on Figure 14. In addition, pressures were observed along the center line of the vertical curve and steep section of the chute. The lowest pressure recorded was 1 foot of water below atmospheric with a discharge of 48,900 cfs, Figure 22B. These tests indicated satisfactory pressure conditions existed throughout the spillway.
