HYDRAULIC MODEL STUDIES OF THE SPILLWAY
TIBER DAM
MISSOURI RIVER BASIN PROJECT

Hydraulic Laboratory Report No. Hyd-288

March 24, 1952

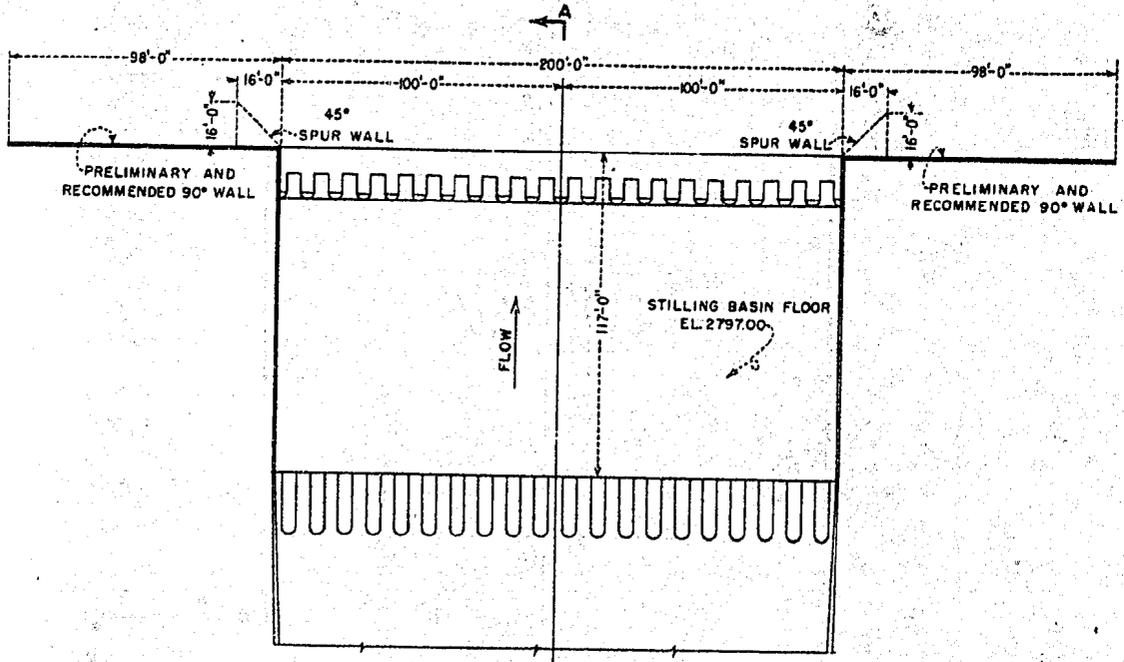
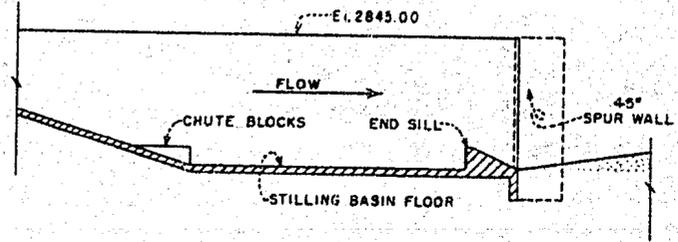
TIBER DAM SPILLWAY
HYDRAULIC MODEL STUDIES
STILLING BASIN
MODEL SCALE 1:48

Stilling basin studies. With the recommended approach and chute arrangement the model was operated using the preliminary stilling basin, Figure 19. The conditions of flow in the basin and channel downstream were satisfactory at the maximum discharge, Figure 20A. The erosion resulting from 1 hour of operation at a discharge of 51,700 cfs is shown in Figure 20B. The maximum scour reached 4 feet below the apron and occurred downstream from the right training wall. The scour in the channel was less than that obtained with the test on the preliminary spillway, Figure 9. Since the same stilling basin was used in

The dentated end sill was installed and spur wing walls were placed on each side of the basin as shown by the dotted lines in Figure 19. Model studies made in the past using this spur wall had been successful in reducing erosion at the cut-off wall on each side of the basin. The erosion resulting from operating 1 hour at a discharge of 51,700 cfs and tail-water elevation 2834 is shown in Figure 21B. The lowest streambed elevation occurred at the end of the spur walls where the scour was 4 feet lower than the apron elevation. The scour was quite similar to that obtained with the 90-degree wing walls shown in Figure 20B. Since the results were not improved by the addition of the spur walls, it was decided to use the preliminary basin for construction in the prototype.

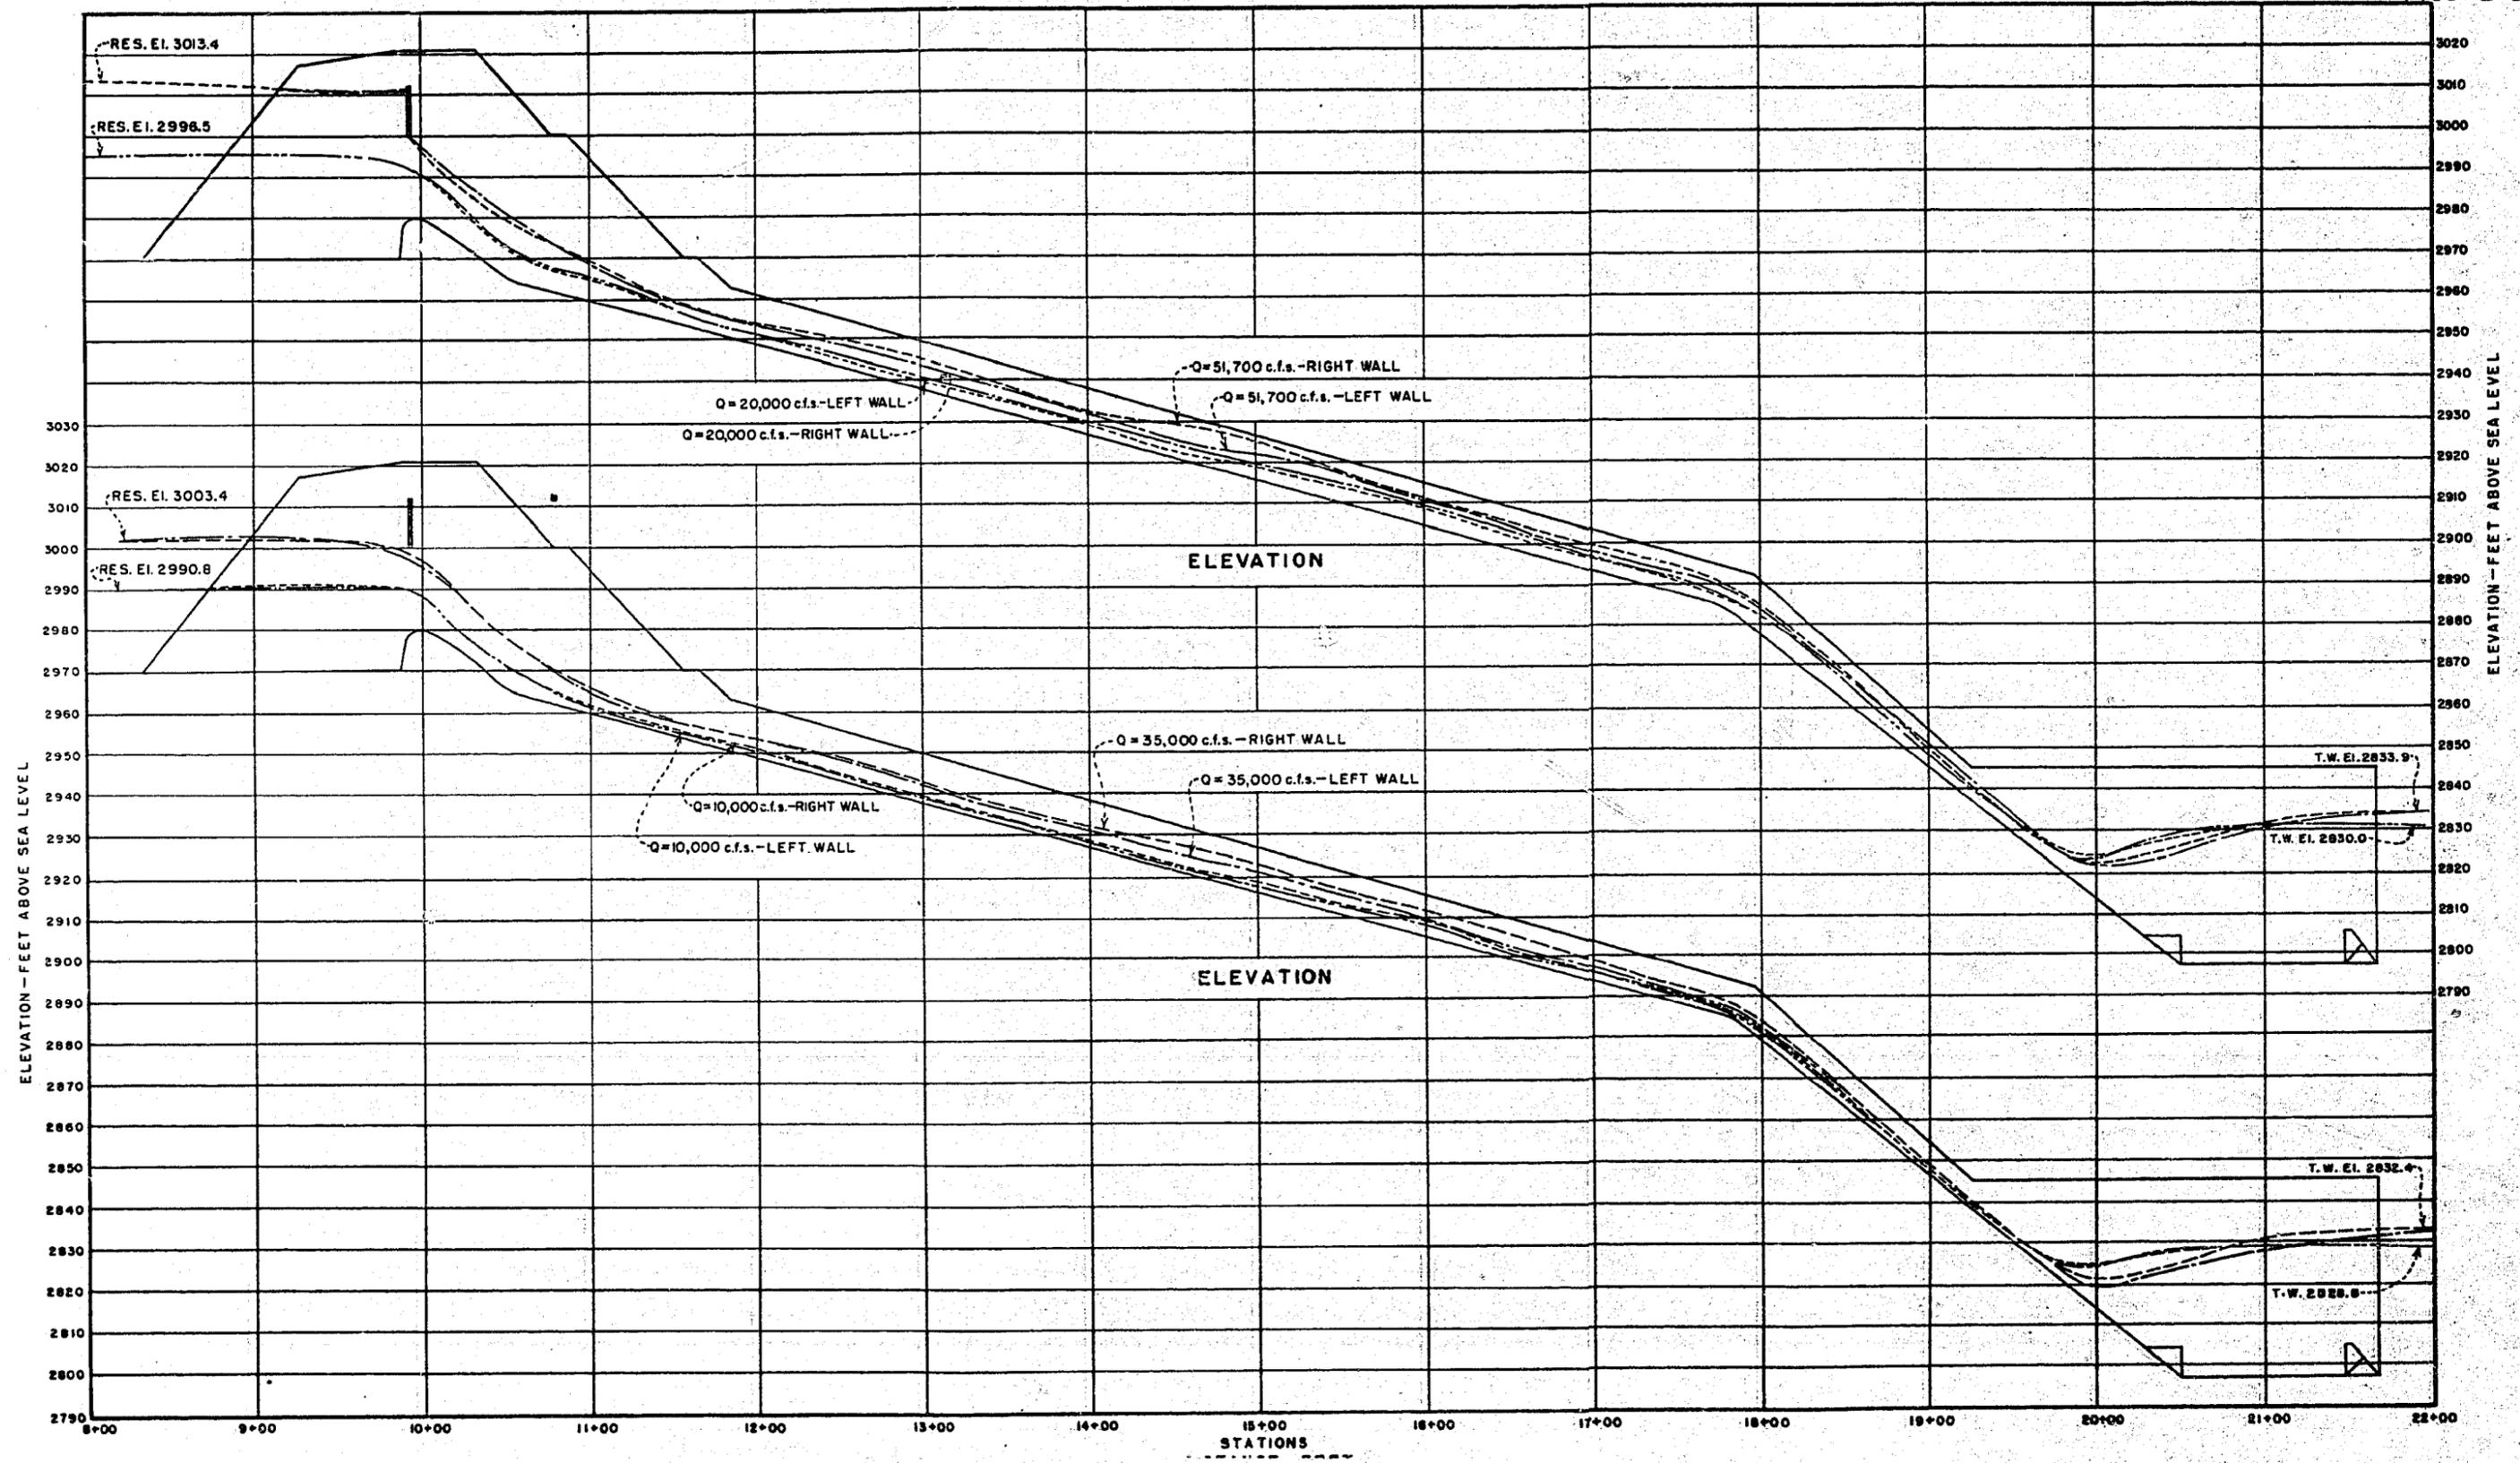
FIGURE 23

Water-surface profiles along each training wall throughout the length of the spillway were obtained for discharges of 35,000 and 51,700 cfs and these are shown in Figure 23. The water did not overtop the

training walls at any point on the spillway. The closest approach to the top occurred along the right wall in the vicinity of Station 15+00 at the maximum discharge. Transverse water-surface profiles were taken at various discharges at five stations along the spillway, Figures 24 and 25. The transverse depth was generally uniform in the overflow section for all discharges, except for a depression in the water surface downstream from each pier, Figure 24. The depth was greater in the center of the chute at Station 11+85, 145 feet downstream from the piers, Figure 25. The depth of the water in the chute at Station 20+28.5, just upstream from the stilling basin, was slightly greater along the center line for the maximum discharge, Figure 25. These measurements of the water surfaces showed the height of the training walls to be adequate throughout the spillway.

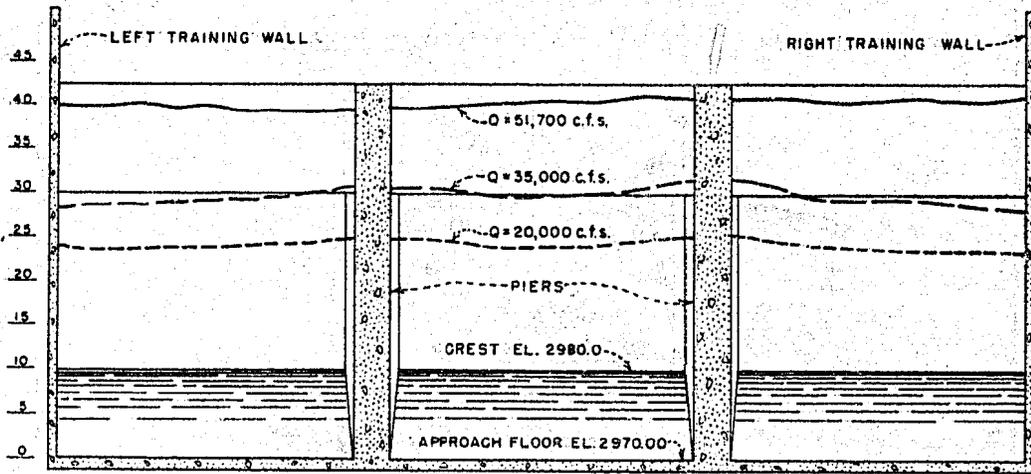
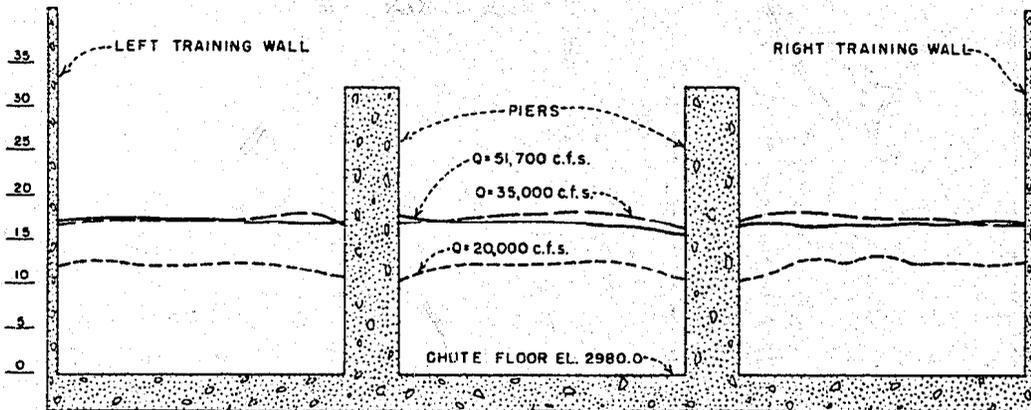
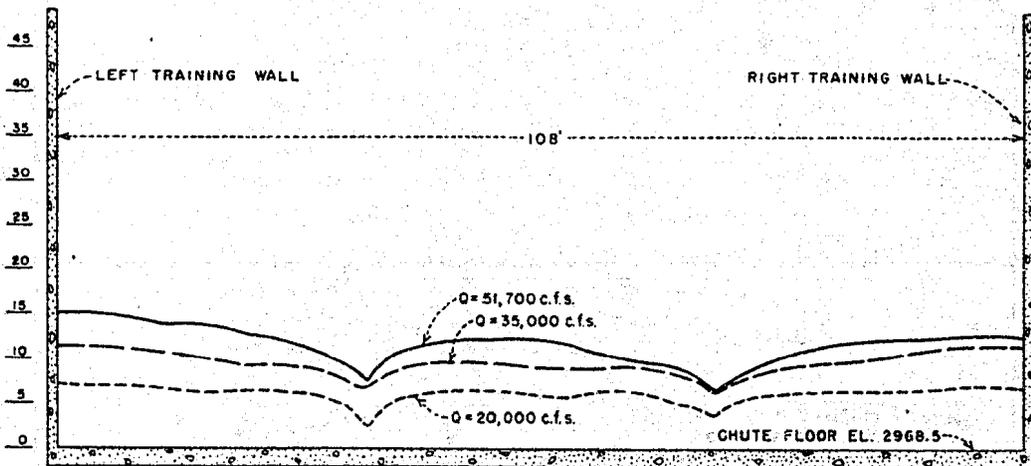
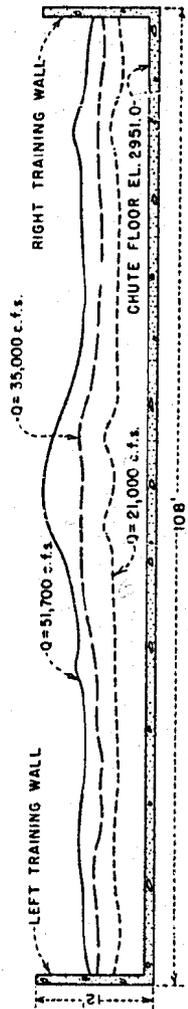
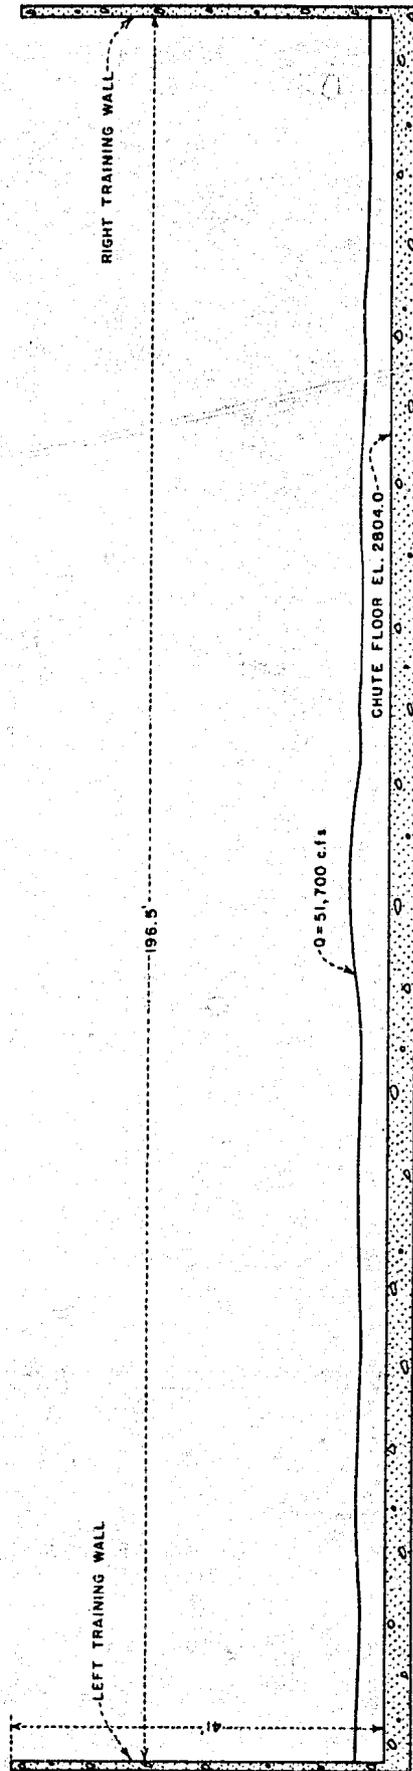
Sta. 20+28.5 where these profiles were measured is just upstream from the upper limit of the hydraulic jump at maximum discharge.

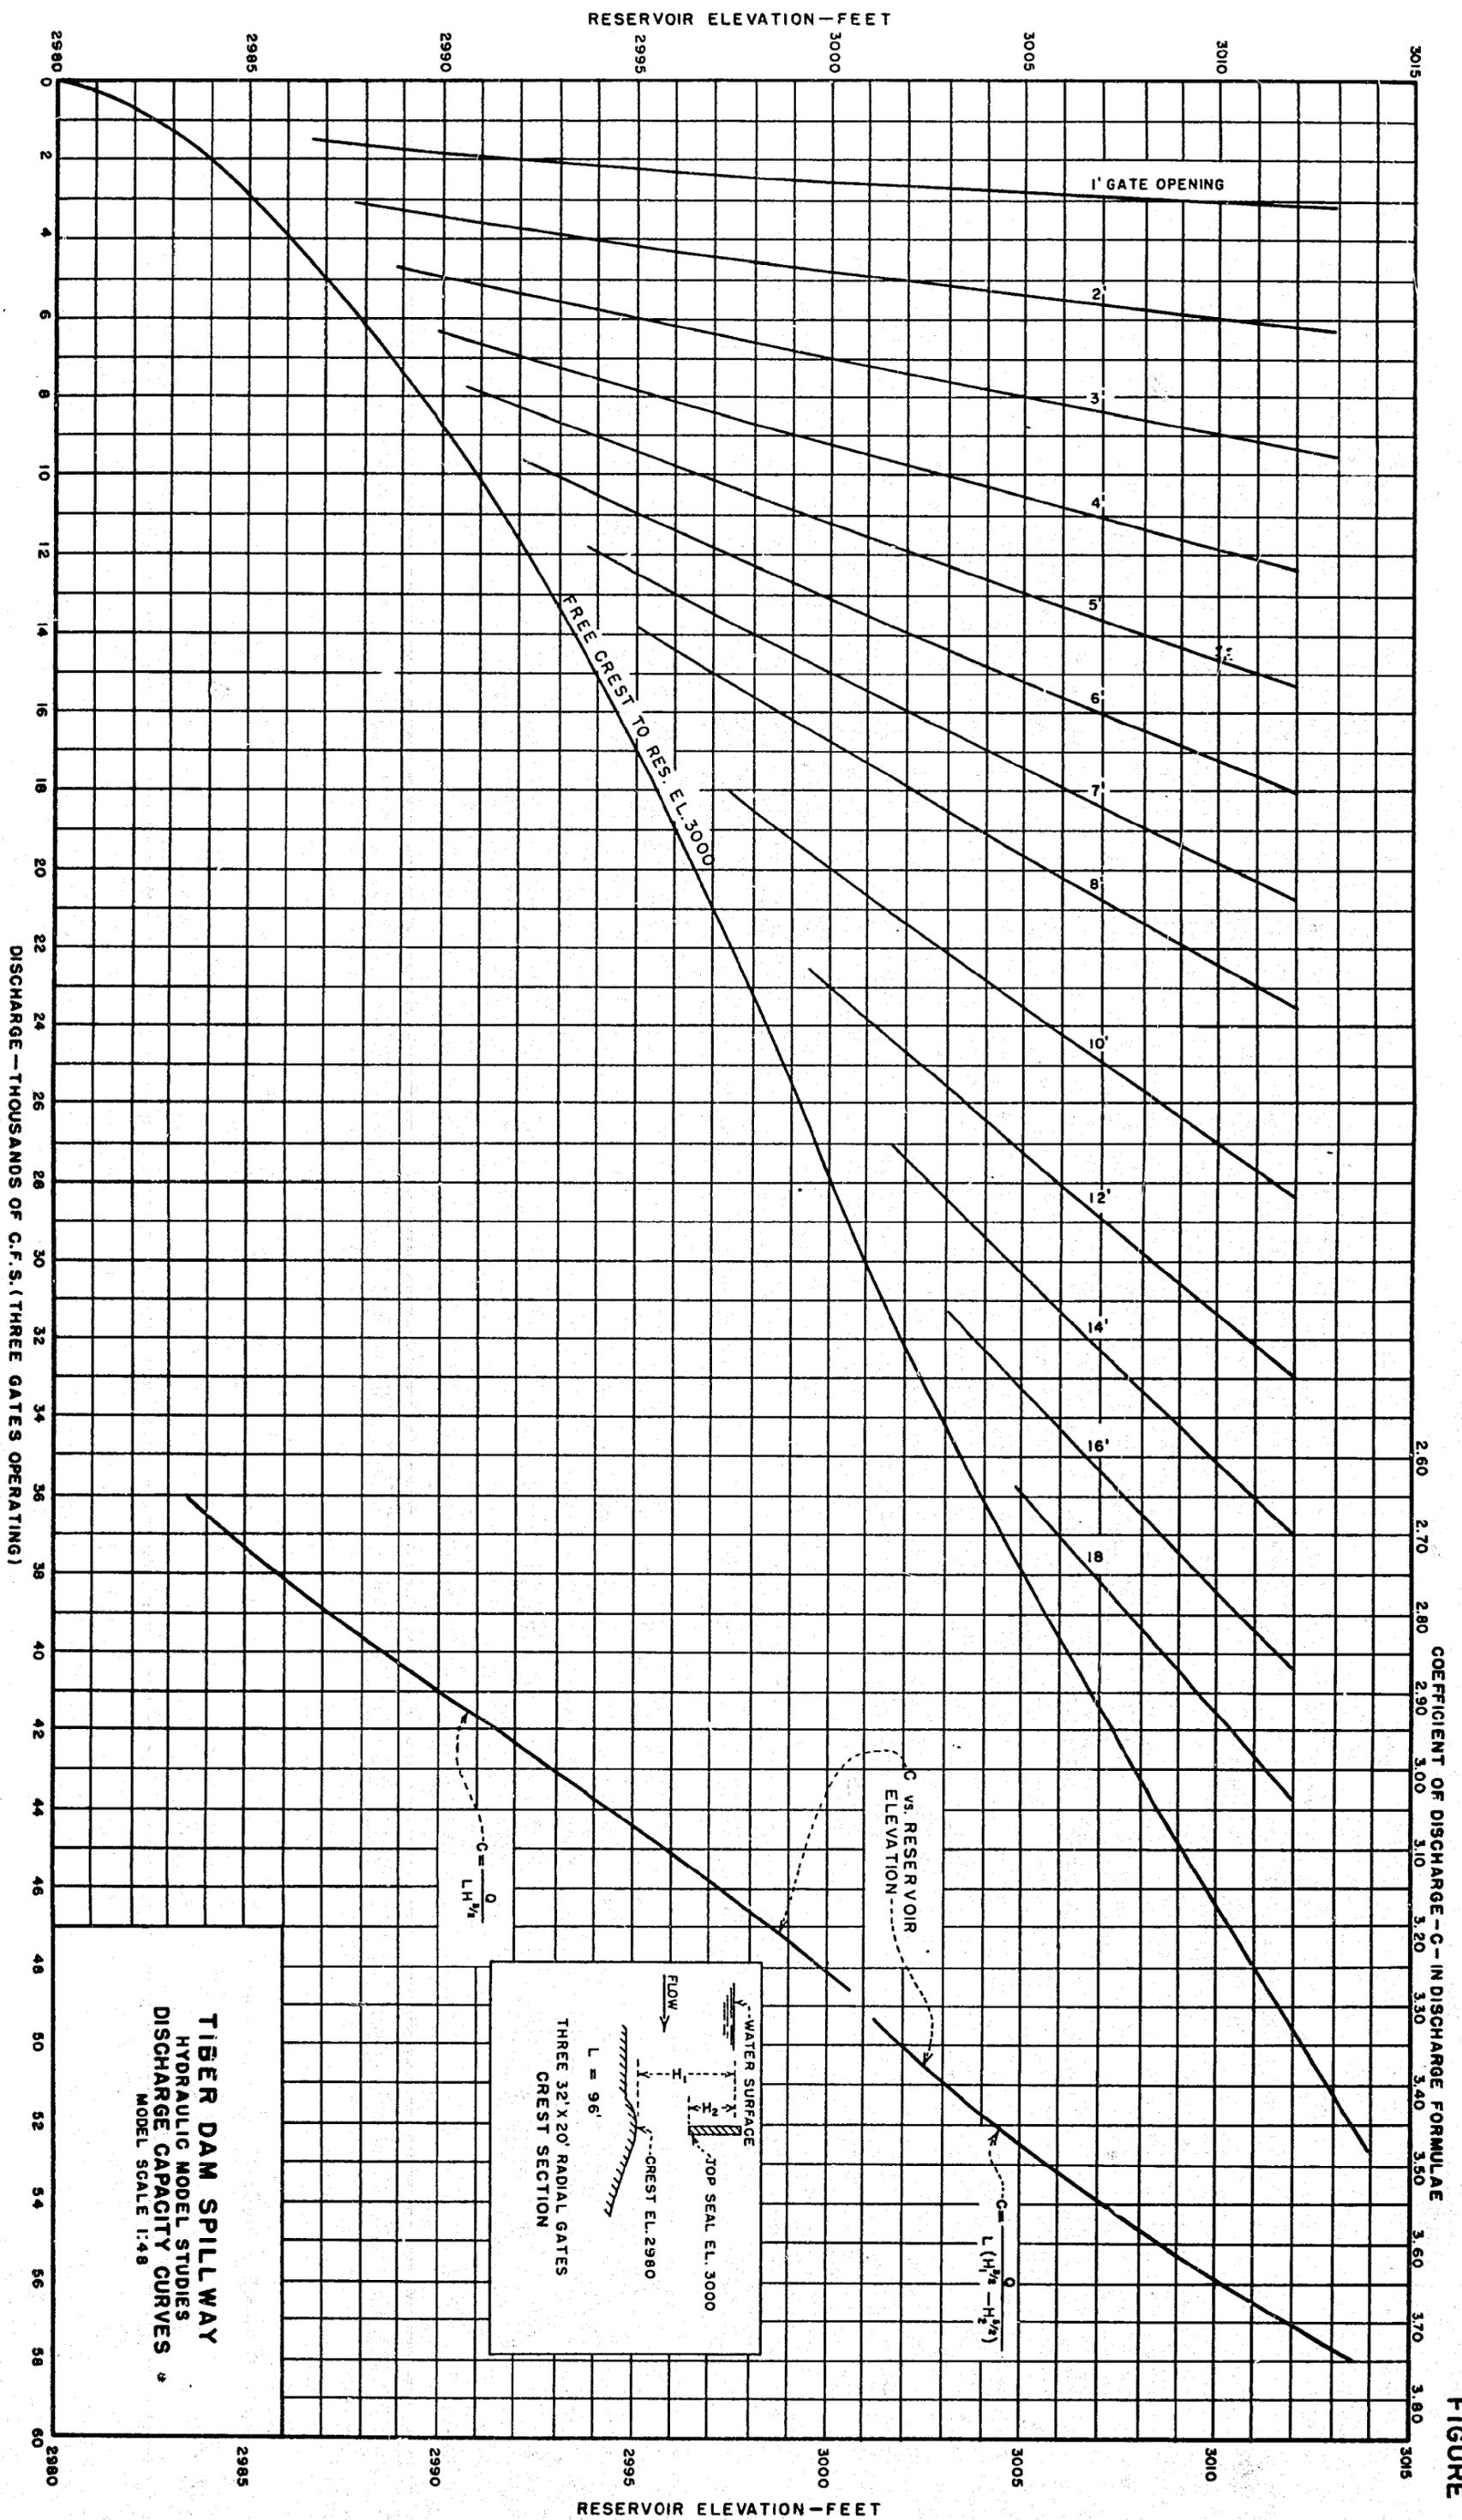
FIGURE 26

Calibration. Discharge-capacity curves were obtained for the spillway for various conditions, Figure 26. These curves are for the discharge through three gates, with all gates opened the same amount for each curve shown on the chart. The gates should be operated symmetrically in the prototype to avoid unnecessary wave action and erosion in the river channel. The maximum gate opening is limited to 20 feet by a curtain wall whose bottom edge is at elevation 3000. Consequently, free flow can occur for only the first 20 feet of head above the crest. The maximum value of the coefficient of discharge C in the equation $Q = CLH^{3/2}$ for free flow with the water surface just free of the curtain wall is 3.28 as shown by the coefficient of discharge curve in Figure 26. With the maximum discharge of 51,700 cfs and the gate openings at 20 feet, the coefficient of discharge is 3.75 using the equation $Q = CL(H_1^{3/2} - H_2^{3/2})$ for submerged flow.

The spillway was satisfactory, as indicated by pressure tests on the overflow section and the steep section of the chute. Water surface profiles were taken throughout the spillway and showed the training wall heights to be adequate. A discharge-capacity curve was obtained for the overflow section and is shown on Figure 26.
