UNITED STATES
DEPARTMENT OF THE INTERIOR
BUREAU OF RECLAMATION

**EROSION TESTS ON FOUR EARTH MATERIAL
SAMPLES FROM THE SITE OF THE
PROPOSED OAHE CANAL--OAHE
UNIT--JAMES DIVISION--MISSOURI
RIVER BASIN PROJECT**

Hydraulic Laboratory Report No. Hyd.-298

DECEMBER 22, 1950

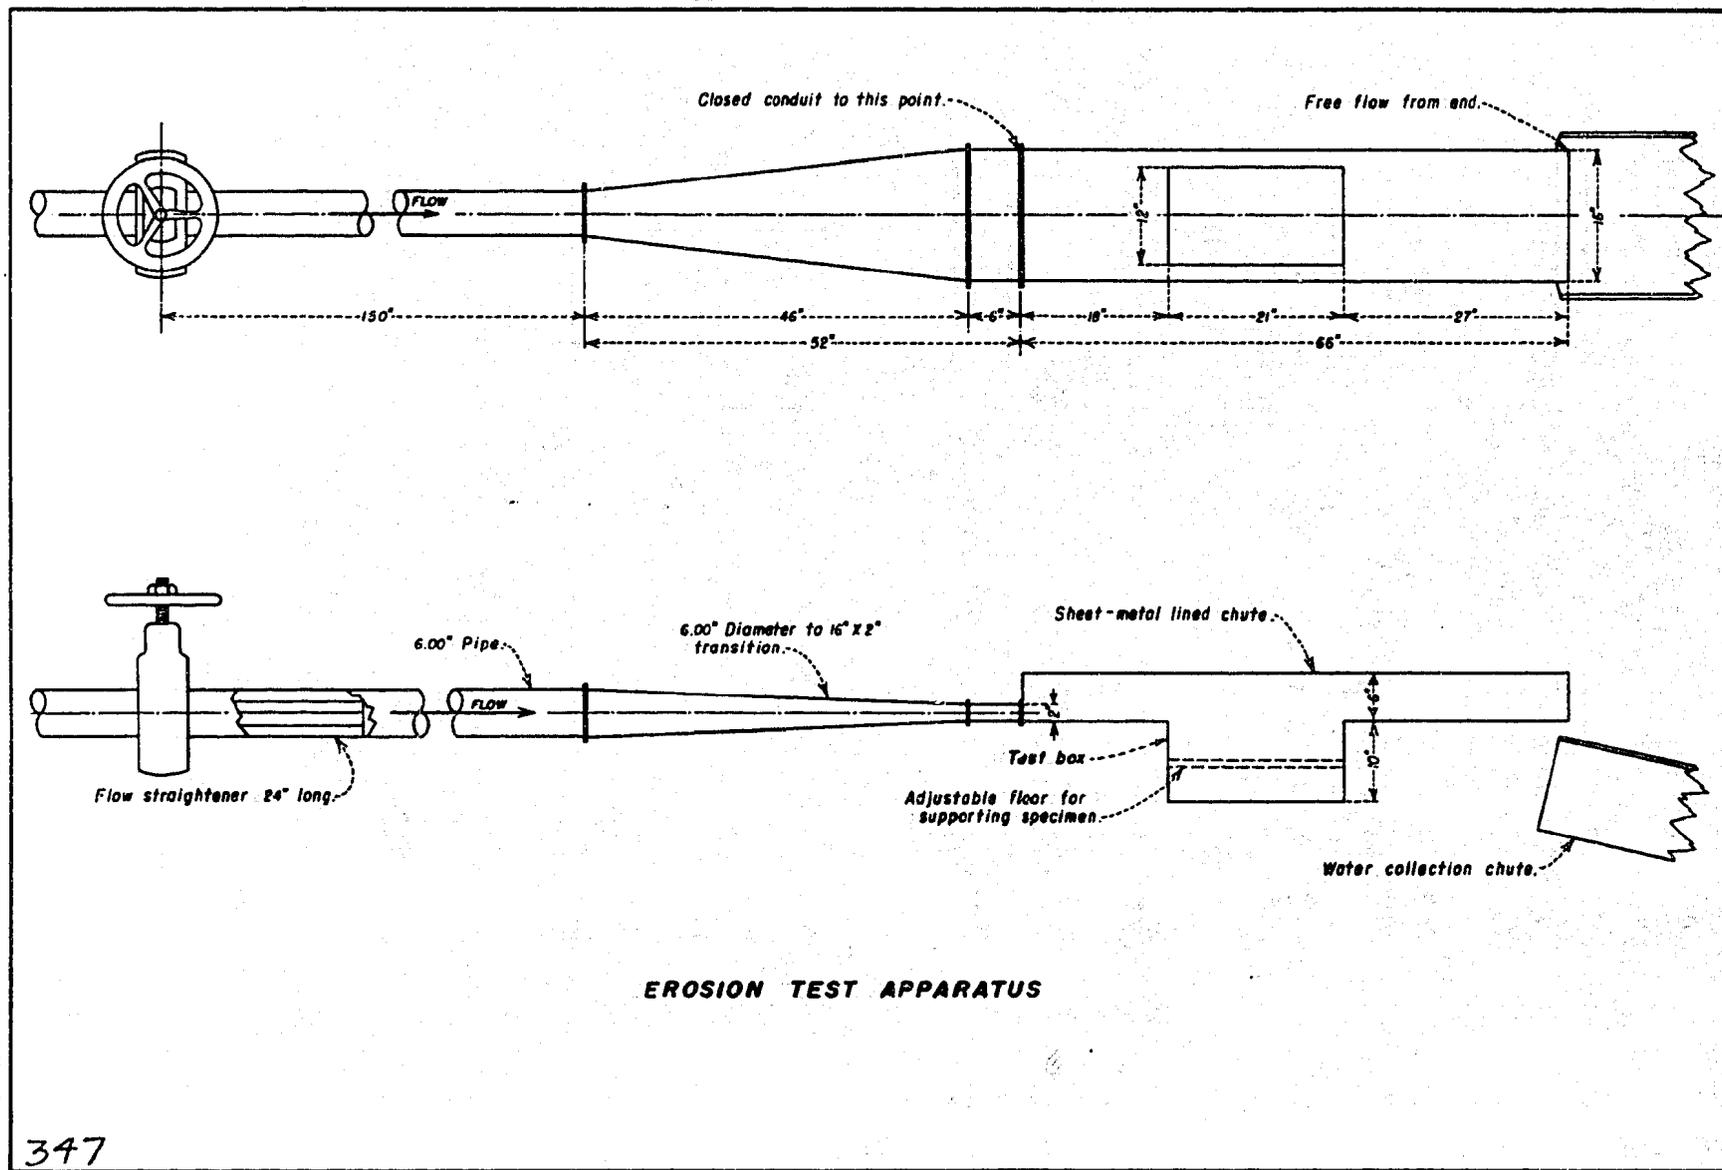
FIGURE 1

A schematic diagram of the erosion test apparatus is shown in Figure 1. Water was supplied through a 6-inch standard pipe and a transition section to the 16-inch wide by 66-inch long test chute. A valve was provided to regulate the discharge and a flow straightener was placed downstream from the valve to insure smooth, straight flow into the test section. The water entered the chute in a uniform stream 2 inches deep and the slope of the chute was adjusted to maintain this depth over the full length of the sample. The velocity of the water over the test sample was determined by measuring with a Venturi meter the quantity of water flowing and dividing this quantity by the cross sectional area of the flowing water in the chute. The water discharged freely from the end of the chute and was returned to the supply channel by a trough. The floor of the test box was adjustable to permit moving the sample to keep its top surface level with the chute floor as the material was washed away. To avoid surges and excessive velocities over the sample when the flow was started, an obstruction was placed across the downstream end of the channel, the chute flooded to a depth of 2 inches,

and the control valve slowly opened while the obstruction was being removed. A final adjustment of the valve established the desired water velocity over the sample.

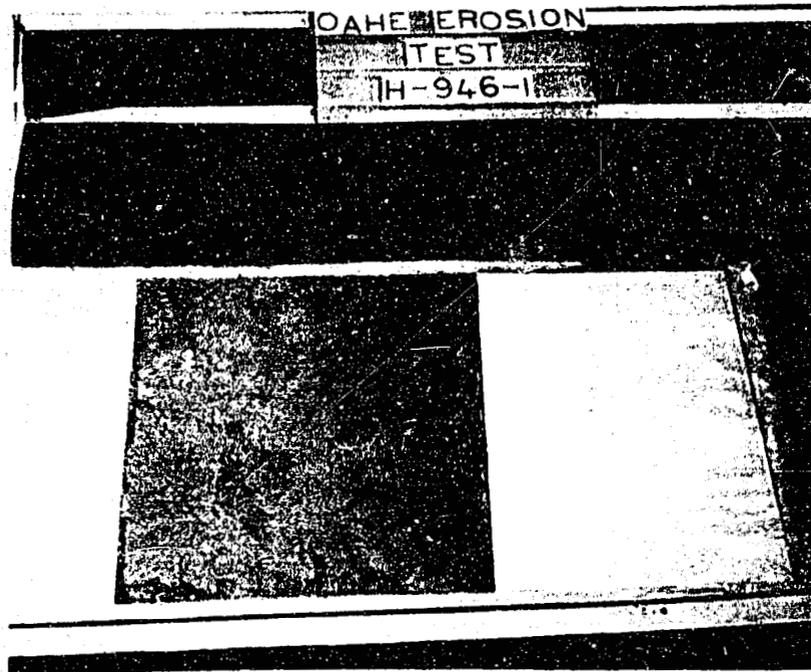
A. Sample in place in the test apparatus before the test.

Sample taken from Hole 5 at a depth from 5 to 6.5 feet

Silty clay, slightly moist, somewhat plastic, and nonlayered (Figure 2).

Previous to procuring the material samples, the field inquired as to the most desirable sample size. They were instructed to obtain samples 12- by 12- by 18-inches instead of 12 inches wide, 18 inches long, by 12 inches deep, thus it was necessary to place the samples upright, exposing only a 12- by 12-inch test surface, in order that the water would flow over the material in the proper direction (Figure 2A).

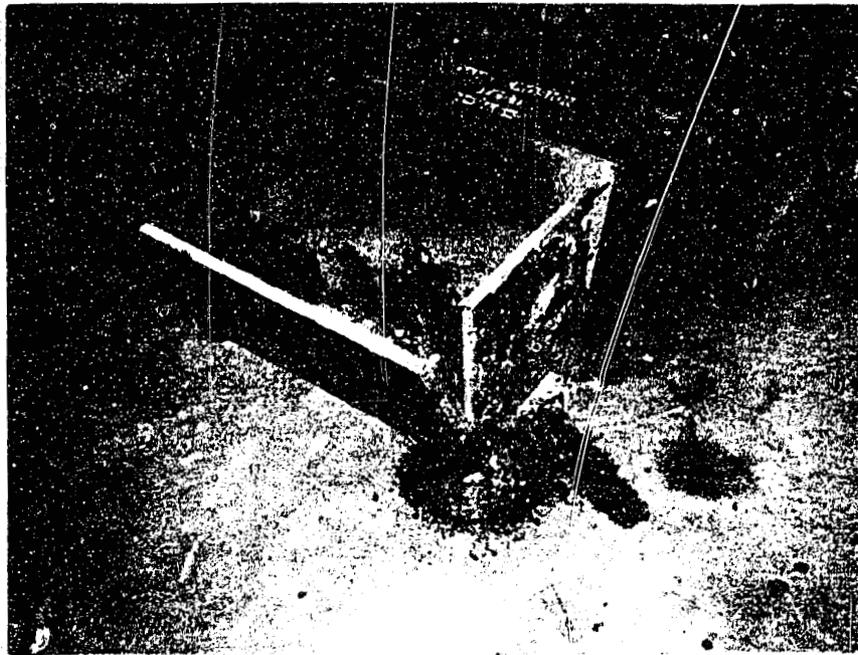
A. Containing box partially supporting the sample.
The top of the sample is at the right.

B. Containing box removed from sides and top
of the sample. Top is in right foreground.

Sample taken from Hole 8 at a depth from 9.5 to
11 feet.

Fine to medium sand with some small gravel, dry, moderately graded, and somewhat layered (Figure 4).

Particular care was taken to avoid jarring these three samples while removing the packing cases because the material descriptions forwarded with the samples indicated that they were fragile. While the cases were being removed, severe crumbling and cracking occurred in the earth material, and photographs were taken to record the sample conditions (Figures 3A, 4A, and 5A). After the cases were removed to the extent that they offered no support to the sides or ends of the sample, further crumbling and cracking occurred (Figures 3B, 4B, and 5B). The samples from Hole 5 and Hole 8 were unsuitable for erosion tests. An attempt was made to place a portion of the sample from Hole 9 in the test apparatus, but the material crumbled as soon as it was moved. It was therefore not possible to run tests on any of these three samples. It is reasonable to assume, however, that from the nature of the materials the erosion rate would be at least as high as for the sample tested.

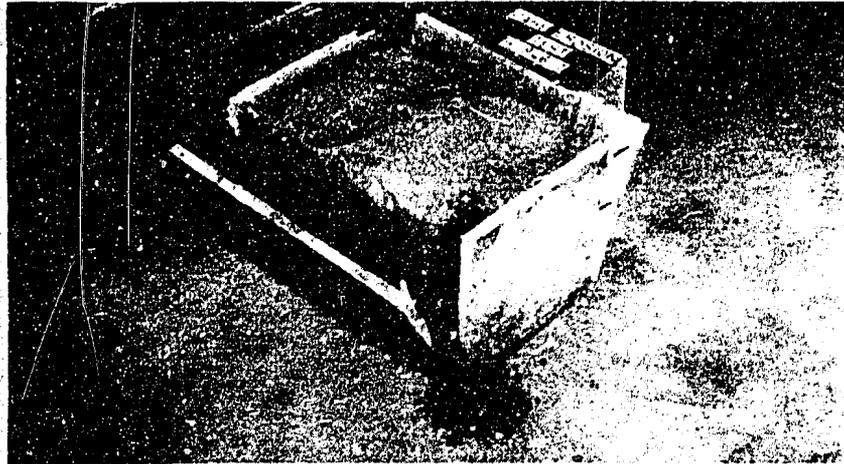
A. Containing box partially supporting the sample.

B. Box removed from the sides and top of the sample.

C. The material crumbled as soon as an attempt was made to move it. Top of the sample is in right foreground.

Sample Taken from Hole 9 at a depth from 3.5 to 5 feet.

Fine to medium with some clay and small gravel, slightly moist, moderately graded, and somewhat layered (Figure 5).
