Office Memorandum

BUREAU OF RECLAMATION
HYDRAULIC LABORATORY

OFFICE
FILE COPYSUBJECT: P-4 pump bearing failure--Grand Coulee Dam--May 22, 1959
WHEN BORROWED RETURN PROMPTLY

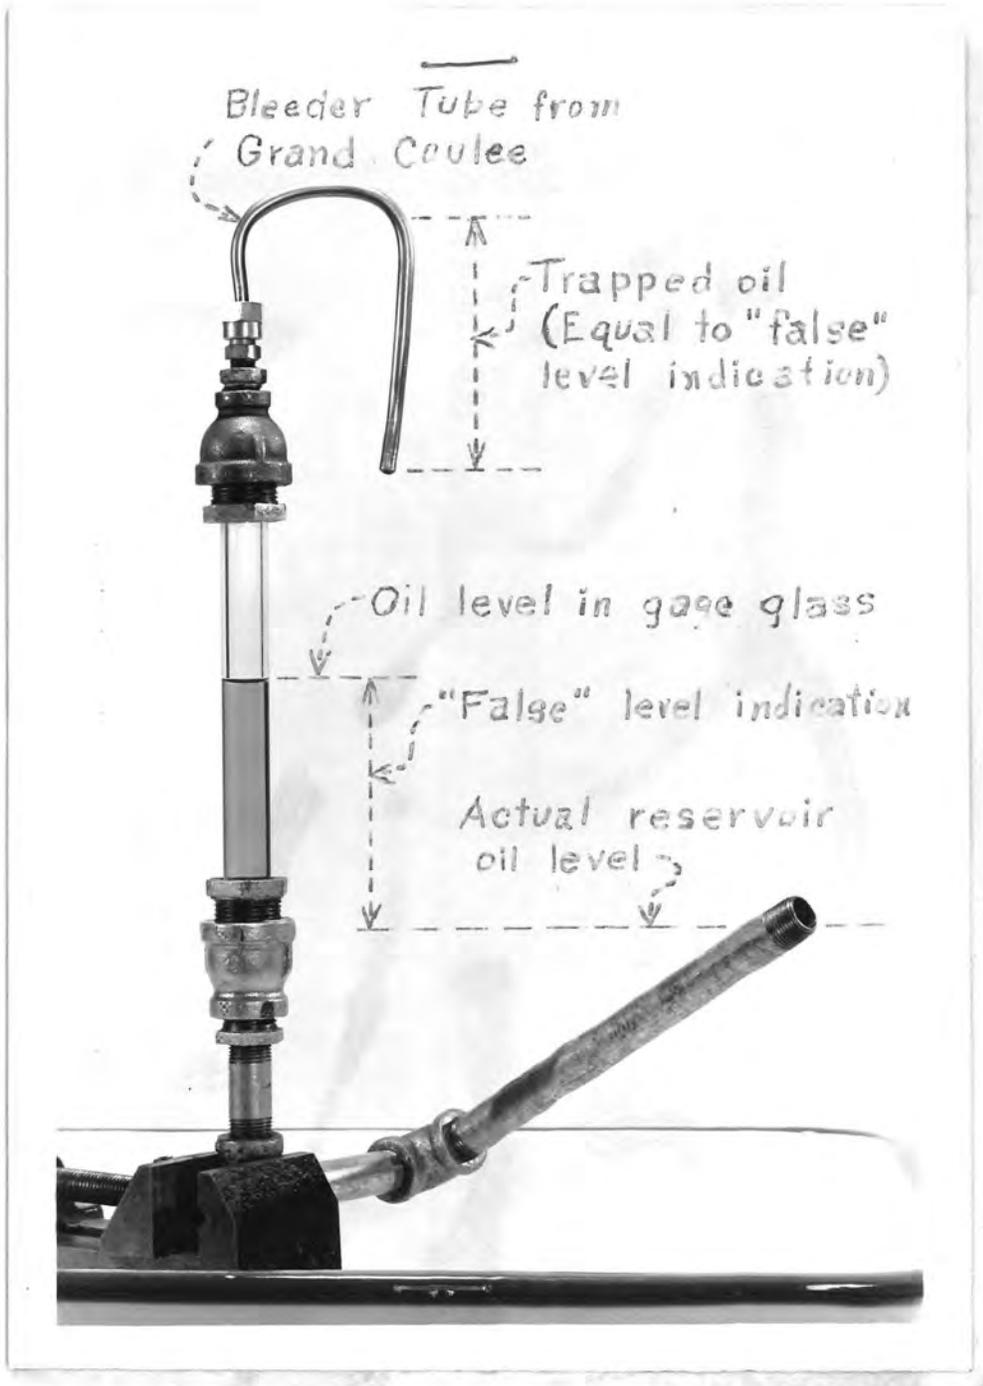
A 1/2-inch-inside-diameter by 8 inches-long glass tube was installed in a piping system, as shown in the accompanying photograph, to simulate the installation at Grand Coulee Dam. The bleeder tube from the project was installed at the top of the glass. The overflow pipe representing the oil reservoir was erected and filled with 20-W oil at room temperature (about 85° F) until the gage glass was about two-thirds full. Next, the open end of the bleeder tube was submerged in a small container of oil, then the overflow pipe was lowered until the oil level in it was below the visible part of the glass gage. The oil draining out of the overflow tube drew oil up into the bleeder tube. When the system reached equilibrium, the container of oil was removed from the open end of the bleeder tube. The oil that had been drawn up into the bleeder tube was trapped in the outside vertical leg and created sufficient siphon head to hold a "false" oil level in the gage glass to about 3 inches above the level which was open to atmosphere in the overflow tube. (This test was witnessed by Mr. Newmeyer and Mr. Edward C. Schurch, Division of Power Operations, Denver Office.) The apparatus was allowed to stand for 24 hours and the oil level

in the glass gage did not drop. The open end of the bleeder tube was forced to the side about 3/4-inch and allowed to snap back violently. This action broke the siphon and the oil in the glass gage drained out.

The above test was repeated using 30-W oil at 50° F, the temperature at Grand Coulee Dam at the time of bearing failure. Under these conditions, the false reading was about 4-1/2 inches above the open surface in the overflow pipe. (This test was witnessed by Messrs. William L. Newmeyer, Sidney M. Denton, Ireal A. Winter, and Edward W. Wengler, all of the Denver Office, and Mr. W. R. Dixon, Special Representative for Westinghouse.) This apparatus was allowed to stand for 24 hours during which time the oil level in the gage glass did not drop. ~~Wrapping~~ and vibrating of the bleeder tube failed to break the siphon.

An additional test was made with a bleeder tube the same size and shape as the one from the project, but with the ends reamed smooth. The test was performed using 30-W oil at room temperature. The false reading was 4-1/2 inches, the same as that with the bleeder tube from the project. Vibration failed to break the siphon and the false reading persisted for 24 hours.
