SUMMARY OF THE HYDRAULIC MODEL STUDY FOR THE
PROPOSED MODIFICATION TO KLANG GATES DAM, MALAYSIA

Ken Gibson

Hydraulic Model Study of Klang Gates Dam

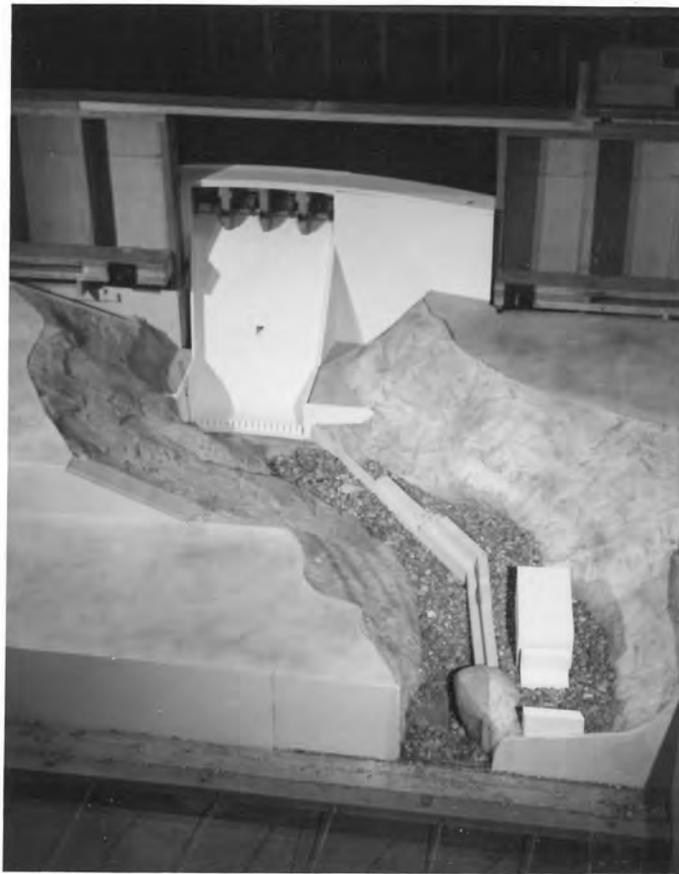
Figure 1. - Upstream view of 1:36 model showing gated spillway.

Constructed to a scale of 1:36 the model included 144 feet of horizontal reservoir approach to the spillway, part of the concrete arch dam, the spillway and stilling basin, and 235 feet of river channel downstream from the stilling basin (figure 1). The spillway and slotted-bucket energy dissipator were milled from high density polyurethane plastic and sanded to the desired profile. Model topography was determined from 5-foot interval contour maps supplied to the Bureau of Reclamation by the Malaysian Government. Scaled contours were cut from wood, placed in the model, and covered with metal lath. The lath was covered with approximately three-fourths inch of cement-sand mortar. Three removable portions of topography were utilized to study possible channelization of the downstream river channel (figure 2). Rock gabions, constructed in the prototype after flooding, and the water supply control house, scaled from the contour maps and recent photographs, were simulated with wood. Riverbed material was scaled from photographs of the riverbed and represented 3/4- to 6-foot boulders. A flap-type tailgate was used to adjust the tailwater elevation and to collect eroded gravel. Water was supplied to the model through the permanent laboratory system and was measured by Venturi meters.

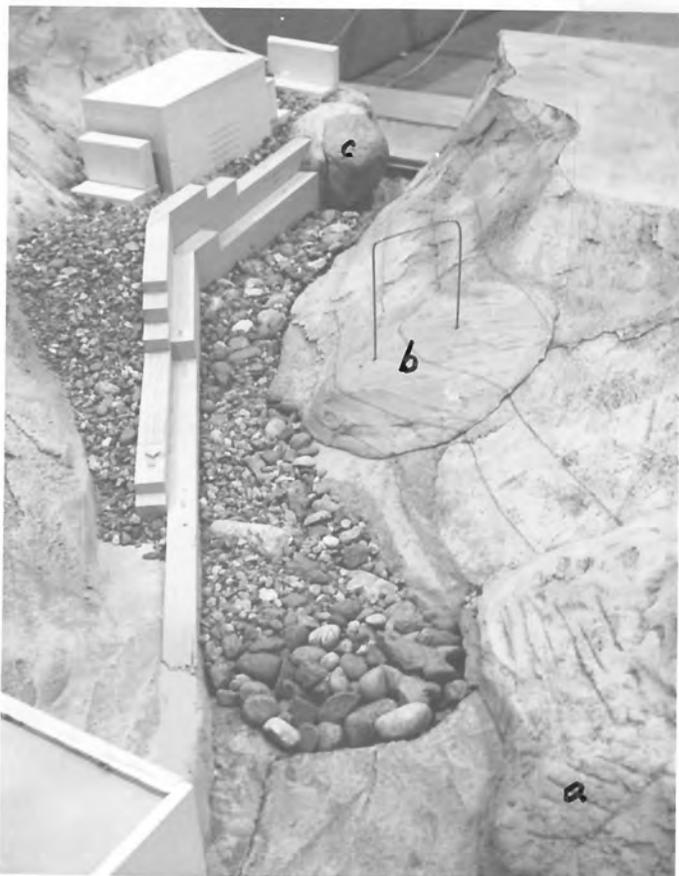
Figure 2. - Downstream channel with gabions and removable topography
(a) canyon
(b) nob
(c) rock

The portion of downstream channel that was modeled had three flow control points, figure 2. The first constriction was the right canyon wall beginning at the end of the stilling basin and extending about 75 feet downstream. This protrusion into the channel constricted the flow leaving the stilling basin. The second constriction was formed by the narrowing of the channel about 100 feet downstream. Bounded on the left by the rock gabions and on the right by the high riverbank, hereafter referred to as the nob, this constriction controlled the spillway tailwater depth for flows up to approximately 6,000 ft³/s. The third constriction occurred at the end of the rock gabion where an outcrop formed the left bank and a nearly vertical cliff formed the right bank. Three

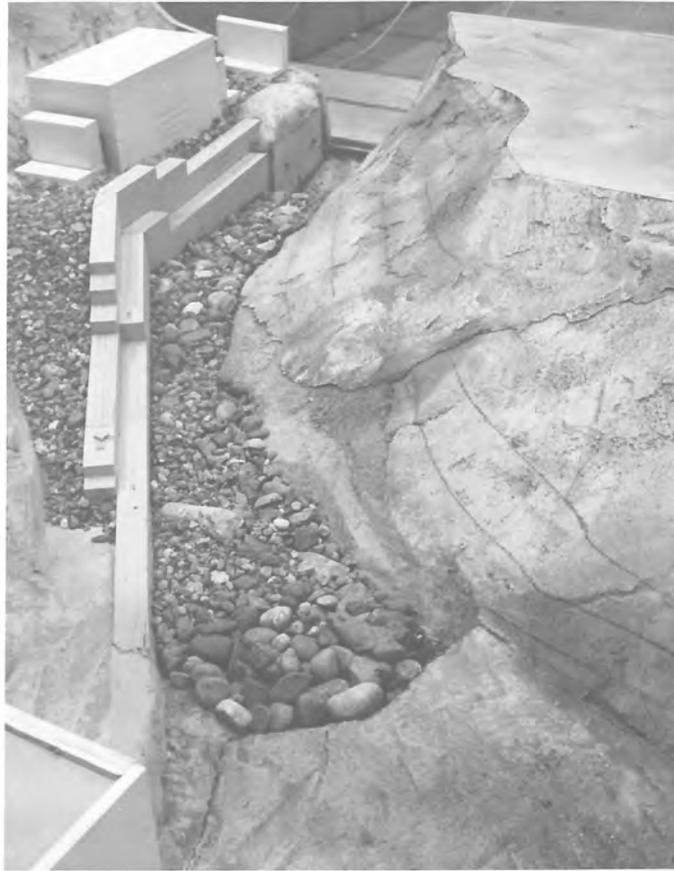
Figure 3. - Downstream view without removable topography in place.

removable topography sections (figures 3, 4, and 5), one at each of the above control points, were removed in various combinations to study the effect on tailwater elevations and flow conditions.

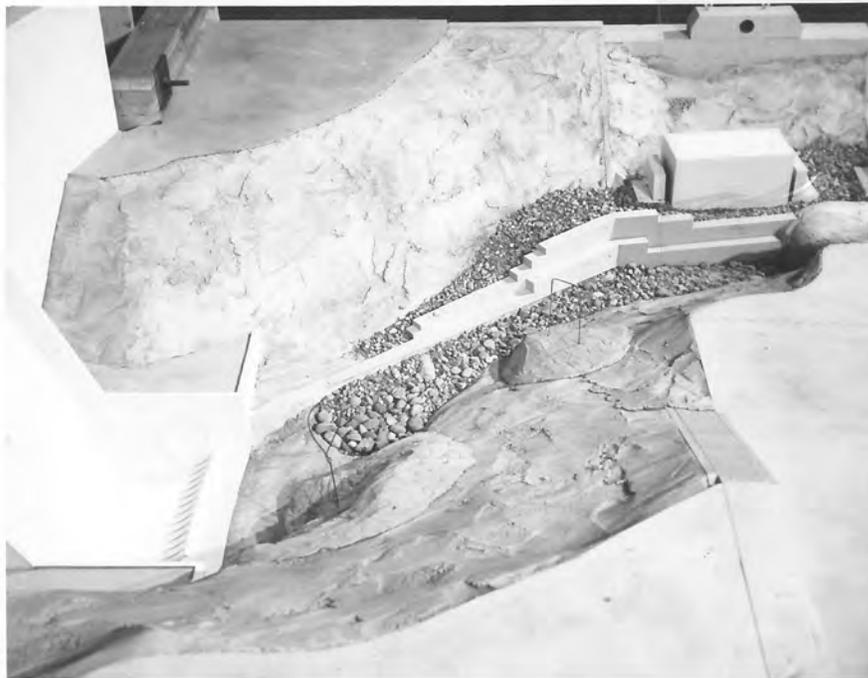
Figure 4. - View from right bank with the removable topography in place.

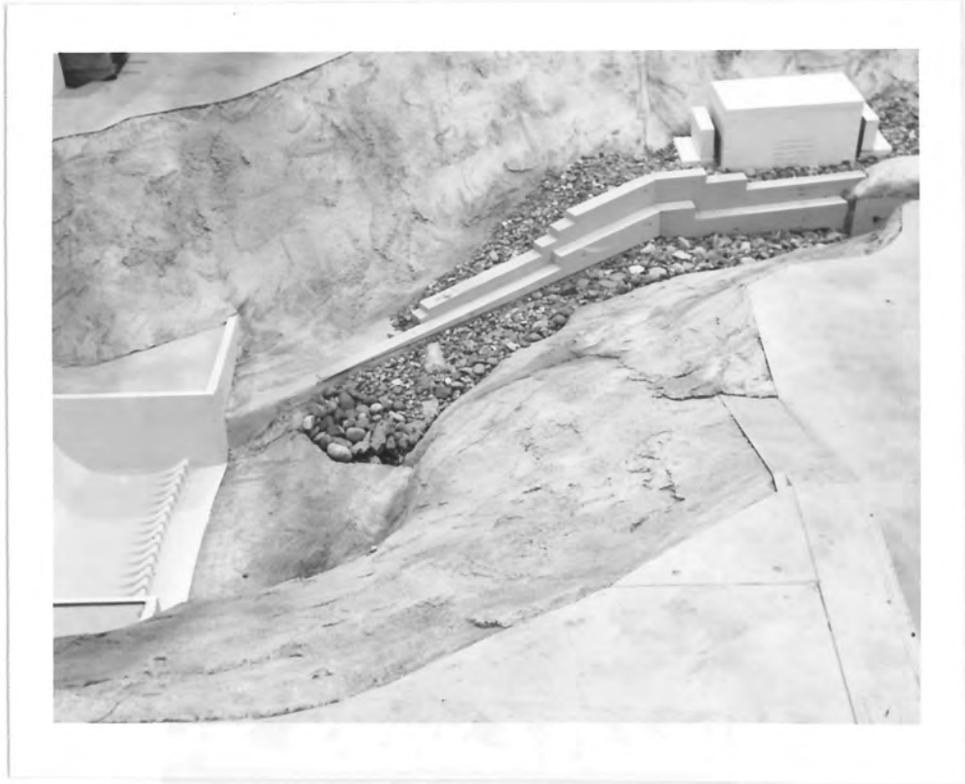
Figure 5. - Right bank view without removable topography.

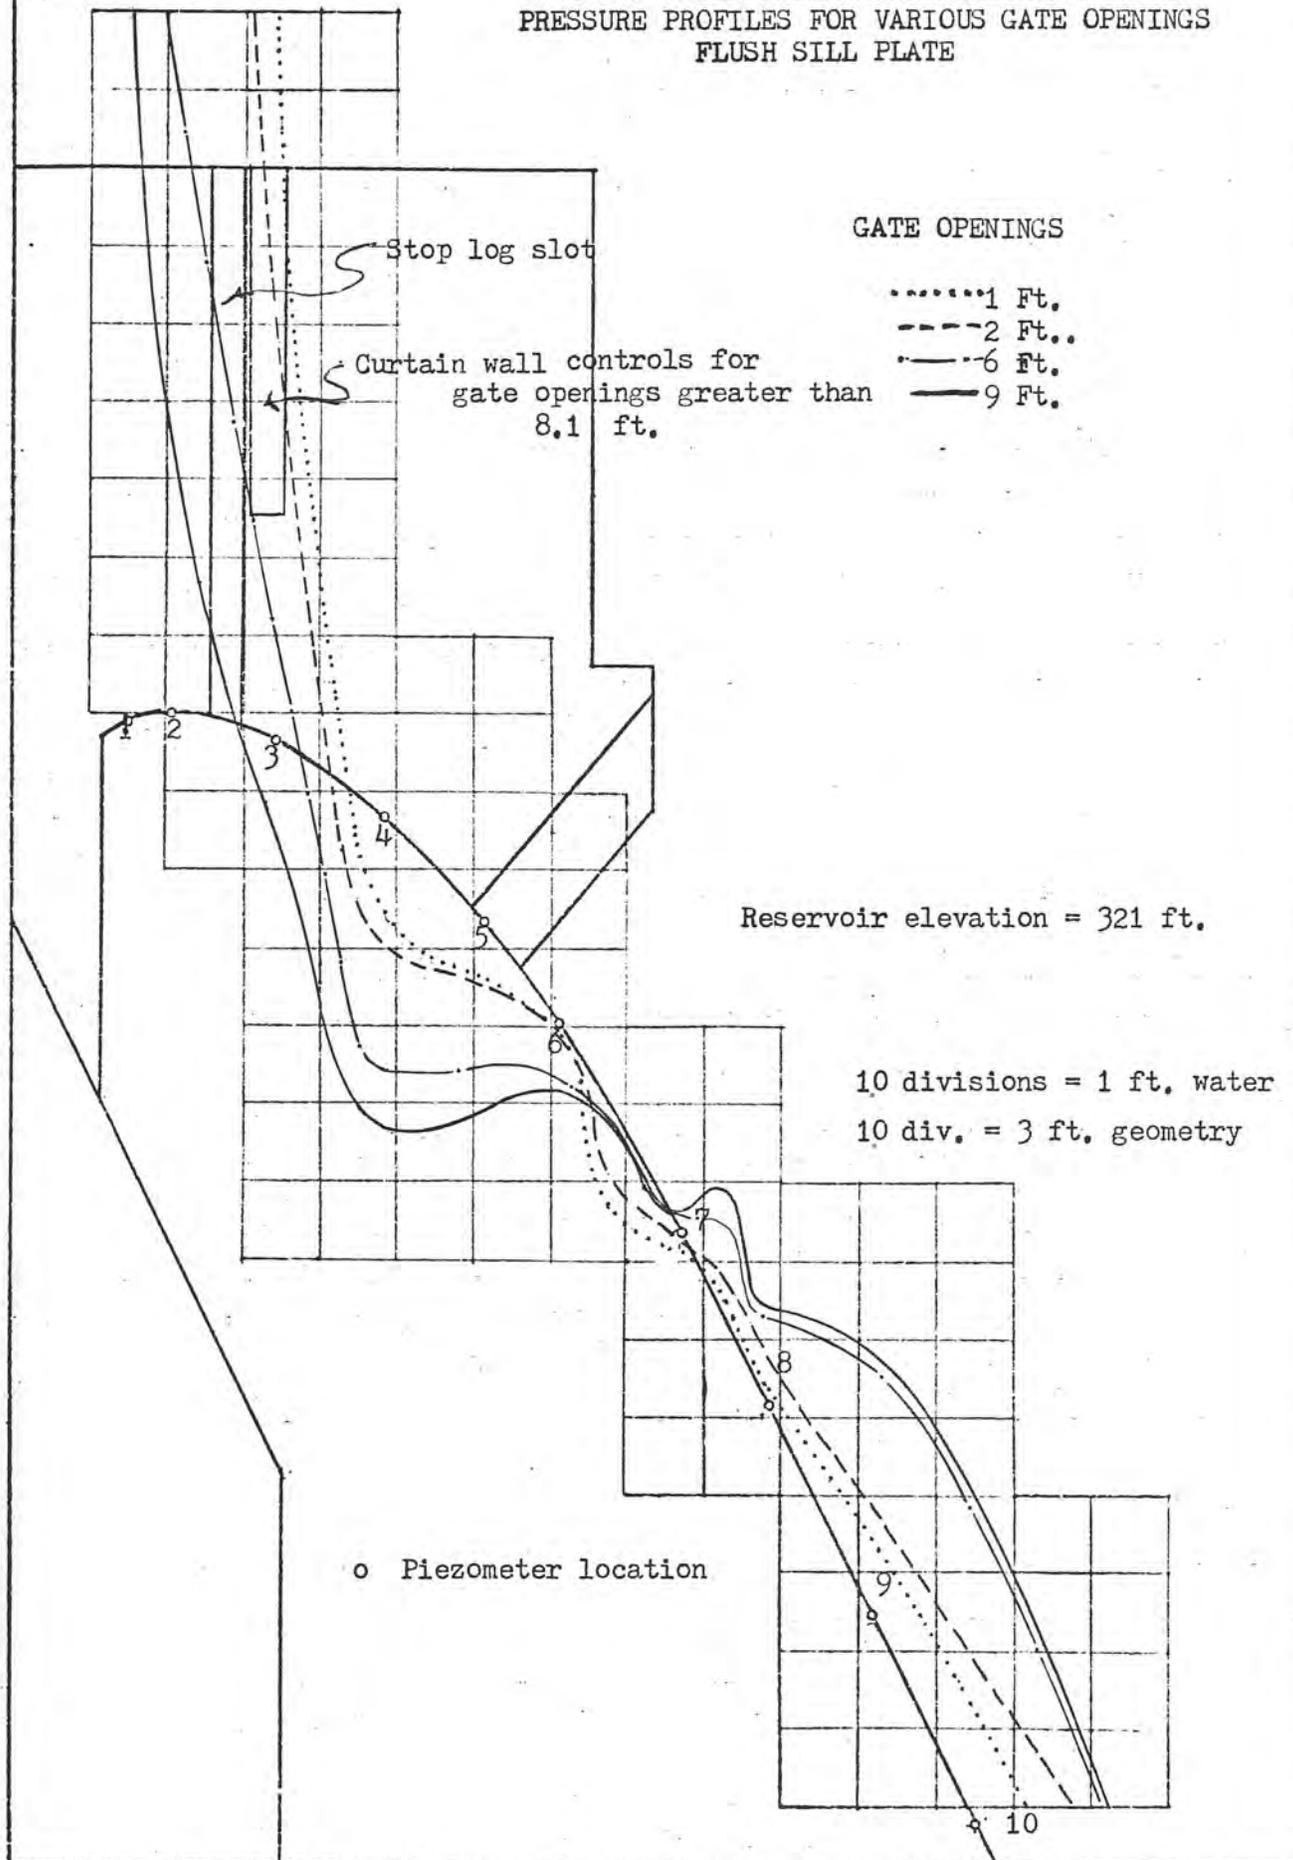
KLANG GATES SPILLWAY MODIFICATION STUDY
PRESSURE PROFILES FOR VARIOUS GATE OPENINGS
FLUSH SILL PLATE

The minimum pressures on the spillway during both gated and free-flow discharge occurred near piezometer No. 4. Figure 6 shows that at design maximum reservoir elevation of 321 feet the minimum pressure decreased to -4 feet of water as the gate opening increased to 9 feet. Figure 7 shows that with gates full open the minimum pressure decreased to -5.5 feet of water as the reservoir elevation increased to 326 feet. Figure 8 shows that the raised sillplate had very little effect on the spillway pressures. The lowest pressure for the design reservoir elevation of 321 feet was also -4 feet of water with gates full open. The pressures measured on the spillway were damped or averaged but are not considered low enough to cause cavitation for the velocities expected on the spillway. No periodic pressure fluctuations that could be attributed to flow tending to separate from the spillway surface were noted. Small pressure variations of ± 4 percent were measured by the transducer system.

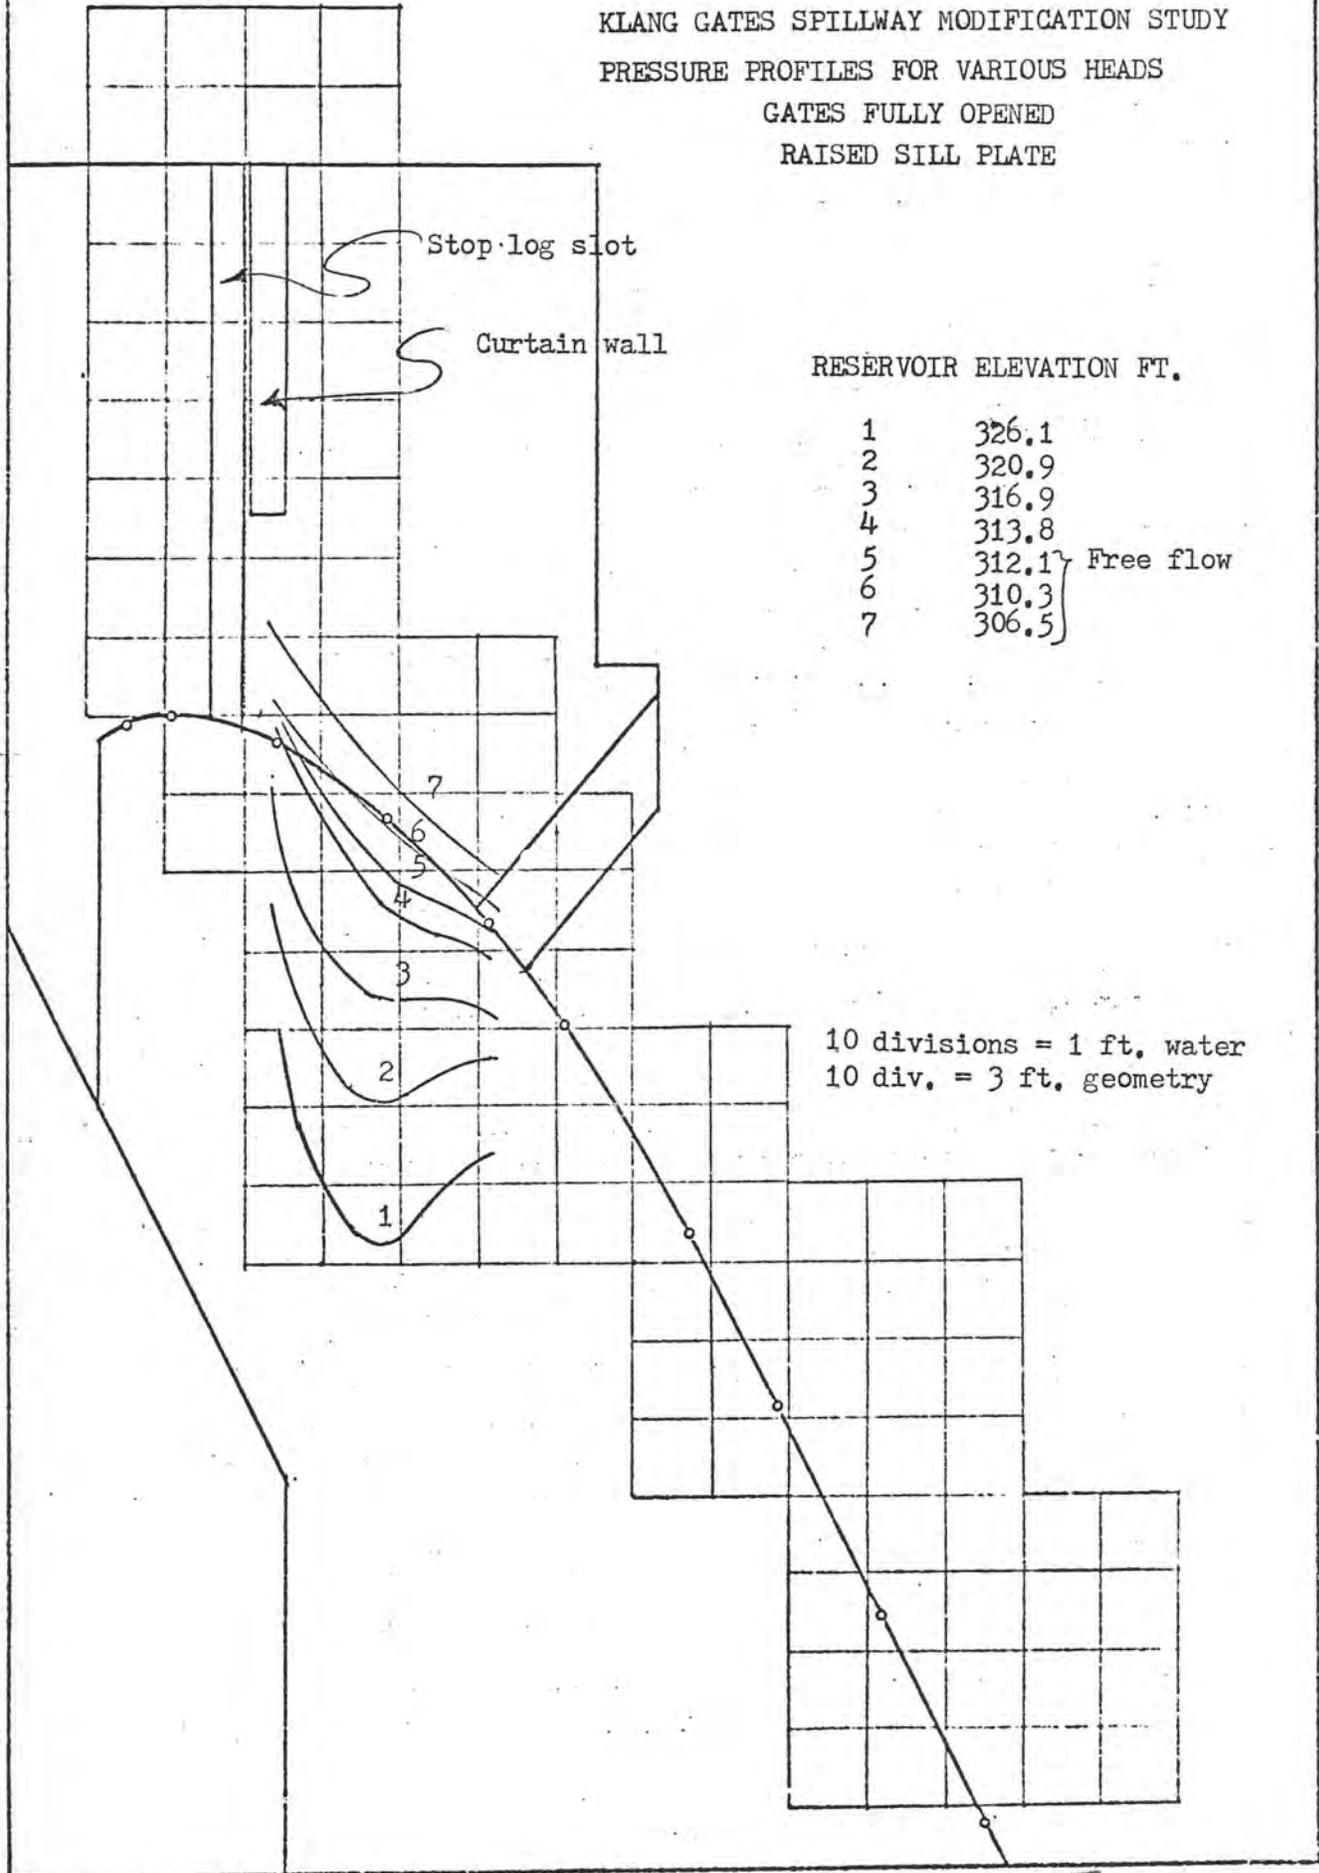
Figure 7

KLANG GATES SPILLWAY MODIFICATION STUDY
 PRESSURE PROFILES FOR VARIOUS HEADS
 GATES FULLY OPENED
 RAISED SILL PLATE

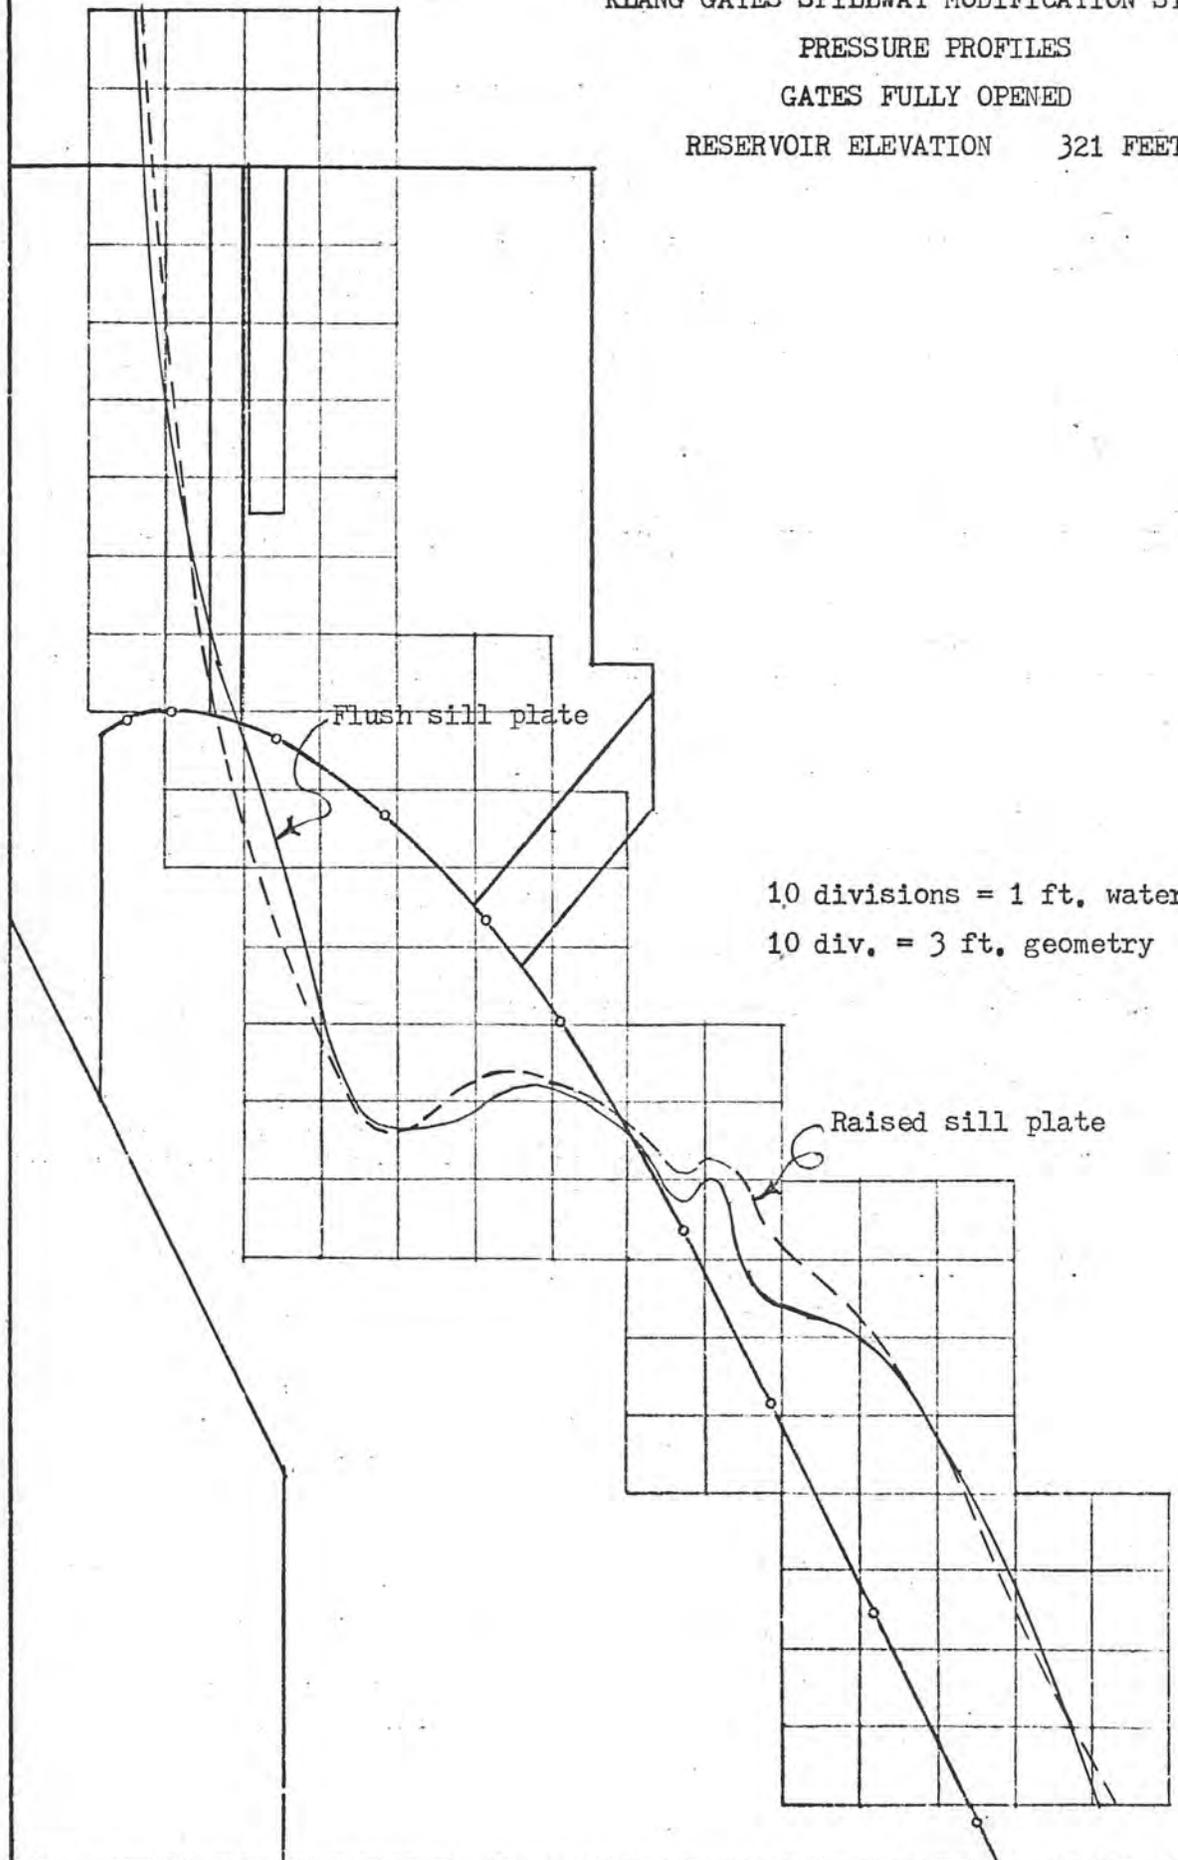
Figure 8

KLANG GATES SPILLWAY MODIFICATION STUDY

PRESSURE PROFILES

GATES FULLY OPENED

RESERVOIR ELEVATION 321 FEET

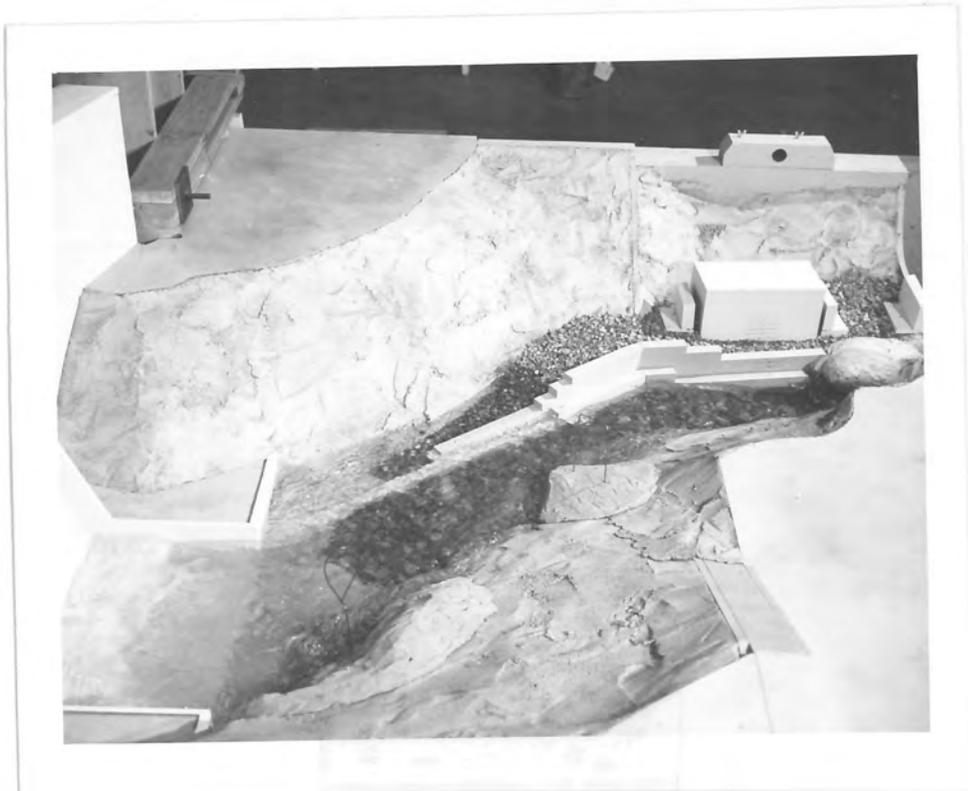
Figure 10. - Flow of $1,900 \text{ ft}^3/\text{s}$, channel with topography features in place.

Color slides, black and white photographs, and a 16-mm color movie were taken as methods of recording downstream river channel data while the model was operated at discharges of 1,900 ft³/s, 3,100 ft³/s, 4,400 ft³/s, 5,800 ft³/s, and 13,300 ft³/s. A tabulation of tailwater elevations and calculated velocities at several locations during the above discharges is given in table 1. The existing channel was satisfactory for discharges up to 1,900 ft³/s, figure 10. However, at discharges greater than 1,900 ft³/s scouring started.

Scene No. 2. Flow at $1,900 \text{ ft}^3/\text{s}$. No appreciable scouring velocities and channel velocities range from 10 to 15 ft/s.

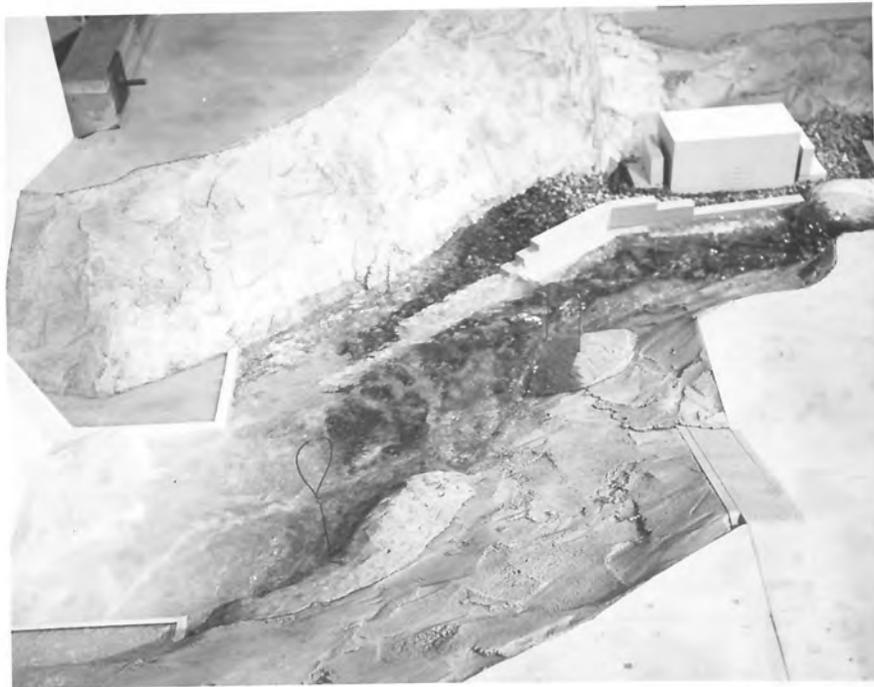
Figure 11. - Flow of 4,400 ft³/s, nob in place.

When the discharge reached 4,400 ft³/s gravel representing riverbed material up to 3 feet in diameter was being moved in the model, figure 11. Scouring was most prominent immediately downstream of both the nob and rock. Average velocities along the gabion between the nob and rock were about 20 ft/s. Also, at 4,400 ft³/s water was beginning to splash over the stilling basin retaining walls. After

Scene No. 4. Flow at $4,400 \text{ ft}^3/\text{s}$. Splashing has begun over the left and right retaining walls of the stilling basin. Velocity through the channel range from 15 to 20 ft/s. By removing the nob the stilling basin water surface elevation is lowered approximately by 1 foot. However, the velocities in the channel are slightly increased.

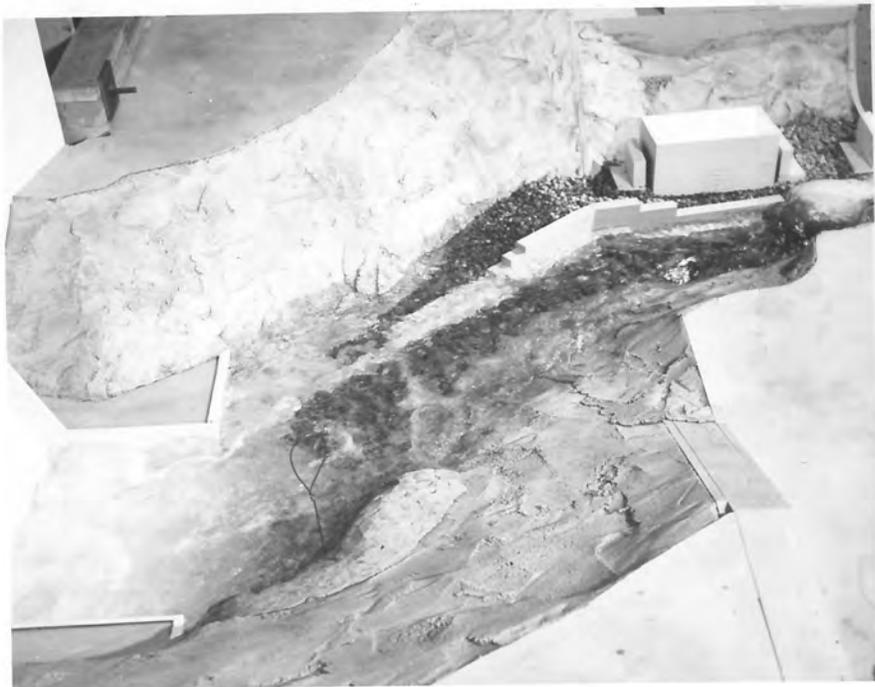
Figure 12. - Flow of 4,400 ft³/s, nob removed.

removing the nob section, the tailwater elevation in the stilling basin was lowered approximately 1 foot and the overtopping stopped, figure 12. However, this channelization increased the downstream velocities.

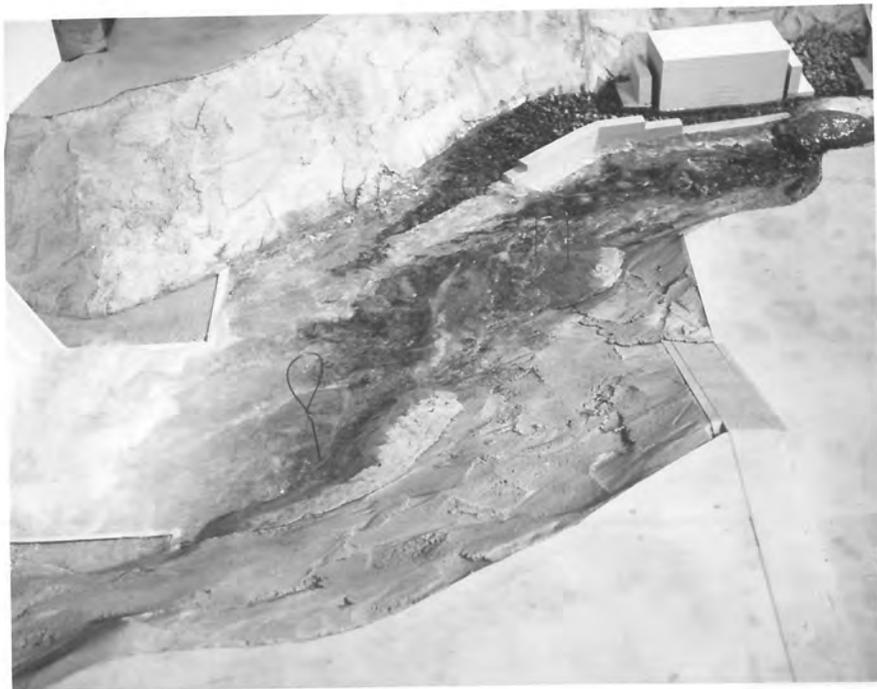
Figure 13. - Flow of $5,800 \text{ ft}^3/\text{s}$, nob in place.

There were several bad flow conditions at the discharge of 5,800 ft³/s. Water was flowing over the retaining walls, over the highest part of the backfill behind the rock gabions, and also over the section of gabions protecting the control house, figure 13. Water was about 2 feet deep around the control house. Removing both the nob and rock sections alleviated all the conditions mentioned above. Water now splashed only over the retaining walls, and no water reached the control house from either behind the gabions or over the gabions, figure 14. However, downstream velocities were considered high, being 20 to 25 ft/s. Removing the canyon section, in addition to the nob and rock, did not lower the tailwater elevation, figure 15.

Scene No. 5. Flow at $5,800 \text{ ft}^3/\text{s}$. Water is now flowing over both retaining walls. Water is also flowing behind the rock gabions and then flowing back over the rock gabions into the channel at the control house. By removing both the nob and the rock, the water surface in the stilling basin is lowered approximately 1 foot and the water no longer goes behind the gabions or over the gabions protecting the house. Removal of the canyon immediately in front of the stilling basin proves to be of no benefit.

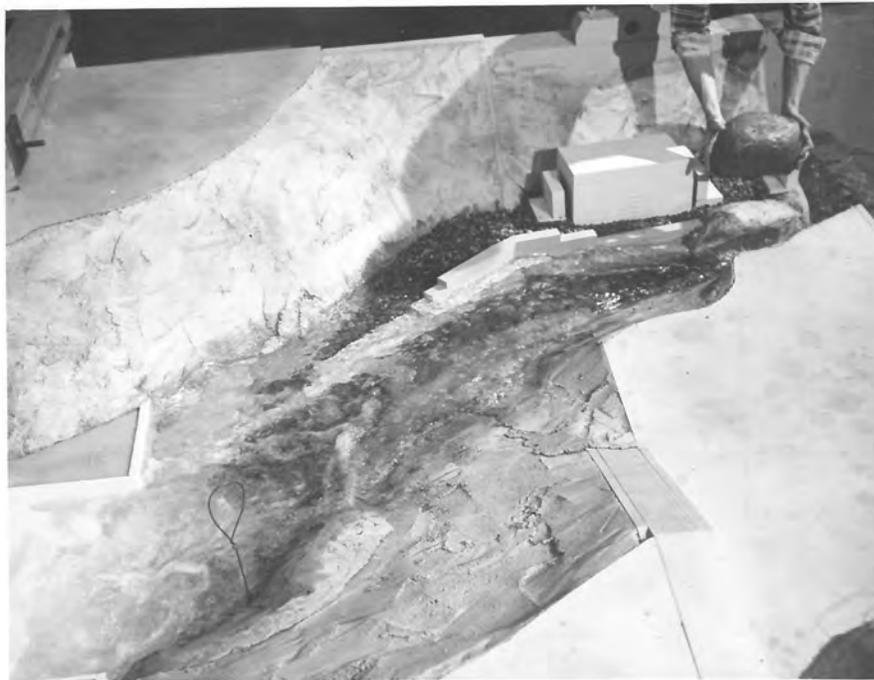
Figure 14. - Flow of $5,800 \text{ ft}^3/\text{s}$, nob and rock removed.

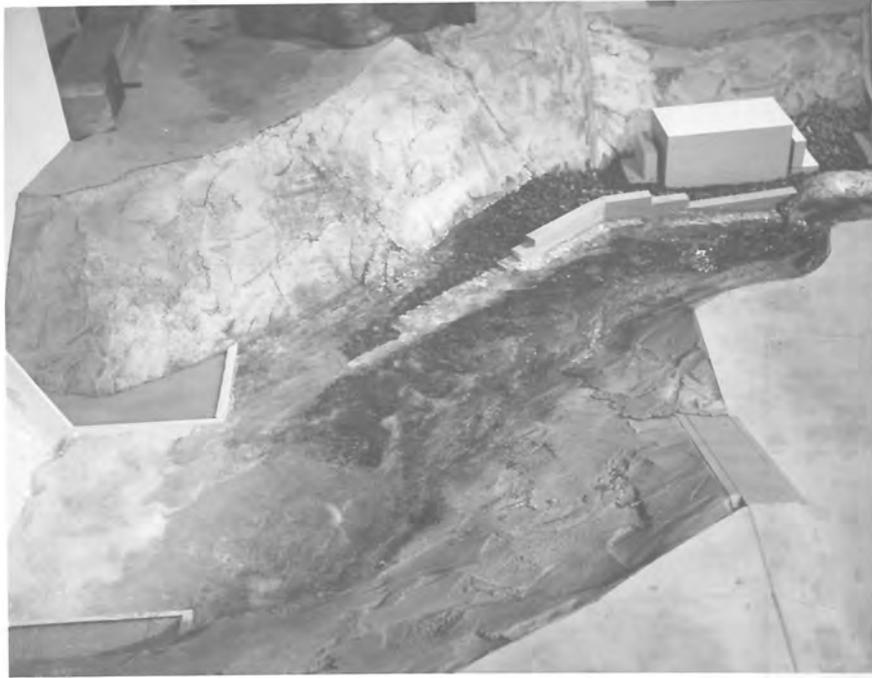
Figure 15. - Flow of $5,800 \text{ ft}^3/\text{s}$, canyon wall,
nob and rock removed.

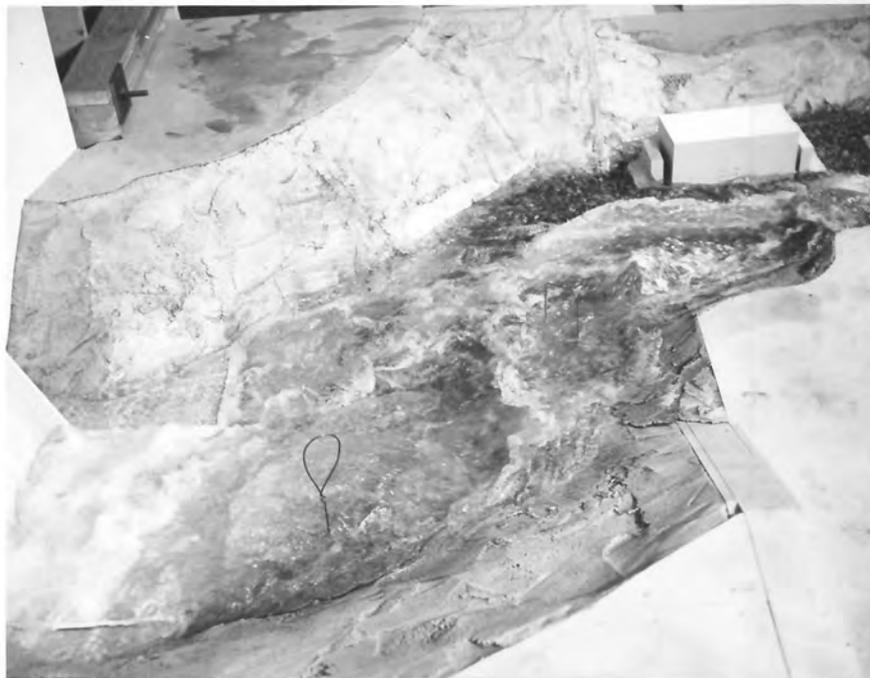
Figure 16. - Flow of $13,300 \text{ ft}^3/\text{s}$, channel with
topography features in place.

At a discharge of 13,300 ft³/s, water flowed approximately 4 feet over the retaining walls, 2 feet over the highest section of gabions, and 6 feet deep along the side of the control house, figure 16. Wave action was very rough throughout the channel, and velocities averaged greater than 20 ft/s. Removal of the nob and rock lowered tailwater elevations approximately 1 foot, figure 17. Removal of the canyon section proved detrimental by creating a very strong back eddy at the right side of the stilling basin, figure 18.

Scene No. 6. Flow at $13,300 \text{ ft}^3/\text{s}$. This is the maximum discharge at maximum reservoir elevation of 321 feet. Water is flowing approximately 3 to 4 feet above the retaining walls, approximately 2 feet above the highest part of the backfill behind the rock gabion and approximately 6 feet along the side of the control house. Removal of the nob and rock has negligible effects upon the stilling basin water surface elevations. Removal of the canyon wall has detrimental effect by creating a strong back eddy.

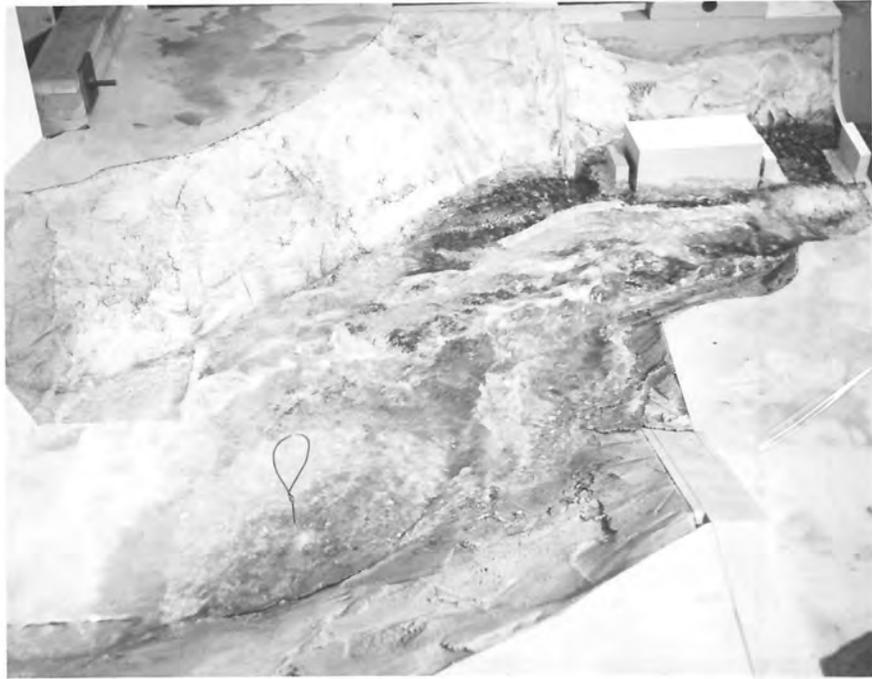
Figure 17. - Flow of $13,300 \text{ ft}^3/\text{s}$ with nob and rock removed.

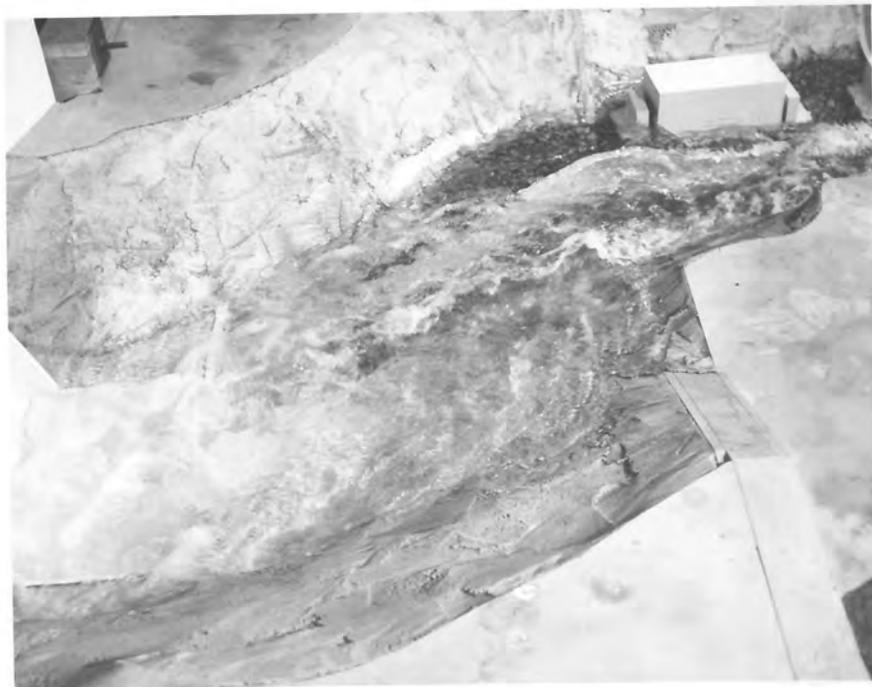
Figure 18. - Flow at $13,300 \text{ ft}^3/\text{s}$ with canyon wall, nob and rock removed.
