# **Dissolved Gas and Fishery Investigations at Ridgway Dam – Phases 1, 2 and 3 Report**

United States Department of the Interior  
Bureau of Reclamation  
Technical Service Center

February 2004

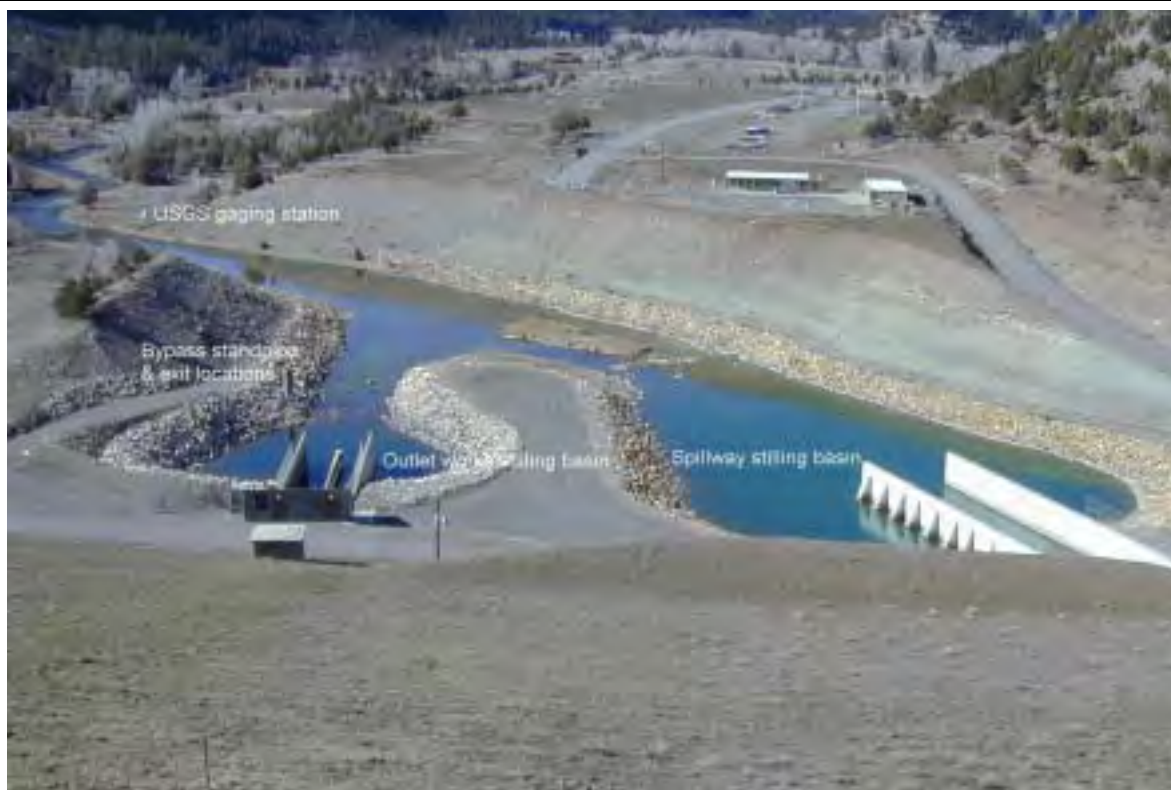
**Figure 1. – Downstream view of Ridgway Dam outlet works and spillway stilling basins and a short section of the river. The bypass pipe has been relocated into the left side of the narrow channel just downstream from the outlet works stilling basin.**

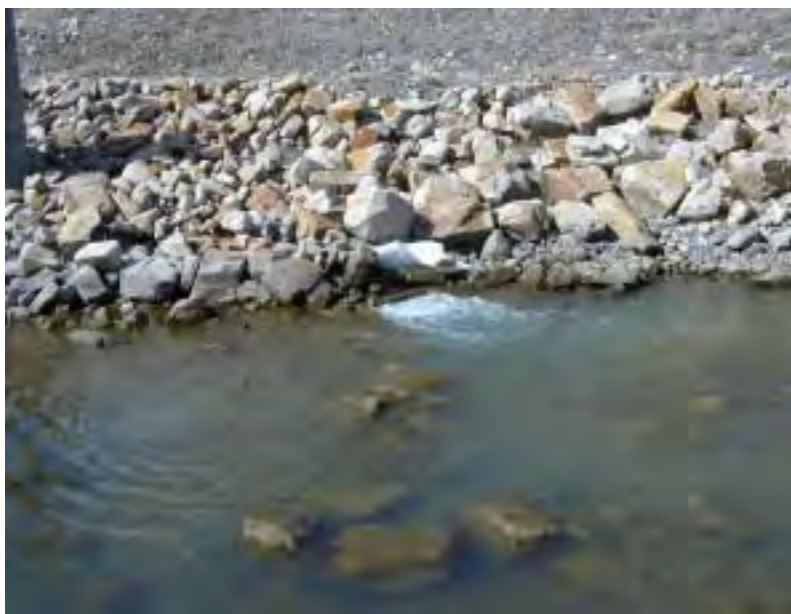
**Figure 4. - Close up view of the bypass pipe exit. A standpipe is located on the very left side of the picture. The standpipe was installed to allow air to escape from the flow.**

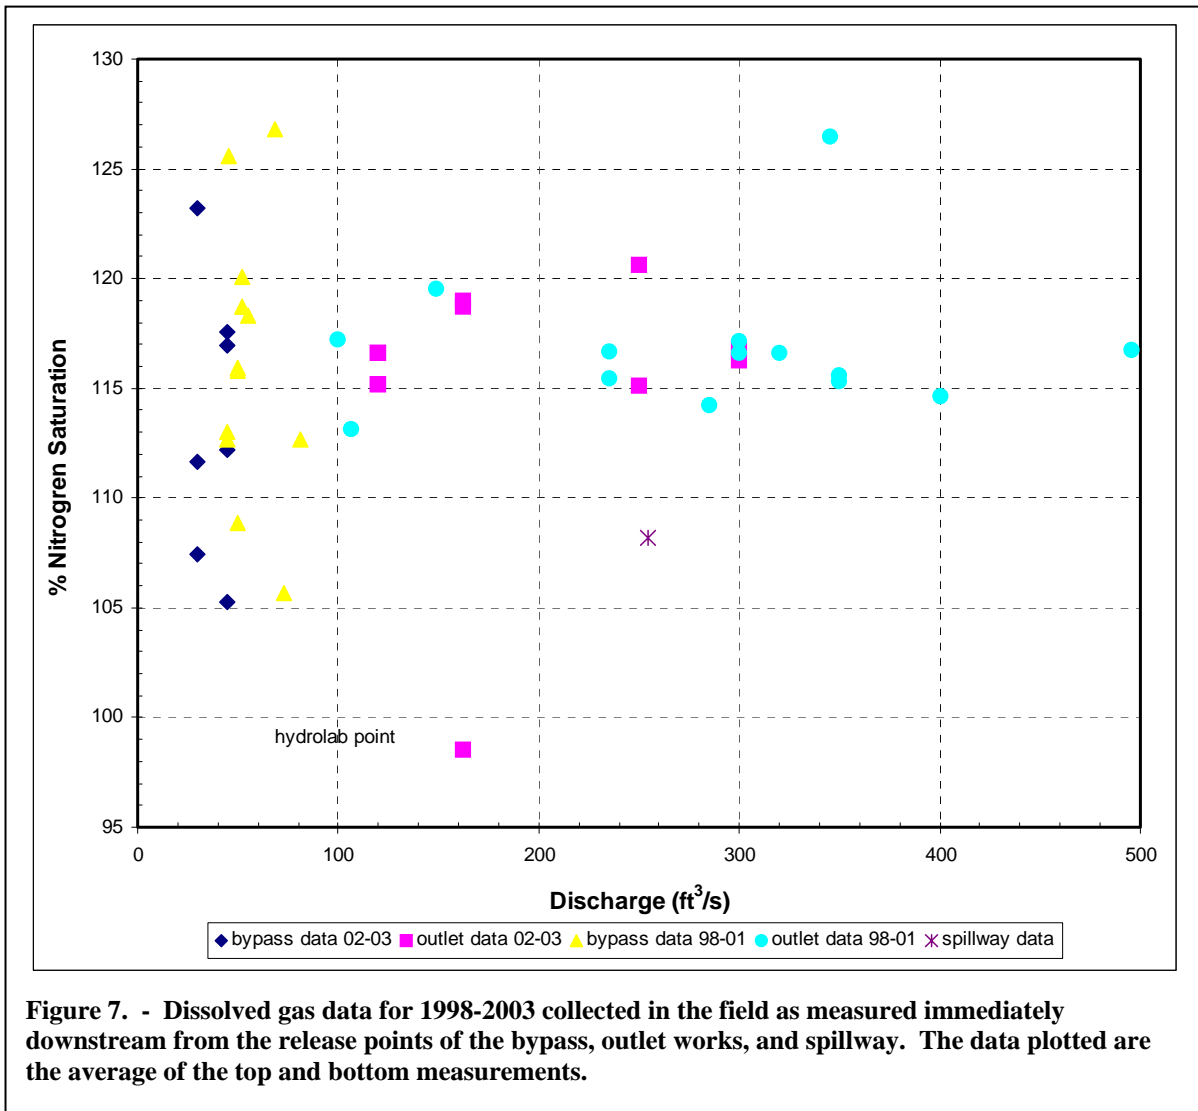
**Figure 7. - Dissolved gas data for 1998-2003 collected in the field as measured immediately downstream from the release points of the bypass, outlet works, and spillway. The data plotted are the average of the top and bottom measurements.**

Again, figures 7 and 8 were plotted using the average of the top and bottom measurements taken in a shallow river. Weston (4) provided separate plots of the top and bottom readings, but with these shallow flow conditions it is probably not appropriate to assume much difference between the surface and depth for the flow conditions that existed during the measurement period. The trend of decreasing nitrogen saturation with distance downstream in the river does appear logical given the shallow, often turbulent river downstream including the sections with rock weirs. The data did not show a significant change in temperature with travel downstream.

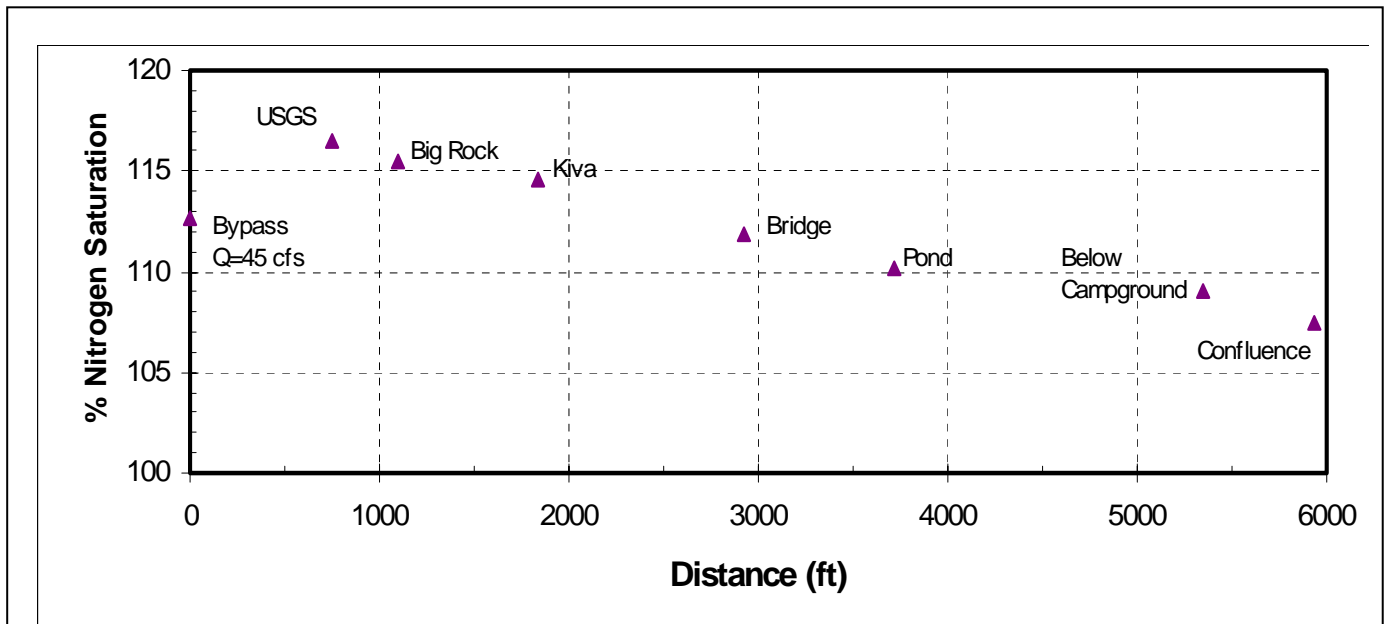
**Figure 8. - Gas data for April 3, 2000 with the bypass operating. Note that the gas level increases between the bypass and the USGS gage site then decreases down river. This was typical for either bypass or outlet operation. (Below Campground is B.C. in the tables.)**

The historical data were then plotted as percent nitrogen saturation versus distance downstream or data station by the Western Colorado Area Office. A typical plot is shown on figure 8 for a bypass release of 45 ft<sup>3</sup>/s in April of 2000.

The trend in figure 8 shows that the river gradient and geometry also is important when evaluating the percent nitrogen gas production.

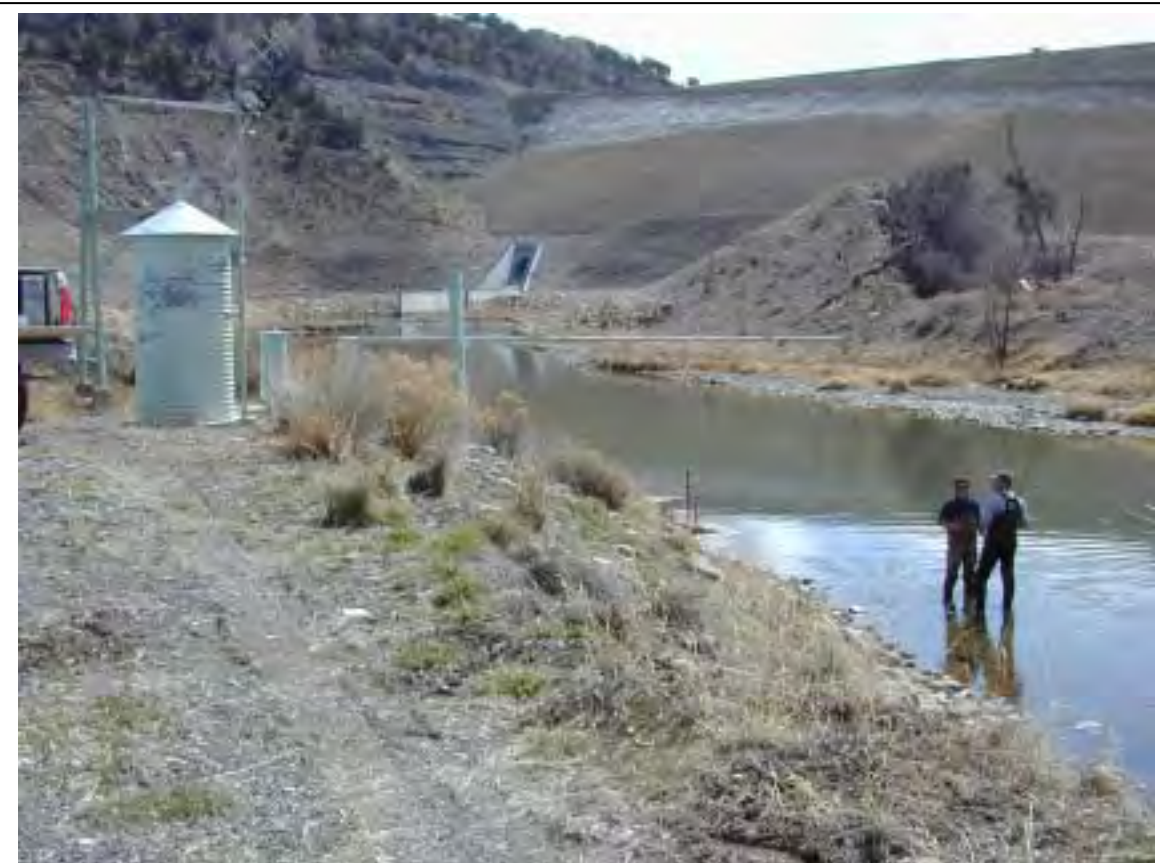
**Figure 9. - The USGS river gage station about 750 ft downstream from the dam. Note the walls of the spillway stilling basin can be seen in the background. Also notice the shallow water at this site. This is typical of the small bypass releases that occur.**

A view of the river between the dam and the USGS station is shown on figure 9. The USGS station is about 750 ft downstream from the toe of the dam. The area upstream from the USGS station is restricted to public access. The river is very shallow and has gone through a significant bend prior to reaching this measurement point. The topographic map also showed some minor tributaries that could provide additional elevated dissolved gas levels between the dam and this station. However, tributary flows causing the problem are highly unlikely. A more likely concern at the USGS station is whether or not the gas distribution is uniform across this section.

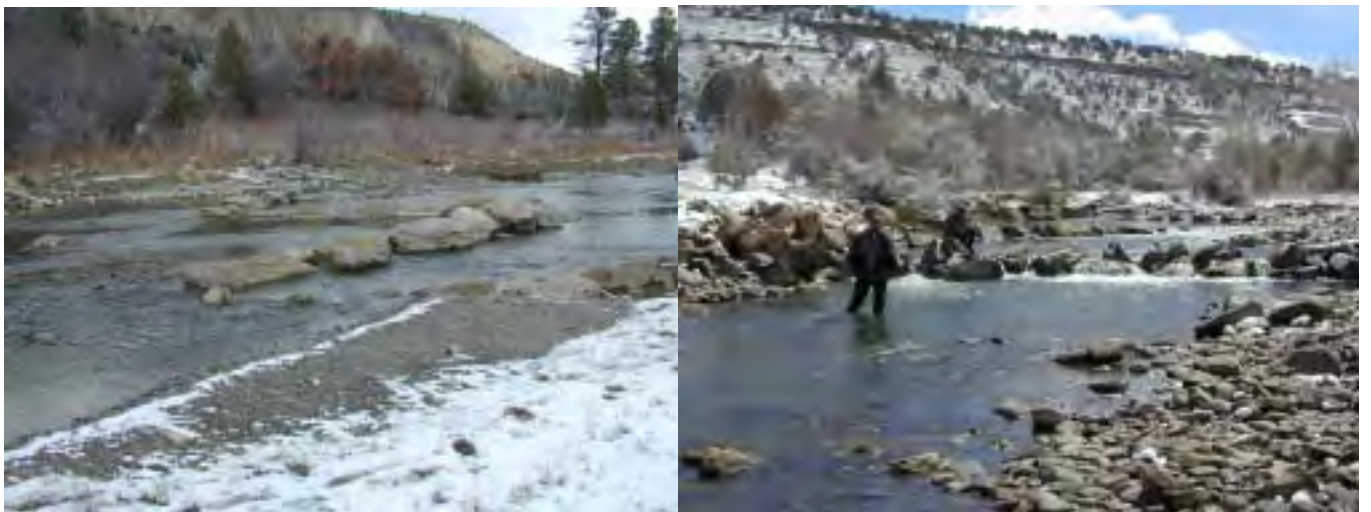
**Figure 10. - Example of two rock weirs or Rosgen habitat structures that have been installed in the stream below Ridgway Dam to provide habitat and help improve water quality.**

Figures 5, 9 and 10 show the variability of the river sections and measurement locations downstream from the dam. Figure 5 shows the measurement locations in the natural river with riffles, and pools, but generally shallow flow conditions. Figure 10 shows typical “natural” stream restoration structures in the form of rock weirs that were designed by Dave Rosgen and constructed in the river in 1994 below the USGS station to promote improved fish habitat. The success of these structures to promote fish habitat is discussed in a later section.

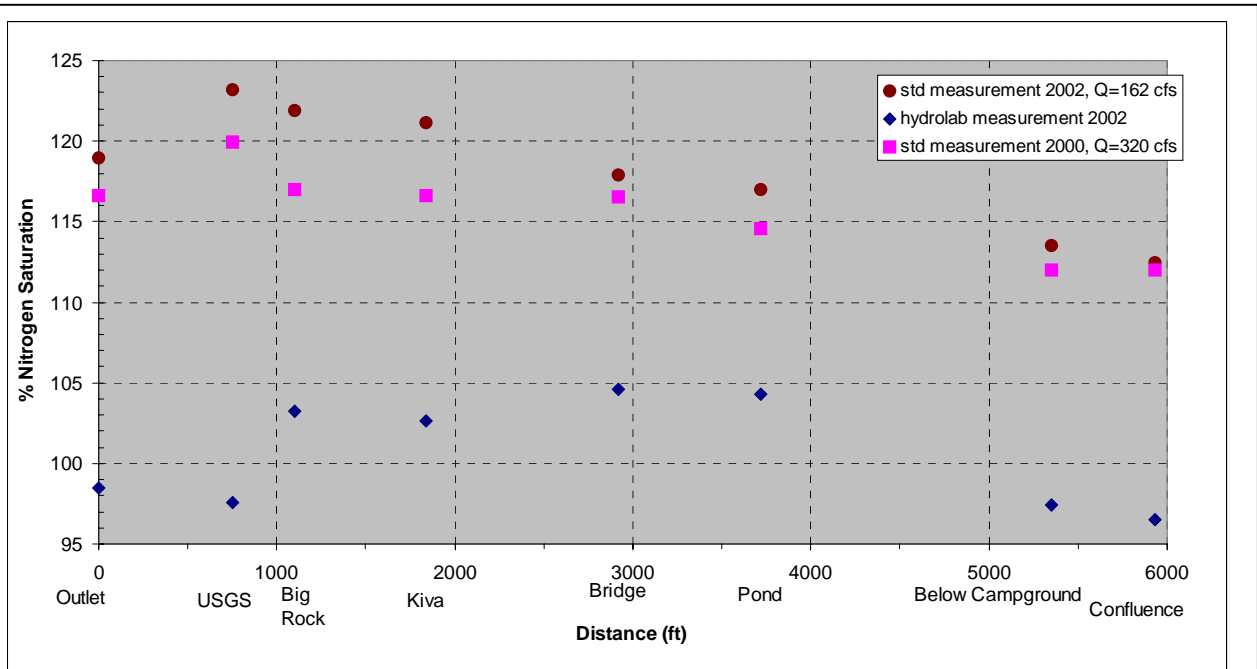
**Figure 12. – Dissolved gas data gathered at the same stations with the standard hand-held saturometer and the Hydrolab instrument on July 2, 2002 with an outlet works flow of 162 ft<sup>3</sup>/s. The data trend is somewhat different as are the data magnitudes with the different instruments. The standard saturometer was used to also measure dissolved gas on July 12, 2000 with an outlet works flow of 320 ft<sup>3</sup>/s and compared favorably with the other saturometer data.**

Figure 12 shows the dissolved gas data gathered with two different instruments. The data trends are similar but not identical, and the magnitudes of the gas values are very different. These data, taken in July 2002 for a discharge of 162 ft<sup>3</sup>/s from the outlet works were the only reported historical data when measurements were taken with different meters. Unfortunately, the saturometer data shows dissolved gas data that exceeds the 110 percent standards, while the Hydrolab data shows gas levels that are below the standard and would not indicate that a problem exists. To determine which instrument was correct, data from July 2000 with an outlet release of 320 ft<sup>3</sup>/s was plotted. The July 2000 and 2002 data measured with the standard saturometer showed similar magnitudes and trends. The data taken with the standard saturometer showed consistent results over the years and fish stress, which implies gas levels over 110 percent, has been noted over the years so perhaps the saturometer measurements are valid. The magnitudes of the hydrolab data are questionable and may be due to the small instrument measurement surface and longer equilibrium time required.

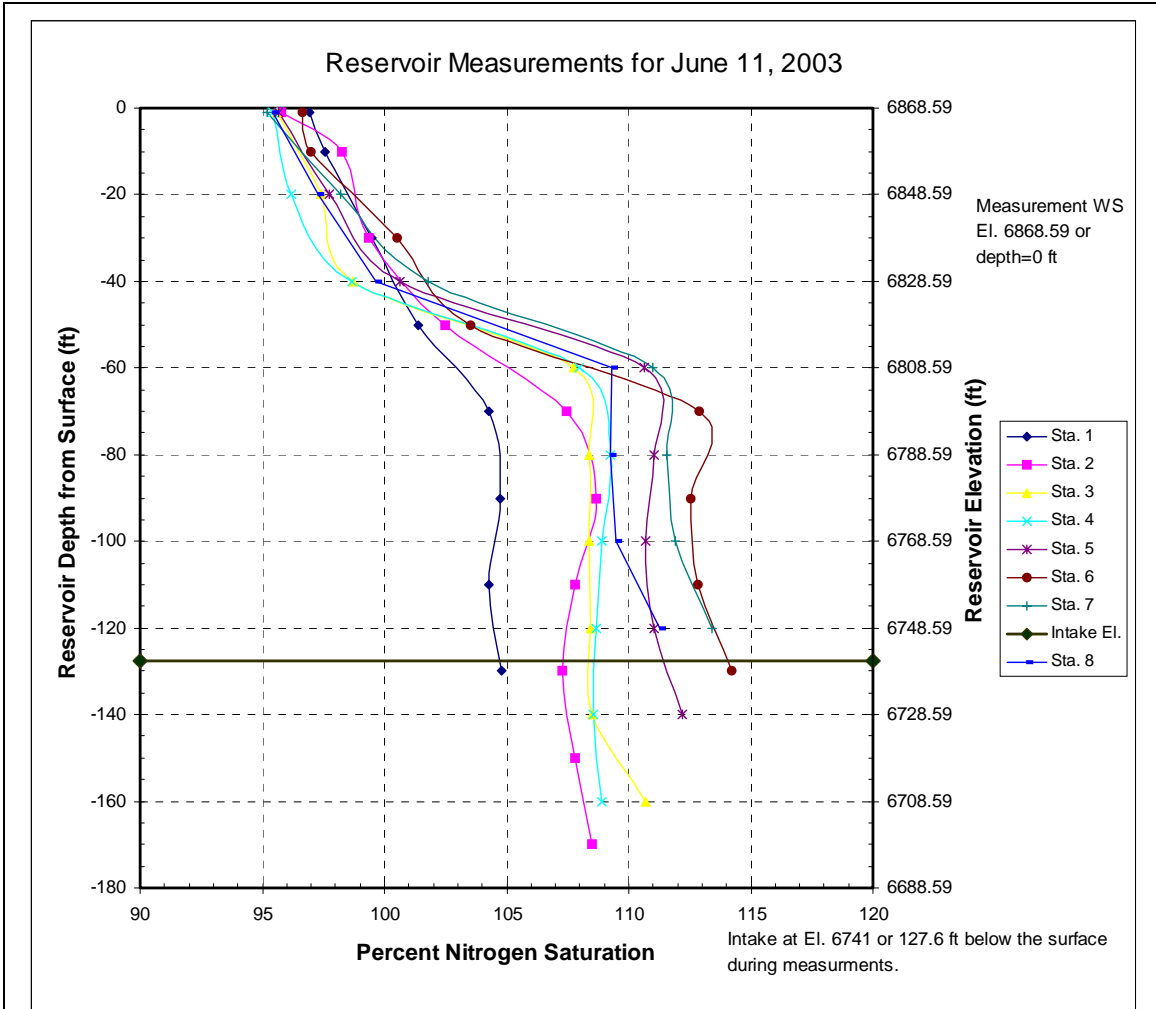
**Figure 13. - Ridgway reservoir dissolved nitrogen gas profiles recorded June 11, 2003. The profiles are shown with zero depth at the surface of the reservoir and show increasing percent nitrogen saturation with depth. The flow through the reservoir at this time was between 120 to 300 ft<sup>3</sup>/s. Station 1 is at the dam and would be the percent saturation level seen by the outlet works or bypass intake.**

Examining both nitrogen saturation data sets from the June surveys revealed that the data from station 1 for the June 11<sup>th</sup> survey has a percent nitrogen saturation value of about 104 percent and from the June 26-27<sup>th</sup> survey of about 117 percent. At the elevation of the intake the percent nitrogen saturation varies between 104 to 114 percent throughout the reservoir on June 11<sup>th</sup> and between 110 to 117 percent on June 26-27<sup>th</sup>. These disparate values in gas levels show a significant difference that is worthy of further investigation. The percent nitrogen saturation of the river flowing into the reservoir on June 27<sup>th</sup> was about 104-105 percent or just over saturation. Spring inflow values could be significantly higher.

Both June reservoir data sets show that the surface gas levels are lower than those at depth. This is the expected general tendency as the system seeks equilibrium by gas exchange from the water surface to the air. Wind can increase gas exchange by causing mixing in the surface layers. The gas levels in the surface layer are also influenced by temperature.

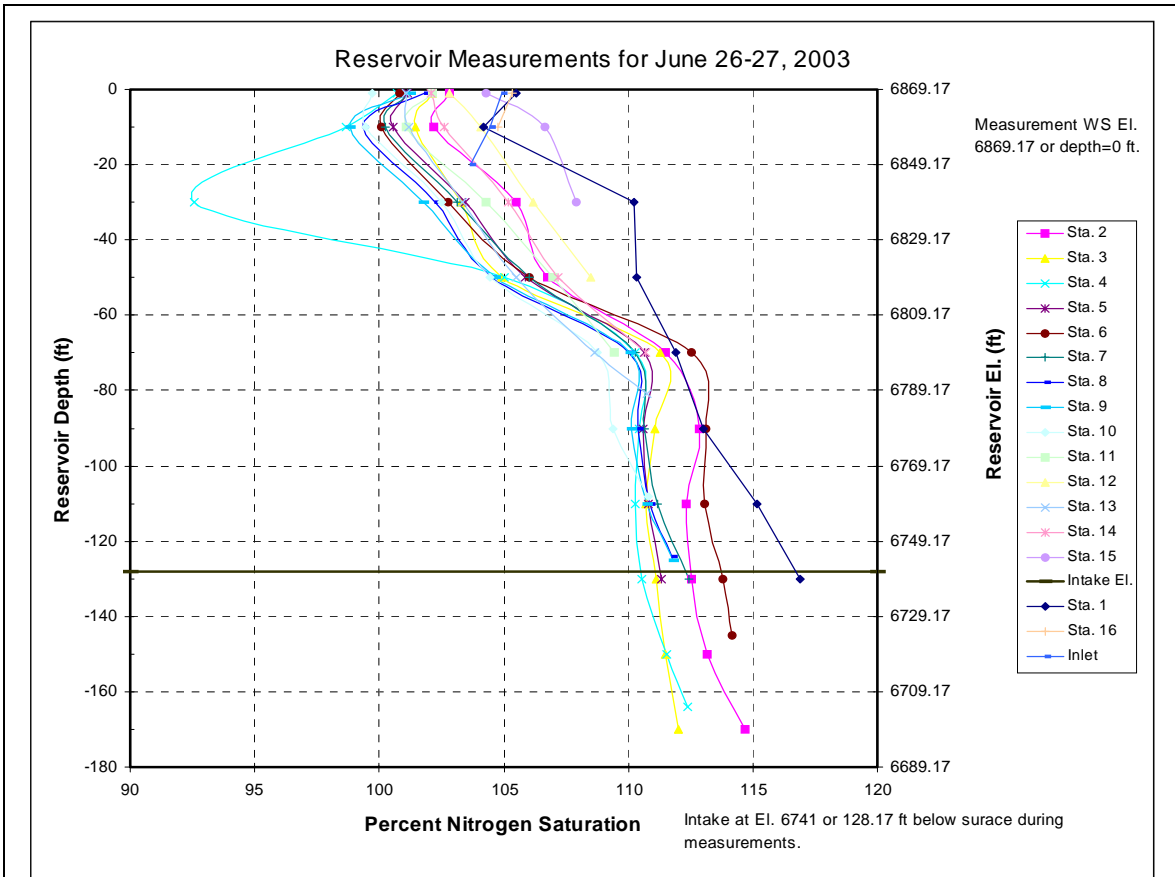
**Figure 14. - Ridgway reservoir dissolved nitrogen gas profiles recorded June 26-27, 2003. The profiles are shown with zero depth at the surface of the reservoir and show increasing percent nitrogen saturation with depth. The flow through the reservoir at this time was 300 ft<sup>3</sup>/s. Station 1 is at the dam and would be the percent saturation level seen by the outlet works or bypass intake.**

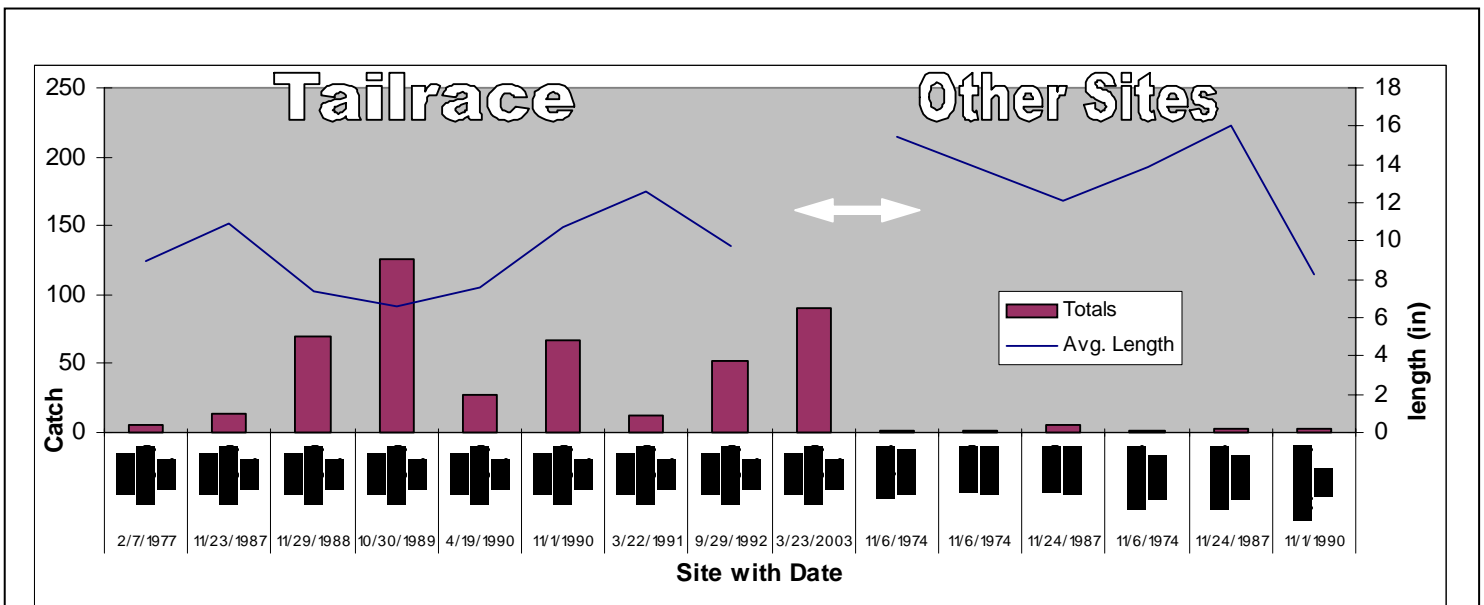
Figure 18. - Brown trout catch per unit effort and average length by sample site (1974-2003), Uncompahgre River.

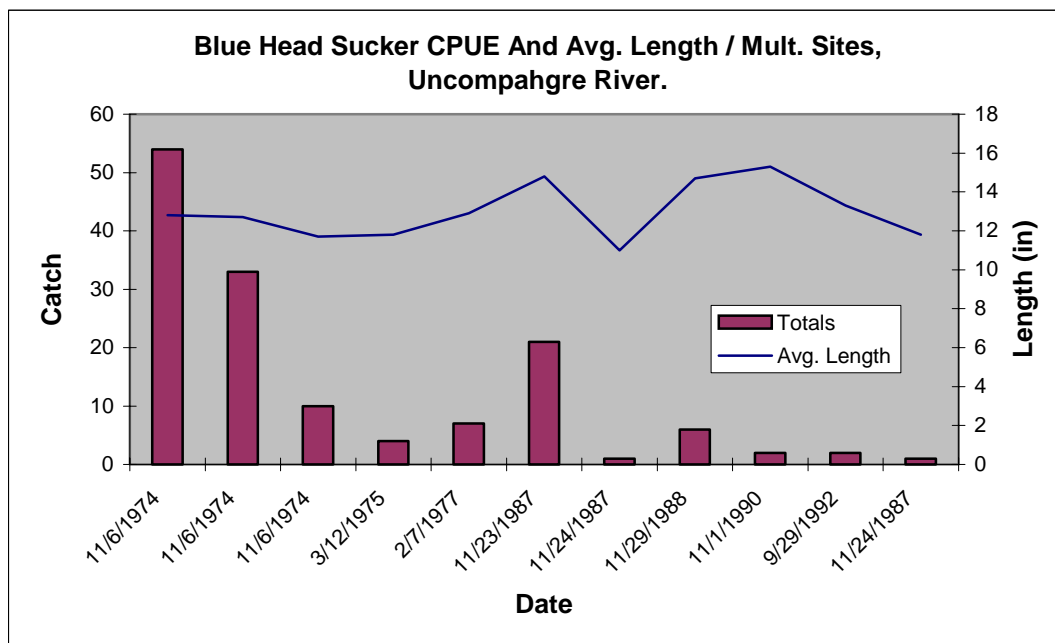
Figure B2. Blue head sucker (*Catostomus discobolus*) catch per unit effort and average length at multiple sites, Uncompahgre River.

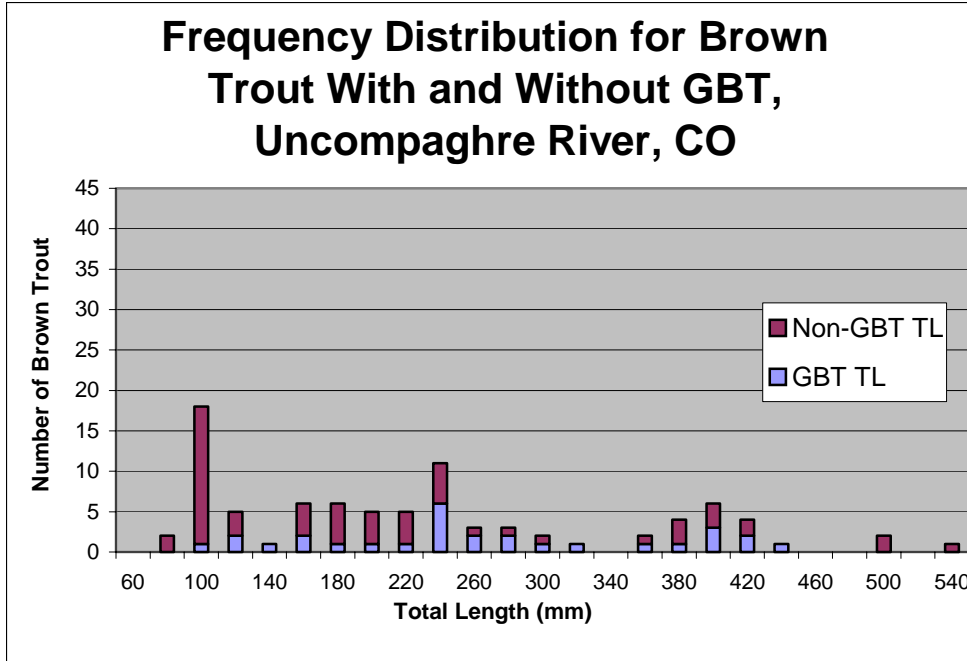
Figure A1. Frequency distribution by 20 mm bin for Brown Trout with and without GBT, two-pass electrofishing effort on 3/26/03 below Ridgway Reservoir, Uncompaghre River, CO.

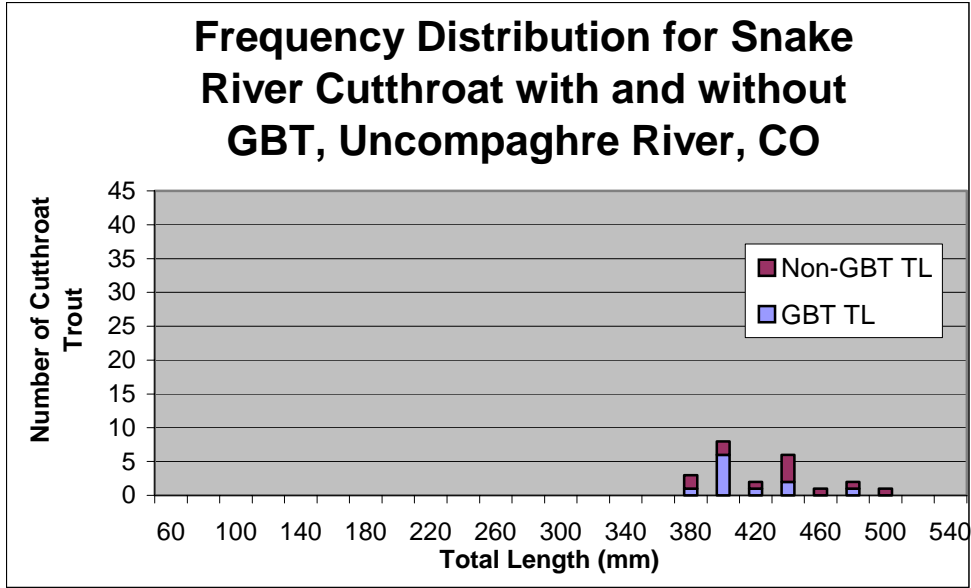
Figure A3. Frequency distribution by 20 mm bin for Snake River Natives with and without GBT, two-pass electrofishing effort on 3/26/03 below Ridgway Reservoir, Uncompahgre River, CO.
