Experimental Methods for Studying Canal Breach Processes

Tony L. Wahl¹, Member, ASCE, and Dale J. Lentz²

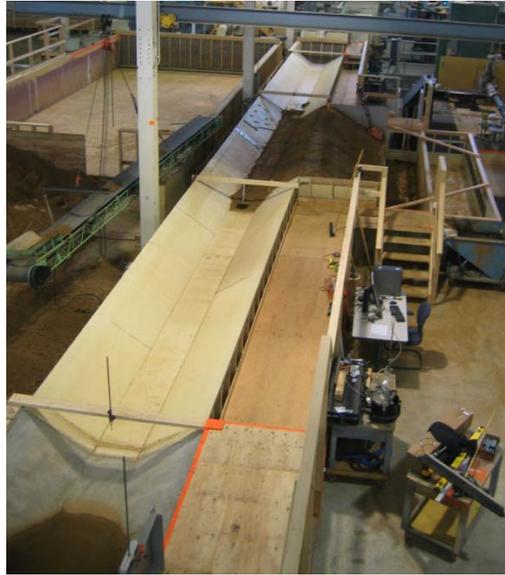
Figure 1. — Canal breach model test facility viewed from downstream end. Initial flow in the canal is toward the viewer. The erodible embankment section is at the right side.

Figure 1 shows a photo and Figure 2 a plan view of the physical model test facility, which consists of a 70-ft long trapezoidal canal constructed between twin head boxes, one at each end of the canal. The canal has nonerodible plywood walls along most of its length, with one sidewall missing in a 20-ft long embankment test section midway between the two head boxes. Flow can be supplied into each end of the model and flow can also be released into wasteways through gates located in each head box. The flow capacity into each head box is equal to the maximum theoretical critical-depth flow that can be produced in each canal reach following a hypothetical instantaneous and total failure of the test embankment. The gate in the downstream head box is oversized so that it can release the entire critical-depth flow plus the normal-depth discharge of the canal. This allows tests to be conducted with normal canal flow initially occurring past the test section. As a breach develops, the head box waste gates are throttled to keep more of the model inflow in the canal, thus providing additional flow toward the developing breach and maintaining near-normal canal water depths, simulating the slow draining of an extended-length canal reach. By accomplishing this flow change using gates, no manipulation of the output from the laboratory pumps is needed during a test. The typical procedure used was to throttle the waste gate in the upstream head box first until canal water levels began to drop, then to throttle the downstream waste gate to maintain canal water levels as long as possible. This maintains normal flow past the breach site for the longest

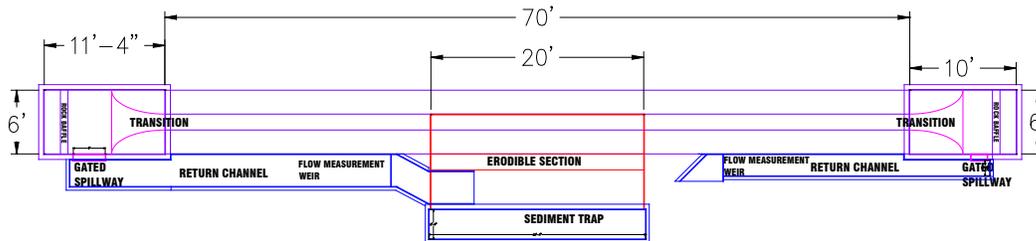
Figure 2. — Plan view of canal breach model test facility. Flow enters via the head boxes at each end of the model.

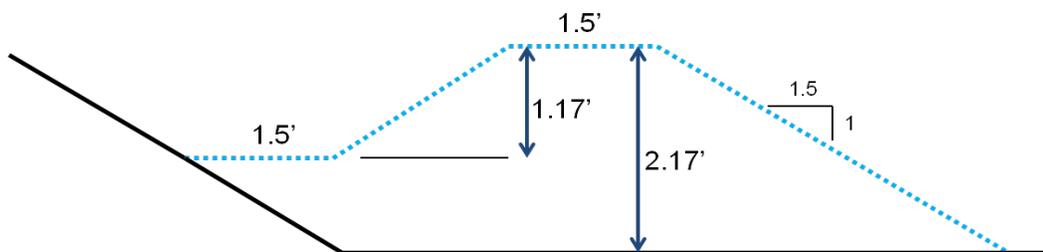
Figure 3. — Cross-section view of model canal and embankment test section.

possible time. The canal and embankment cross-section used for the facility is shown in Figure 3. The model canal was constructed with no slope over the short reach of the model. Flow measuring flumes in each wasteway and measurement of the inflow to each end of the model make it possible to compute the outflow through the canal breach.

The tested embankments were constructed in the model as simulated fill sections in a canal reach that is elevated above the surrounding landscape. On the wetted side of the embankment, the embankment crests were constructed to an elevation of 1.17 ft above the canal invert. On the land side of the embankment, the toe of the embankment was located 1.0 ft below the canal invert elevation. In the model, embankment material was placed in the invert of the canal to allow for potential downward erosion in this zone, and advancement of headcuts up both canal reaches away from the breach. This configuration was not a model of any specific situation in Reclamation, but was meant to be representative of canals constructed as fill sections, a configuration that is recognized to carry heightened risk of failure and potential for damage to surrounding areas.
