Hydraulic Laboratory Technical Memorandum PAP-1074

## Resistance of Protective Coatings to High Pressure Water Jets for Invasive Mussel Removal

February 2013

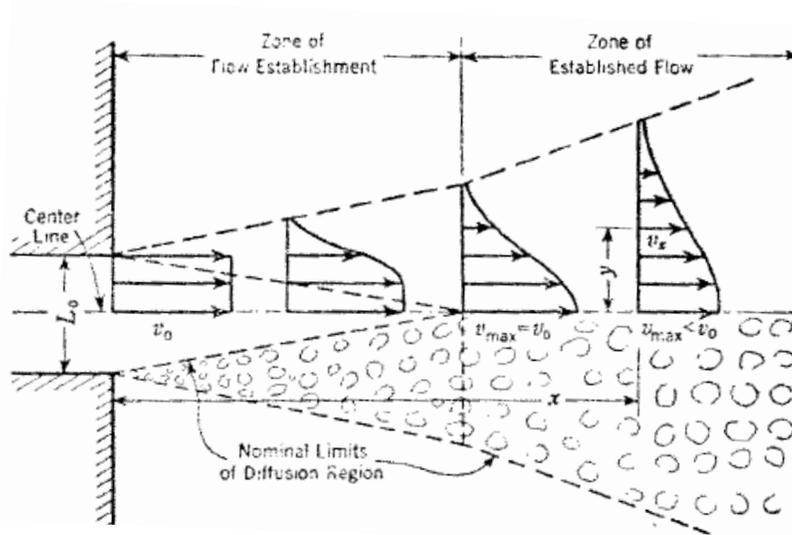
Figure 1 Schematic showing zones of submerged jet flow, from Albertson *et al* (1948)

Various journal articles pertaining to hydrodynamics of submerged jets were reviewed to better understand the parameters that may affect coating durability as well as mussel removal. Albertson *et al* (1948) discussed separate flow zones of a submerged jet. The zone of flow establishment (core length) is the distance from the exit to where the centerline velocity is begins to vary as shown in Figure 1. Within this region, the diffusion region of the jet with the ambient fluid has not yet reached the center line of the jet which allows the jet velocity to remain unchanged. Test results indicated that the core length is approximately 6 times the orifice diameter when using a circular jet. Once the diffusion region has encroached upon the center line, jet velocities begin to decrease with distance from the exit. Fluid behaviors within these zones are of interest for coatings since durability and mussel detachment will be affected by velocity and distance. Resulting parameters such as pressure and shear stress need to be quantified to develop water jet operating criteria for specific coatings. Cavitation may also be an issue for coating durability due to the formation of eddies and the pressure drop that results from the diffusion of a high velocity jet.

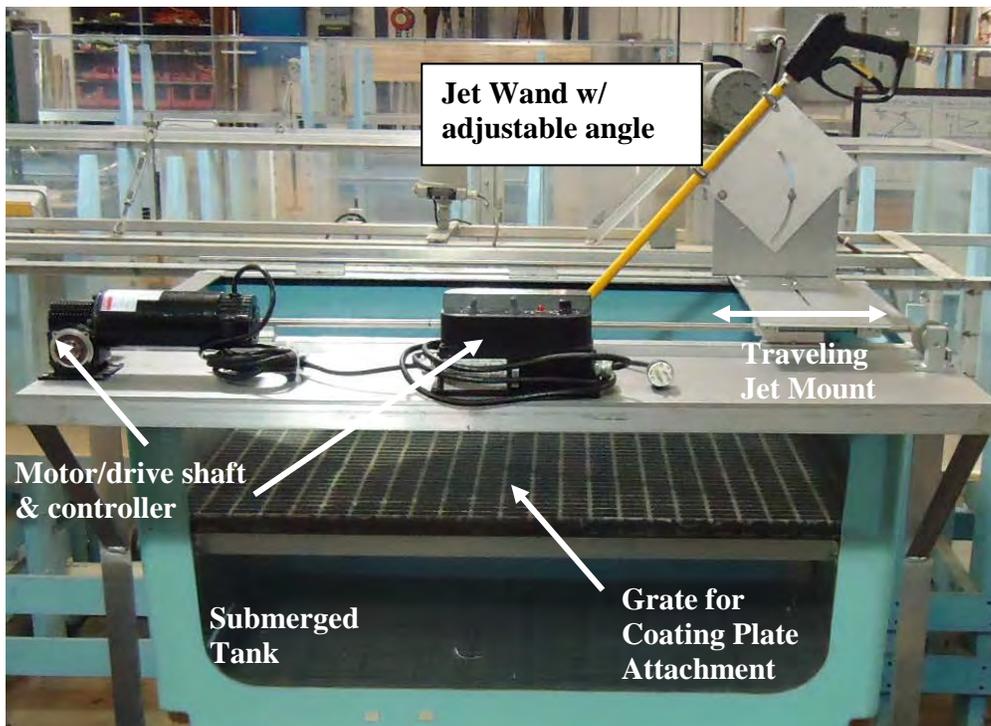
Figure 2 Test apparatus used for coating durability and mussel release testing in both the laboratory and the field.

A 120 gallon tank was used as the main structure of the test apparatus. Figure 2 shows the features of the test tank which include a side window to view testing. A sample coating plate was clamped to the grate beneath a submerged water jetting nozzle attached to a high pressure wand. The wand was mounted above the tank so that its position and angle could be adjusted to any horizontal or vertical location within the tank. The mount was attached to linear motion shafts and a belt and pulley system controlled by a variable speed motor. This system allowed coatings to be tested with either a stationary or traveling water jet at a controlled speed.

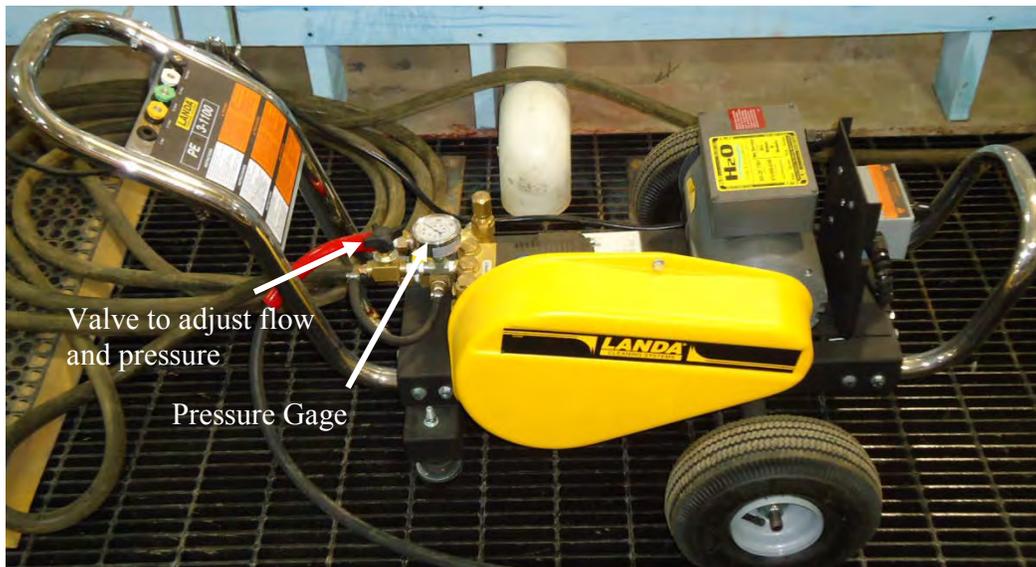
Figure 3 Landa pressure pump used to create water jets for coatings testing.

Water was supplied to the wand and nozzle by a 2 HP Landa pressure pump (Figure 3) at flows and pressures up to 2.8 gpm and 1,000 psi respectively. The pump required a 120V power outlet and a water supply from a garden hose type attachment which was simple to setup and operate at a field test site. Figure 3 also shows a pressure gage used to measure pump pressures during testing. A 10 HP pump became available later in the study and was used for some of the impact pressure testing in the lab. Jet velocities were estimated with the continuity equation using measured flow and orifice area. Flows were measured upstream of the pressure washer using a model F-1000 inline Blue-White propeller meter with an accuracy of  $\pm 2\%$  (Figure 4).

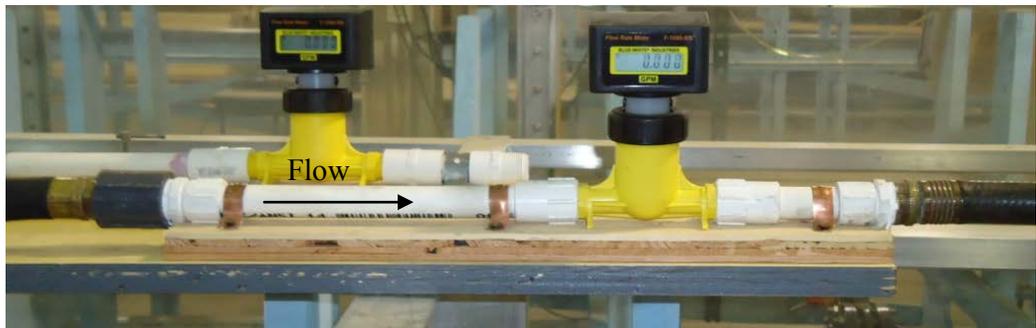
Figure 4 Inline propeller flow meter used to measure flow and estimate nozzle jet velocity.

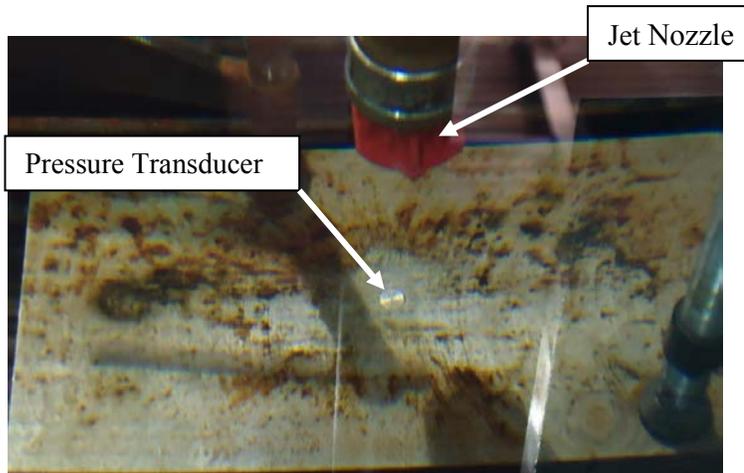
Figure 5 Piezometric pressure transducer set flush with the surface boundary used for impact pressure testing.

To predict impact pressures from submerged cavitating jets, measurements were made on a flat plate using a piezometric dynamic pressure transducer (Figure 5). Table 2 provides information for the transducer and settings used during testing. A sensitivity analysis showed that a high acquisition frequency was needed to capture the rapid pressure fluctuations caused by cavitation. However, a short sample time period (2 seconds) was sufficient. Also, the Root Mean Square (RMS) of the measurements was used to quantify the magnitude pressure of each test due to the large variation of positive and negative pressures.

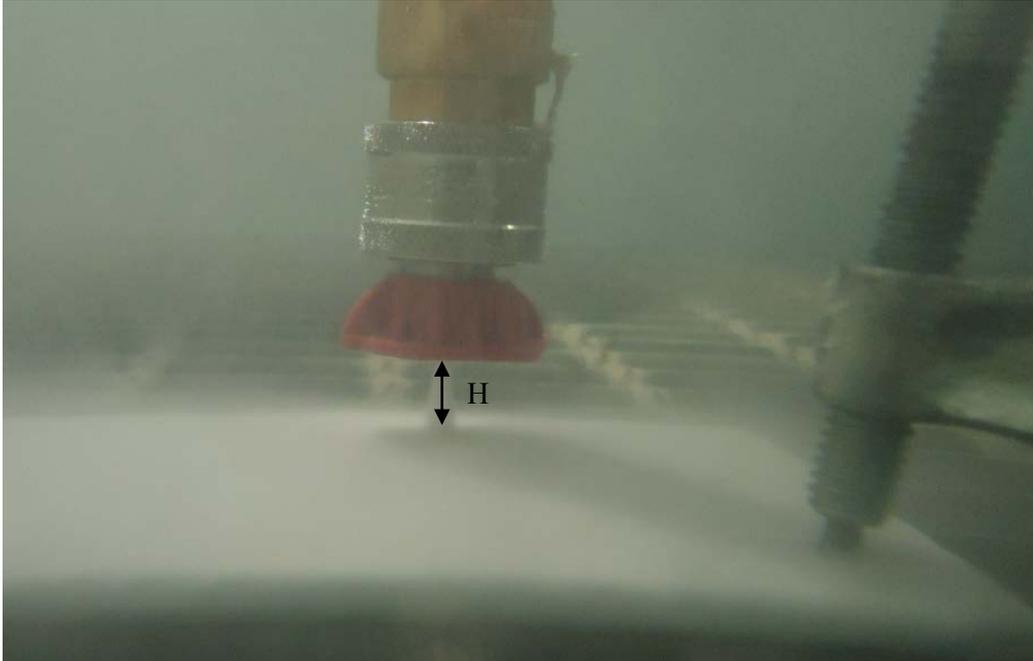
Figure 6 Spot jet used for durability pressure testing.

For durability testing time was held constant while nozzle distance to the surface (H) varied (Figure 6). While time does affect test results, distance and velocity were chosen as variables because they will likely be the design variables in a prototype application where the jet nozzle will be traveling along the surface. Due to the traveling motion of the jet time will become less of a factor for durability.

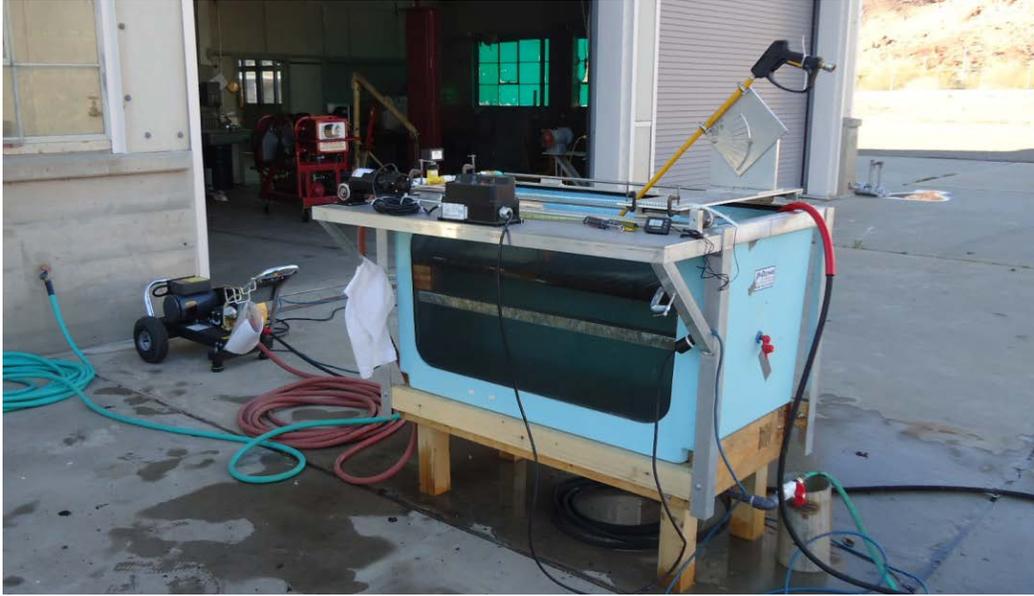
Figure 7 Test apparatus used for initial mussel removal testing at Parker Dam December 2011.

Testing for mussel removal was performed at Parker Dam near Lake Havasu City, AZ where live quagga mussels were attached to the coatings. Plates were coated and submerged near the upstream face of the dam where they remained for several months to allow adequate mussel settlement. Field tests have shown that that highest settlement typically occurs in summer months. Therefore, it is desirable to test coatings in late summer or early fall after at least 2-3 months of immersion (Reclamation, 2012). The same test apparatus used for durability testing in the laboratory was taken to the field for removal testing (Figure 7). TSC researchers made two different trips to Parker Dam for testing. Initial testing was performed the beginning of December 2011 and additional tests the middle of July 2012 after the respective fall and spring mussel breeding seasons. This also allowed testing of mussel removal at two drastically different water temperatures (average of 65.1°F in December and 98.2°F in July).

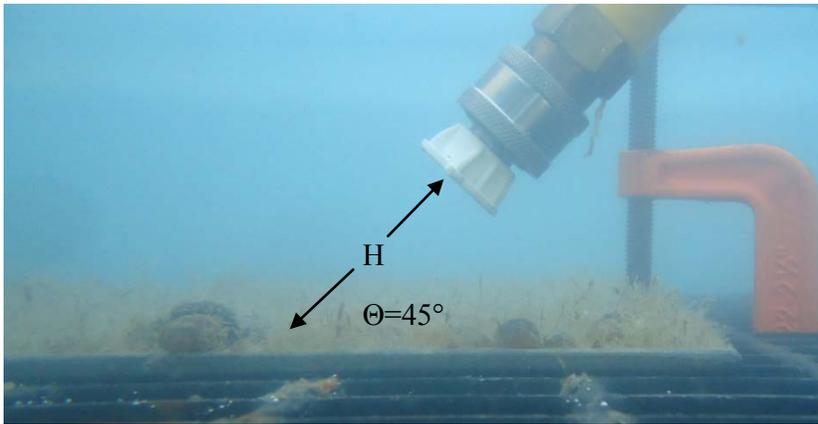
Figure 8 40° fan jet at a 45° angle used for release pressure testing in field tests with live quagga mussels.

The test procedure for mussel removal shown in Table 4 created test conditions more likely to be found in an actual prototype application. A 40° fan jet with an orifice diameter of 0.06 inches was used to cover a wider section of the surface. The jet was set at a 45° angle to the surface to create additional shear stress on the attached mussels (Figure 8). Also, the jet travelled along the boundary at a constant speed of 0.5 inch per second. The same hydraulic parameters (nozzle distance and velocity) used for durability testing were measured at the time when all mussels were removed from the coating. Tests were documented with photographs and videos.

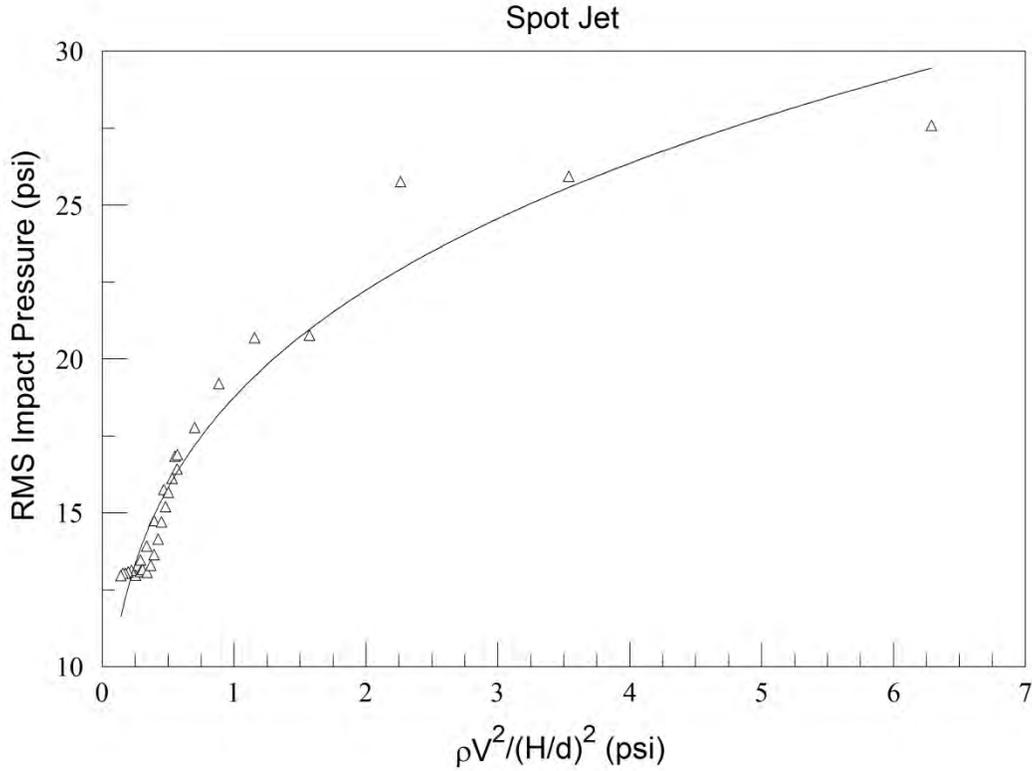
Figure 9 Impact pressure results for a spot jet set perpendicular to the surface for durability testing. For this data set  $R^2 = 0.943$ .

Figure 9 shows data from spot jet testing used to form Equation 3. This equation was used to predict damage pressures for durability testing and is valid for a distance range of 0.75 – 5 inches and a velocity range of 190 – 280 ft/s. Due to the tight concentration of the spot jet, pressures were sensitive to velocity as well as distance. While equation 3 predicts the RMS pressure it should be noted that pressures greater than 300 psi were detected due to the intense cavitation implosions near the boundary.

Tests at distances less than 0.75 inches produced pressure results that were not consistent with the trend shown in Figure 9. For this case damage and release pressure results are reported as 30 psi because the true value is not known but is not greater than 30 psi. The cause is not known but may be due to this distance being a transition of flow establishment zones discussed previously by Albertson *et al* (1948) (Figure 1). The transition from one zone to the other may affect the amount of cavitation implosions on the pressure transducer. However, for all

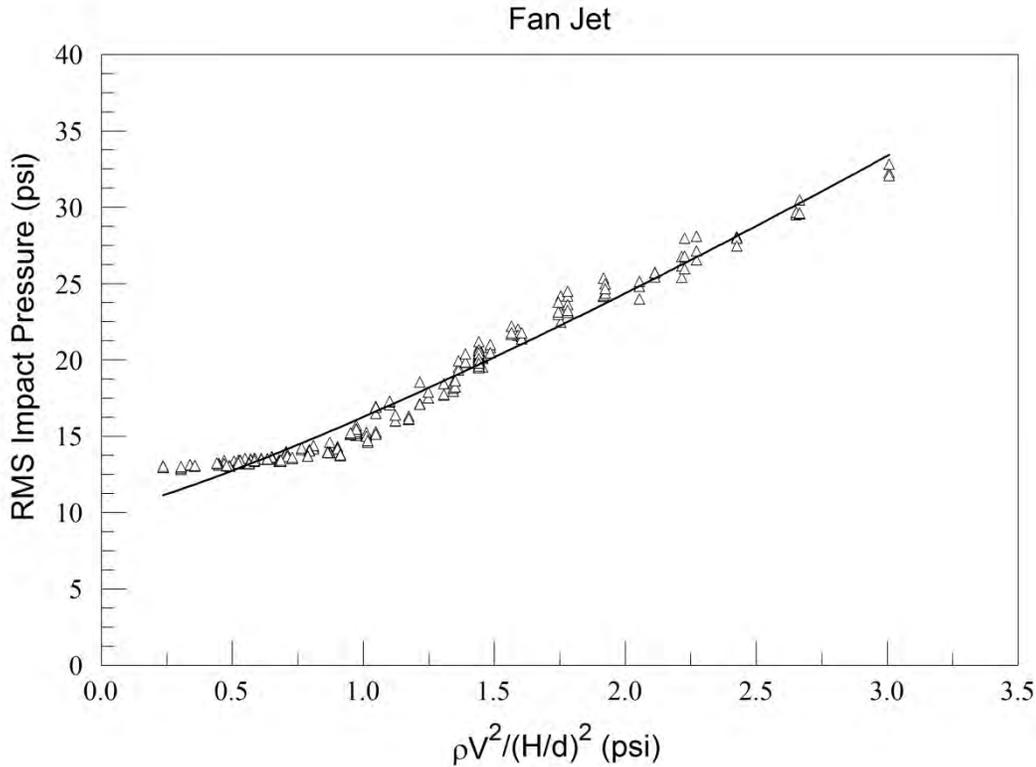
Figure 10 Impact pressure results for a 40 degree fan jet set at 45 degrees to the surface for release pressure testing. For this data set  $R^2 = 0.972$ .

Figure 10 shows data from the fan jet tests used to form Equation 4 which was used to predict detachment impact pressures for mussel release testing. Equation 4 is valid for a distance range of 2.25 – 5.15 inches and velocity range of 215 – 570 ft/s. Similar to the spot jet data, nozzle distances less than 2.25 inches produced trends that varied from Figure 10 results. Additional fan jet data were collected using the 10 HP pump to provide accurate results for mussel removal tests where nozzle distance was less than 2.25 inches (Appendix B). Again, occasional pressures greater than 300 psi were detected.

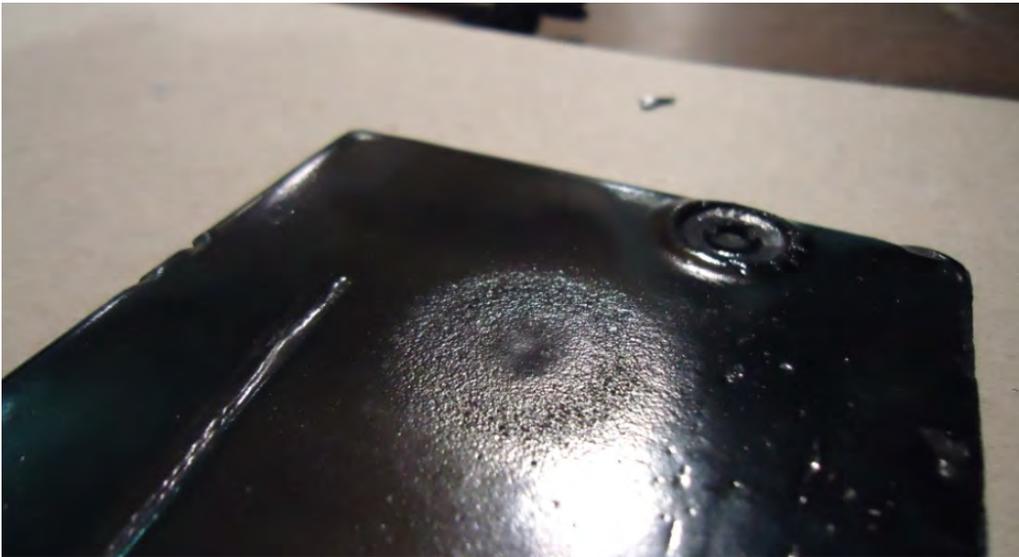
Figure 11 Photo of Coal Tar Enamel sample after durability testing. The center of the jet caused a small hole to form surrounded by cavitation pitting.

Coal Tar Enamel was the only conventional coating that revealed damage during the 3 minute test. A small dent formed near the center of the jet but the coating was not torn or detached from the plate. This may be due to the plastic properties of the coating that allows it to deform without breaking down. Figure 11 shows the same sample after the 60 minute test. The dent was enlarged and significant pitting from cavitation impacts formed on the outside. While not unexpected, the high durability of conventional coatings is encouraging because these coatings are commonly used on much of Reclamation's hydraulic equipment and structures.

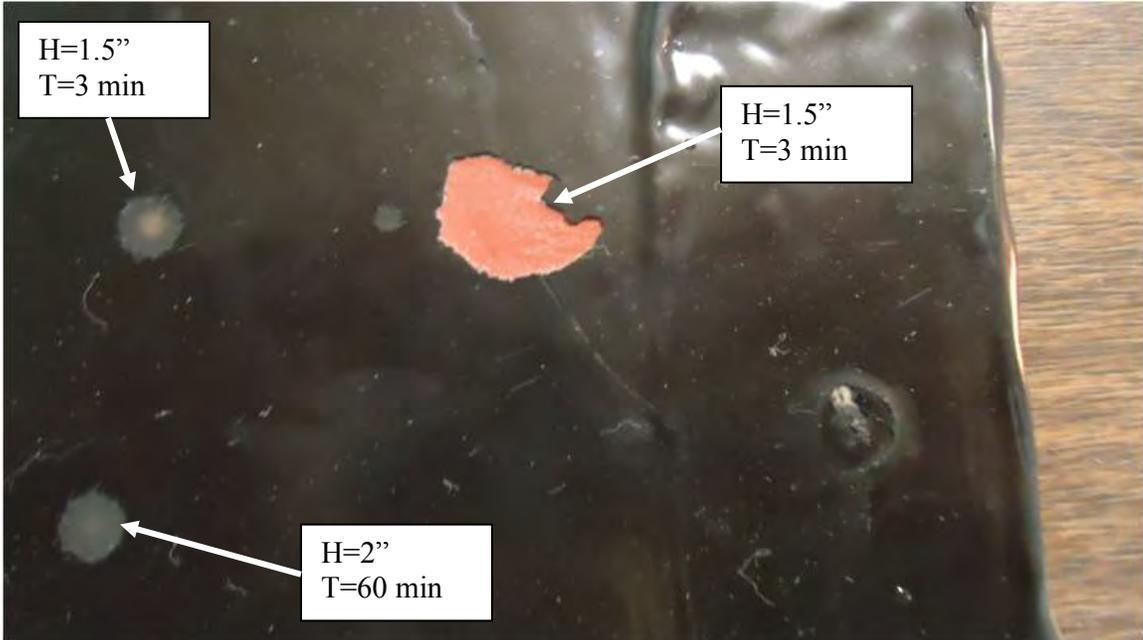
Figure 12 Fuji test sample; visible damage from 3 minute and 60 minute tests.

For the foul release coatings, those that are silicone based seemed to be the least resistant to jetting damage. The pressure of the impinging jet along with intense pressure fluctuations from cavitation caused the coatings to be either worn away forming a small hole in the coating layer or completely torn off of the plate in large chunks. Another observation was that durability was much more dependent on jet distance than jet velocity or even time of exposure. Figure 12 – Figure 14 show examples of damage from silicone based and experimental coatings for 3 and 60 minute tests.

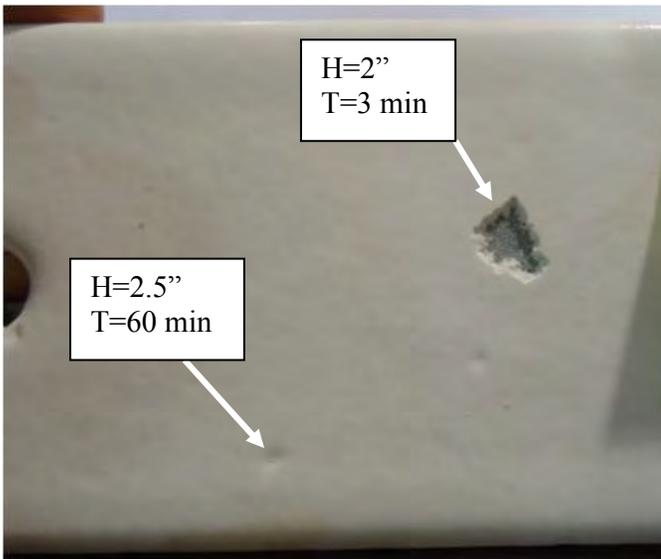
Figure 13 1420 PFA test sample; chunk removed from 3 minute test and slight dent (no damage) from 60 minute test.

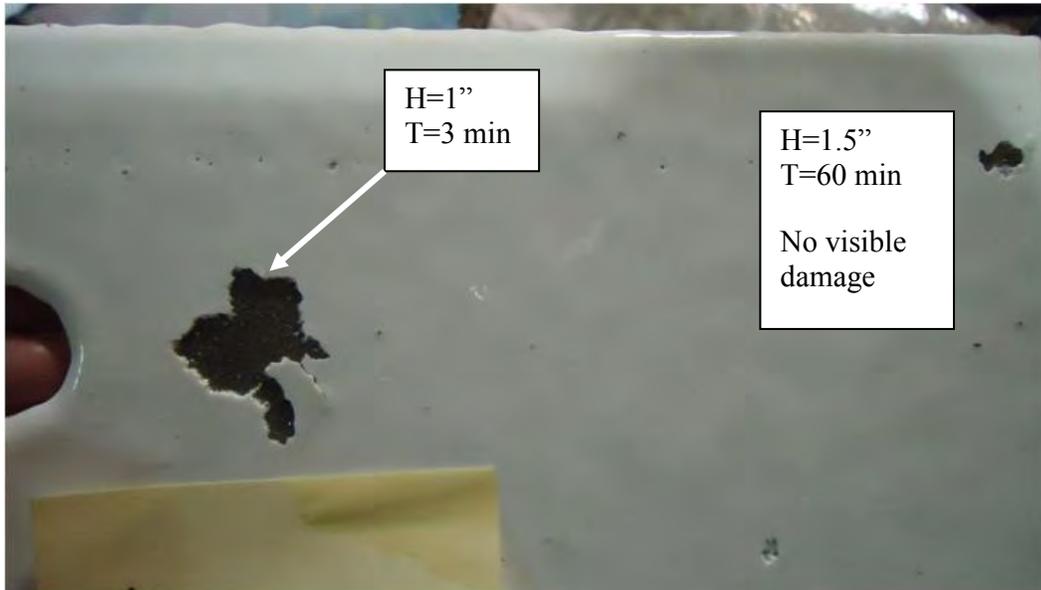
Figure 14 R3 sample; visible damage of coating peeled of test plate after 3 minute test. No damage was observed from 60 minute test with distance of 1.5 inches.

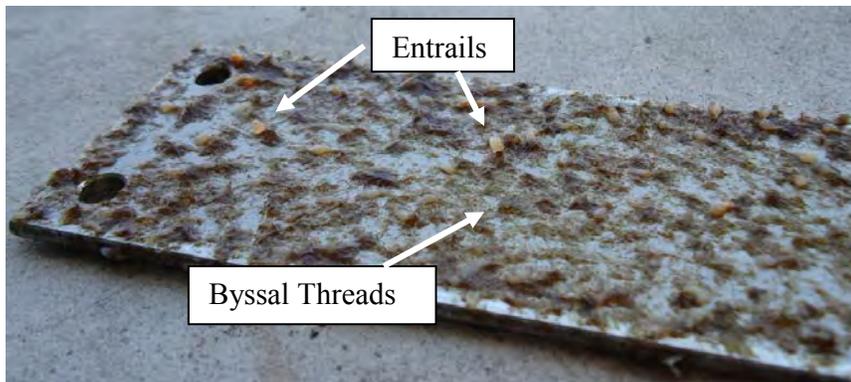
Figure 15 Byssal threads and entrails of mussels that were removed from a stainless steel plate during water jetting.

Visual observation of the test plates before and after cleaning showed that the mussels did not release (let go or slide off) as expected but were rather torn off by the shear forces of the jet. This was indicated by the severed byssal threads and entrails of the mussels that remained attached to the plate (Figure 15). This seemed to be the only mechanism of failure as results and observations were similar for every coated and non-coated surface. The difference in pressure results may be the variation of byssal thread strength or failure mode as seen by Ackerman et al (1995), the significant difference in water temperature during testing or of the test measurement itself.

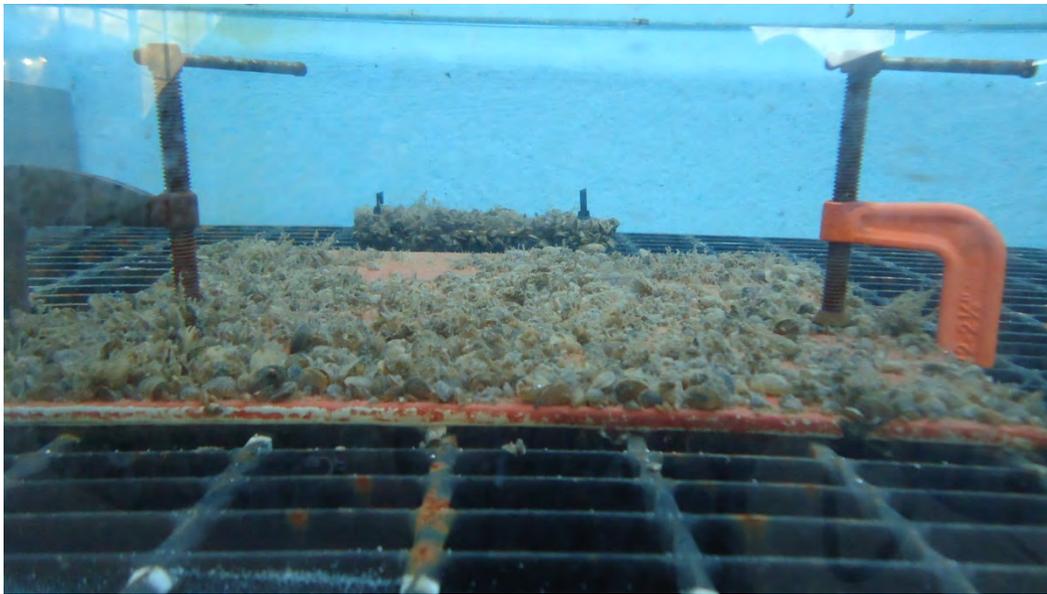
Figure 16 Seaspeed sample with live quagga mussels attached prior to testing for release pressures.

There was a large variation in the amount of mussels that were attached to the sample plates. In general there were more mussels attached to bare metal samples or conventional coatings than the foul release coatings. Often mussels would attach in clumps and would be 2 or 3 mussels thick. While the pressure required to remove mussels did not seem to vary with the amount of attached mussels, plates with less mussels were cleaner after jetting. Figure 16 and Figure 17 show a test sample before and after jet testing with mussels removed but byssal threads remaining after cleaning.

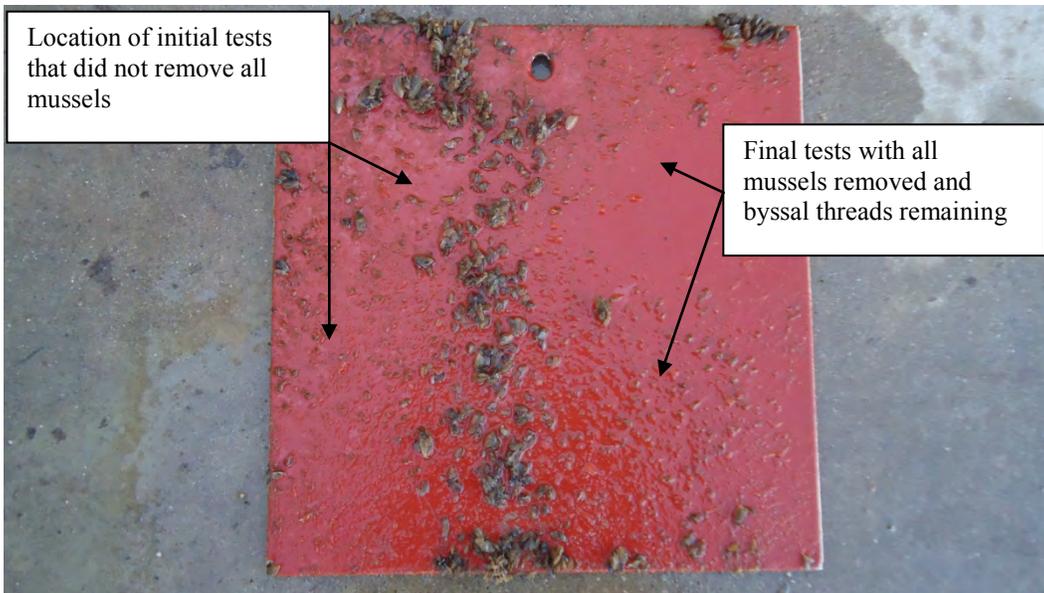
Figure 17 Seaspeed sample after release pressure testing. Mussels are removed where the proper jet distance and velocity were found (right side) but byssal threads remain on the plate.

Byssal threads remained stuck to the surface of every test sample. Plates with significant mussel attachment were left with byssal threads and sometimes entrails that could not be removed with the jet. Even tests with the spot jet close to the surface were unsuccessful at completely removing the byssal thread remains (Figure 18). While it is undesirable to have threads remaining on the coating surface it may not be necessary to have them completely removed as they do not protrude into the flow enough to significantly increase flow friction or head differential.

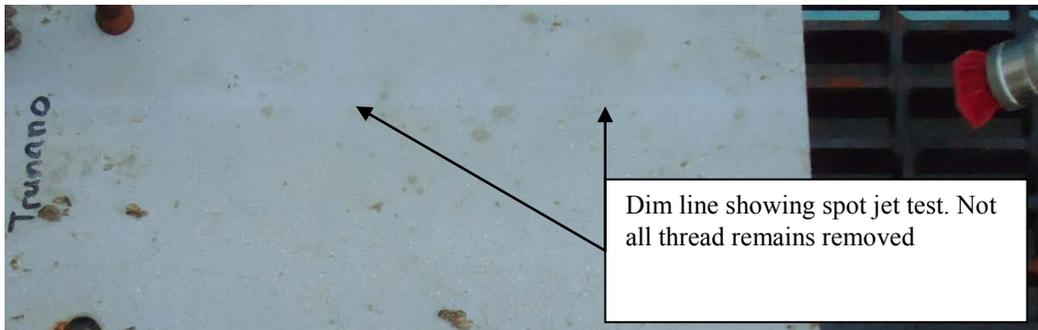
Figure 18 Attempt to remove byssal thread remains using a spot jet ½ inch from surface.

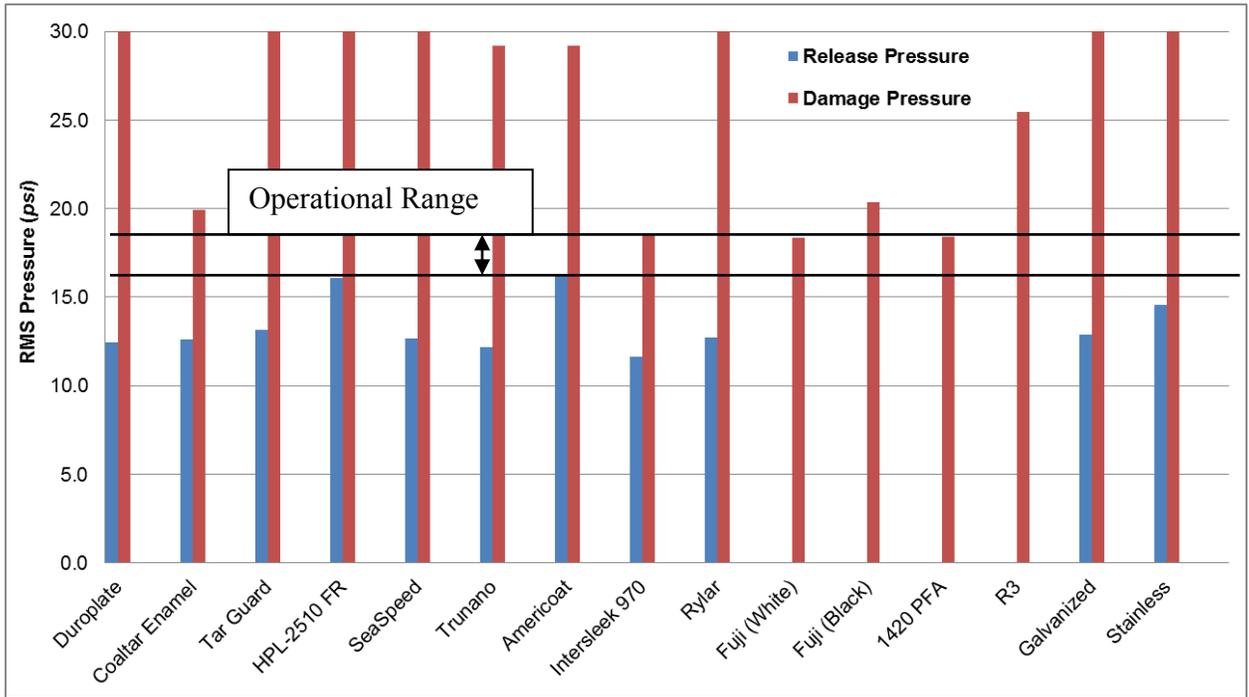
Figure 19 Average RMS impact pressure results for both mussel removal and coating damage.

Figure 19, which summarizes average damage and release test results, shows a gap between the damage and release impact pressures for the coatings tested. This gap allows a range of pressures in which jetting operation would effectively remove mussels without causing damage to the coated surface. The minimum range is between 16.3 and 18.4 psi (mostly foul release coatings) and could be significantly extended depending on the coating system applied to the surface.

With information compiled in Figure 19, impact pressure equations can now be used to determine basic design parameters such as nozzle distance, orifice diameter and jet velocity for a controlled water jetting system. These basic design parameters can be used to design and size other system components such as the pumping and deployment systems. While additional impact pressure testing may be necessary for jetting systems with an extended range of hydraulic parameters, the operational limits defined for the coatings shown in Figure 19 should help provide guidance needed for future development and design.

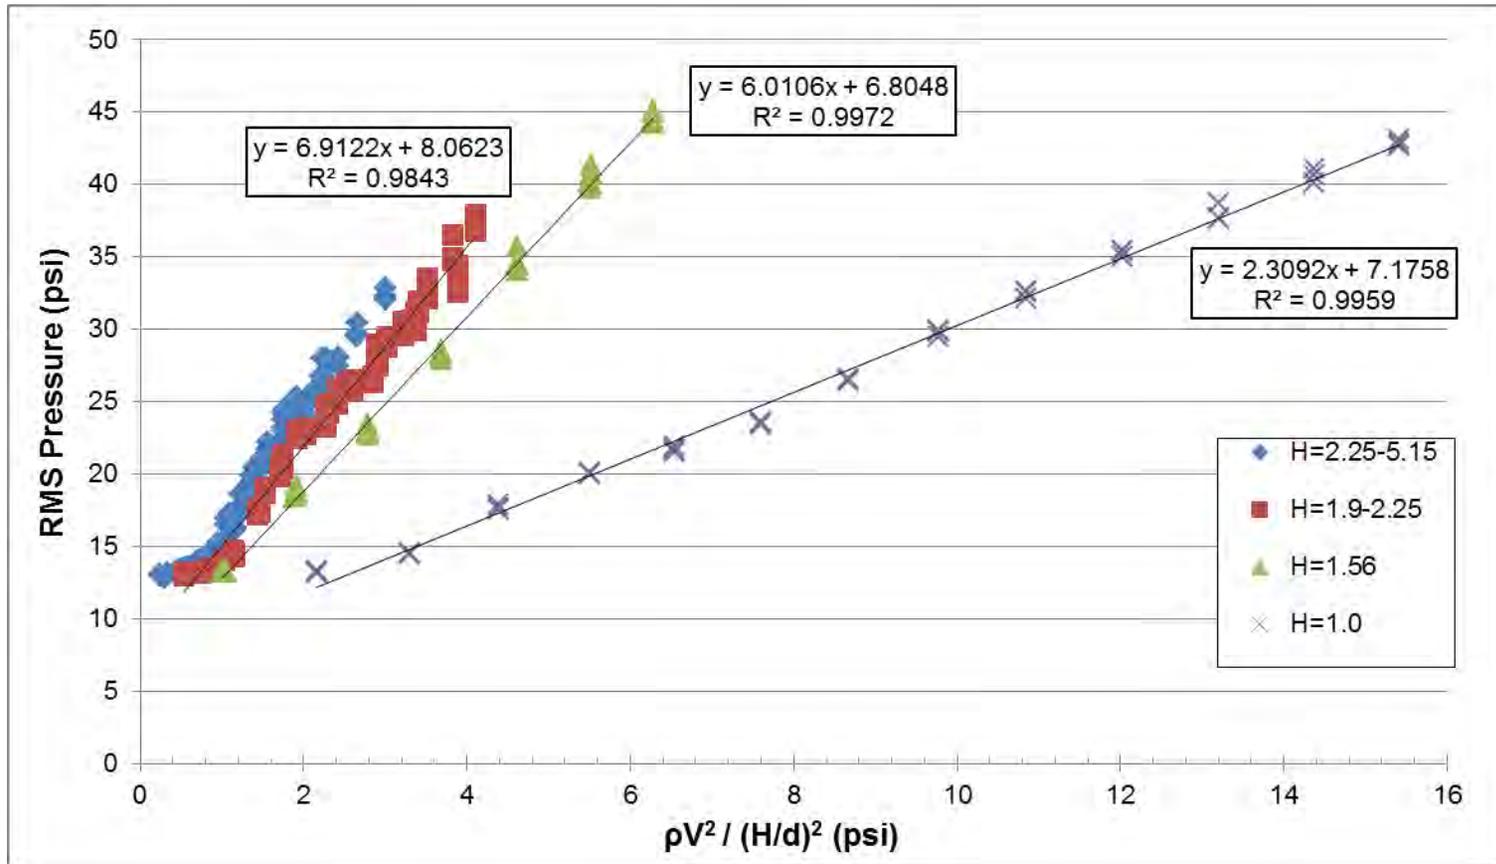
Figure 20 Fan Jet data sets for nozzle distances less than 2.25 inches. Equations on plot were used for pressure predictions for mussel removal data for close nozzle distances. Additional testing may be necessary for gaps in data (ex.  $H < 1.0$  inch or  $1.0 < H < 1.56$  inches).
