**BUREAU OF RECLAMATION  
TECHNICAL SERVICE CENTER  
DENVER, COLORADO**

**TRAVEL REPORT**

**Subject:** Travel to Santa Fe, New Mexico, to provide flow measurement assistance to the Pojoaque Valley Irrigation District

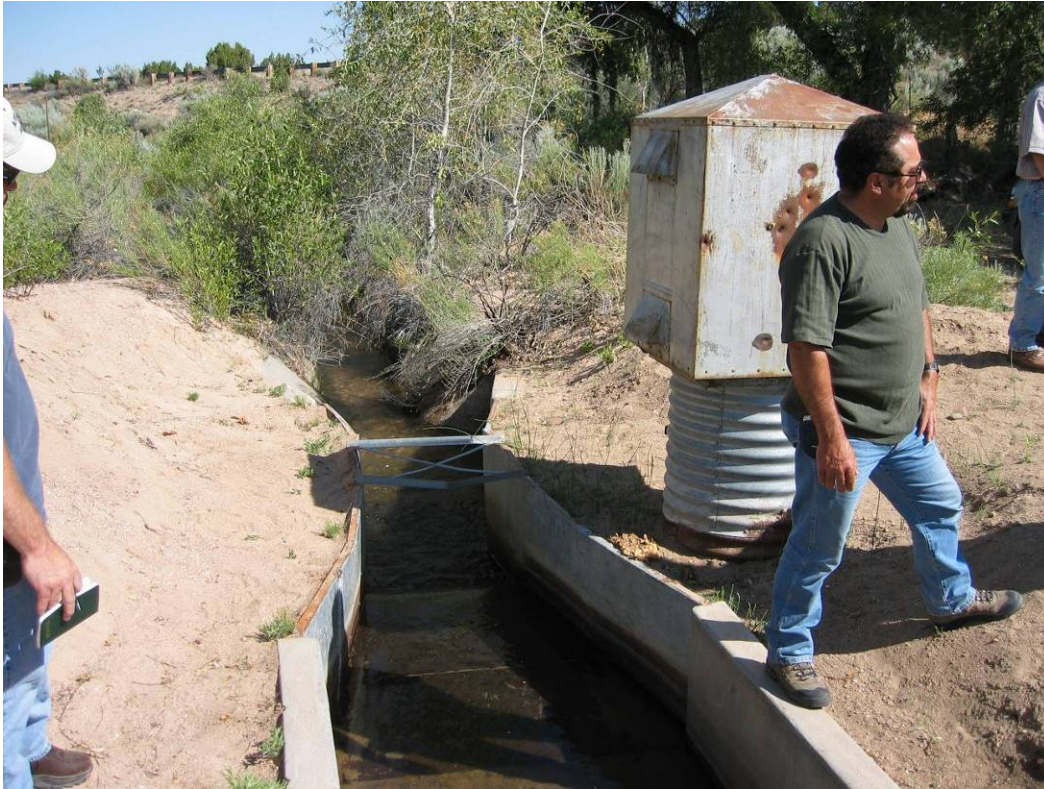
Nine of the measurement locations visited featured Parshall flumes (figure 1) as the primary flow measurement structure, with the remaining nine locations utilizing newer, pre-fabricated Nu-Way Adjust-A-Flume™ ramp flumes. Two of the ramp flume sites (figure 2) also had pre-existing Parshall flumes which had been abandoned as flow measurement devices in favor of the ramp flumes. Each measurement structure was accompanied by a stilling well and equipment shelter to facilitate monitoring water levels and discharges through the structure. Some shelters were equipped with Stevens Recorders (figure 3), while others had Sutron 8210 dataloggers attached to shaft encoders (figure 4).

Figure 1—Parshall flume with stilling well and equipment shelter.

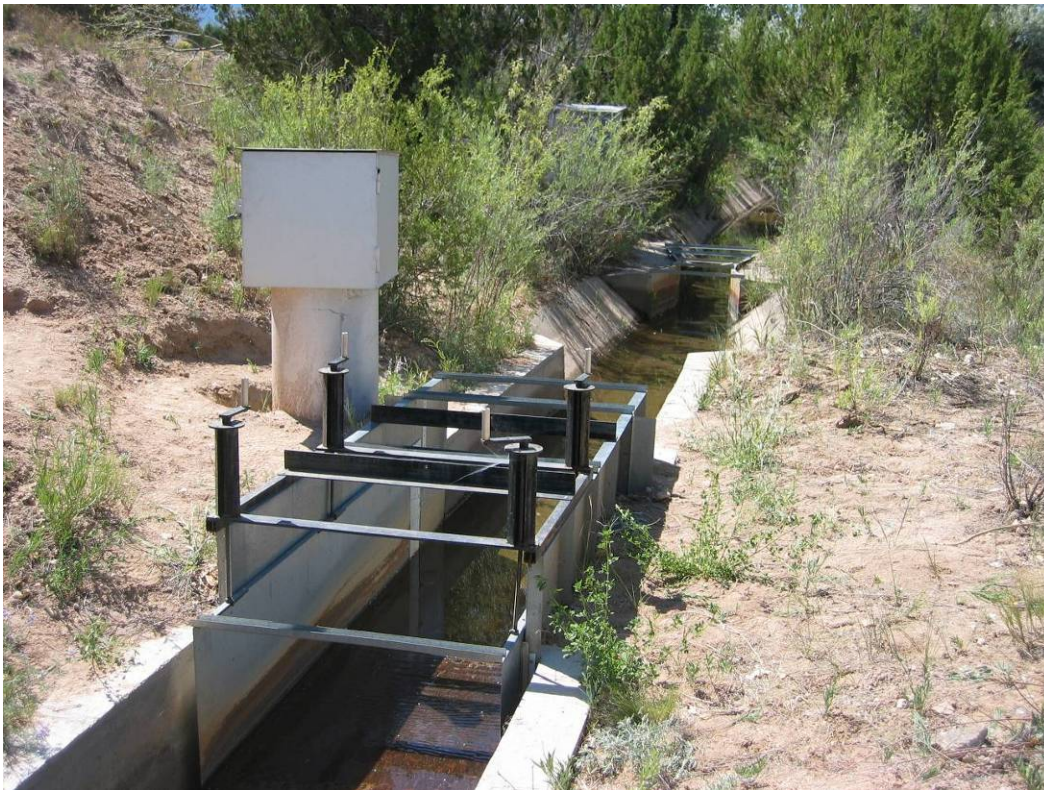
Figure 2—Adjust-A-Flume™ ramp flume with stilling well and equipment shelter. Note the abandoned Parshall flume located upstream.

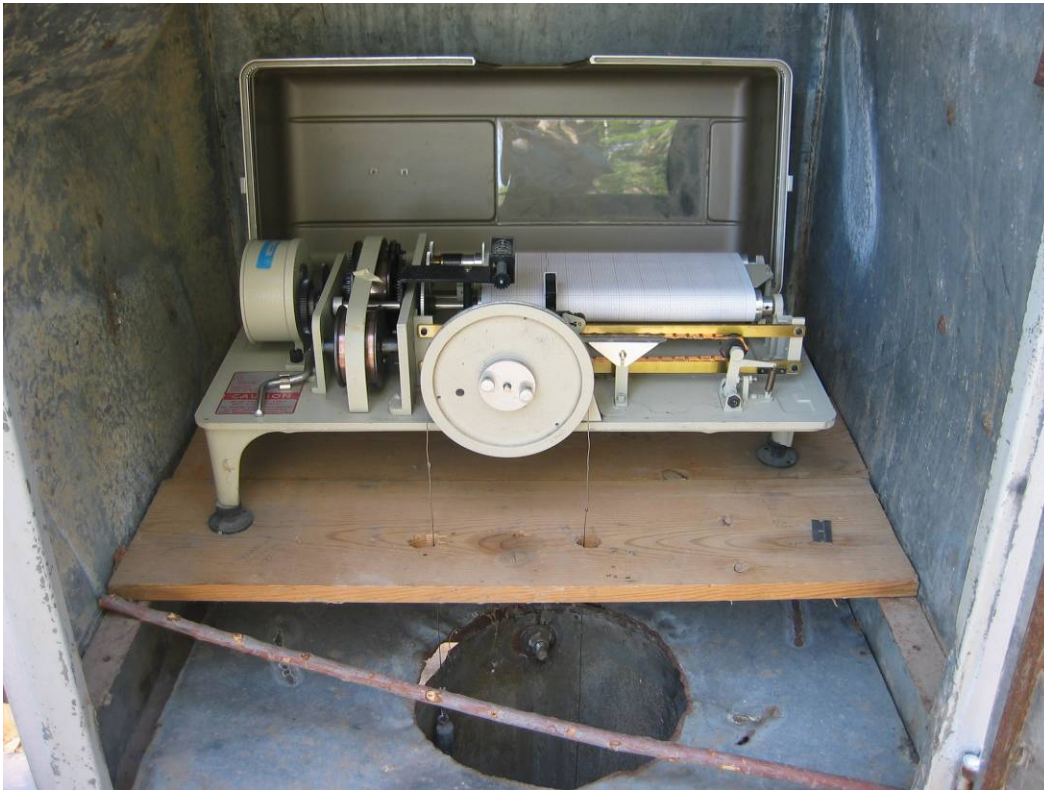
Figure 3—Stevens Recorder in equipment shelter atop a stilling well.

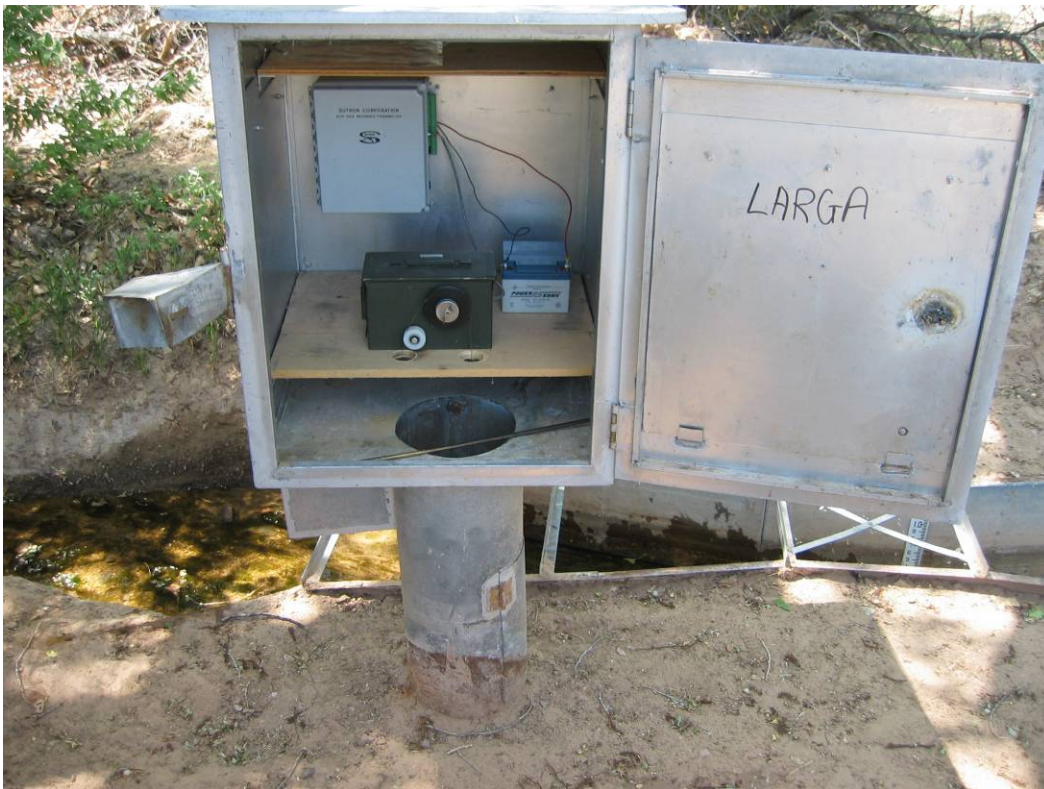
Figure 4—Sutron 8210 datalogger with shaft encoder.

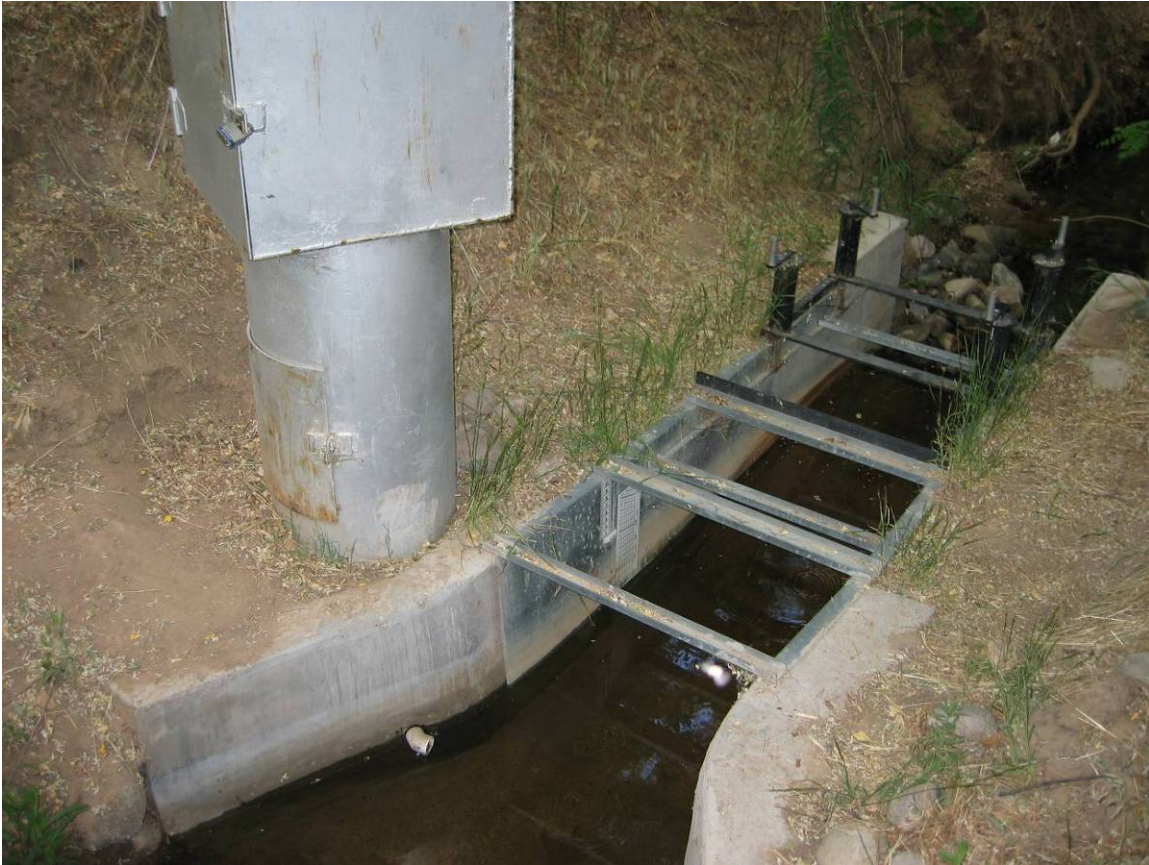
- Stilling well inlet location and configuration—stilling wells were being cleaned out and revitalized, but there were concerns over the proper location and configuration of the inlet port in the flume. In one example (figure 5) the inlet was located in the transition section upstream of the flume and above the level of the flume crest. The proper location and configuration of stilling well ports for both Parshall flumes and ramp flumes was discussed.

Figure 5—improper stilling well inlet location, elevation, and configuration.

- Device Accuracy
    - The stilling well inlets and wall-mounted staff gages need to be located in accordance with the specifications and ratings for the particular structure. For Parshall flumes, this location is along the contracting approach walls at a distance equal to two-thirds of the approach wall length upstream of the beginning of the throat section. For the prefabricated Nu-Way flumes, the location of the factory-applied wall gage indicates the location for the stilling well inlet. The zero mark on a Parshall flume staff gage should be at the same elevation as the level floor of the approach section, while the zero mark on a ramp flume staff gage should be set at the same elevation as the level crest of the ramp in the throat section. Stilling well inlets should be located such that they are submerged for the full range of flows to be measured (i.e., below the crest elevation of a ramp flume).
