POND LININGS FOR DESALTING PLANT EFFLUENTS

**Evaluation of four types of lining materials
for seepage control in brine disposal ponds**

W. R. Morrison
R. A. Dodge
J. Merriman
Engineering and Research Center
Bureau of Reclamation

Final Report

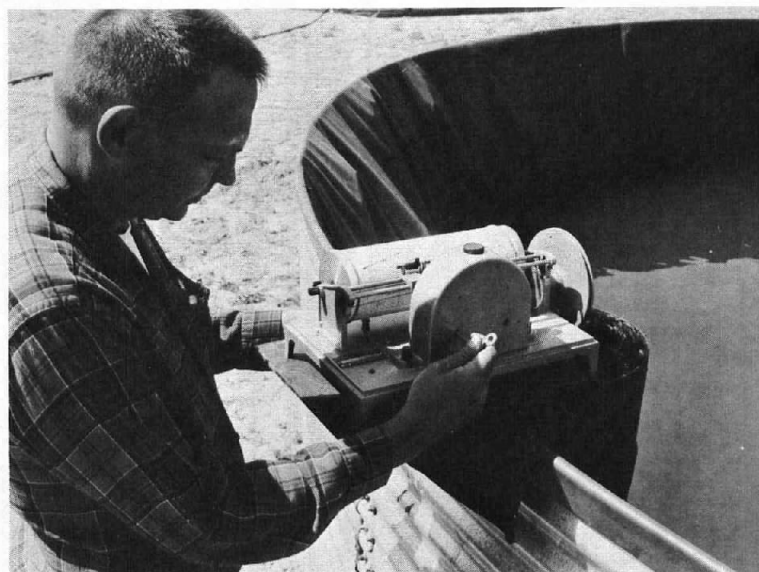
Photograph 1. Dalpra Farm test site for evaluation of lining materials for use in surface facilities for disposal of desalting plant effluents.

General view of test site. Brine effluent pond for demineralizer plant is shown in foreground. Photo P800-D-66522

View of evaporation pond showing stilling well, water level gage and thermocouples. Photo P800-D-66523

Water level gage. Photo P800-D-67362

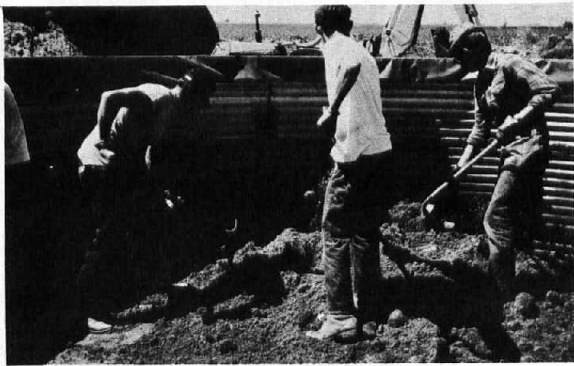
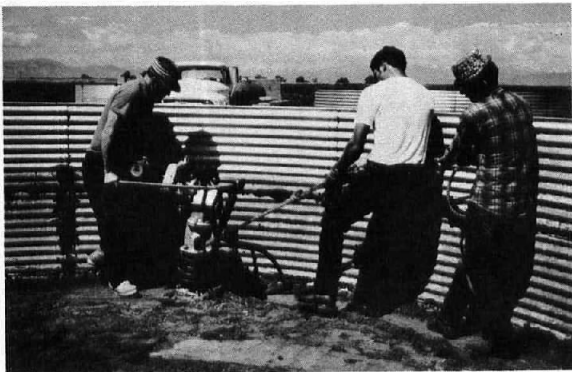
Photograph 2. Reconstruction of OSW test ponds at Dalpra Farm.

(a) Spreading soil in tank. Photo P800-D-68959

(b) Compacting soil in tank with a Wacker compactor. Photo P800-D-68960

placement of two clean sand drainage pads, and three native soil linings. Placement of the soil linings is shown in Photograph 2. The linings were compacted to a 6-inch (15.2-cm) thickness at 90 percent of maximum density to provide a natural in-place condition. The sand-cone method¹⁰ shown in Photograph 3 was used to determine the in-place density of both the soil linings and the sand drainage pads. Results of these tests are summarized in Table 1, and the gradation of the soil is shown in Figure 3.

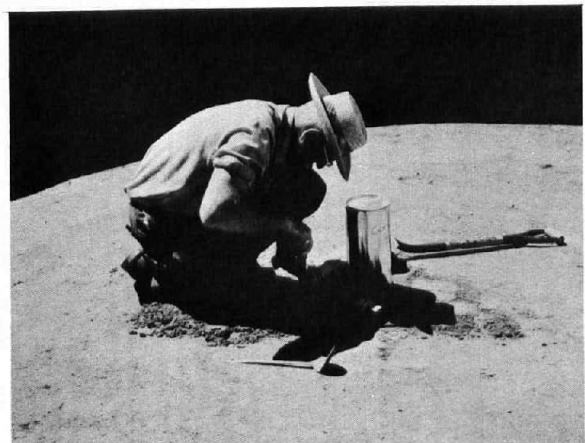
Photograph 3. Field density test using sand-cone method. Top photo P800-D-68961. Bottom photo P800-D-68962

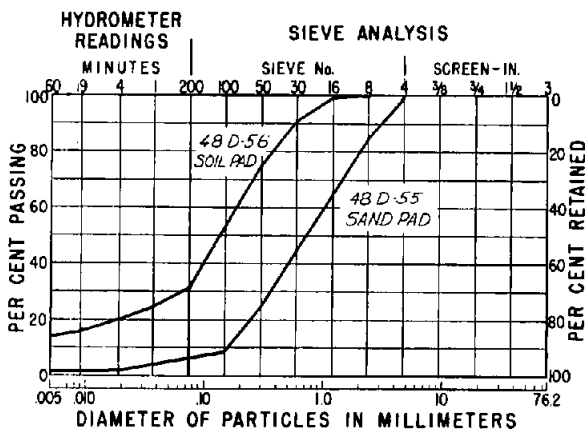
Figure 3. Mechanical analyses soil lining and sand pad.

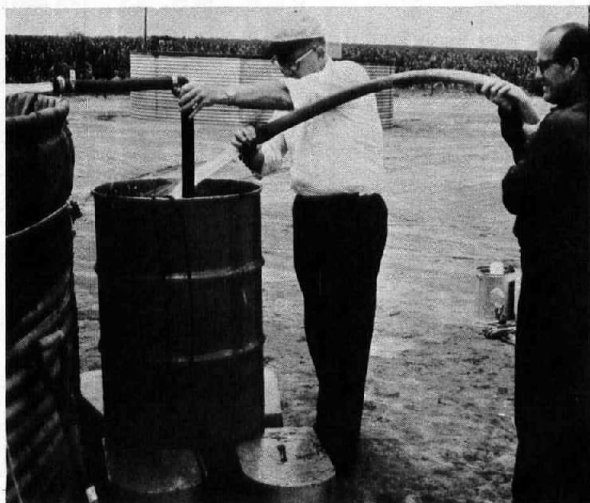
Photograph 5. Installation of soil sealants by ponding treatment method. The dry powder or slurry mixture, depending upon the sealant, was slowly added to the 55-gallon (208-liter) drum where it was continuously mixed and then pumped into the test tank. Photo P800-D-68965

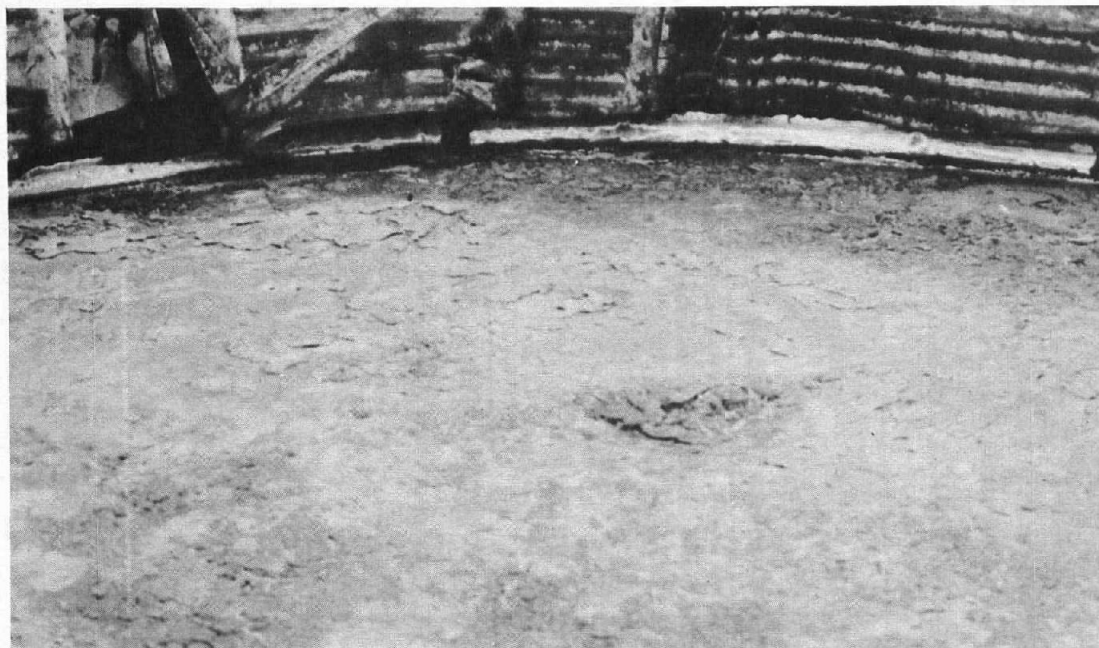
Photograph 10. Appearance of soil surface after ponding treatment with sealant B-6166. The material was applied at a rate of 2,000 pounds per acre (2,200 kg/ha). View shows that a major portion of the sealant did not penetrate the soil. Top photo P800-D-68973. Bottom photo P800-D-68974
