Calendar Year 2020 Report to the Rio Grande Compact Commission

Interior Region 7: Upper Colorado Basin

Prepared by Bureau of Reclamation, Albuquerque Area Office, Albuquerque, New Mexico

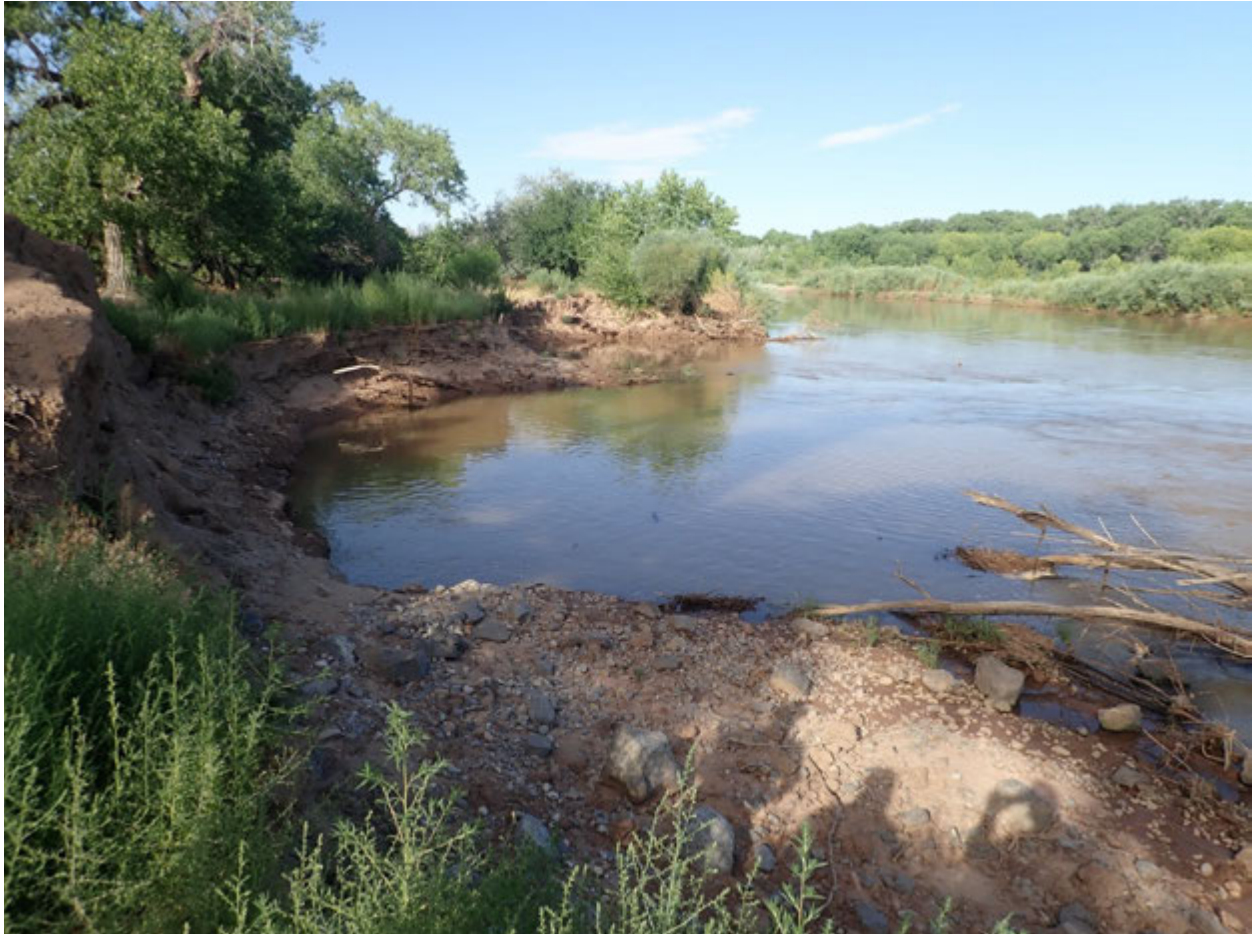
Photo 1: Looking downstream at Santa Ana River Mile 205.8 east bankline bendway weirs and bankline repairs (Reclamation photo)

This site is within the Pueblo of Santa Ana, on the east bank of the Rio Grande across from the Tamaya Resort pavilion. Nine bendway weirs and a low elevation floodplain were designed by a contractor hired by the Pueblo and were constructed by Reclamation in 2014. Through a P.L. 93-638 contract, the Pueblo of Santa Ana planted vegetation at this site in early 2015. During the 2015 spring runoff, erosion at the site washed away the newly planted vegetation and caused bankline scalloping between some of the weirs shortly after completion. An interim adaptive maintenance project was completed in January 2016 to provide additional protection of the levee system while a longer-term solution could be investigated. The site experienced additional bank erosion during the 2016 and 2017 runoff, but the existing weir field and temporary controls placed in 2016 minimized the extent of the lateral bank migration.

An investigation to evaluate the specific geomorphic and hydraulic conditions that led to the unexpected bank erosion during the 2015 runoff was completed in October 2018. In the past year, the scalloped sections of this weir field experienced significant infill and formed a shelf that has started to support new vegetation. Reclamation is currently planning adaptive maintenance work at the site as part of a permanent repair project. These repairs will include the placement of

longitudinal stone toe protection between the existing bendway weirs for toe strength, the construction of a new side channel on the opposing bankline to relieve hydraulic pressure on the bendway, and the installation of vegetated, mechanically stabilized earth along the hillslope above the stone toe to promote further bank stability.

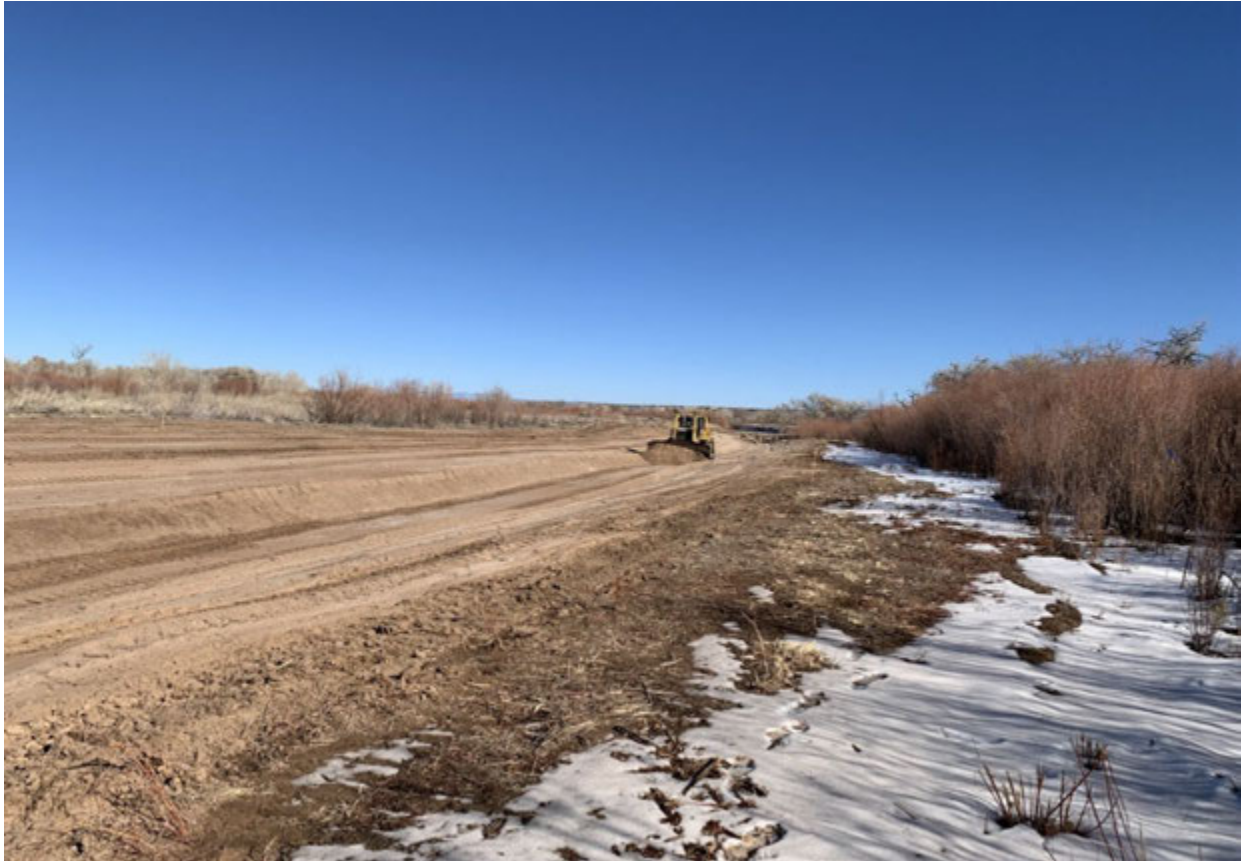
Photo 2: Construction of a new side channel on the western floodplain of the Sandia Priority Site (Reclamation photo)

An investigation to evaluate the specific geomorphic and hydraulic conditions that led to the 2016 spring runoff bank erosion was completed in August 2018. As a result of this investigation, Reclamation has planned adaptive maintenance work at the site as part of a longer-term repair project. The adaptive maintenance work consists of Phase I which includes rehabilitating the side channels constructed on the western floodplain as part of the original 2008 project and a new side channel to facilitate water and sediment transport from an arroyo on the western floodplain. Phase II includes two new side channels just downstream of the project in an area that is also eroding. Construction on Phase I began in early 2020, but progress has been impeded due to the COVID-19 pandemic. The expected completion of Phase I is in March 2021. Construction on Phase II is expected to start in fall 2021 or later.

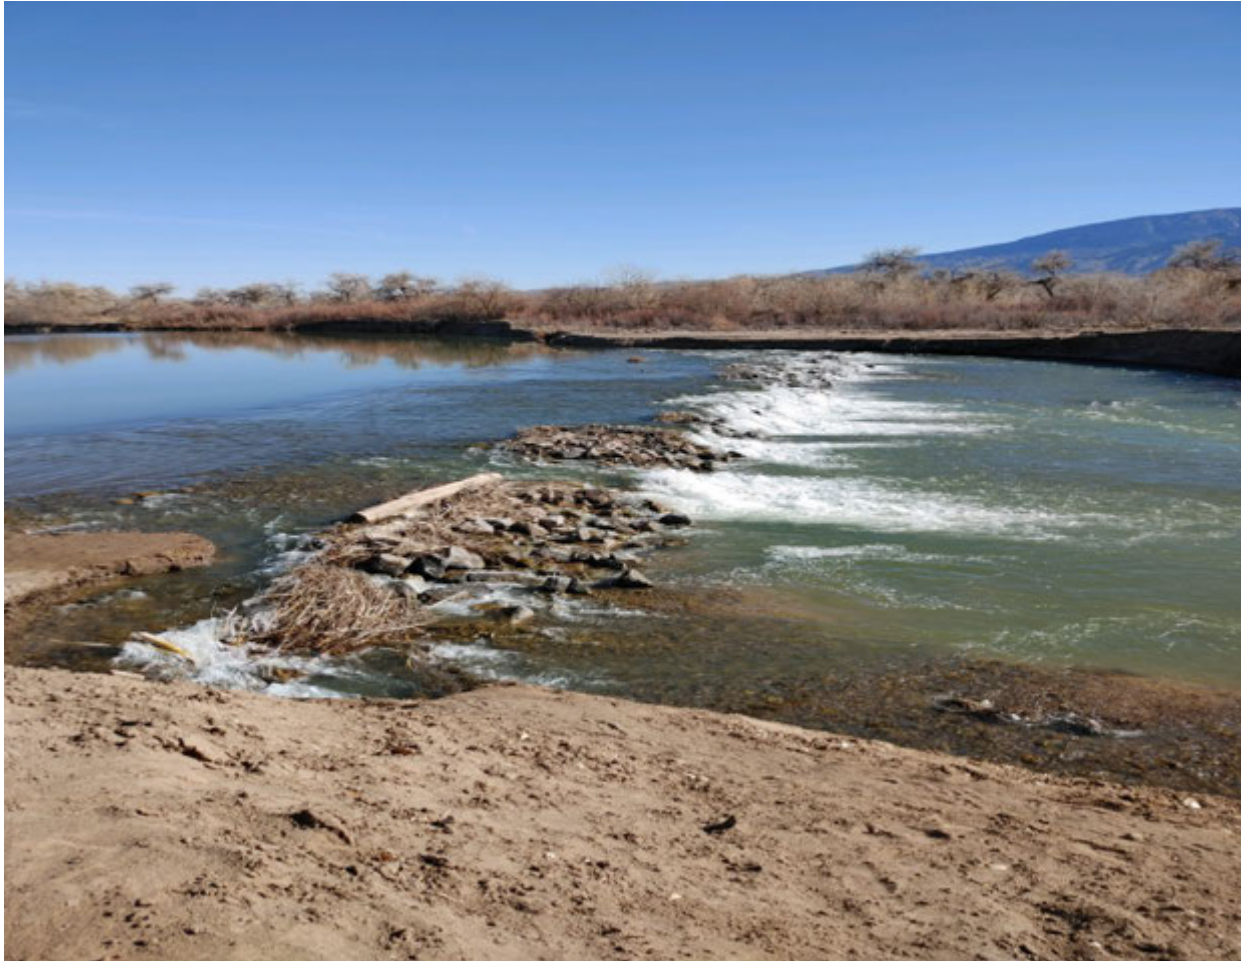
Photo 3: Looking east at the Corrales Siphon and the 2020 riprap protection placed downstream of the siphon (Reclamation photo)

Reclamation and MRGCD collaborated on a short-term project that placed riprap in the scour hole downstream of the exposed siphon. Approximately 1,800 cubic yards of riprap were placed upstream and downstream of the siphon along the west bankline.

The scour hole and exposed part of the siphon have moved away from the west bank toward the center and east bank of the river channel. In fall 2020, MRGCD placed more riprap downstream of the siphon extending the entire width of the river and keying a short distance into the bankline.

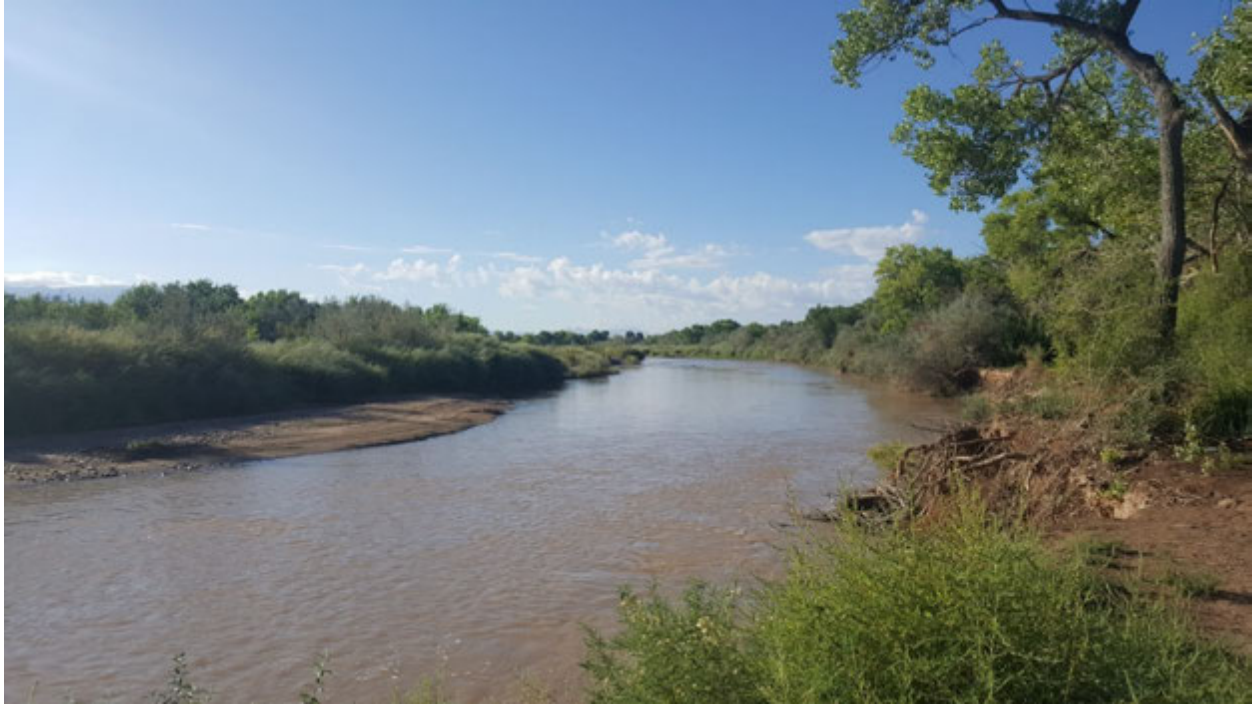
Photo 4: New erosion in the RM 199 project area looking downstream below Corrales Siphon (Reclamation photo)

In spring 2017, Reclamation identified a new erosion site near RM 199 in the Corrales area. This site is on the west side of the river, and the active bankline is approximately 120 feet from the west levee toe. The Angostura to Montañño reach plan provides a detailed geomorphic and hydraulic study of the reach and sub-reaches and has helped evaluate erosion at RM 199 in the context of the overall reach needs.

In 2019, Reclamation began alternative formulation and analysis to address bank erosion near the Corrales levee system. Project goals include dissipating energy in the surrounding two-mile reach between the Corrales Siphon and RM 198 and improving ecological function at this site. Alternative selection and design will take place in 2021, with construction targeted for fall 2022.

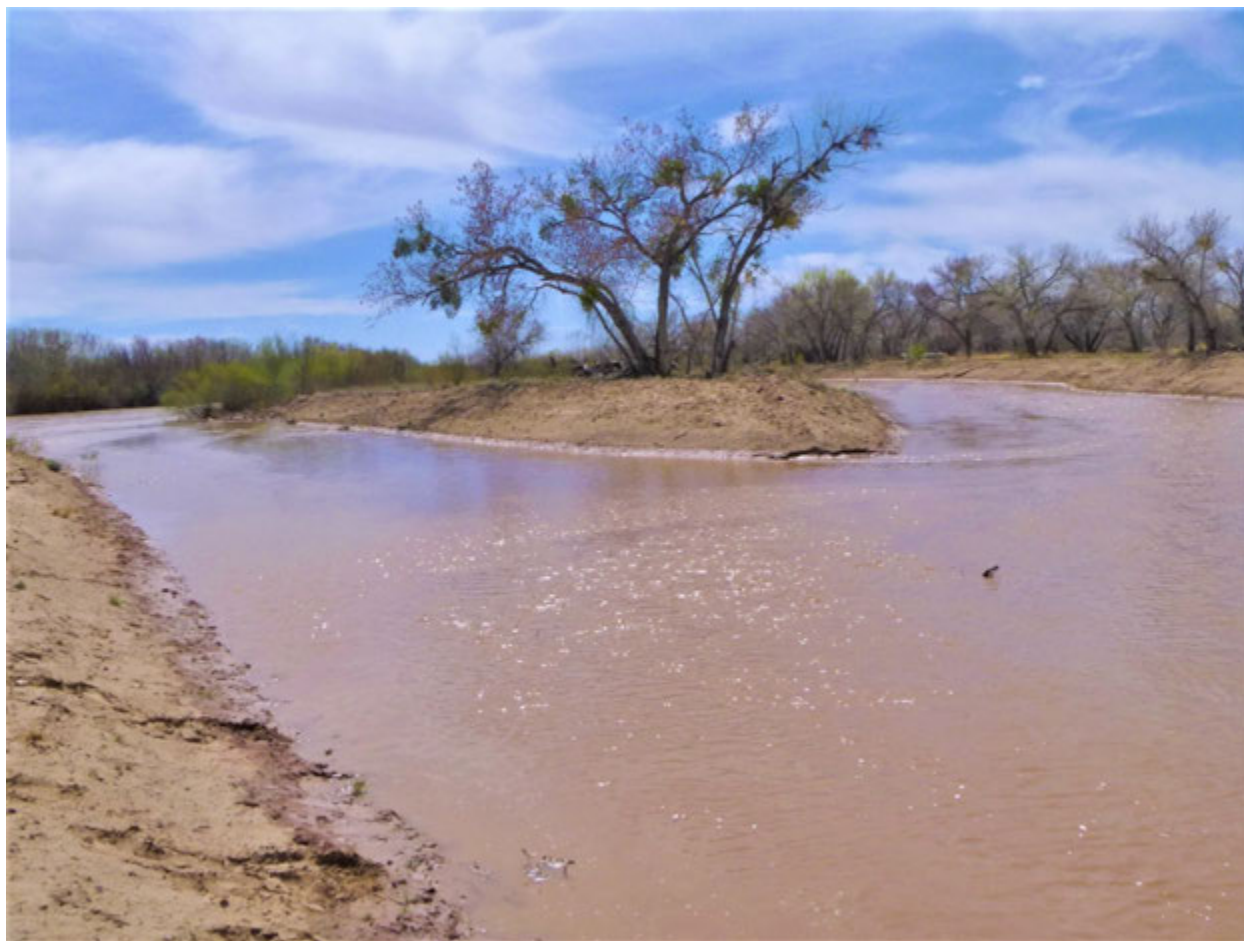
Photo 5: Escondida side channel project during 2019 spring runoff (Reclamation photo)

In June 2016, a wildfire burned approximately 524 acres in the bosque near Escondida, New Mexico. Two aquatic habitat restoration sites were designed, and construction was completed in July 2018. The two sites include floodplain lowering at the Arroyo de la Parida delta and a side channel network just upstream of Nogal Arroyo. This work helps Reclamation and its partners meet MRG BO commitments.

In 2019, six monitoring visits were made to the sites. The monitoring included surveying sedimentation changes, collecting inundation extents, flow velocity and depth, water temperature, isolated pool monitoring, and noxious weed mapping. This monitoring data will inform future adaptive management decisions. No site visits were made in 2020 due to the COVID-19 pandemic and the low runoff year. Further monitoring is planned in 2021.

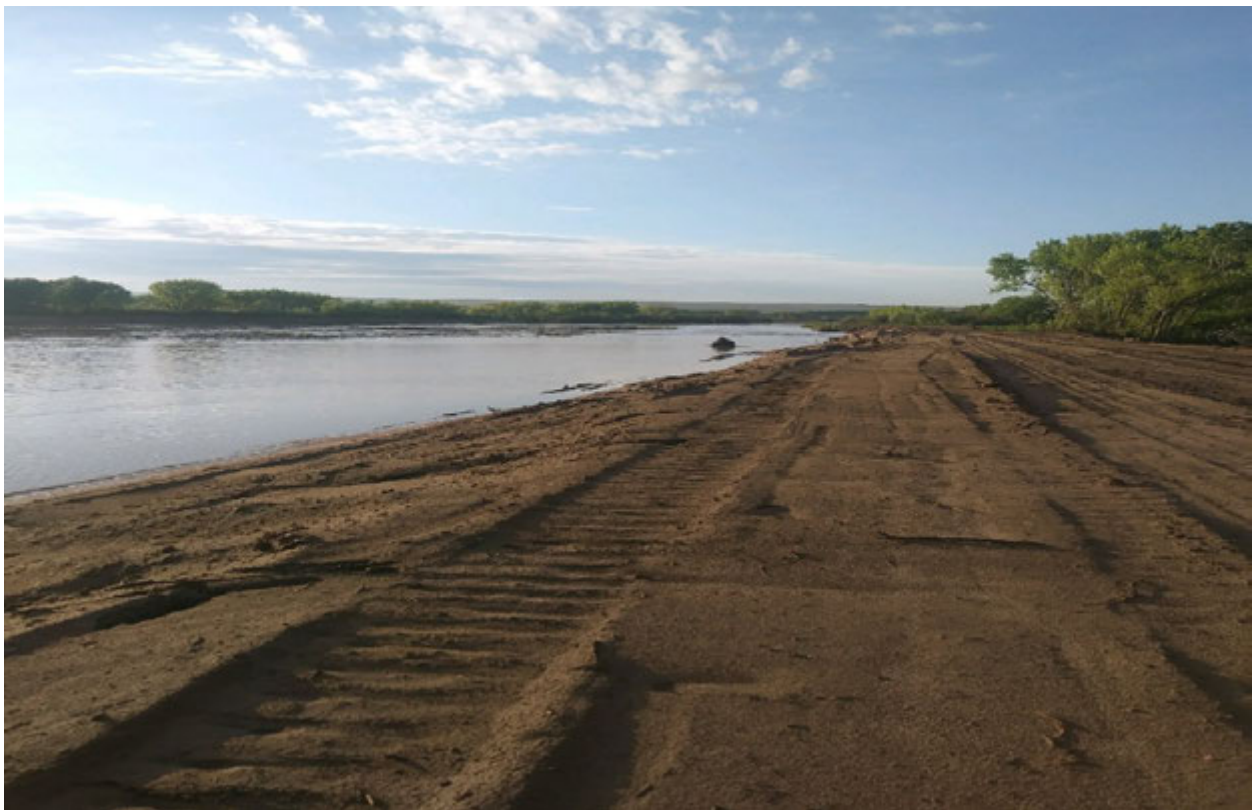
Photo 6: View of realigned Rio Grande channel on the BDANWR from the west bank following summer monsoonal flows (Reclamation photo)

Designs were completed on the BDA Pilot Realignment Project in 2017. Mowing began in January 2018. During the extended 2019 spring runoff, a plug again formed in the main river channel at the same location as in 2017. This plug completely blocked flow from the main channel, and water was forced into the area mowed for the Pilot Realignment Project. The necessary Clean Water Act compliance was obtained from USACE that summer and Reclamation's Socorro Field Division began excavating the pilot realignment channel at the beginning of September 2019, following the end of migratory bird season. By October, a pilot channel was excavated along the planned realignment, restoring river conveyance.

The excavation phase of the project was completed in September 2020 despite some construction delay caused by the COVID-19 pandemic. Spoils movement from the excavation for spreading over the old river channel continues and is expected to be completed by March 2021. A Reclamation-led hydraulic data collection effort through the realignment corridor was completed in March 2020 and additional hydraulic data collection efforts will be undertaken again in March 2021. Site revegetation work has begun with the planting of the northern willow grid within the old river channel in January 2021. Ongoing project monitoring efforts will continue with invasive species vegetation control being carried out by Refuge field crews over the next several years, regular channel monitoring being undertaken by Reclamation staff in coordination with ISC staff, and minnow studies being carried out with funding by both the State and Federal stakeholders.

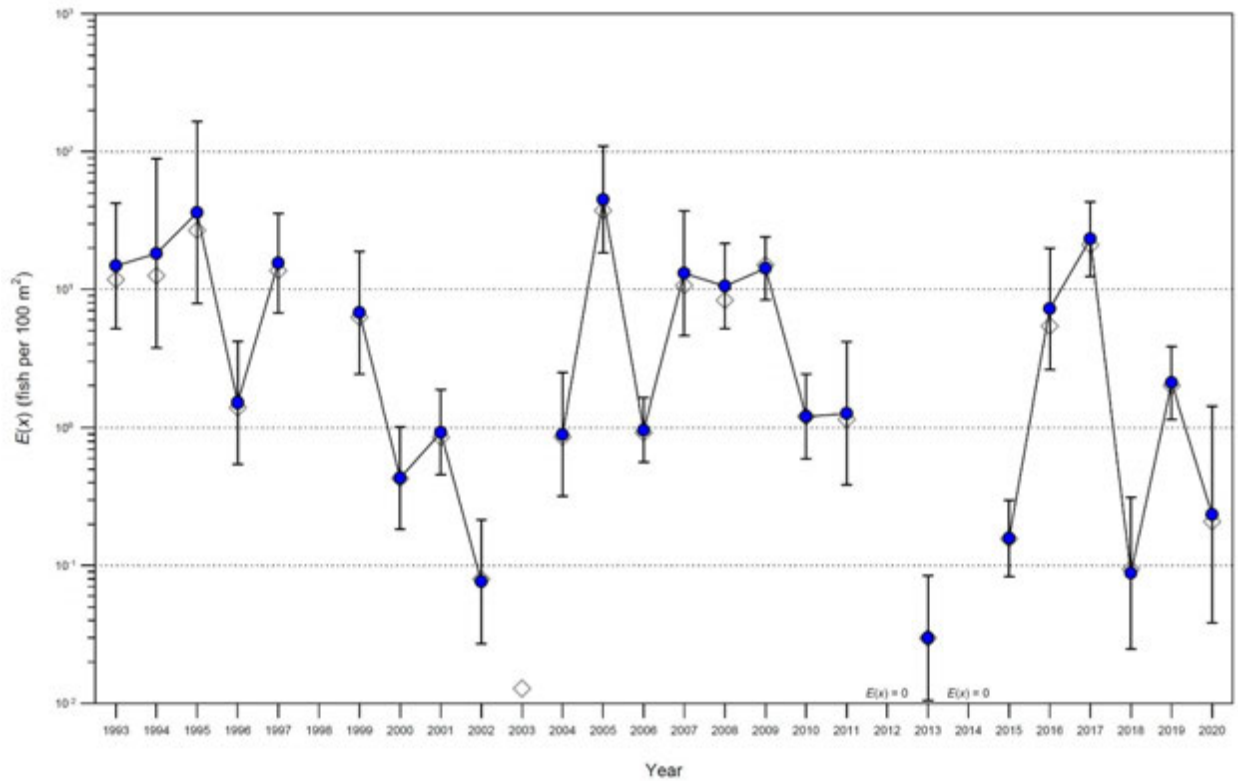
Figure 5: RGSM estimated densities ($E(x)$) using standard site October data for 1993-2020. Solid circles indicate estimated densities, bars represent 95% confidence intervals, and hollow diamonds represent simple methods-of-moments estimates (Dudley et al. 2020a, and written comm.).

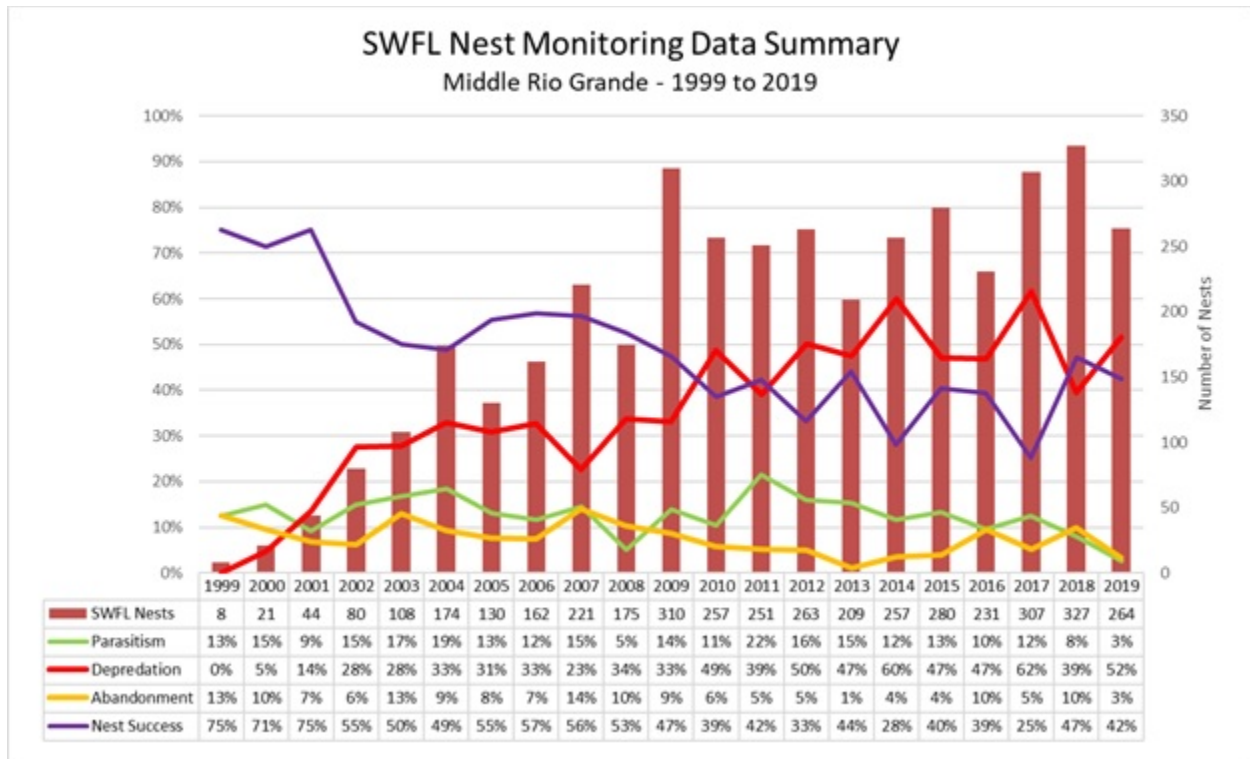
Figure 6: Summary of Flycatcher nesting in the Middle Rio Grande from 1999 to 2019

Nest success in the Middle Rio Grande rebounded to 47 and 42 percent in 2018 and 2019, respectively, following a study period low of 25 percent in 2017 (Figure 5).

The decline in nest success from 2009 to 2017 may be related to the decline in habitat suitability and quality in heavily populated areas. Depredation, the biggest source of nest failure, averaged 27 percent from 1999 to 2011. Since 2012, the depredation rate has nearly doubled, averaging 51 percent. The depredation rate in 2017 was 62 percent, the highest recorded since 1999, but dropped back to 39 percent in 2018.

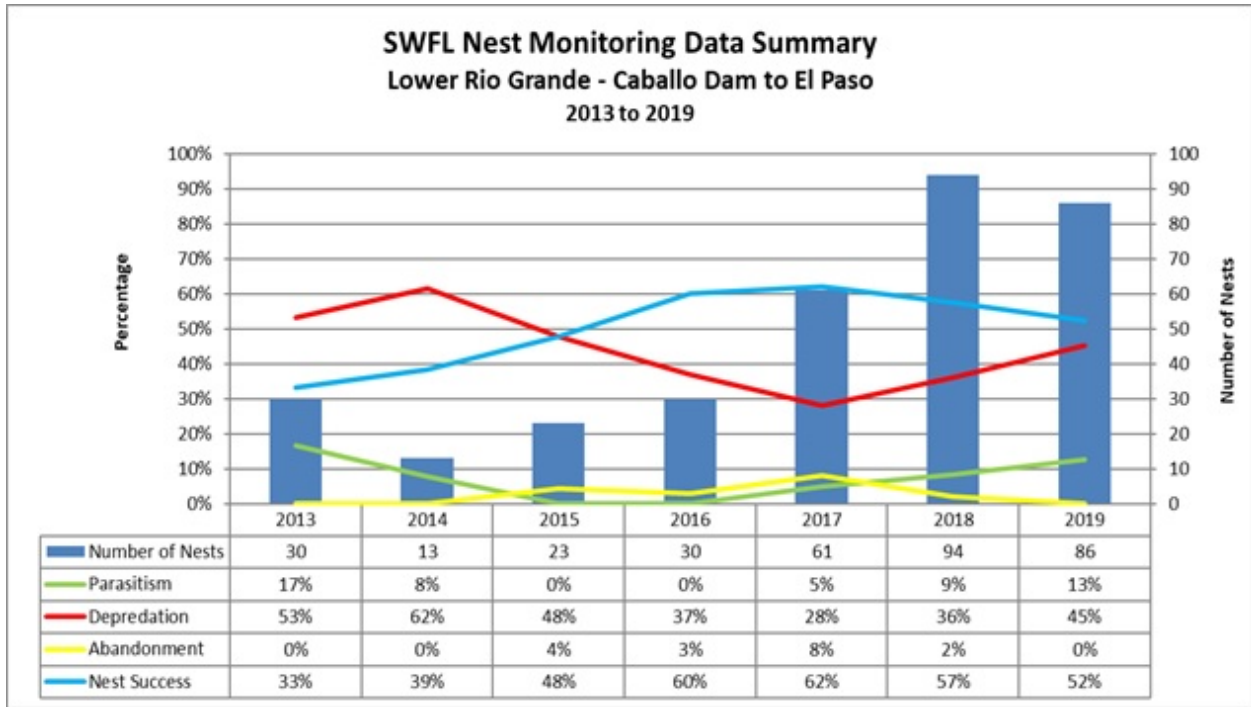
Figure 7: Flycatcher nest variables, Lower Rio Grande, Caballo Dam to El Paso, 2013 to 2019

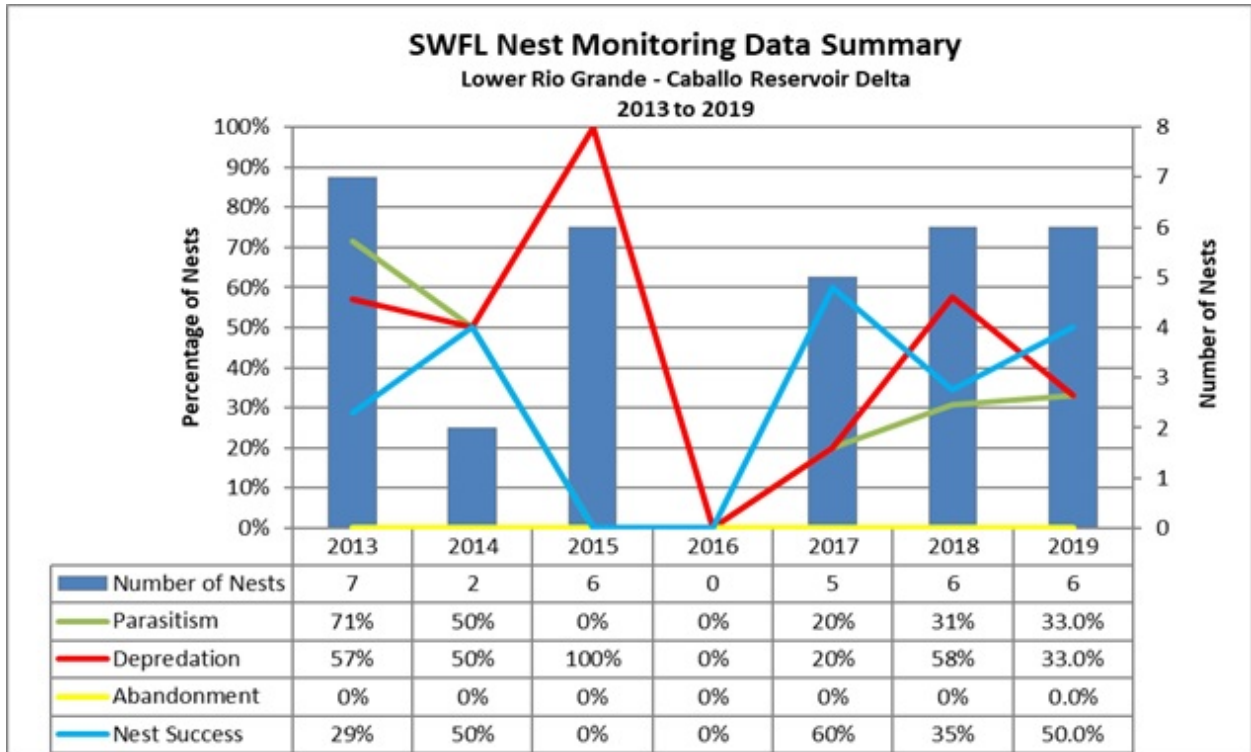
Figure 8: Flycatcher nest variables, Lower Rio Grande, Caballo Reservoir delta, 2013 to 2019

These changes may be a result of reduced habitat quality because of lower flows. Drought conditions, which typically result in reduced discharge and groundwater levels, reduce plant vigor and canopy cover. This reduces nest concealment, exposing the nest to predators and the elements. The defoliation of saltcedar by *Diorhabda spp.* has similar effects and may be of greater concern in the future. Nest success in the Lower Rio Grande has been much higher in recent years, averaging 58 percent between 2016 and 2019 for territories downstream of Caballo Dam, primarily in the Hatch Reach, and 48 percent within the Caballo Reservoir Delta (Figures 6 and 7).
