Potential Site Locations

Visited 6 sites, two sites mentioned have not had site visits (Figure 1).

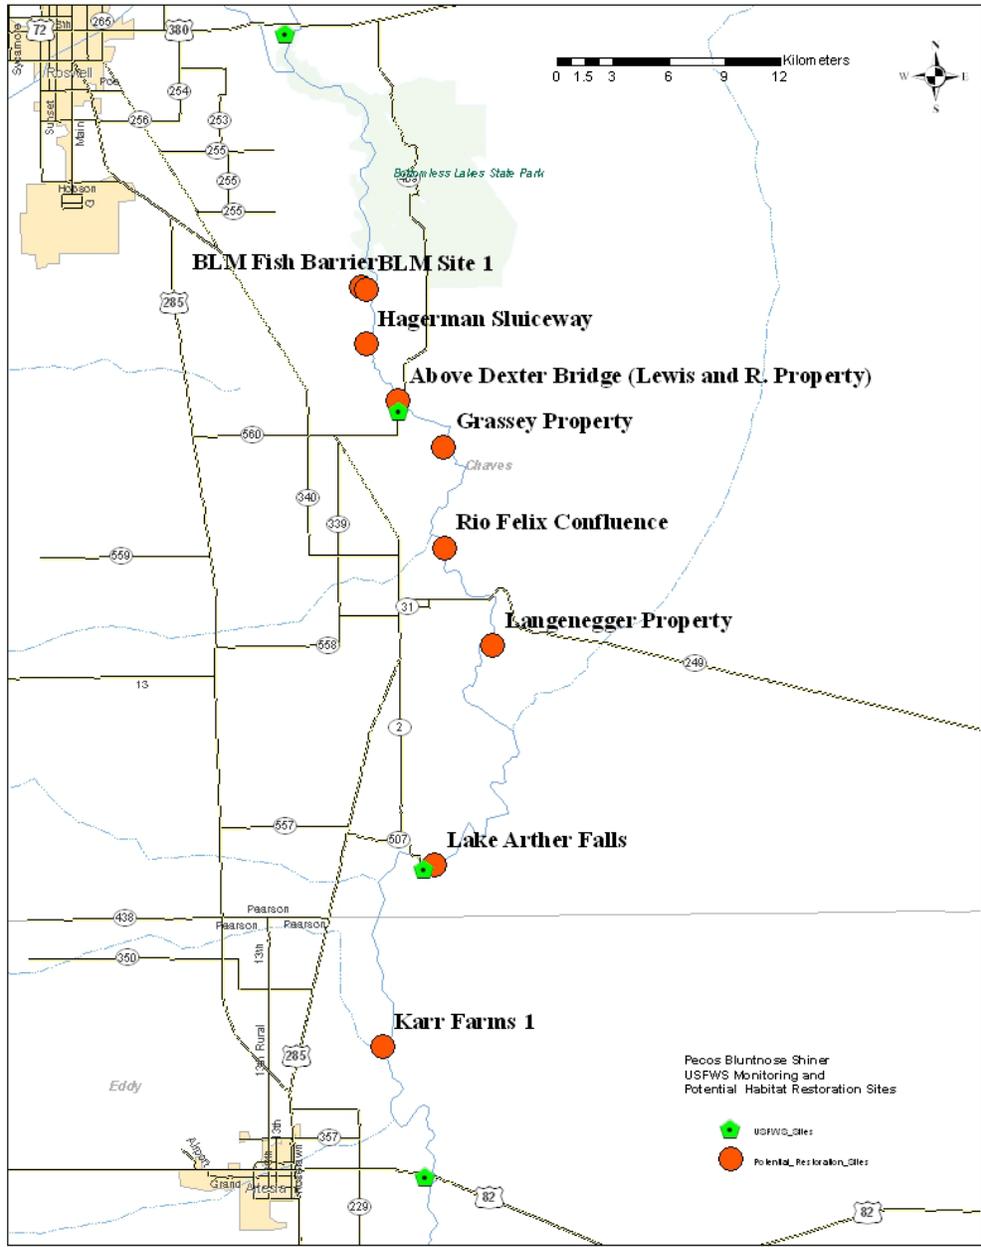
Figure 1. General location of potential sites for habitat restoration projects for Pecos bluntnose shiner.

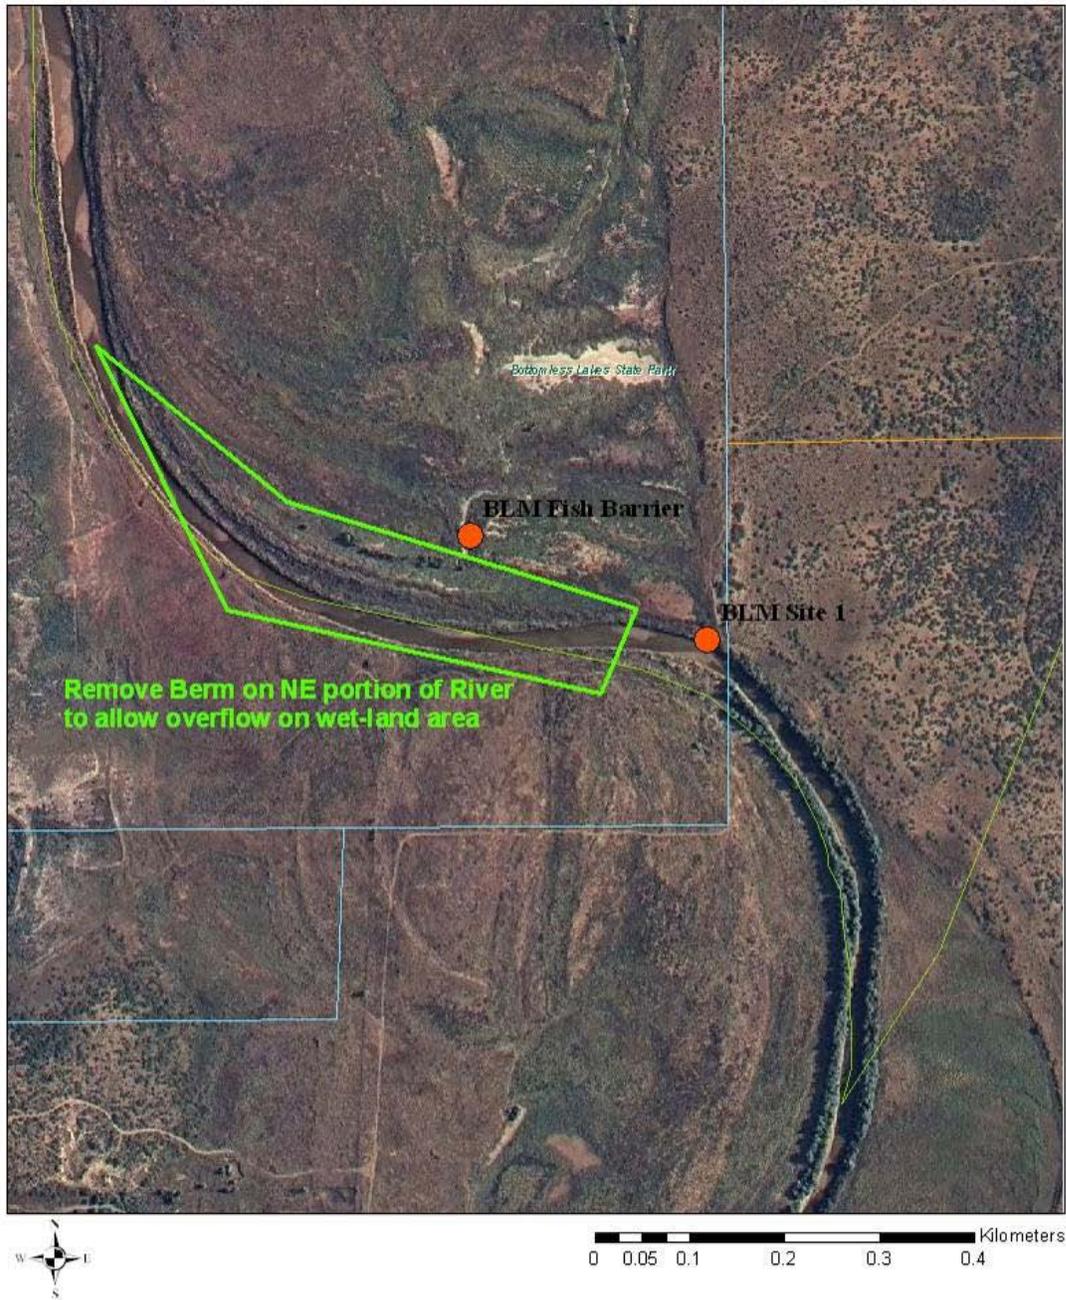
BLM property south/downstream of Bottomless Lakes State Park (Figure 2). There is currently a weir on the north-east shore of the river that prevents the river from overbanking and moving dynamically in the area (Figure 3).

Figure 2. Aerial view of BLM proposed site and action.

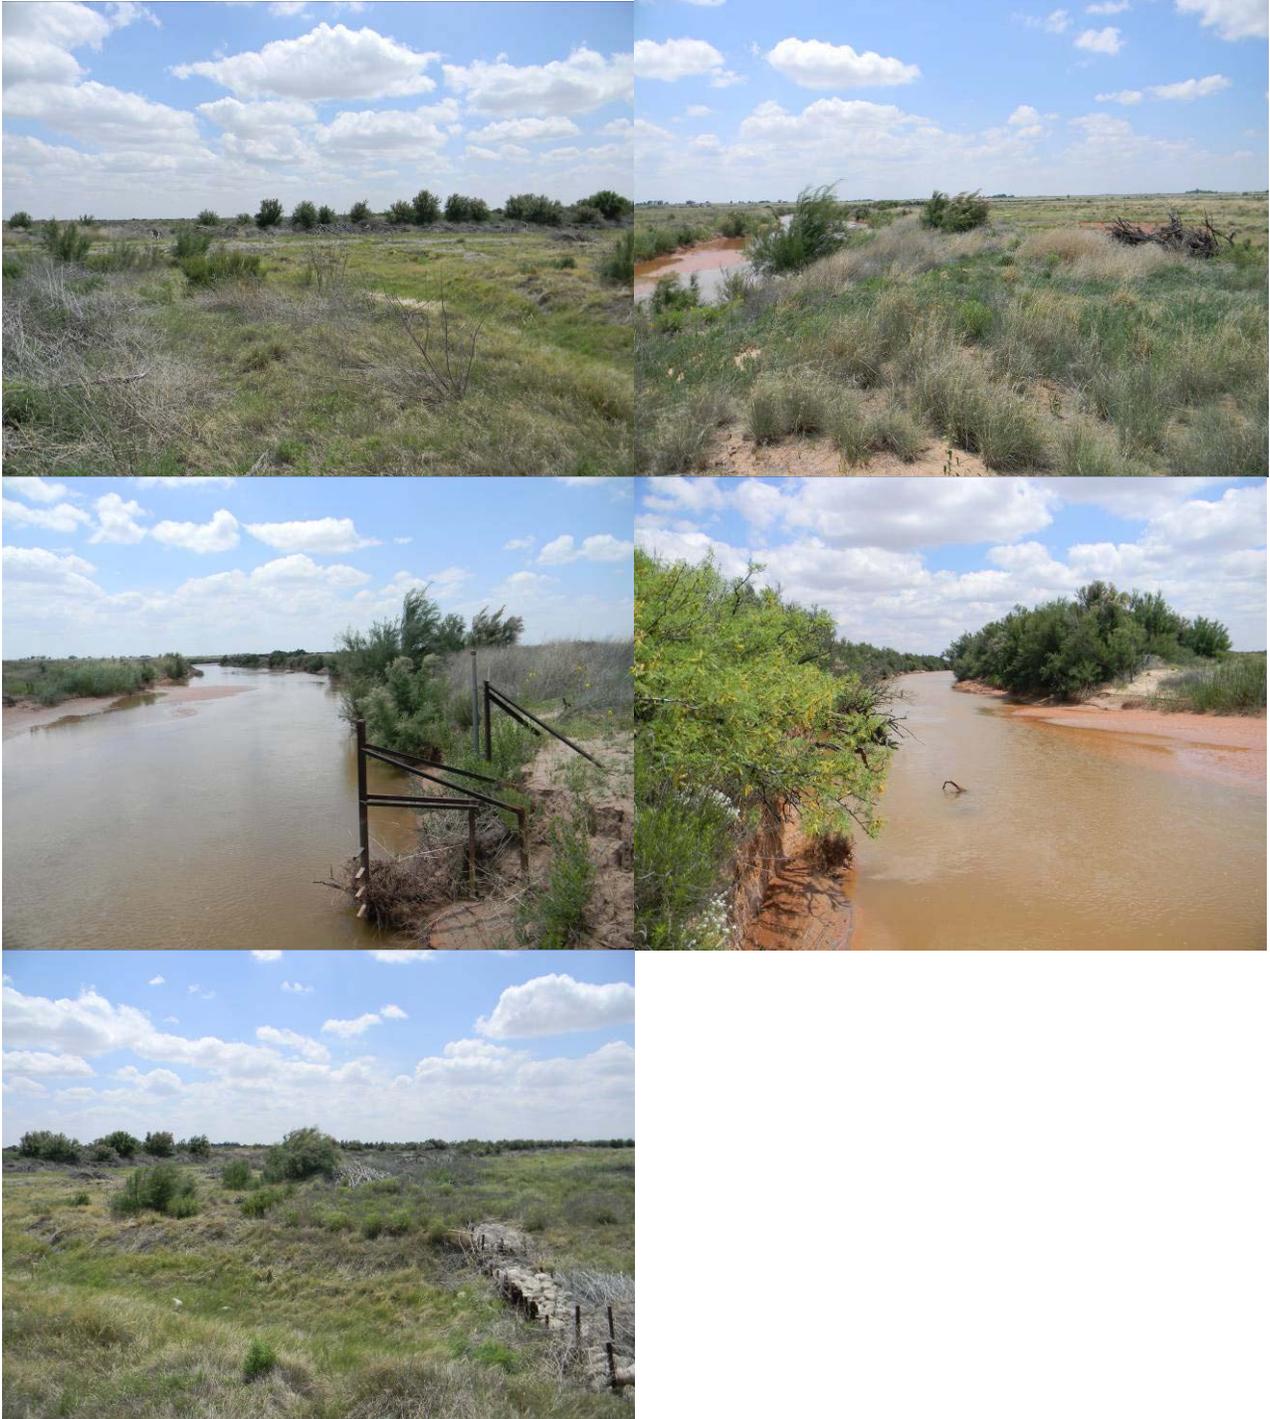
- Nearby, there is a fish barrier on an outflow from one of the Bottomless Lakes to protect Pecos pupfish habitat from possible introduction of sheepshead minnow. Movement of the river into the floodplain may compromise this barrier.

Figure 3. Views of BLM property. Upper Left – View of berm. Upper Right – Top of Berm. Middle Left – Upstream view from gage site. Middle Right – Downstream view from gage site. Lower Left – Fish Barrier on outflow area.

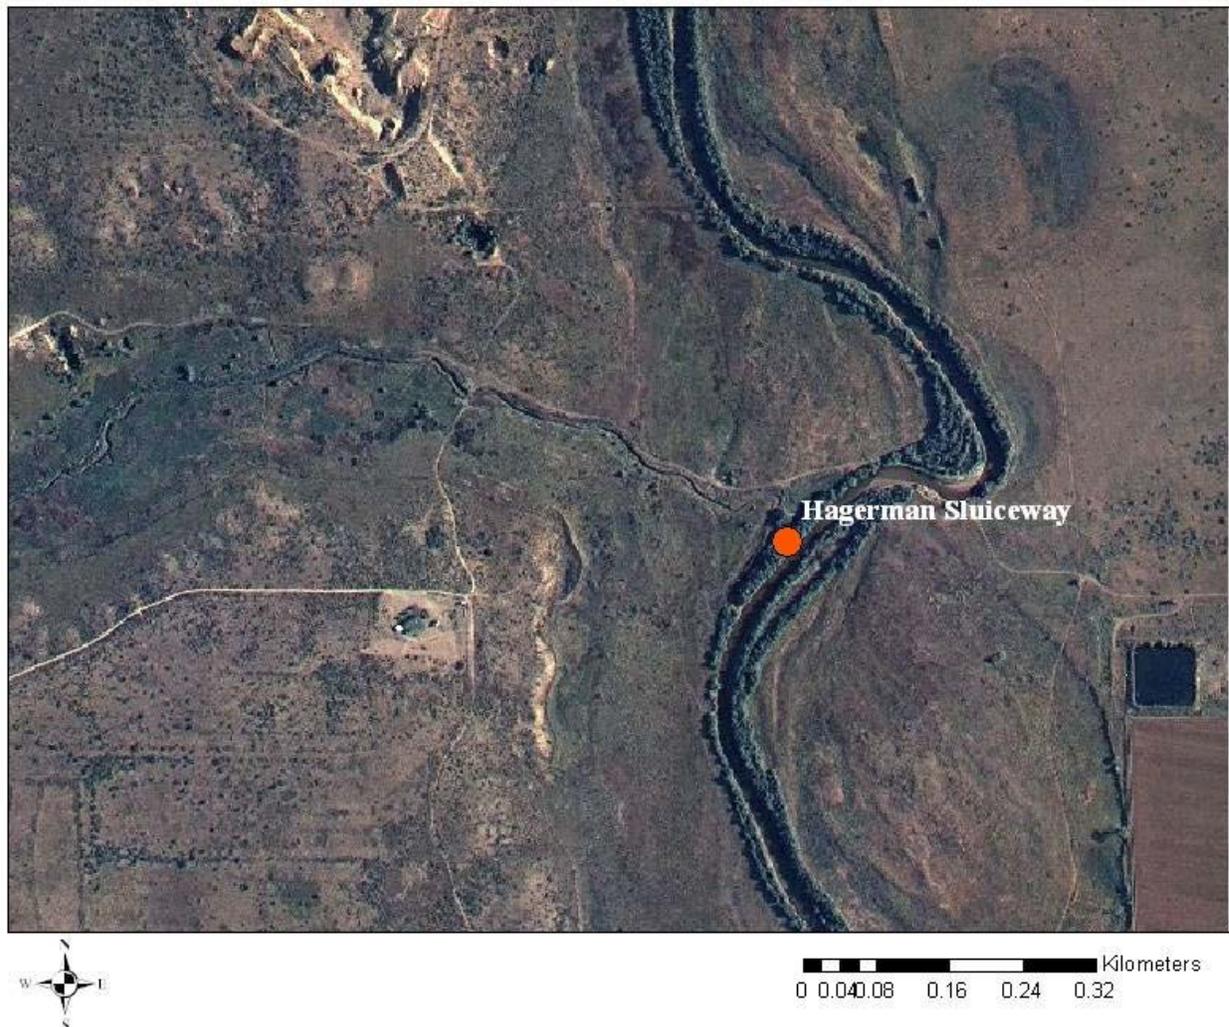
Private land – unknown owner (Figure 4). No site visit. Potential area for backwater construction.

Figure 4. Aerial view of confluence of Hagerman Sluiceway.

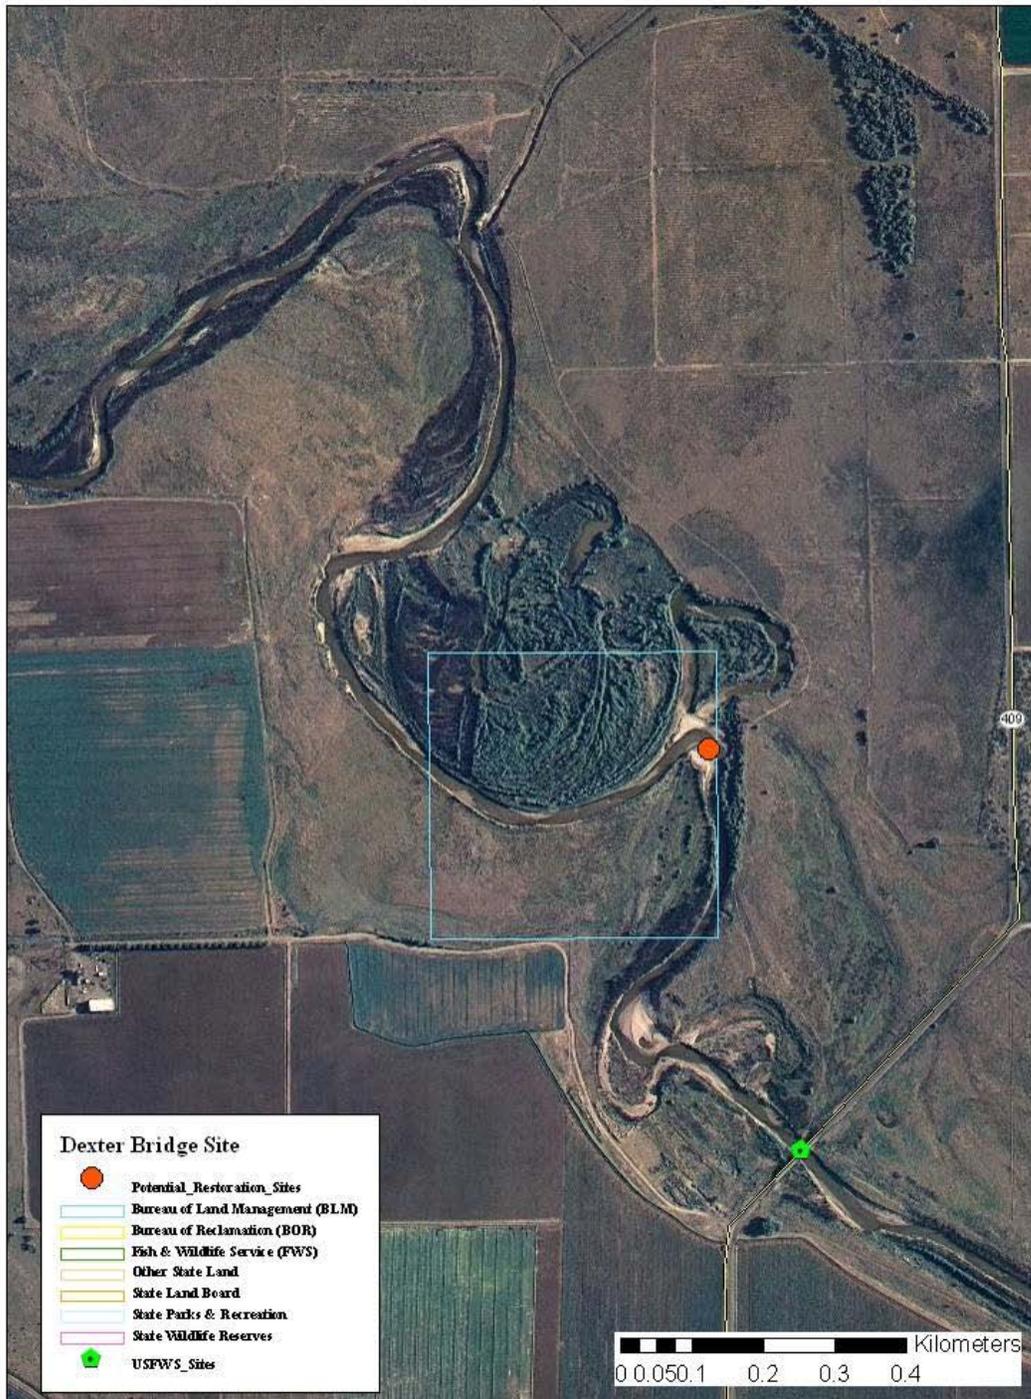
Site is mixed private (at least two landowners) and BLM leased property less than half mile upstream of the Dexter Bridge (Figure 5). Very diverse area with dynamic river movement (Figure 6). There are at least two detached oxbows in the area. Area is just upstream of the USFWS monitoring site. Agricultural fields west of river in production.

Figure 5. Aerial view of Dexter Bridge site.

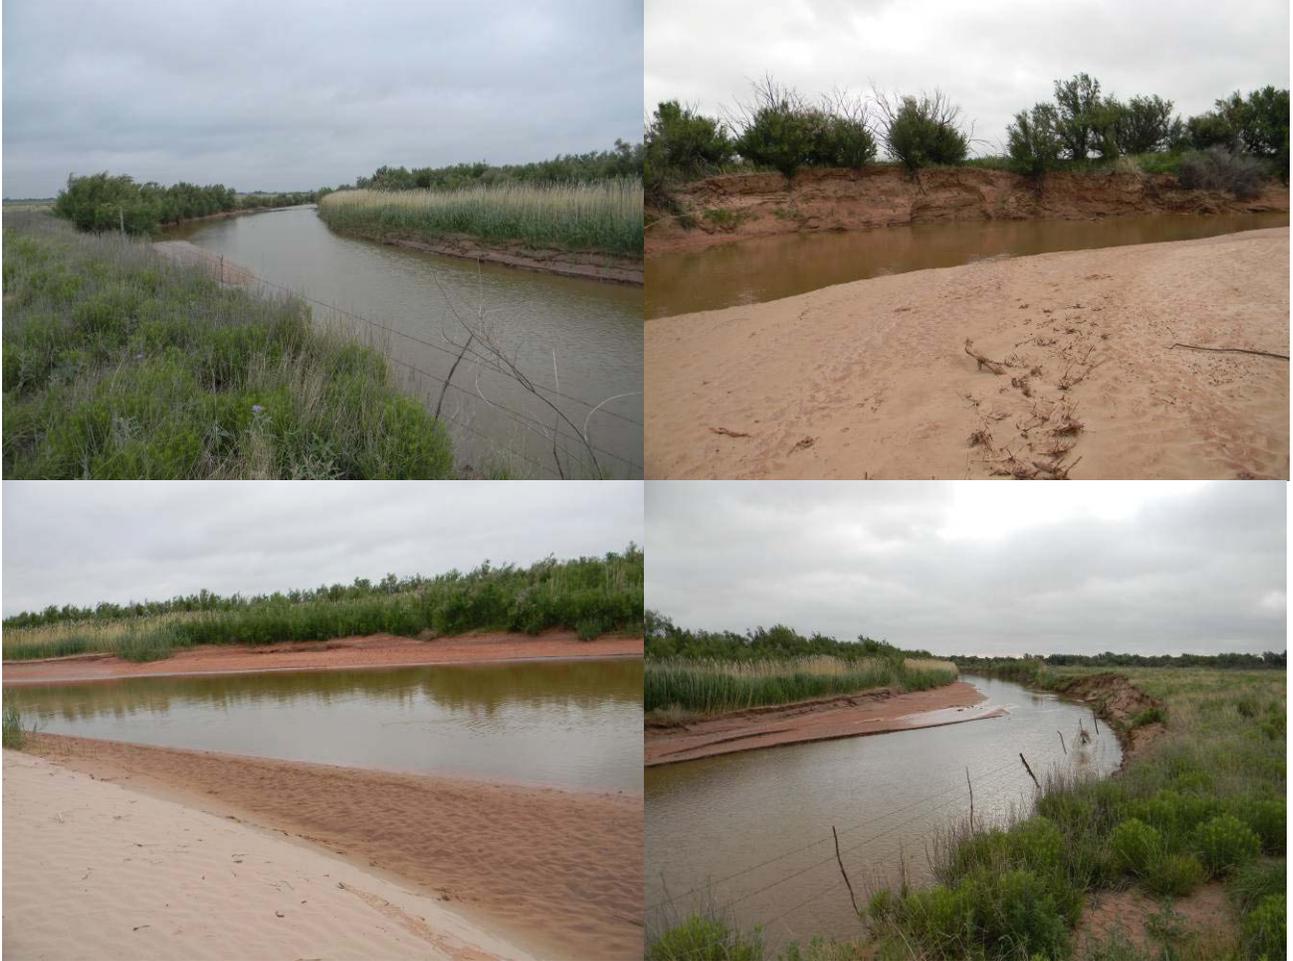
Figure 6. Views within Dexter Bridge site. Upper right just below old oxbow.

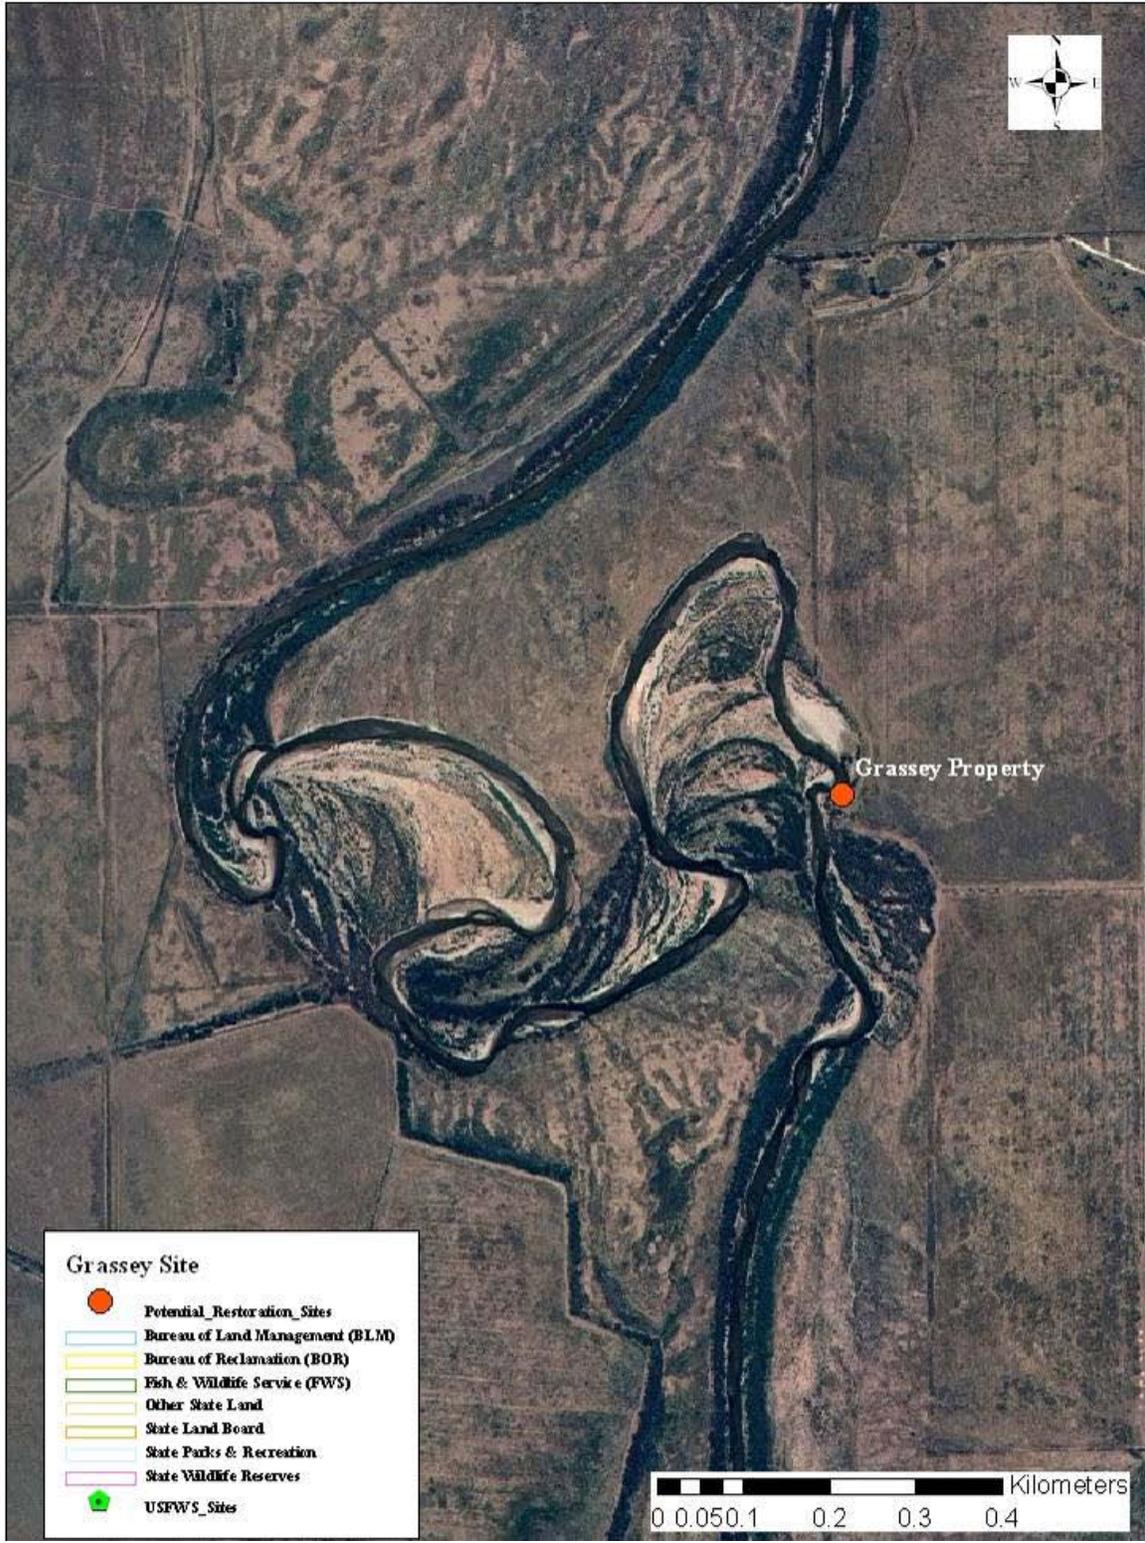
Private land parcel south of Dexter (Figure 7). Unknown boundaries of private land owned by Grassey. Very diverse area with dynamic river movement agricultural fields south west of site not in production. Control of nonnative vegetation within the area may help maintain the dynamic nature of this section.

Figure 7. Aerial view of Grassey site.

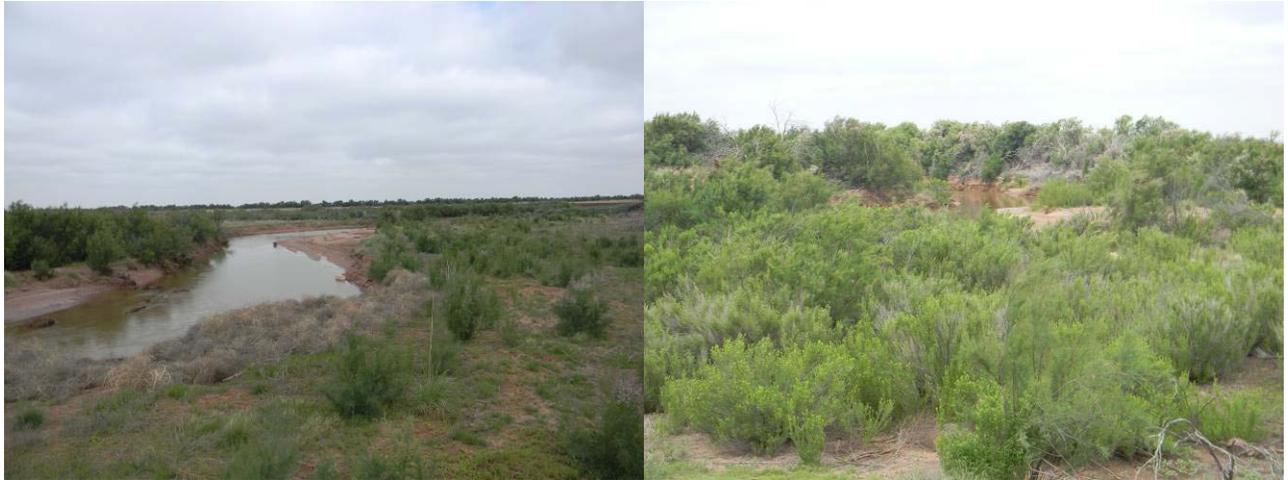
- Site is currently very dynamic
 - conditions already benefit Pecos bluntnose shiner habitat (Figure 8).

Figure 8. Grasse property site.

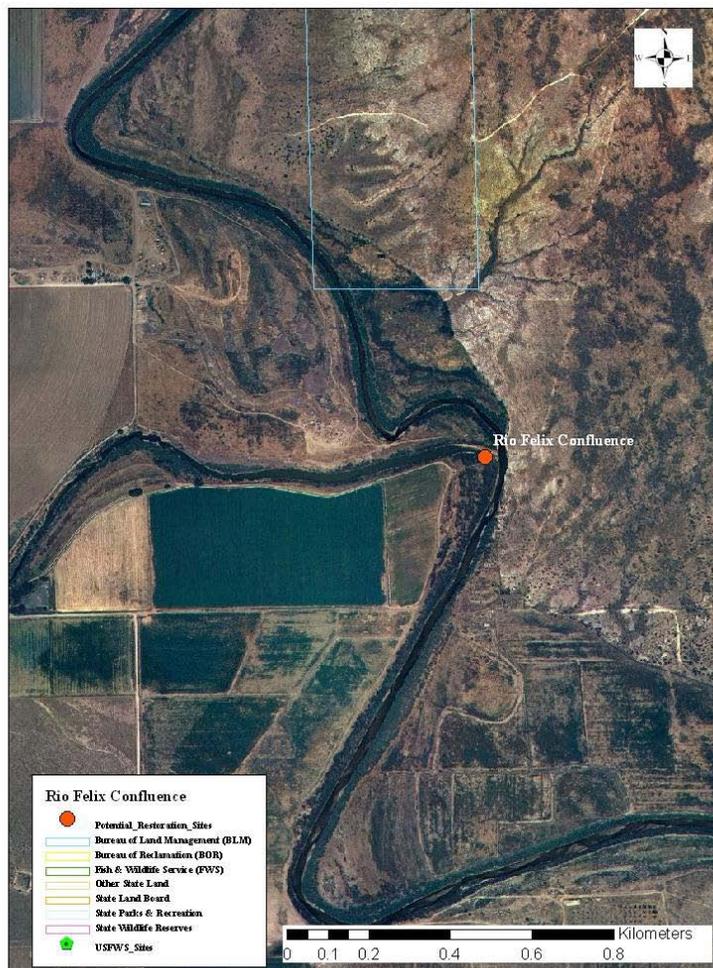
Private land – unknown owner (Figure 9). No site visit. Potential area for backwater construction. Perennial water in Rio Felix for approximately one mile above confluence with Pecos

Figure 9. Aerial view of Rio Felix confluence.

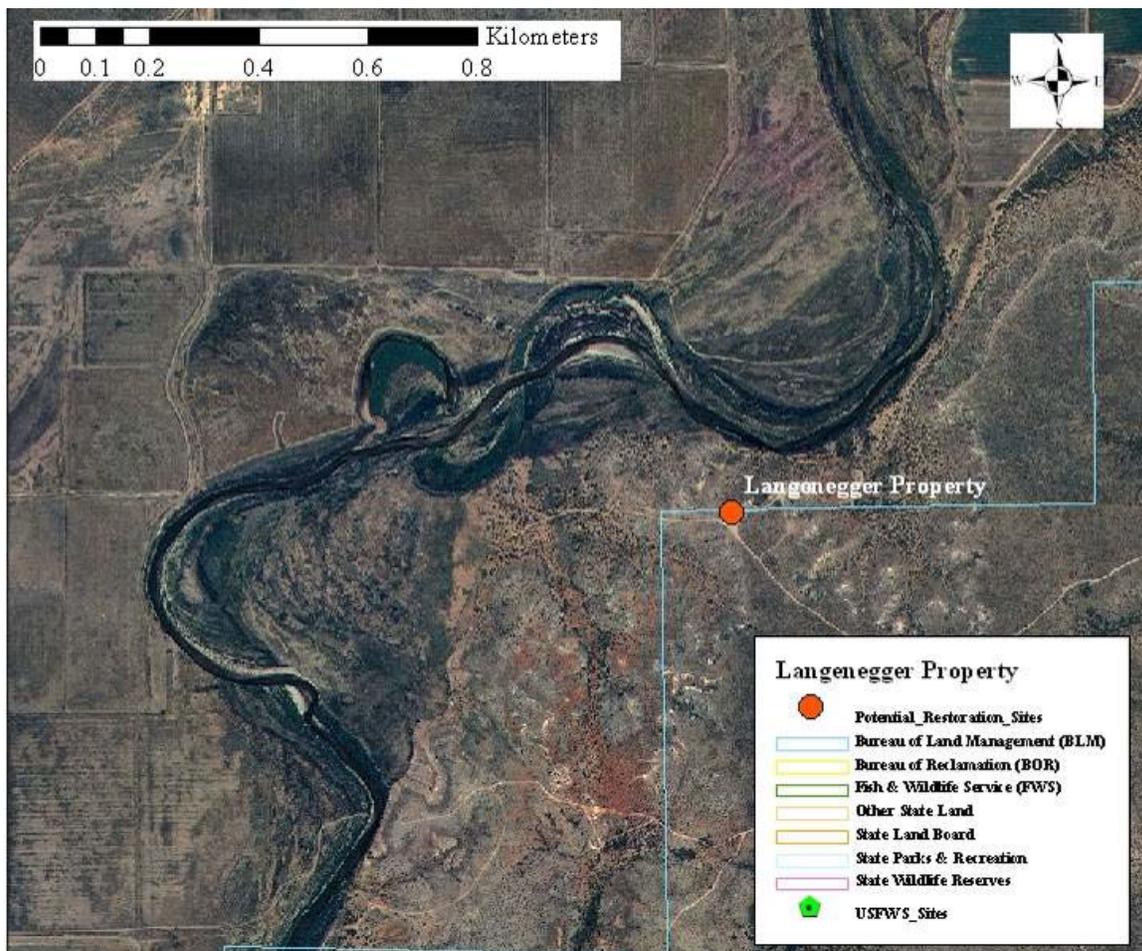
Private land parcel (Figure 10). Unknown boundaries of private land owned by Langenegger. Very diverse area with dynamic river movement, some confinement from cap rock on east side of river. Agricultural fields west of site not in production, river-pumper site on east-upstream side in production. Vegetation control in area and reconnection of oxbows may maintain habitat diversity in the area (Figure 11).

Figure 10. Aerial view of Langenegger property.

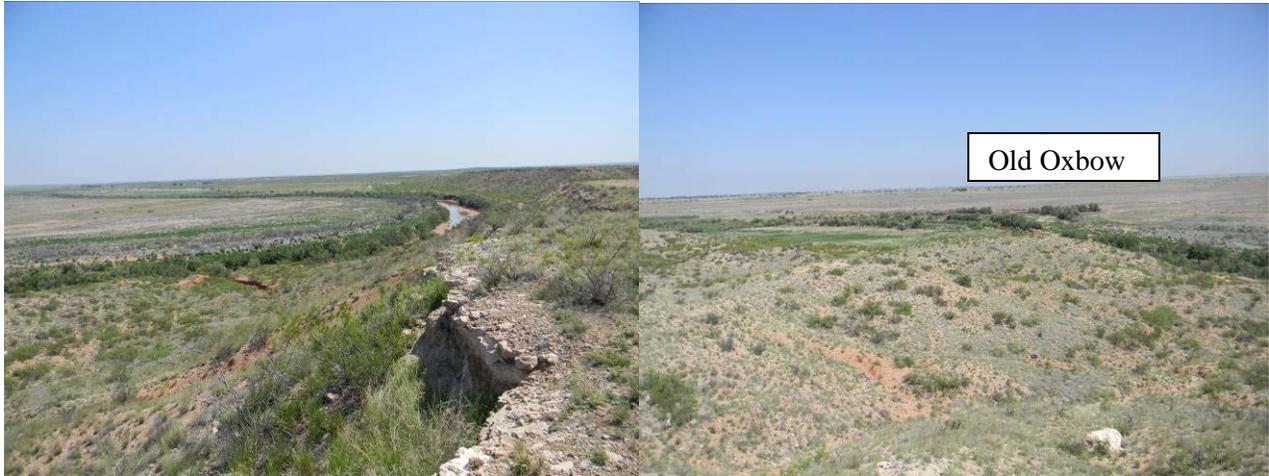
Figure 11. Langenegger upstream view (left) and downstream view (right).

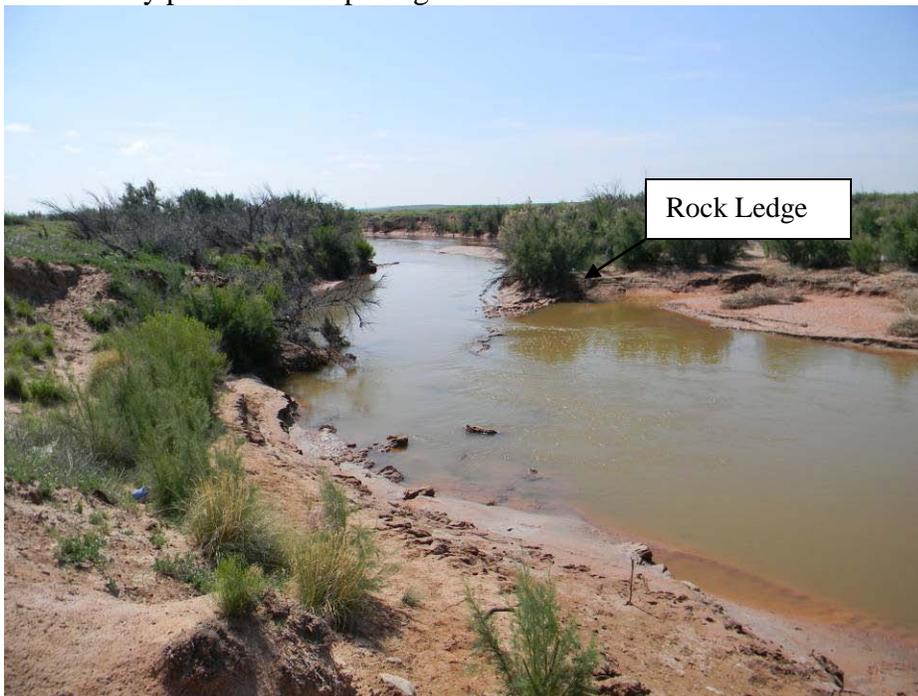
Private land parcel (Figure 13). Unknown landowner. Very diverse area with dynamic river movement. Small ledge on north side of river is where “falls” were historically. River has moved southward, rock ledge now acts like weir creating a backwater area below (Figure 12). Proposal to move river back over falls.

Figure 12. Current view of Lake Arthur falls.

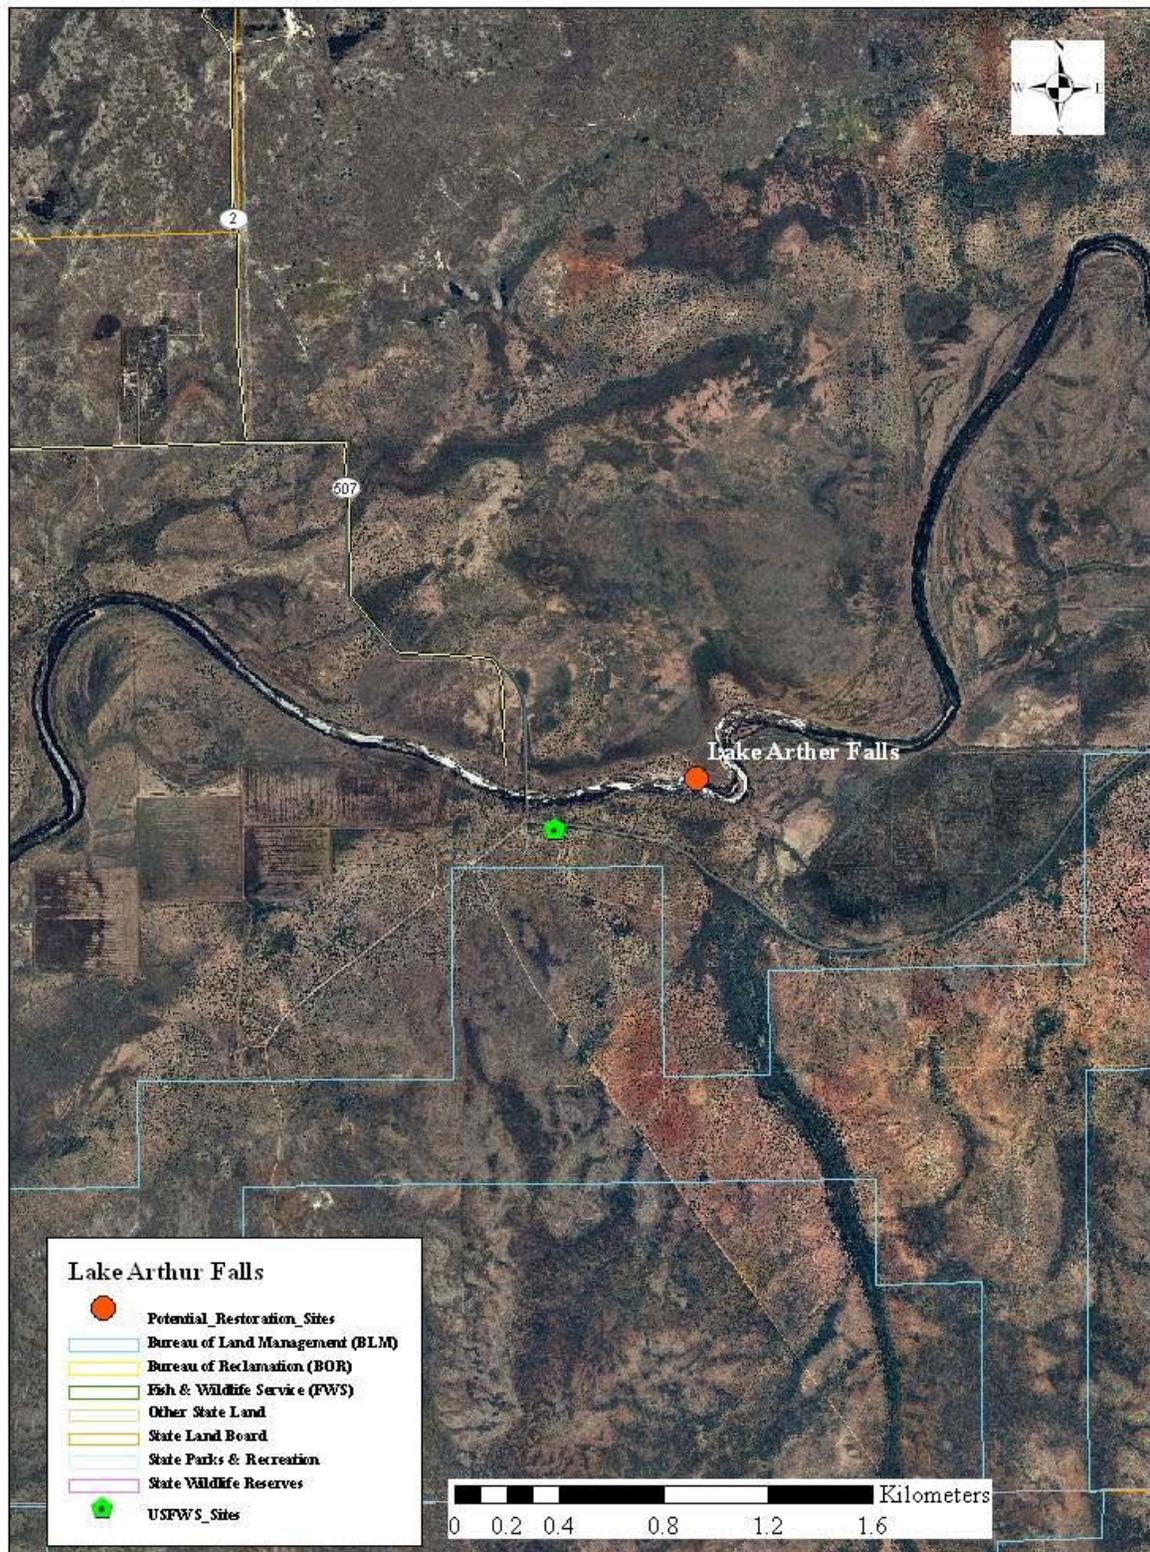
Figure 13. Aerial view of Lake Arthur Falls area.

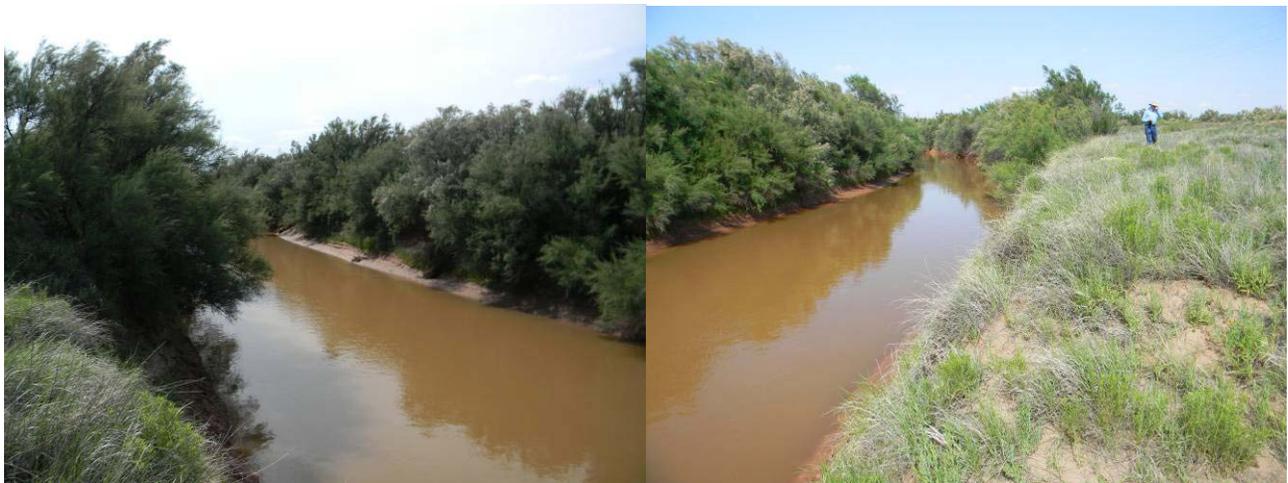
Karr Farm is owned by U.S. Bureau of Reclamation and managed by New Mexico Department of Game and Fish. There is a total of 7.35 river kilometers (4.35 miles) available within Reclamation and Game and Fish property (W.S. Huey). The area is currently deeply entrenched and nonnative *Tamarisk* dominates both shorelines (Figure 14). There are multiple restoration opportunities within the Karr Farm area (Figure 15).

Figure 14. Downstream (left) and upstream (right) views of upper Karr Farm site.

1. Vegetation could be removed from the inside bank of the left turn in the upper area to allow for overbank flooding and channel widening in the area.
2. Vegetation could be removed and eastern levee moved to allow for meander within straight area.
3. Reconnect historic oxbow to perennial flow or high flow.
4. Strategic vegetation removal in the lower areas to allow for overbank flooding and channel widening in the area.
