Subject: Distribution of Final Reports by Schmidt et al. & Grams et al. – Synthesis of Fine-Sediment and related Geomorphic data of the Colorado River Ecosystem Below Glen Canyon Dam

The Degraded Reach: Rate and Pattern of Bed and Bank Adjustment of the Colorado
River in the 25 km Immediately Downstream from Glen Canyon Dam

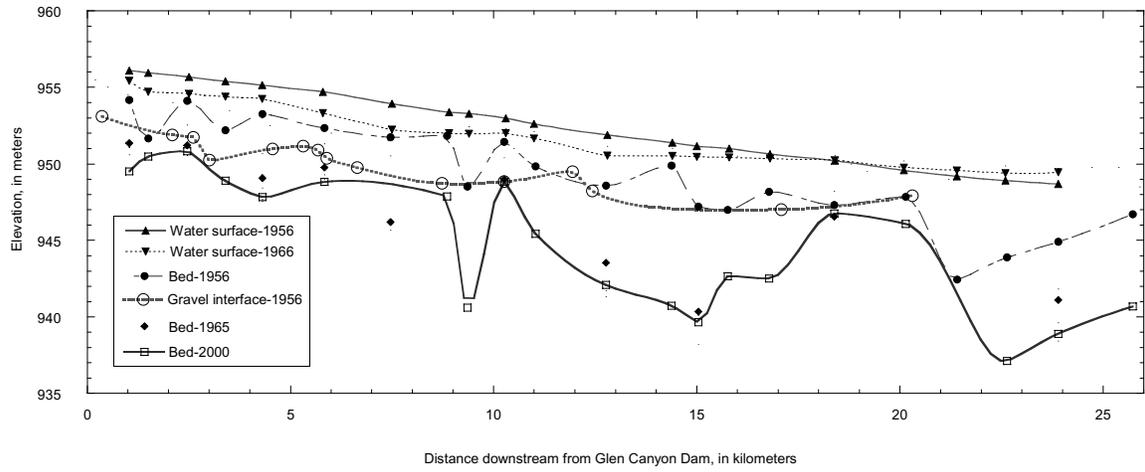
Figure 7

Prior to closure of Glen Canyon Dam, the average gradient through the study area was similar across a broad range of discharges (Figure 7). The reach average gradient was 0.00034 and 0.00037 at discharges of 79 and 2067 m³/s, respectively. The onset of bed degradation, which has been greatest at the upstream end of the study area, caused the reach-average gradient to decrease to between 0.00025 and 0.00028. While reach-average gradient has decreased, differential bed erosion has caused the local gradient to become steeper in some locations and less steep in others.

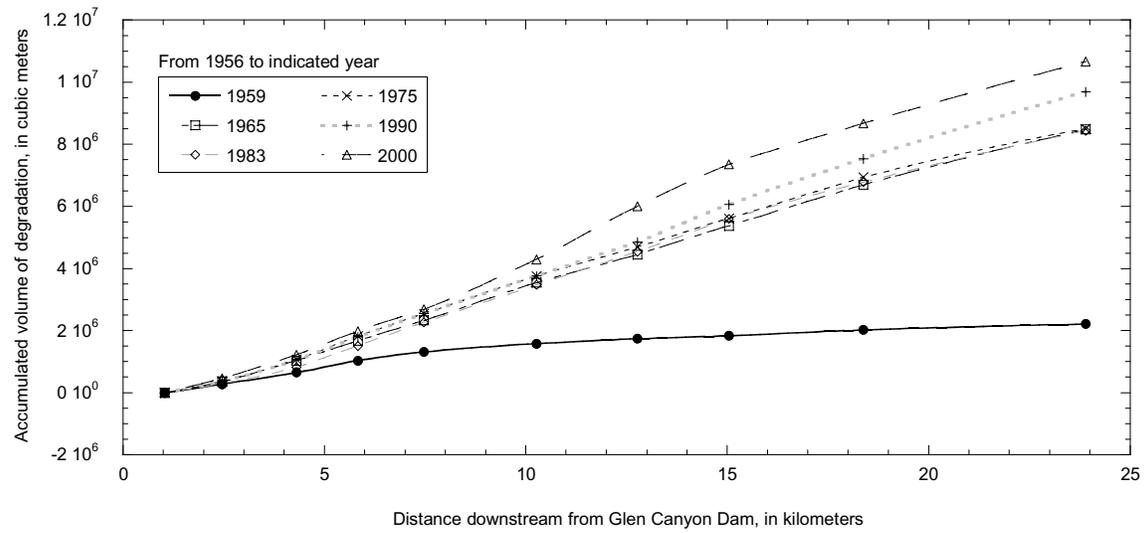
Figure 8

A total of approximately 10.7 million m³ of sediment was eroded from the study area (Figure 8), exceeding the volume of degradation predicted at the time of dam construction (Pemberton, 1976) by about 30 percent. In the upstream 10 km, the accumulated volume of degradation has not changed significantly since 1965. At distances greater than 10 km downstream, the volume of degradation increased significantly after 1983 and was concentrated at cross-sections 10 and 11A. In both cases, the degradation occurred along the margins of the channel and not in the thalweg. Thus, continued degradation has evacuated sediment from the reach without affecting the longitudinal profile of minimum bed elevation.

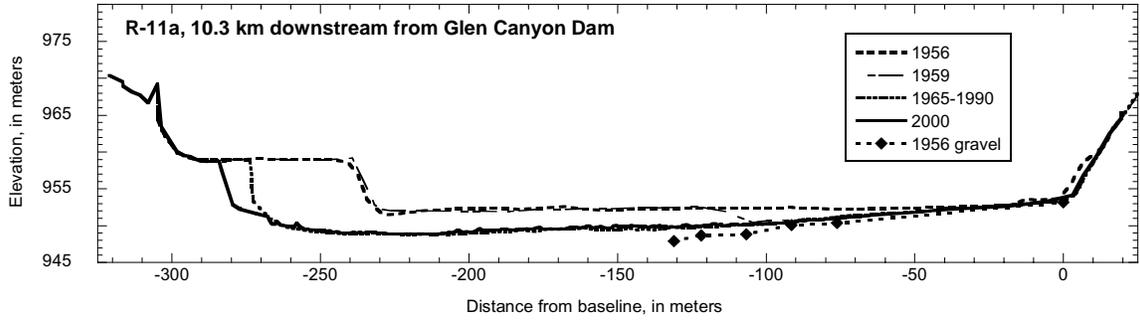
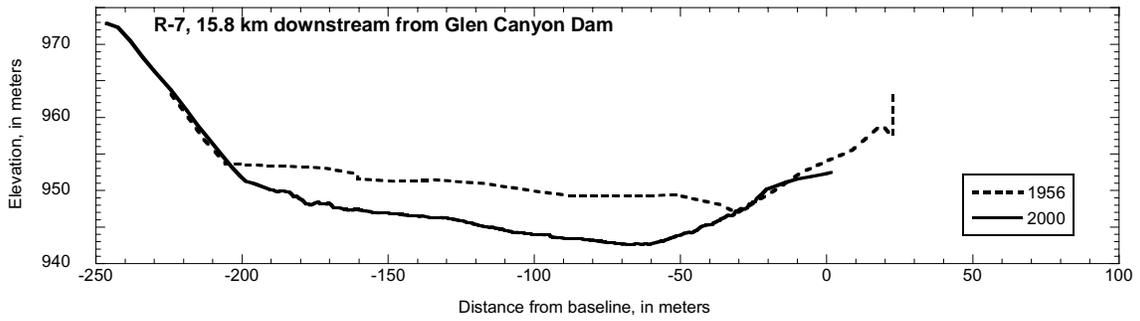
Figure 9

The locus of degradation varied considerably among the cross-sections (Figure 9). Riffles tended to degrade differentially across the channel, often leaving part of the bed near its pre-dam elevation, e.g. R-11A. In pools, degradation tended to occur across the width of the channel, resulting in near uniform lowering, e.g. R-7. In nearly all cases, the degradation was contained within the limits of the 1956 channel, thereby resulting in a deeper and narrower channel. Exceptions to this pattern of narrowing occurred at R-11A (Figure 9) and R-4, where bank erosion caused channel widening.

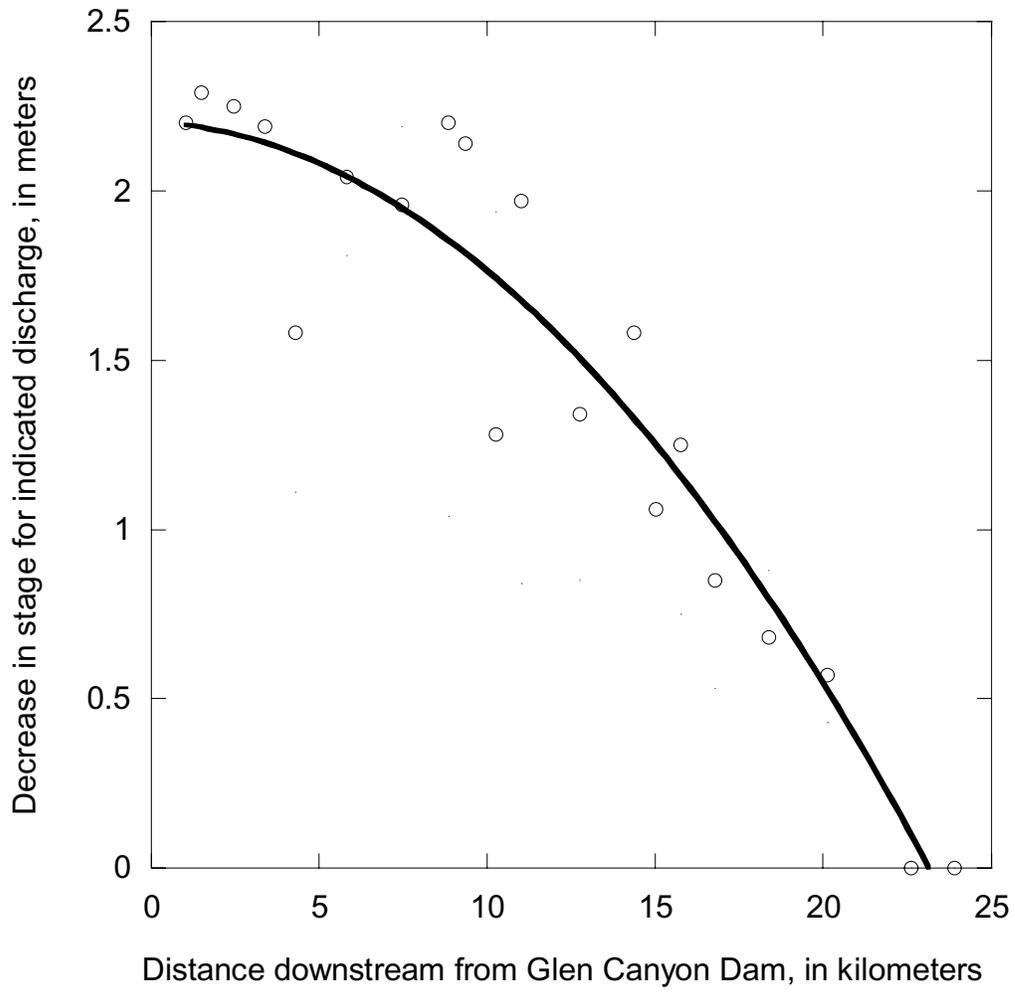
Figure 11

The lowering of the bed has caused large shifts in stage-discharge relations that are greatest near the dam and decrease downstream. The pattern exhibited by these shifts in the stage-discharge relationships are, in fact, a better indicator of degradation of channel controls than the actual measurements of bed topography at the cross-sections. Stage-discharge relations were determined for each cross-section using all measured water surface elevations. Linear trends were fit to each cross-section for periods where the relation remained stable. For cross-sections where there were shifts in the stage-discharge relation, most of the adjustment occurred by 1965, consistent with the period of greatest bed degradation (Figure 10a). Stage-discharge relations at the downstream end of the reach have been stable (Figure 10b). The downstream trend in the stage-discharge adjustment was determined by evaluating the change in stage for a discharge of $150 \text{ m}^3/\text{s}$ between the pre-1965 period and the post-1965 period. The change in stage decreases from over 2 m at the upstream end of the study area to no significant change at R-1, 24 km downstream (Figure 11).

riffle is the furthest downstream channel control for which degradation due to dam operations is known to have occurred. The next riffle downstream at Fall Creek may have degraded, but we were unable to reoccupy the cross-section at R-3, to determine whether the stage-discharge relation had changed. The next significant channel control downstream is the riffle opposite the mouth of the Paria River, and stability of the stage-discharge relations at cross-sections downstream from Fall Creek indicate that that channel control has been stable (Figure 11).

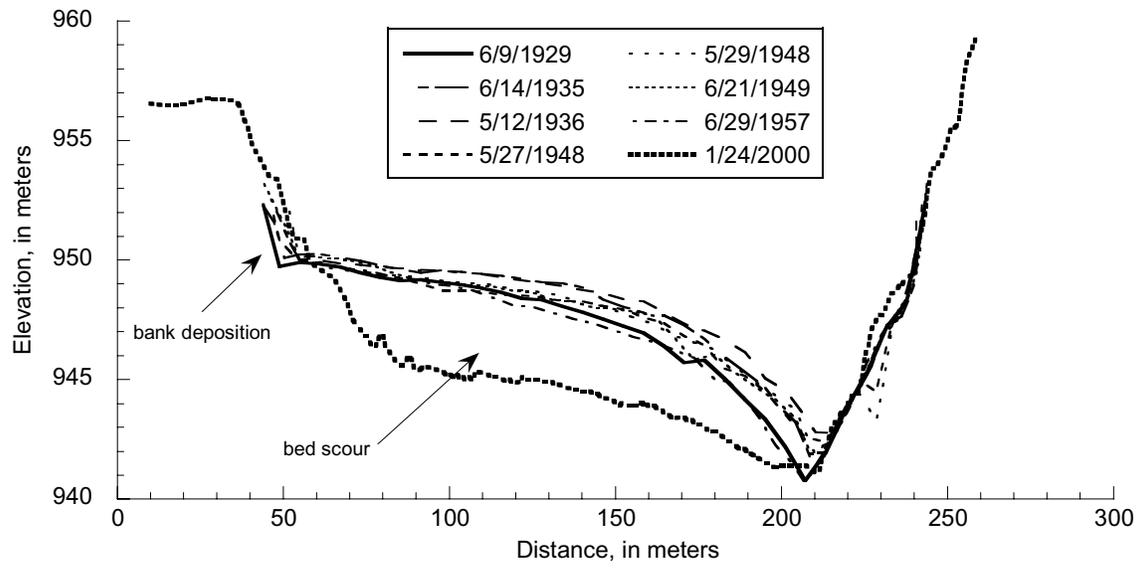
Figure 14

Selected plots of the cross-section at the Lower Cableway show that the bed has degraded along much of the channel width, creating a more rectangular cross-section than existed in the pre-dam era (Figure 14). While the thalweg elevation in January 2000 is similar to the elevation during pre-dam floods, there has been 2 to 5 m of erosion along more than 100 m of the cross-section that never scoured during pre-dam floods. Thus, the area of degradation at this cross-section is large even though the depth of degradation is less than for the Upper Cableway.

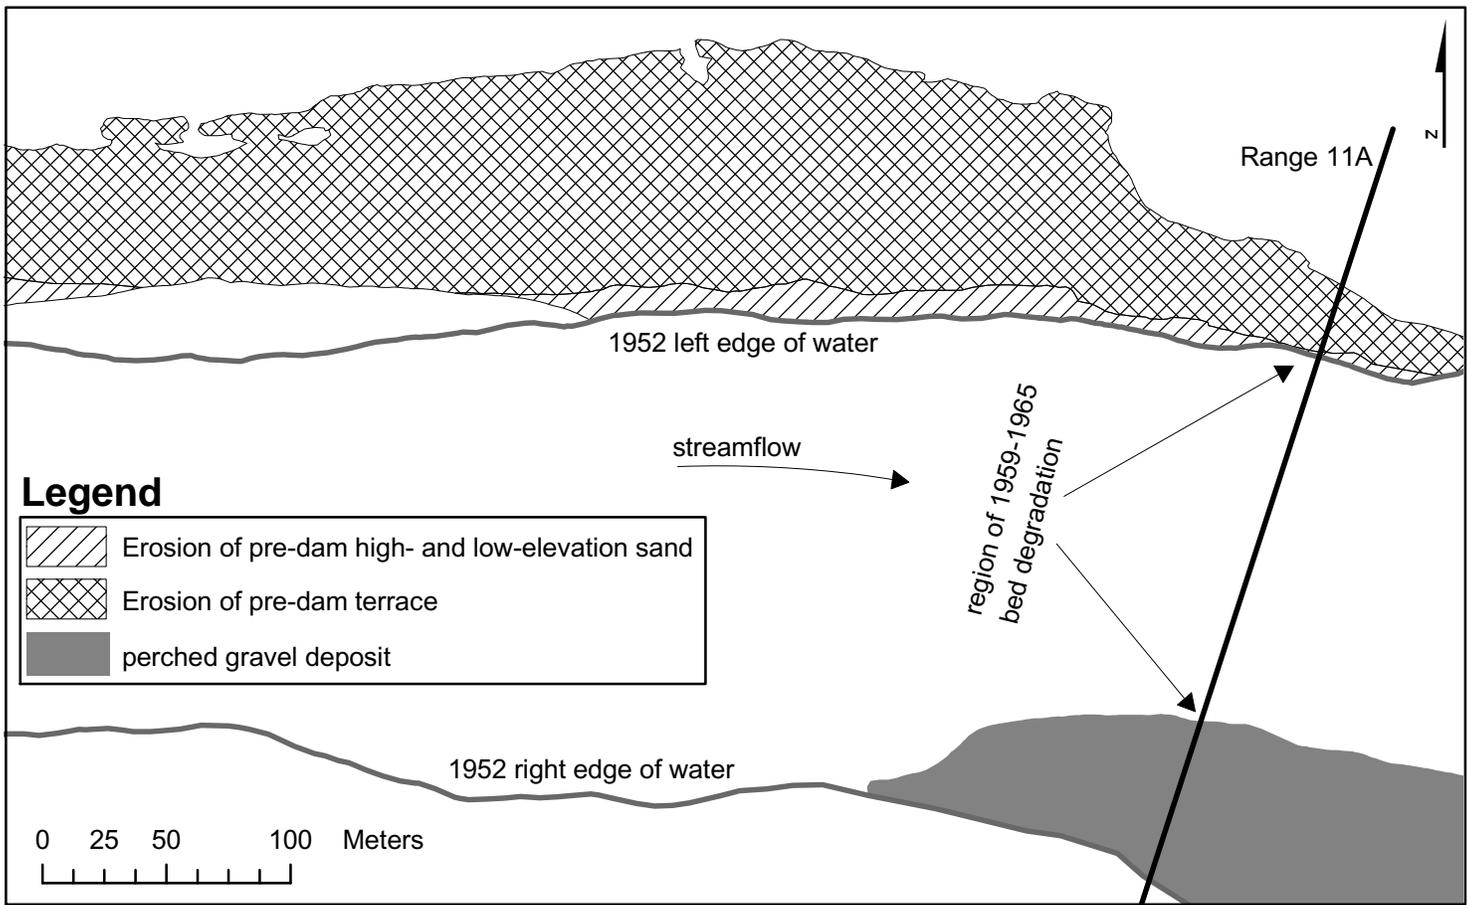
Figure 21

The 1952 to 1984 erosion-deposition maps indicate apparent deposition on many of the gravel bars. We refer to this as apparent deposition because the cross-section measurements show that these deposits have not changed in elevation or have in fact degraded (Figure 21). The appearance of deposition in these locations is a result of the

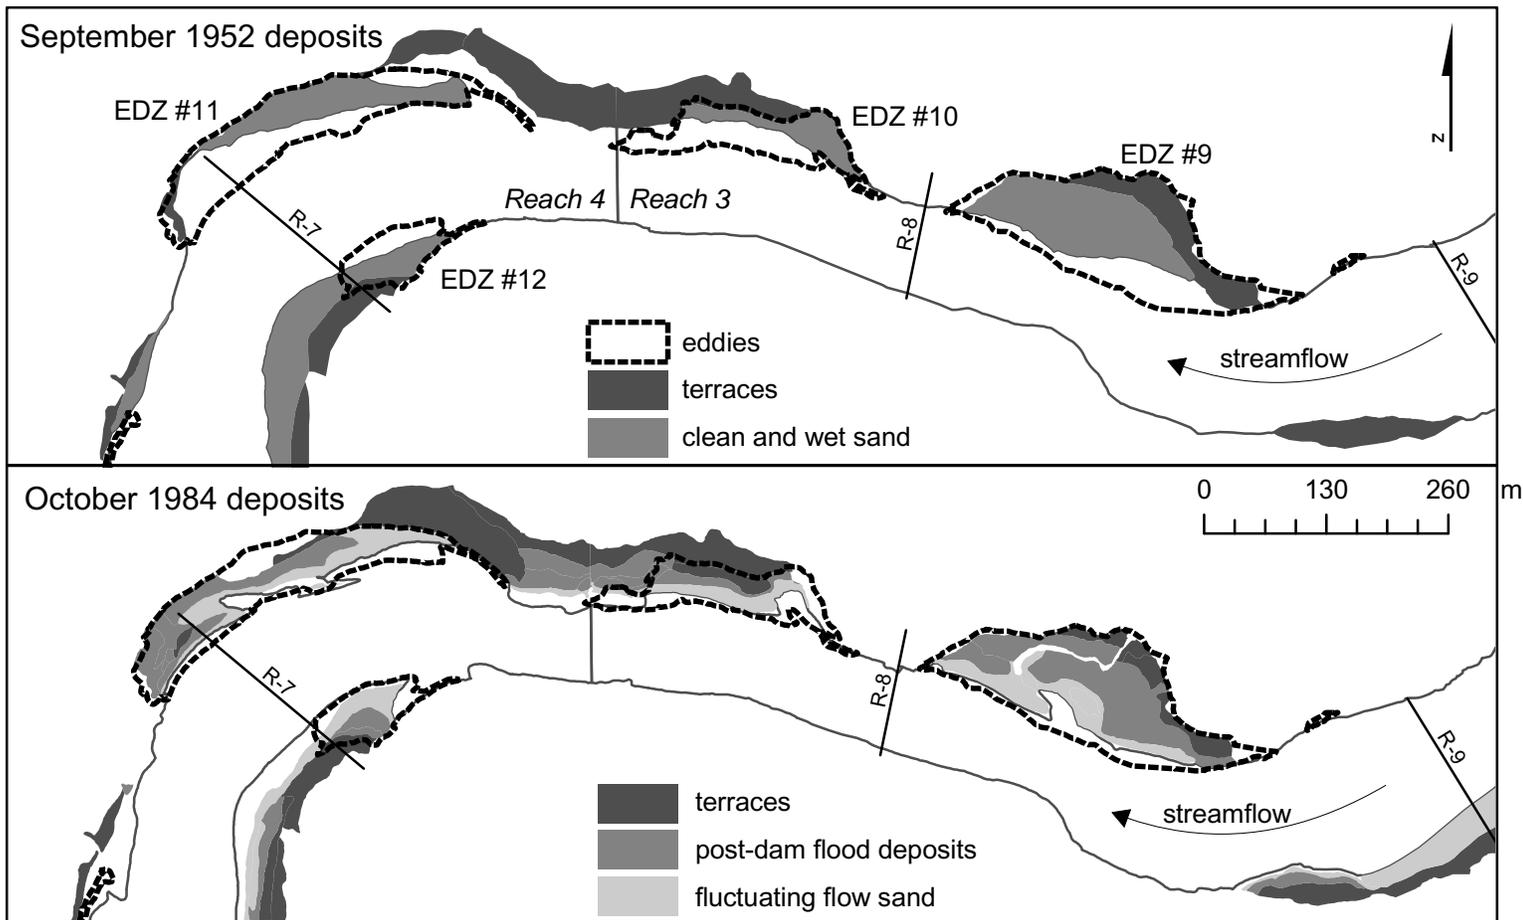
Like the gravel bars and channel-margin deposits, active eddy bars in Glen Canyon became perched and stabilized with vegetation as a result of bed degradation. Figure 25 shows four nearby EDZs between 14.5 and 16.0 km downstream from Glen Canyon Dam. These four EDZs are among the largest in Glen Canyon. The area of exposed sand has not changed significantly between 1952 and 1984. Most of the area that was mapped as clean sand in 1952 is mapped as a post-dam flood deposit in 1984. These deposits consisted primarily of clean sand in 1952, and were densely covered by vegetation in 1984. Examination of the repeat surveys of R-7 indicated that these bars are currently at a lower elevation than in 1952 (Figure 9B), indicating net loss of sand from the EDZs. Thus, despite negative changes in the volume of sediment stored in eddies, the area of exposed sand has remained remarkably constant. Changes at these sites are representative of the rest of Glen Canyon (Figure 26). The area of *high-elevation* sand in eddies has decreased slightly since 1984, although this decrease is not within our estimate of error. Meanwhile, the area of low-elevation sand has

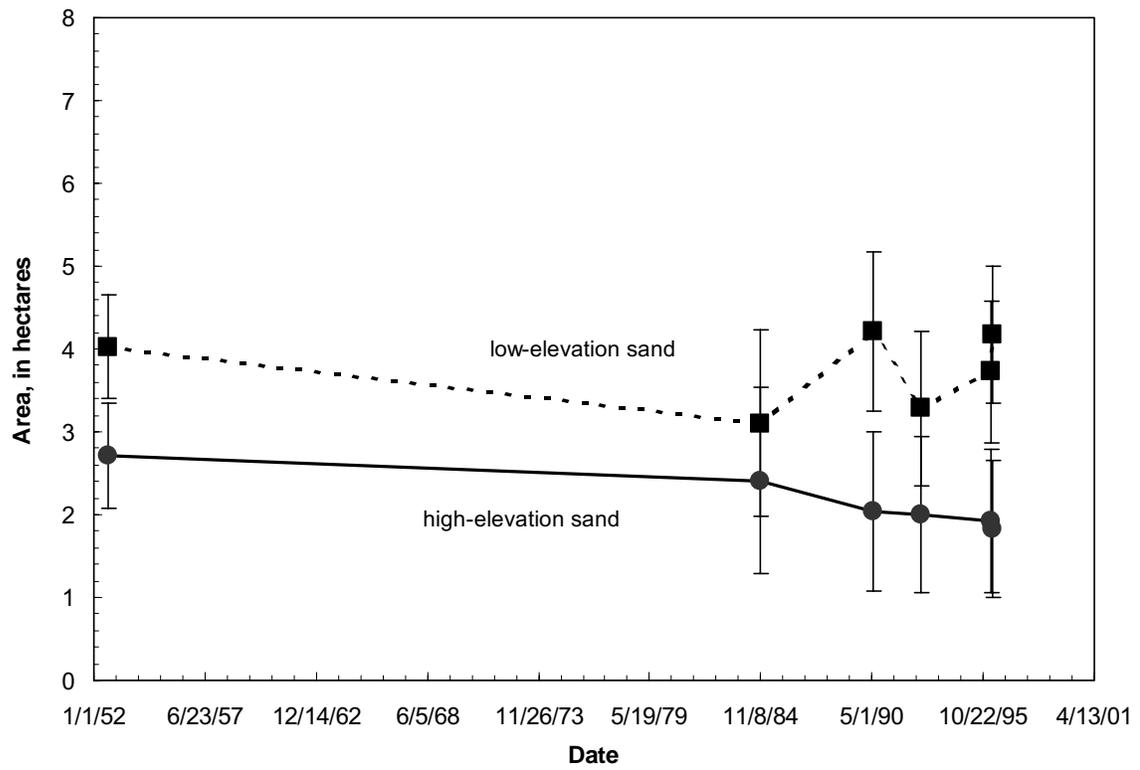
Figure 26

Figure 26. Time series showing total area of post-dam flood, and fluctuating-flow elevation sand in all eddies.

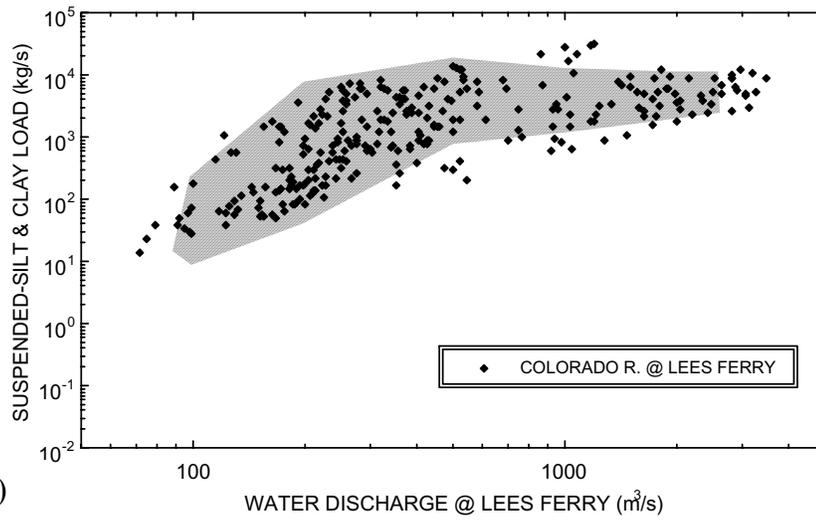
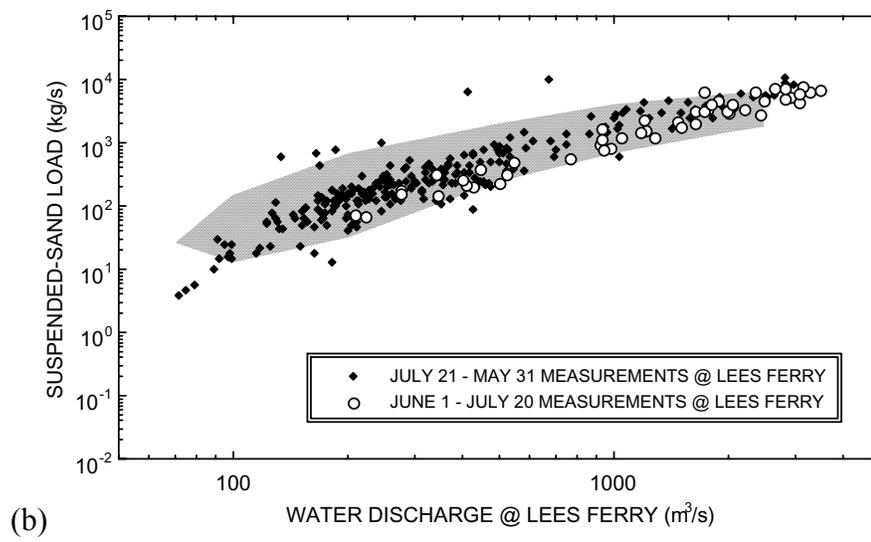
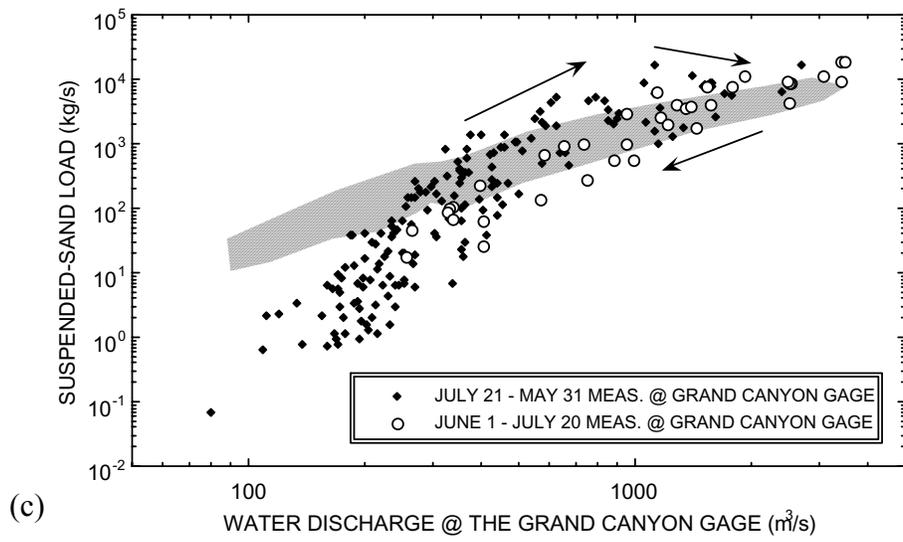
Figure A4

Figure A4. (a) 1951-1958 silt and clay loads of the Colorado River at Lees Ferry as a function of instantaneous streamflow. The cross-hatched area indicates the region in load-discharge space of the combined silt and clay-loads of the Colorado River at Hite and the San Juan River near Bluff. Note that this region occupies the same space as the Colorado River at Lees Ferry data, indicating that the silt and clay loads did not change by very much through Glen Canyon. (b) 1951-1958 sand loads of the Colorado River at Lees Ferry as a function of instantaneous streamflow. Open circles show data collected during the peak and recessional limb portions of the snowmelt flood, diamonds show data collected during the rest of the year. Note that there is little hysteresis in these data. The cross-hatched area indicates the region in load-discharge space of the combined sand-load data from the Colorado River at Hite and the San Juan River near Bluff. Note that this region essentially occupies the same space as the Colorado River at Lees Ferry data, indicating that the sand loads did not change by very much through Glen Canyon, though there is a slight tendency for the sand loads to decrease slightly through Glen Canyon during lower discharges, and to increase slightly through Glen Canyon during higher discharges. (c) For comparison with b, at the same scale, 1951-1958 sand loads of the Colorado River at the Grand Canyon gage as a function of instantaneous streamflow. Open circles show data collected during the peak and recessional limb portions of the snowmelt flood, and diamonds show data collected during the rest of the year. Arrows show the direction of the pronounced hysteresis in the sand-load data from the Grand Canyon gage. The

cross-hatched region indicates the region in load-discharge space of the sand-load data from the Colorado River at Lees Ferry.

the upstream and downstream ends of Glen Canyon as a function of discharge (Figure A4). This analysis is similar to that in Topping et al. (2000, their Figure 4). Both the loads of silt and clay and the loads of sand were found to be similar at the upper and lower ends of Glen Canyon at all discharges.

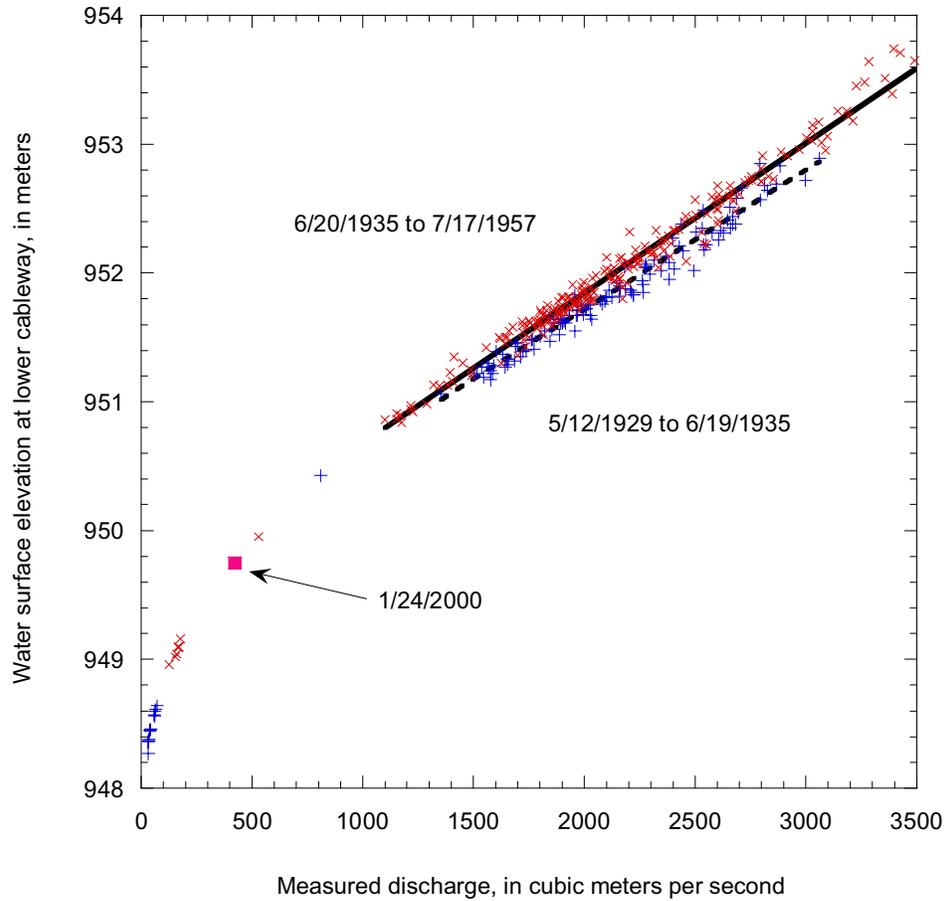
Figure C1. Rating curve showing water surface elevation as a function of discharge at the Lower Cableway from 1929 to 1957. The data were divided into two time periods and fit to separate linear relations for elevations above 950.8 m. At elevations below 950.8 m, there is no shift in the rating relation. The elevation measured in 2000 fits on this relation.

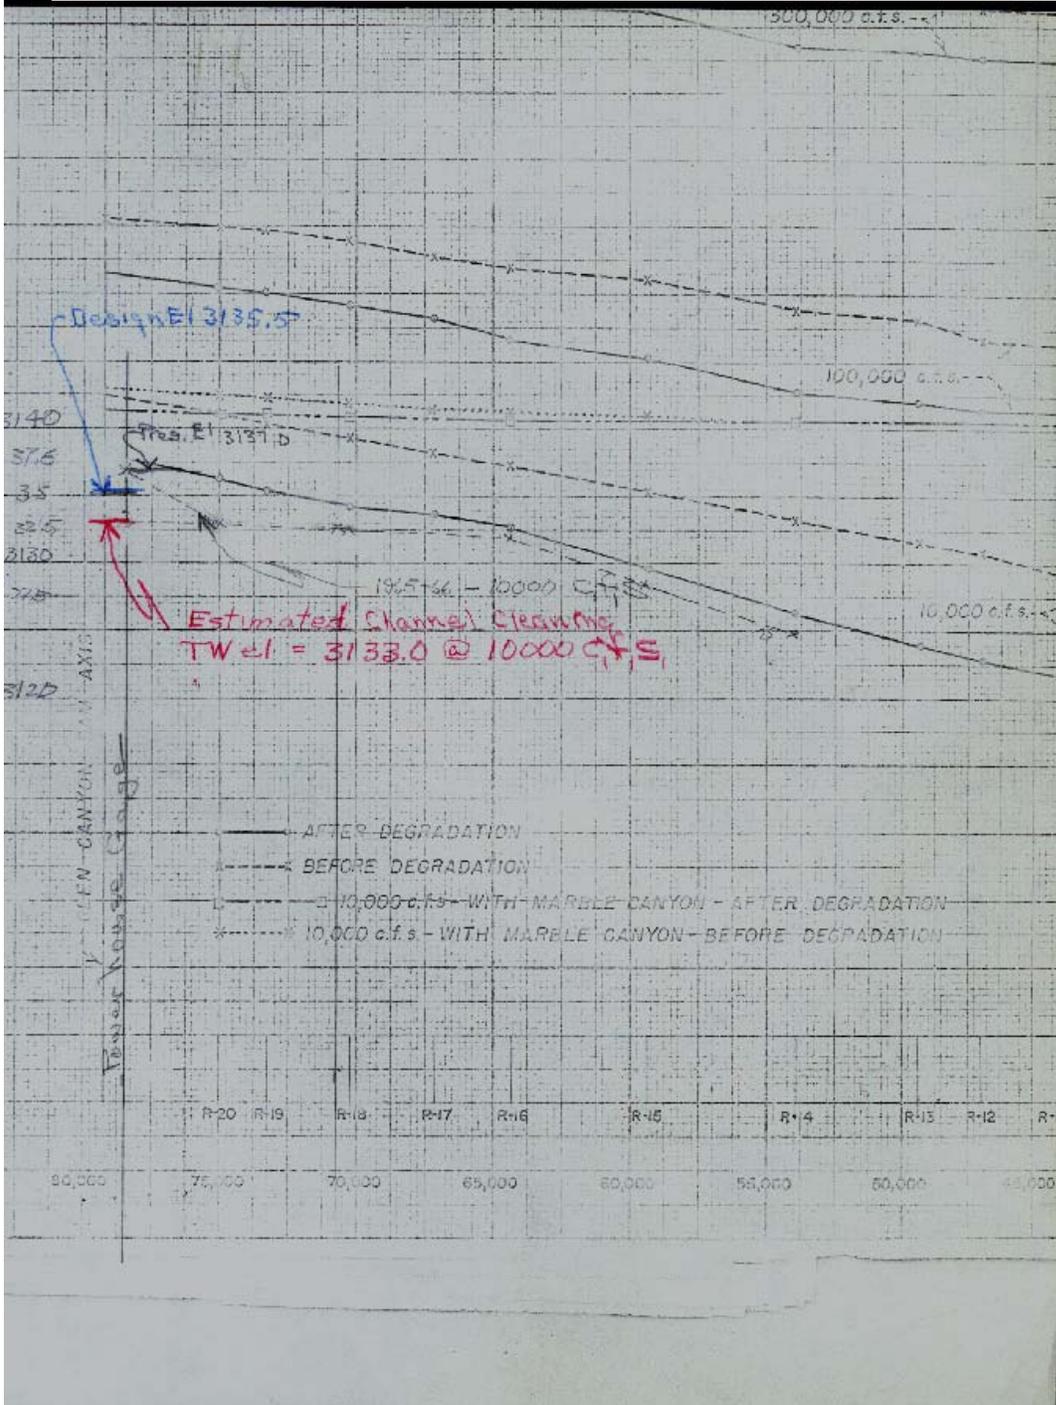
(a)

Appendix E: Bureau of Reclamation Documents. Diagram of the bed elevation immediately below the dam with handwritten notes indicating the “present” elevation, the “design” elevation, and the estimated “channel-cleaning” thalweg elevation (a). Computation sheet describing the effects of thalweg, “TW” lowering (b).
