**Heart
Mountain
Irrigation
District**

FY 2018

**Rattlesnake Canal Liner
Phase I Project**

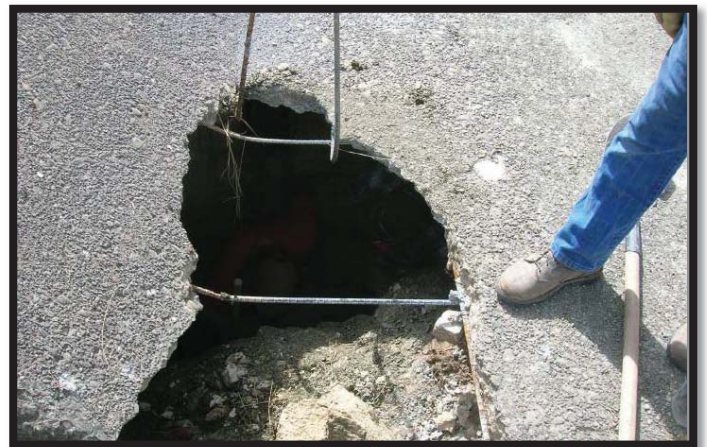
Photo 1 Void within the floor of the Rattlesnake Liner

There are so many caverns and voids under the canal that the liner is weak and eroding. The District has made many repairs to the canal over the past 20 years, but the repairs do not seem to resolve the issues that keep returning no matter what they do; largely because the issues have to do with the fundamental way in which the canal was originally built.

On February 18, 1997, the District did a process called “sounding” to identify potential voids and caverns under the concrete liner. Sounding involves striking the concrete surface and interpreting the sound produced. Solid concrete will produce a ringing sound, while concrete that is delaminated, spalled, or has separated from the base material will produce a flat or hollow sound. Subgrade voids will also produce a flat or hollow sound. Numerous locations were identified as having potential voids. District personnel then used a hammer drill to check these areas for voids. Three sections were chosen to be removed because of significant voids. Since 1997, the District

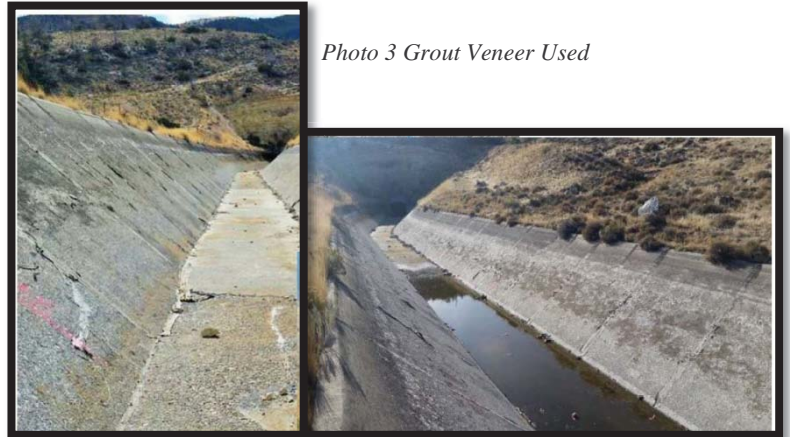
Photo 3 Grout Veneer Used

has tried many ways to fix the liner. Some of these include pouring new concrete liner sections, using asphalt crack repair, applying polyurethane coating to random crack and cold joints, using hot tar for cold joints, dumping cement grout into caverns as they surfaced, and placing grout veneer along the floor of the canal. Still, many breaks, leaks, and voids have continued. Many of these fixes have caused even more problems.

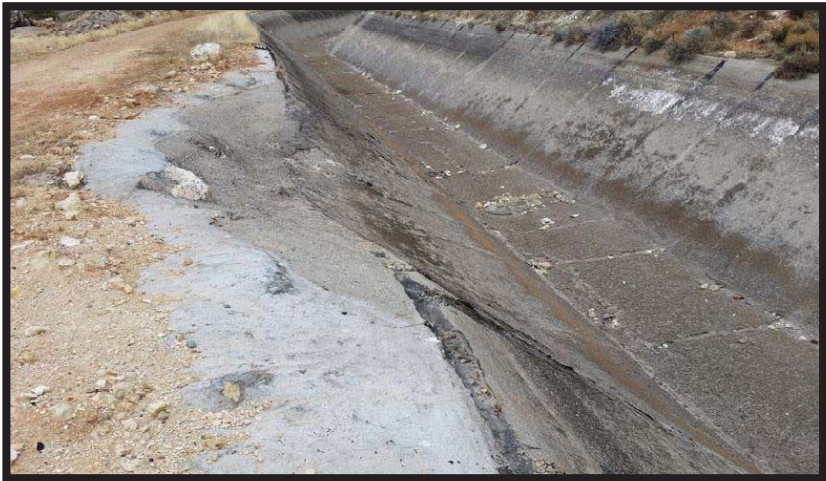
Photo 6 Canal Liner Collapse in 2011 at Station 30+92

It is estimated that this lining project will have an impact on water savings, especially as we complete all three phases. However, this phase will have an estimated savings of 211 acre-feet of water annually through the first section of canal associated with this project. The first section of the canal liner has had a number cracked panels (see Figure 2 below), leaks, breaches, and large voids. In 2011, a major failure of the canal liner occurred at Station 30+92. On July 27, the canal flow was recorded at 904.79 cfs. This caused a breach. The water flowed over the top of the liner and eroded the material

behind it to the point that the canal liner collapsed. The District shut down the canal for two days to repair the collapse. From discussions with the former District Manager at the time of the failure, a cavern that was found behind the liner was large enough that a person could walk into it and stand. Over 200 cubic yards of cement grout was pumped into the cavern, leaving the existing liner in place, as shown in Photo 6. The water losses could be much higher. However, based on the best information available to HMDI, they feel that this estimate of 211 acre-feet will be saved as a direct result of this project.

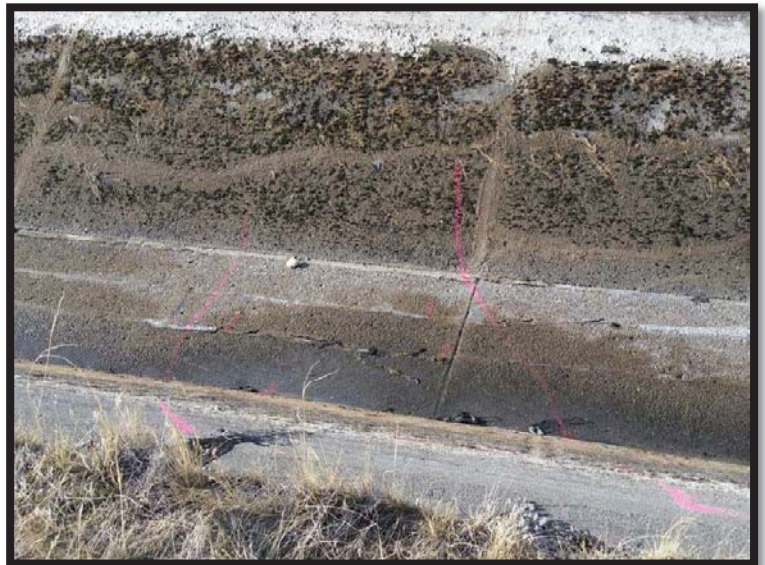
Photo 7 Cracked and broken liner

Liner Failure: In 2011, a major failure of the canal liner occurred, causing a breach. The water flowed over the top of the liner and eroded the material behind it to the point that a portion of the liner collapsed. The District shut down the canal for days to repair the collapse, leaving over 30,000 acres without irrigation water. A more recent canal failure occurred multiple times during the 2017 irrigation season, prompting days without water during this critical time. This has been happening over the past twenty years, but over the past five to ten years, the number of shutdowns has been increasing with each irrigation season. When a leak occurs, it causes massive voids under the liner that initiate the failure of the liner.

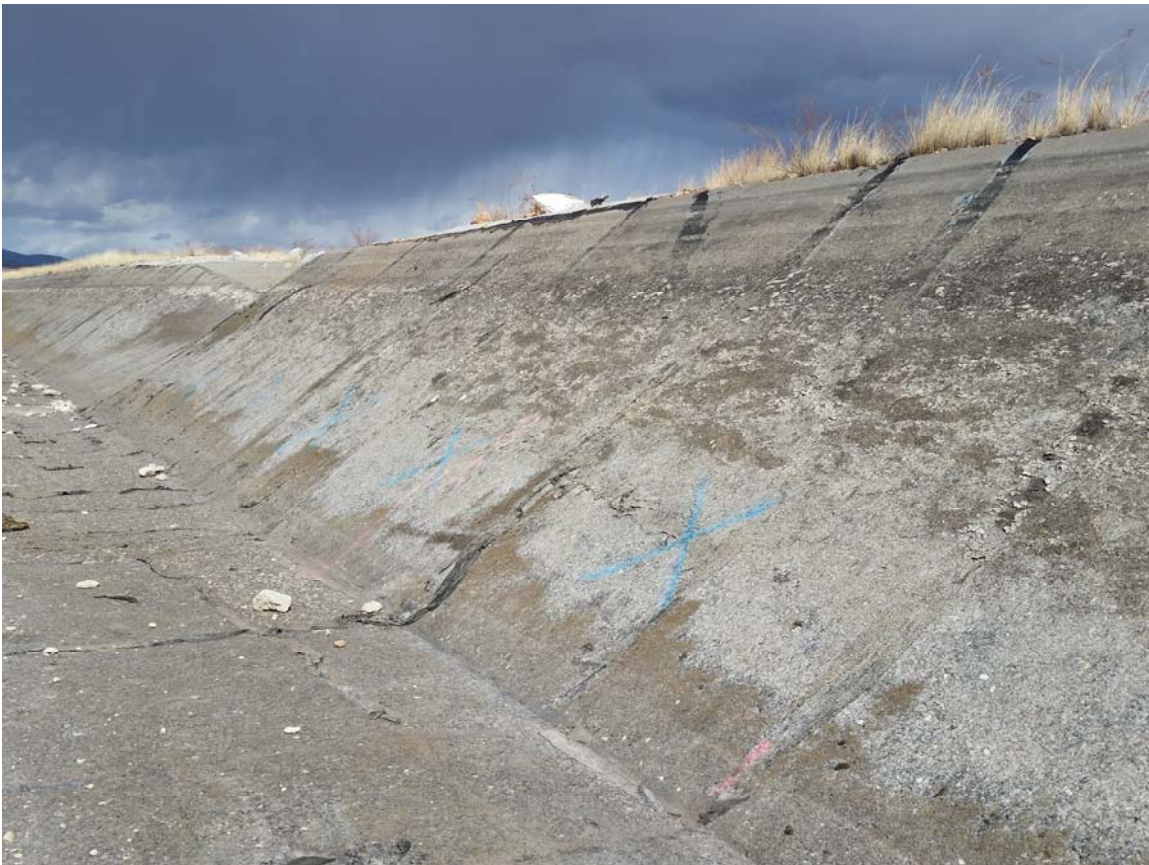
Figure 2

The concrete lined section of the HMID canal was visually inspected in dry condition from November, 2015 to March, 2016 and during the irrigation season from July, 2015 to September, 2015. During the dry inspection, large cracks, exposed rebar, and deteriorating concrete were located at numerous locations. 95 concrete panels on the west side of the liner and 87 concrete panels on the east side of the liner have extensive cracking.
