**CANAL-LINING DEMONSTRATION PROJECT
YEAR 7 DURABILITY REPORT**

September 1999

**U.S. DEPARTMENT OF THE INTERIOR
Bureau of Reclamation**

**Pacific Northwest Region
Water Conservation Center**

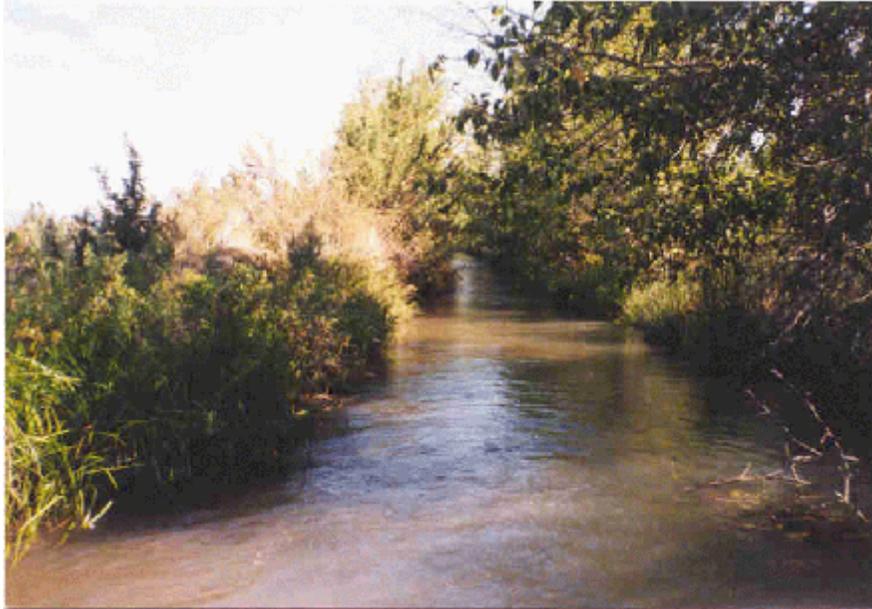
Photograph 1.—Preconstruction conditions at Juniper Flats. Vegetation had overgrown the canal, and large trees lined the canal banks.

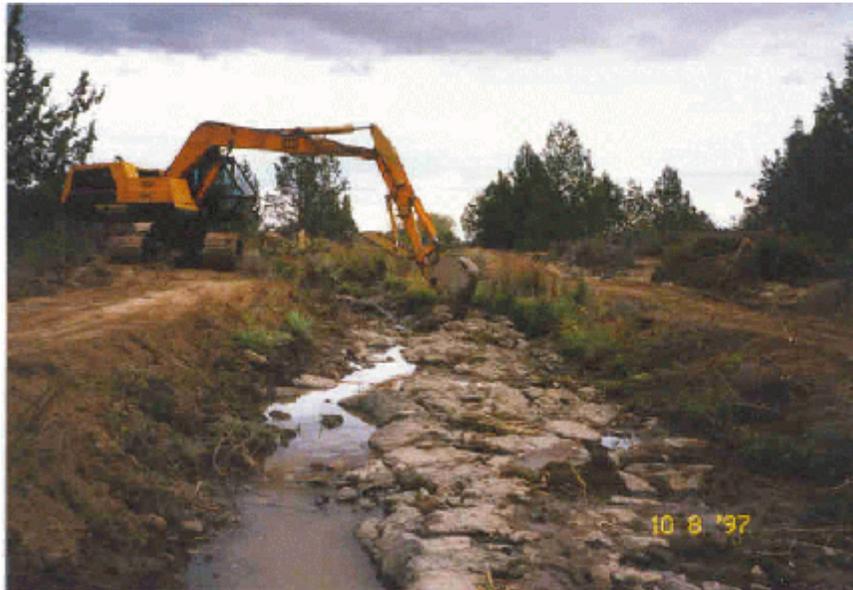
Photograph 4.—Station 12+00 - Trackhoe unsuccessfully attempts to remove rock outcroppings that are restricting flow in the canal invert.

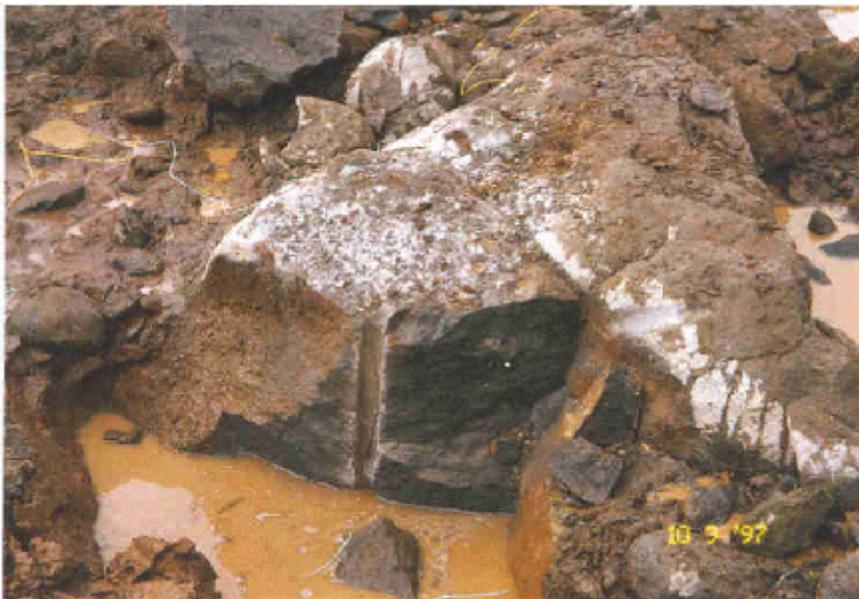
Photograph 8.—Fractured rock in canal invert after blasting.

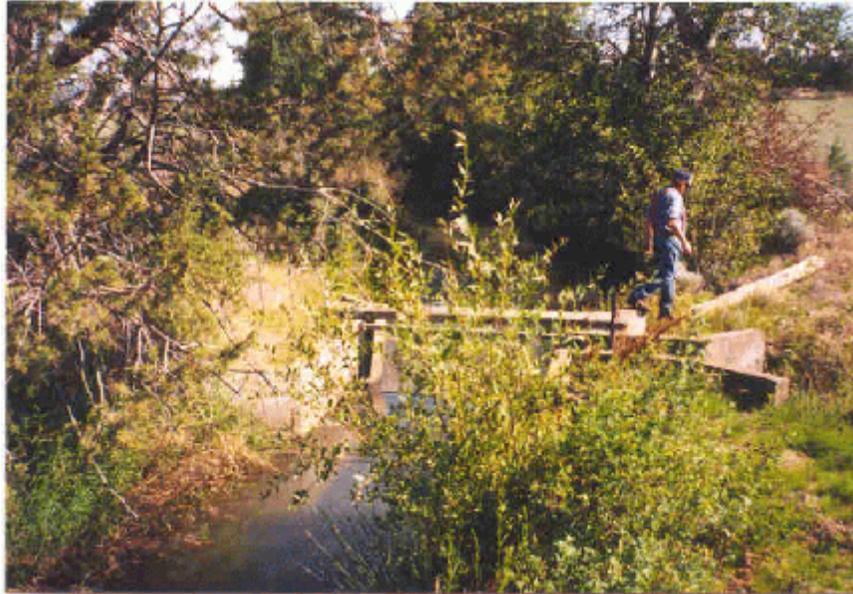
Photograph 19.—The Walters Turnout at station 0+00 was overgrown with vegetation.

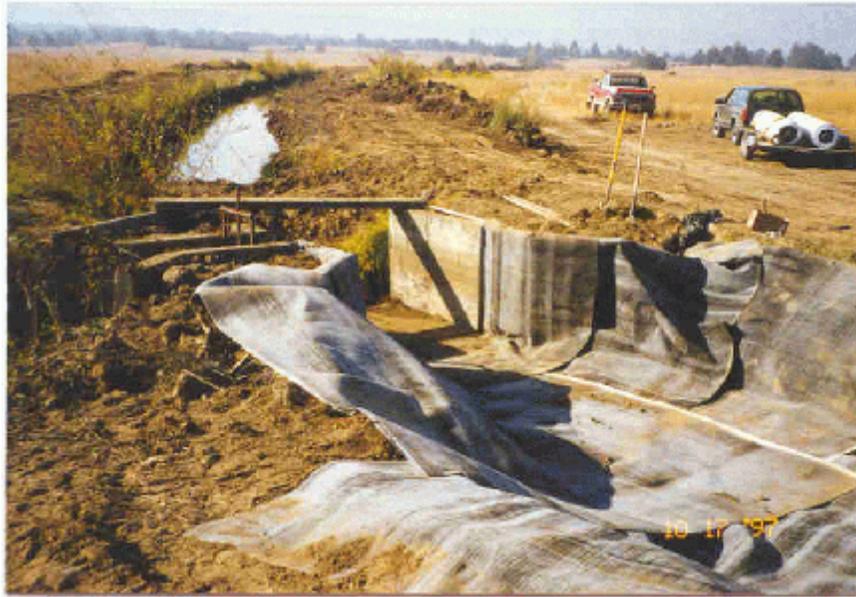
Photograph 21.—Teranap has been installed in the downstream portion of the Walters Turnout.

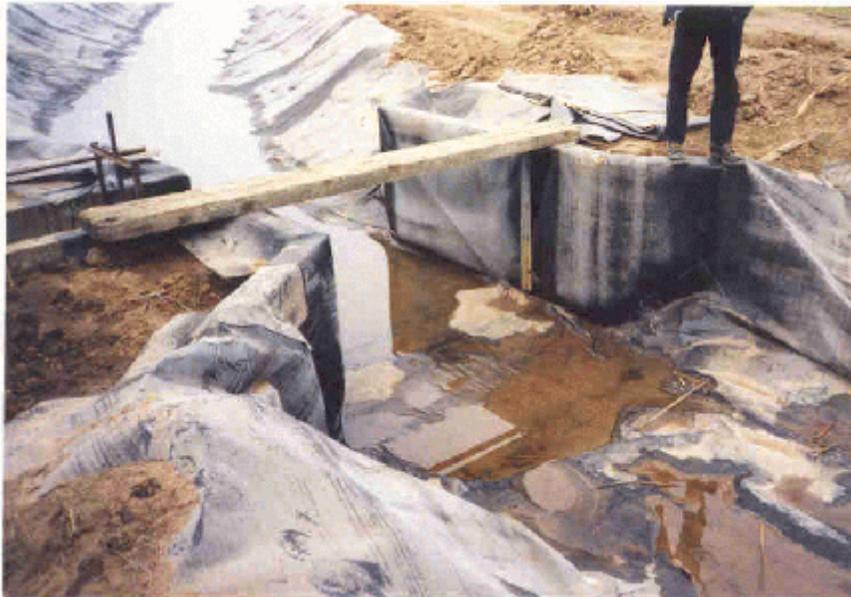
Photograph 22.—Teranap is bolted to the concrete turnout structure with existing stoplog supports used as batten strips.

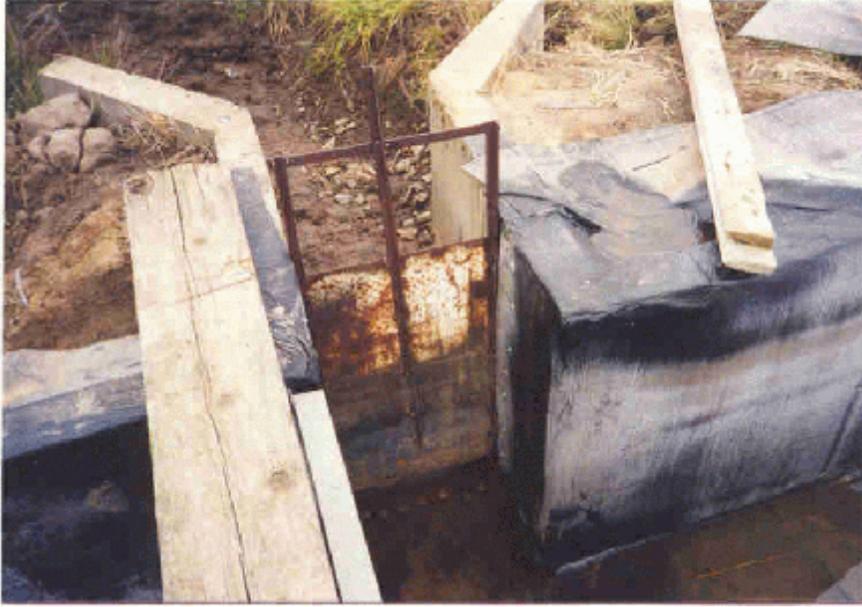
Photograph 23.—Closeup of the bolted attachment of the Teranap to the turnout.

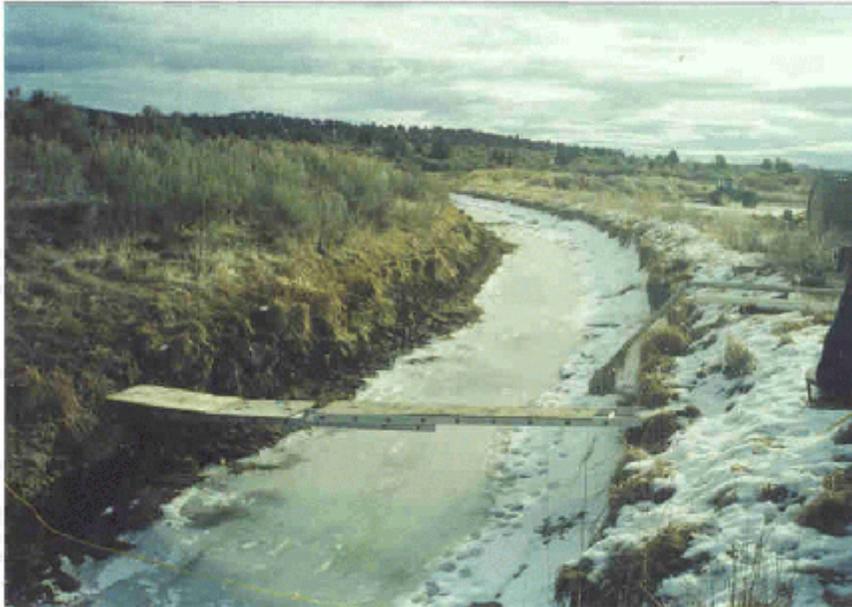
Photograph 24.—Unlined canal prior to construction of GCL test sections.

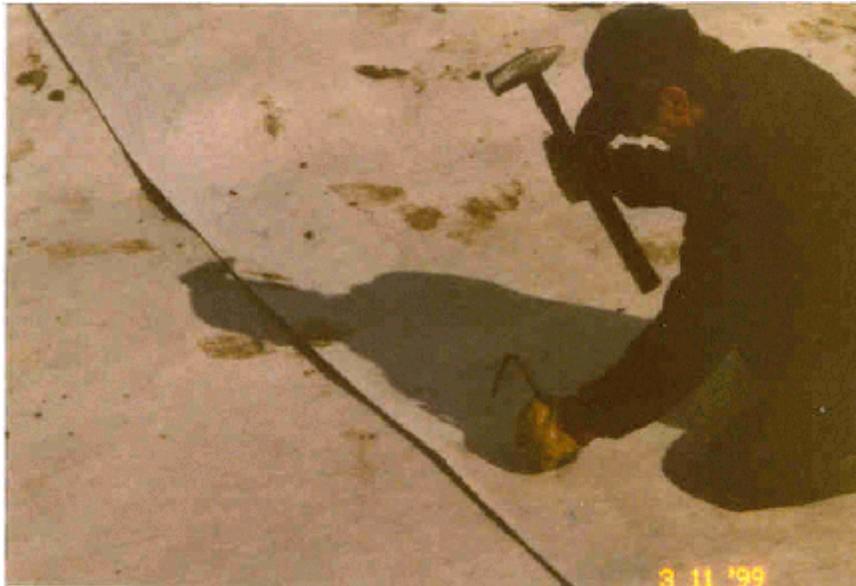
Photograph 32.—In the exposed application, four pins were used to secure each seam. No. 3 rebar was originally used, but it was too weak.

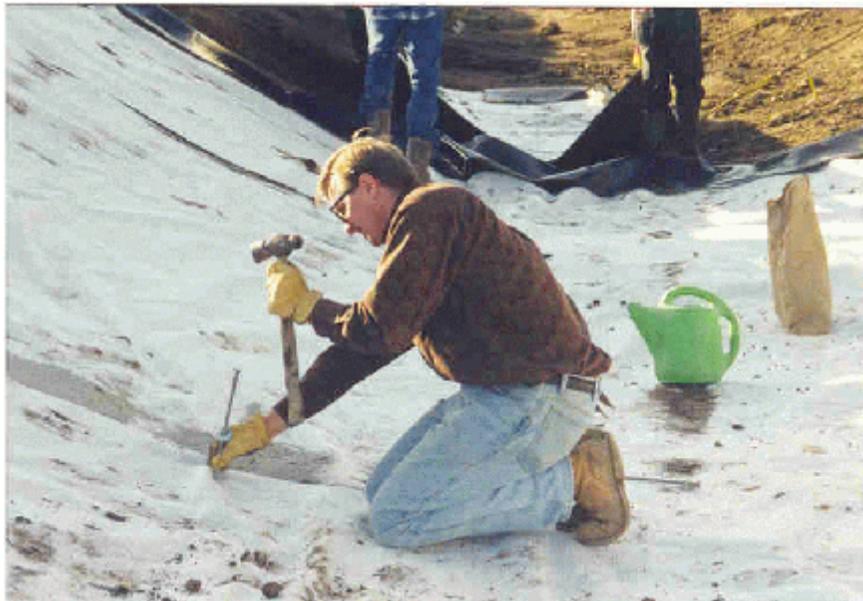
Photograph 33.—Three-eighths-inch spikes with 2-inch washers used to secure seams and patches in the exposed GCL test sections.

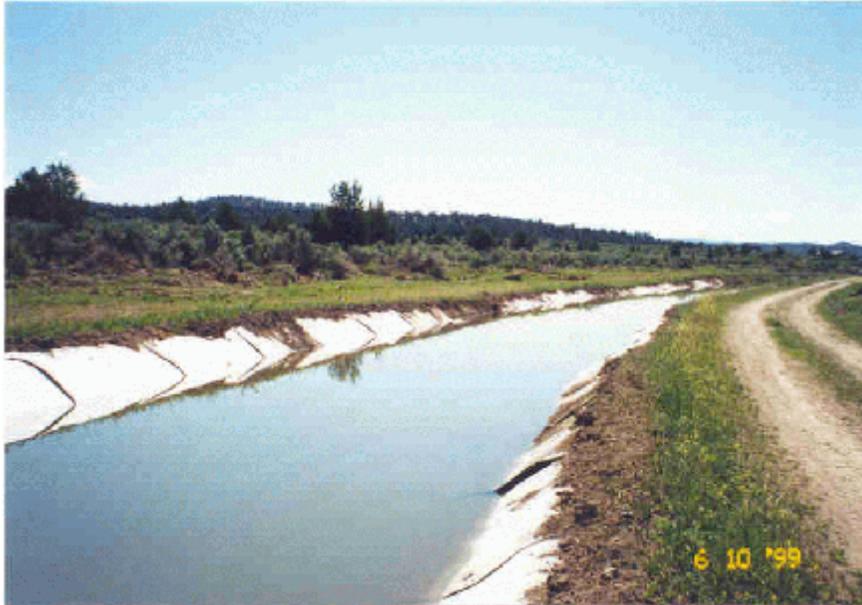
Photograph 40.—Exposed seam edges are curling after 2 months' service. Curling edges are more prevalent in the exposed Bentomat CL than in the Bentomat DN.

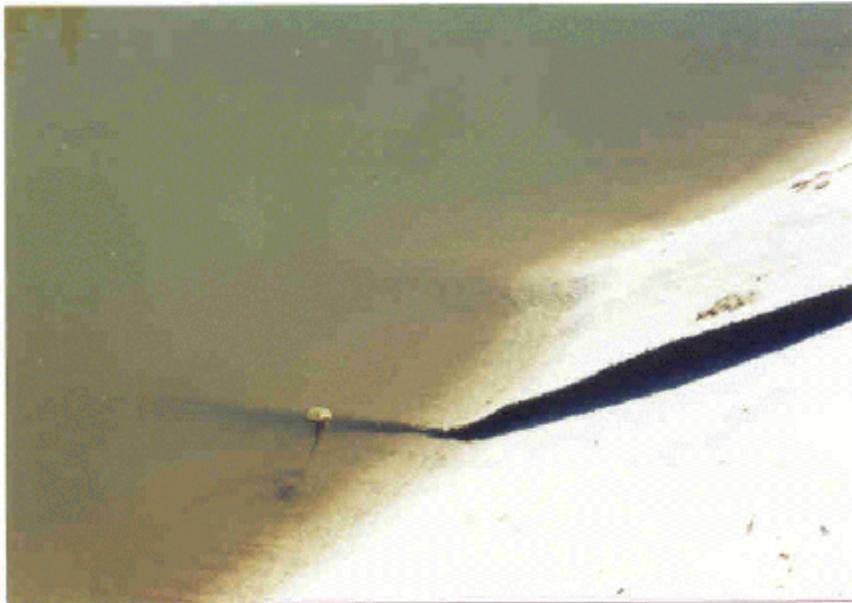
Photograph 41.—Closeup of curled seam edges in exposed CL test section.

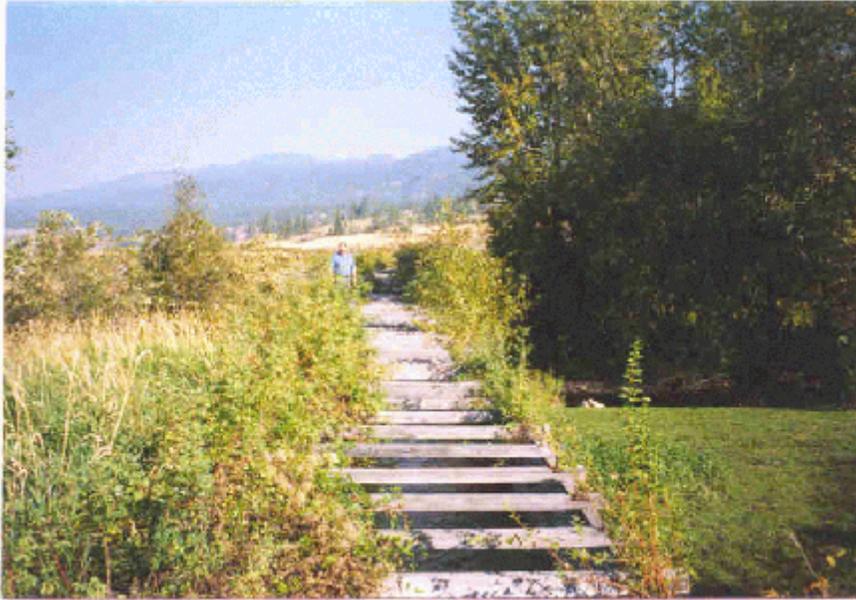
Photograph 42.—Preconstruction conditions at Mill Creek Flume.
Vegetation had overgrown flume along both sides.

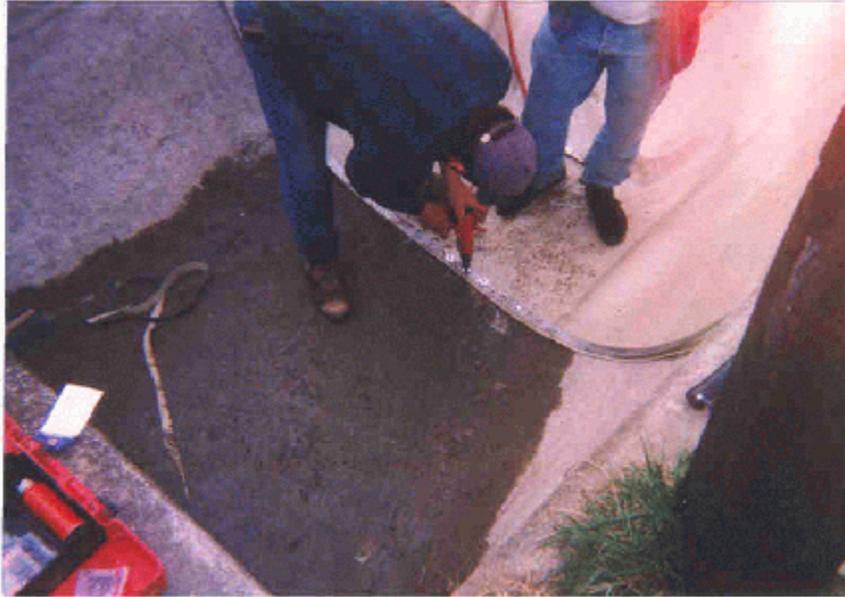
- The PP geomembrane was attached to the upstream concrete transition with a stainless steel batten, and attempts were made to attach the battens trip with concrete nails from a Hilte gun. However, the Hilte gun could not set the nails into the old concrete. Instead, it was necessary to attach them with drilled concrete anchors on 6-inch centers.

Photograph 58.—Crew attempts to use Hilti gun to attach liner to the concrete upstream transition. Hilti gun could not set the nails into the old concrete.

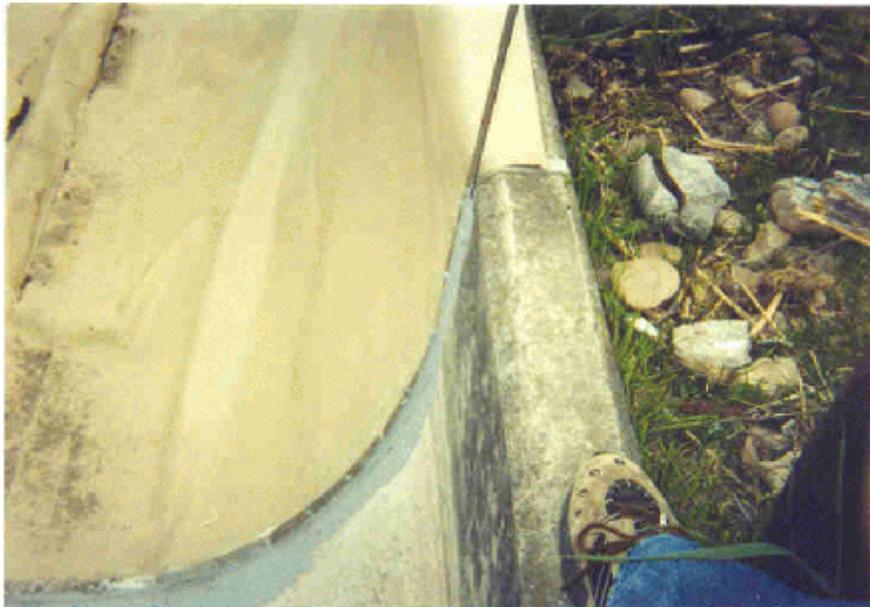
Photograph 59.—Stainless steel batten attached with drilled concrete anchors. Calking was also used for additional seepage protection.

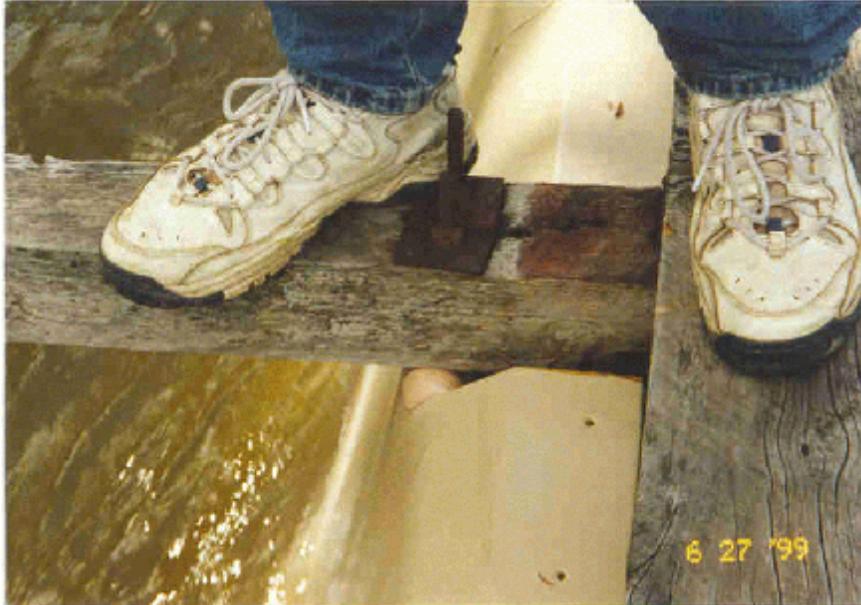
Photograph 64.—Closeup of the liner stretched tight, compressing the pipe insulation over edge of flume.

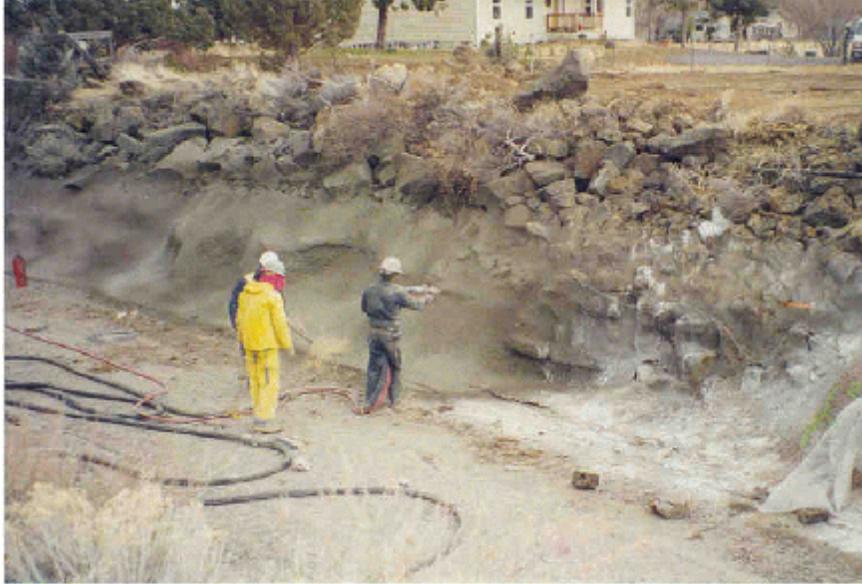
Photograph 76.—New shotcrete applied over old shotcrete, estimated to be about 45 years old.

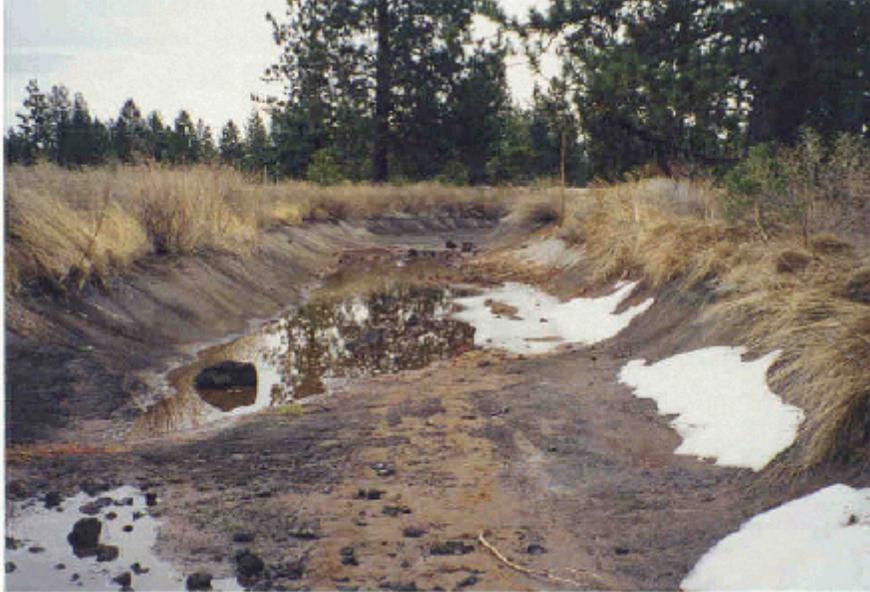
Photograph 79.—Excellent condition after 7 years of service - shotcrete in the first 400-ft section is unreinforced.

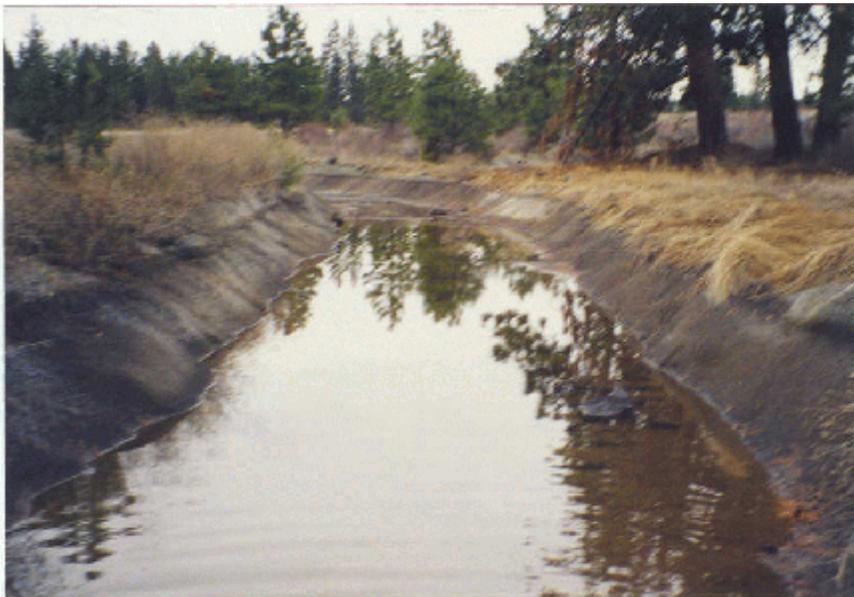
Photograph 80.—Excellent condition after 7 years of service - shotcrete in the second 600-ft section is reinforced with polyfibers.

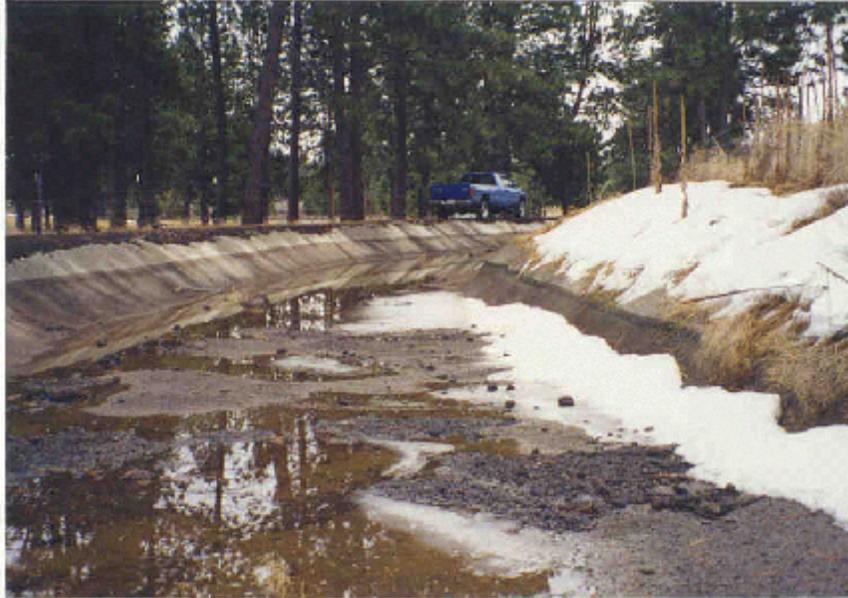
Photograph 83.—Canal overview - Excellent condition after 6½ years of service.

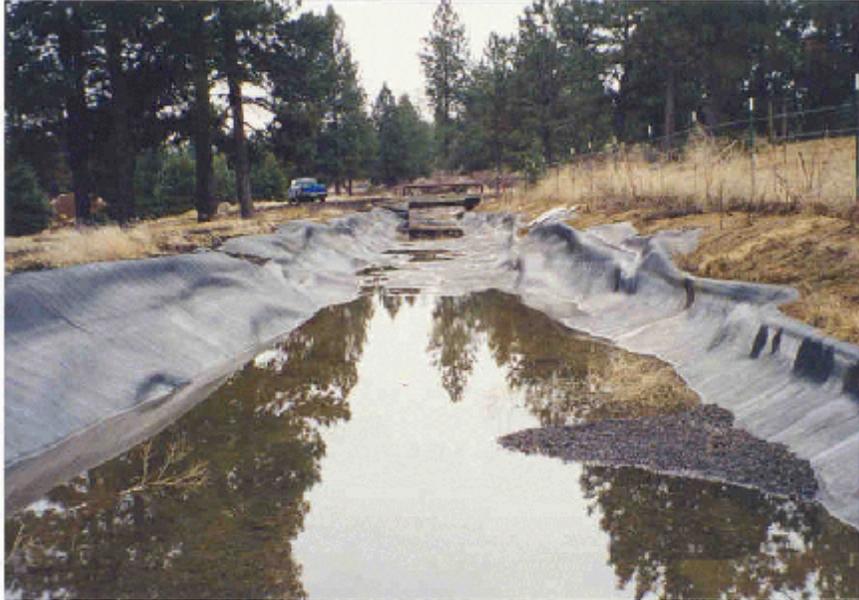
Photograph 87.—Canal overview - Very good condition after 6½ years of service.
Note the high waterline shows little available freeboard.

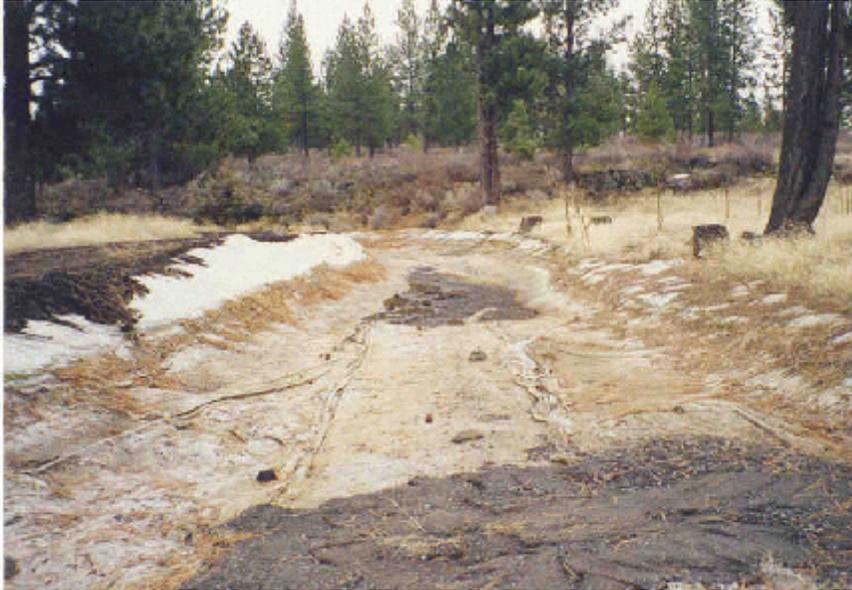
Photograph 89.—Canal overview - Very good condition after 7 years of service.

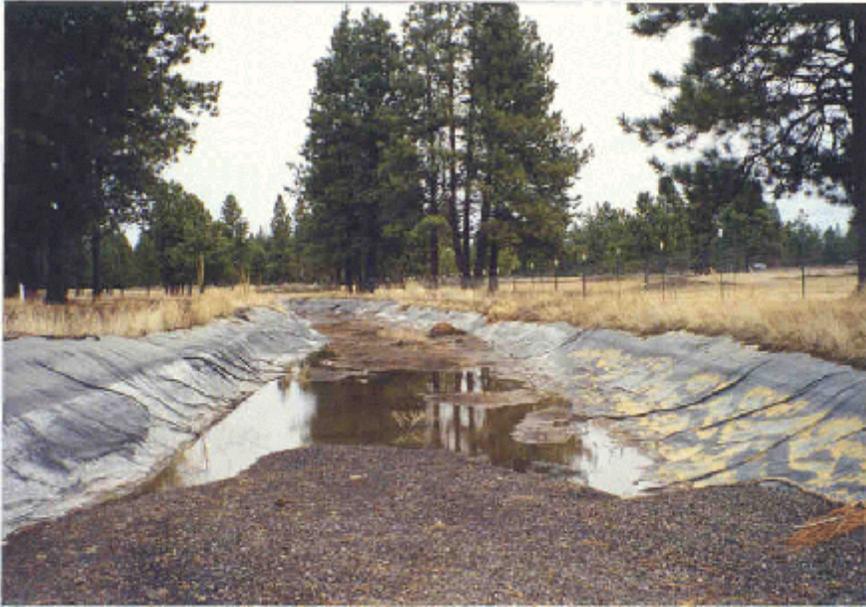
Photograph 95.—Canal overview - Very good condition after 7 years of service.

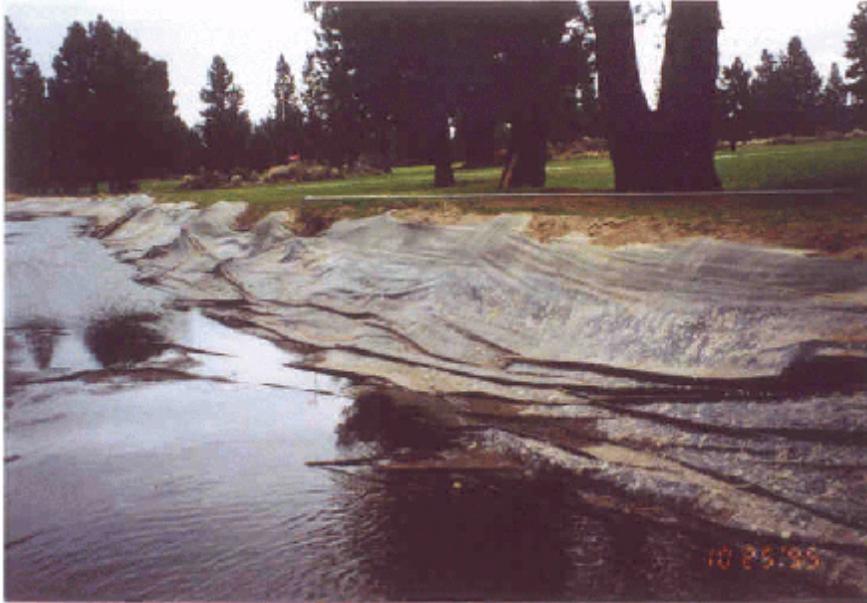
Photograph 97.—Sloughing of the embankment beneath geomembrane liner (station 33+00 to 35+50).

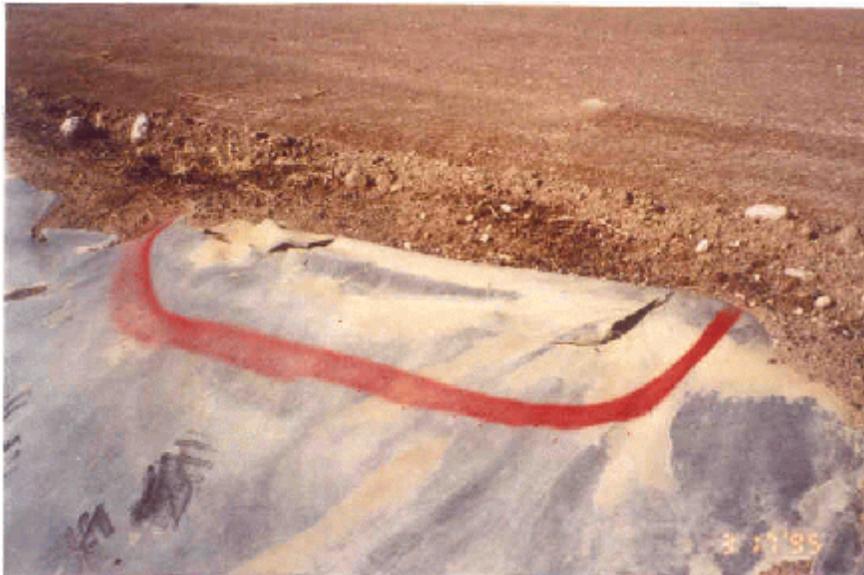
Photograph 98.—Two small tears near the anchor trench.

A small tear in the Hypalon at the anchor trench (station 35+00 left) needs to be repaired. Five or six small tears in the invert were patched in Spring 1994 around the golf course turnout at station 35+50. All the patches look good and are holding up well. At station 39+90, a large tear on the left bank (probably caused by a backhoe during dike removal) needs to be repaired. A couple of survey stakes were found at the top of the bank on the left side. At station 39+95, several large cuts were made to relieve trapped water. These cuts allow some water to leak out of the canal, but they also allow any water trapped beneath the liner to escape. These tears need to be repaired to more fully evaluate the performance of the exposed hypalon liners. At station 40+00, the Terra-Tuff liner is connected to the adjacent grout-filled mattress (Test Section 7) by batten strips, which are functioning satisfactorily. In the future, any dikes built between Test Sections 6 and 7 should be constructed on the grout-filled mattress in Test Section 7, not on the exposed hypalon in Test Section 6.

Needed: Patch several small tears and cuts, especially at the downstream transition. Again, the district plans to remove sediment to improve flow, and great care should be taken to prevent damage to the exposed liner.

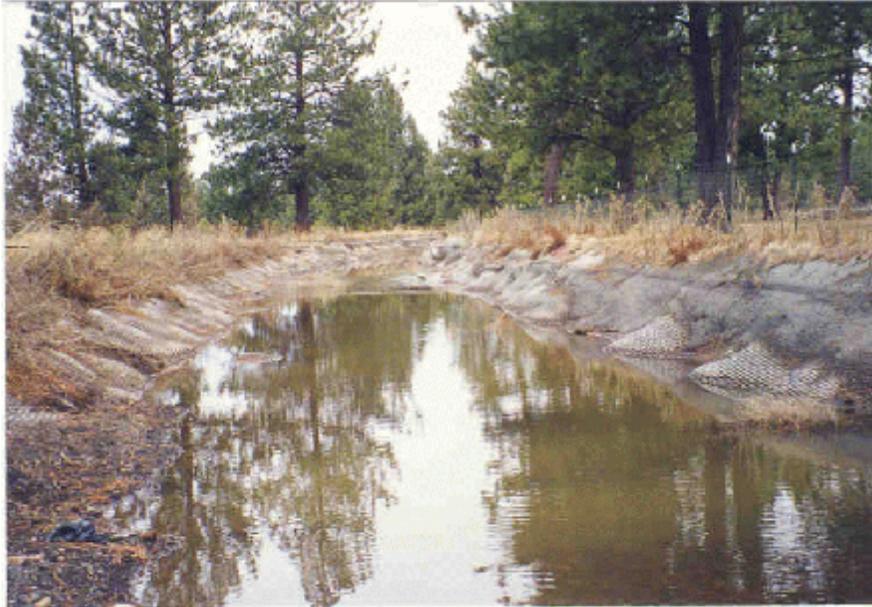
Photograph 101.—Canal overview - Excellent condition after 7 years of service. The first 500 feet of this test section has a significant amount of sediment and standing water.

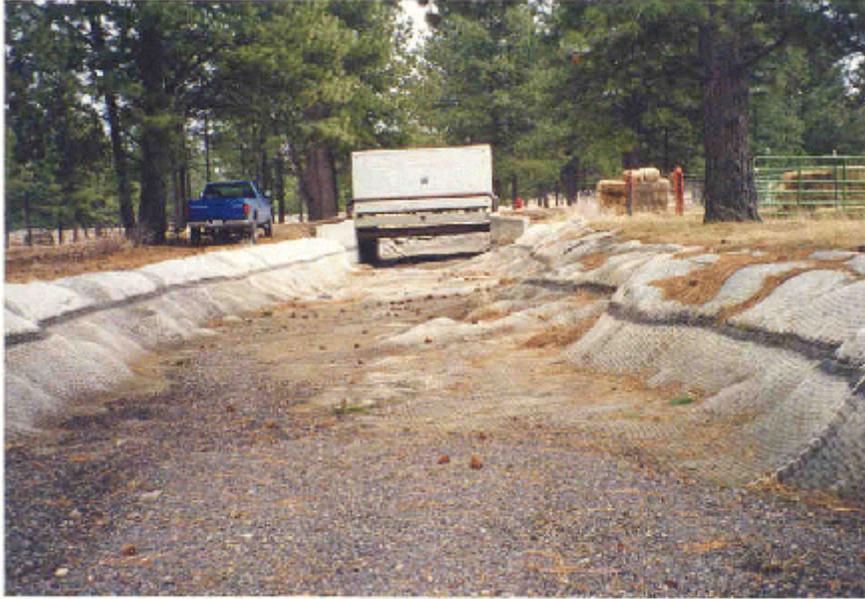
Photograph 105.—Canal overview - Excellent condition after 7 years of service.

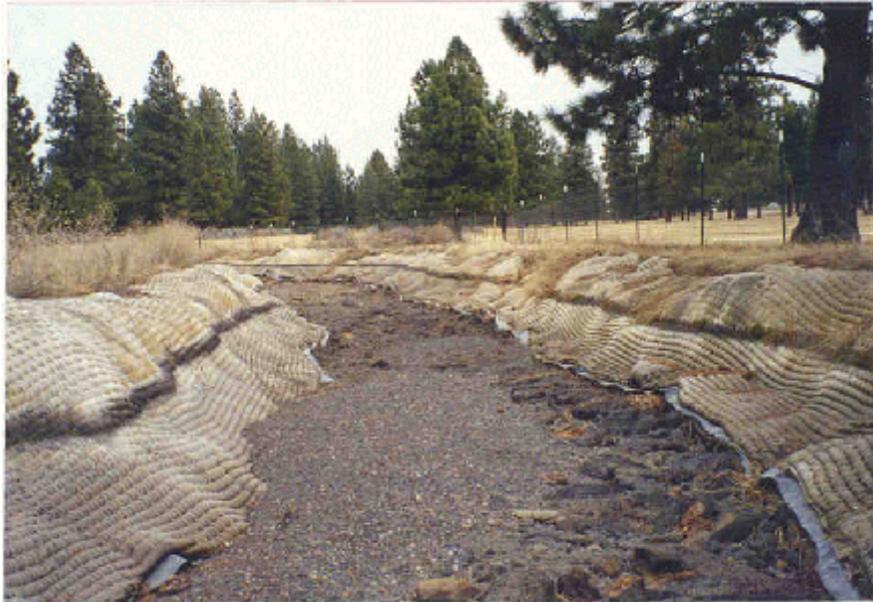
Liner “whales” caused problems in these test sections from the first water run. Several attempts were made to repair this test section, but none were successful. Unfortunately, the cause of the “whales” was never resolved. Volcanic gases are suspected to be the cause.

Photograph 107.—Canal overview - Removed from study after 2½ years of service. Geomembrane liner in the invert was removed in spring 1995 because of liner “whales” impeding flow.

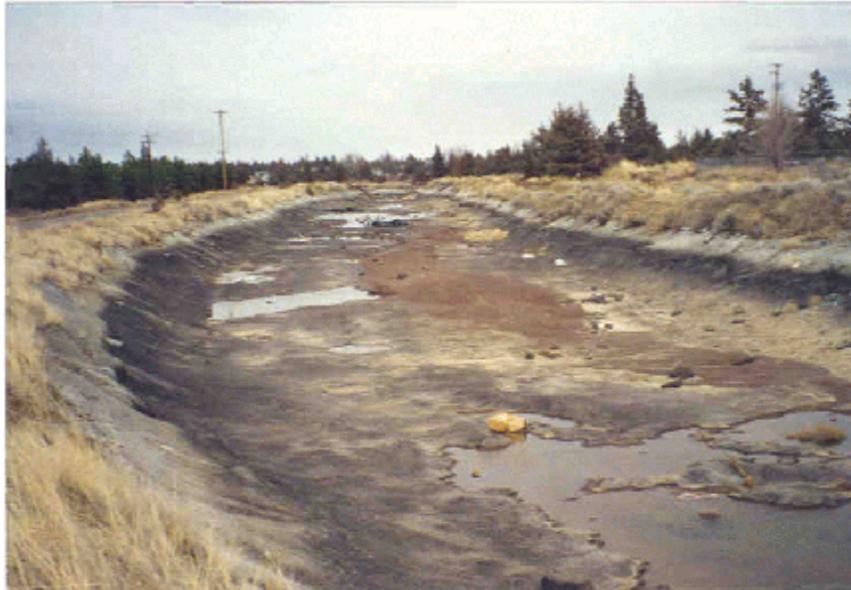
Photograph 108.—Canal overview - Excellent condition after 7 years of service.

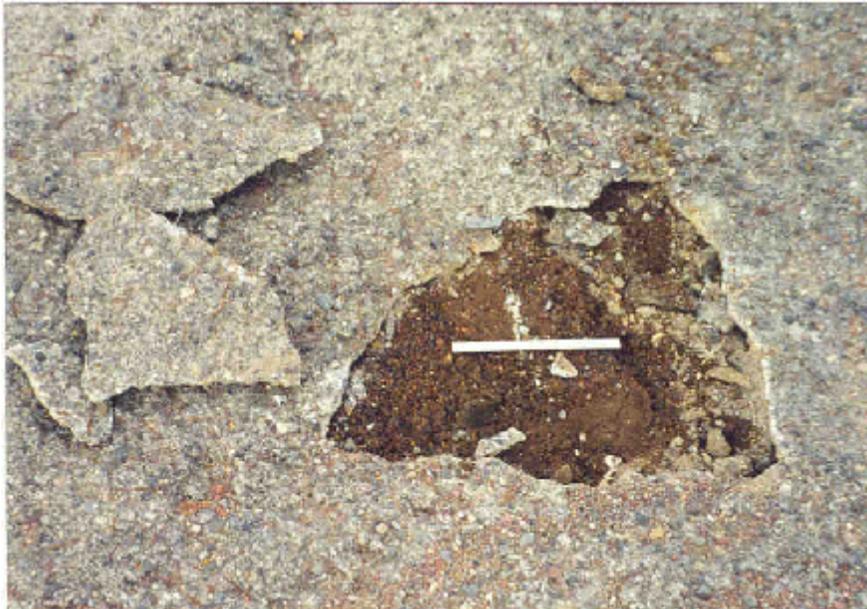
Photograph 111.—12-inch-diameter hole in shotcrete lining.
Shotcrete is less than 1 inch thick at this location.

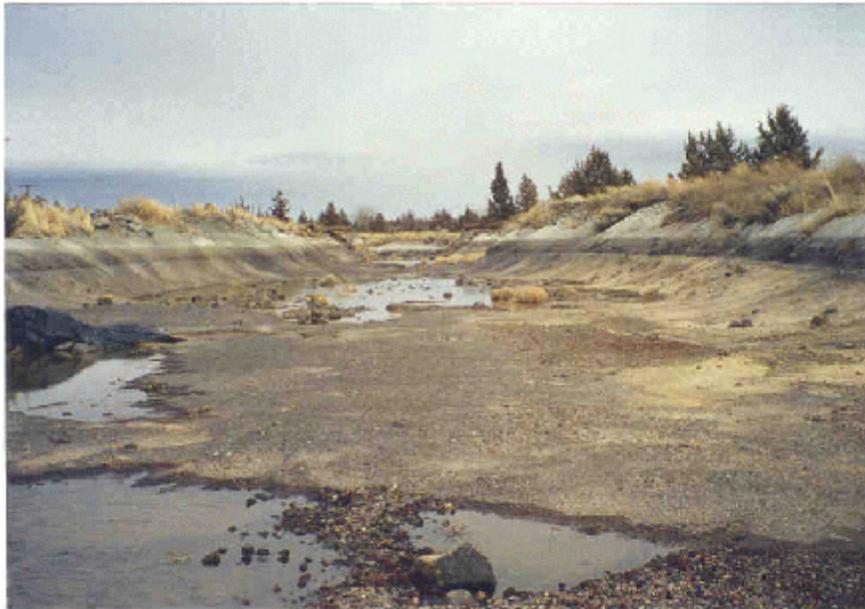
Photograph 114.—Canal overview - Excellent condition after 7 years of service.

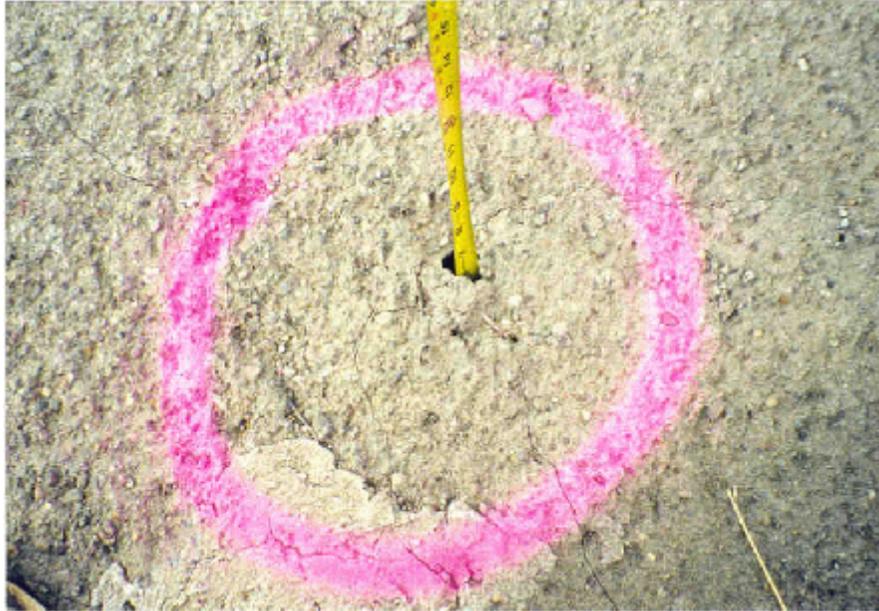
Figure 116.—Void beneath small hole in shotcrete lining is about 6 inches deep.
Extent of void is unknown.

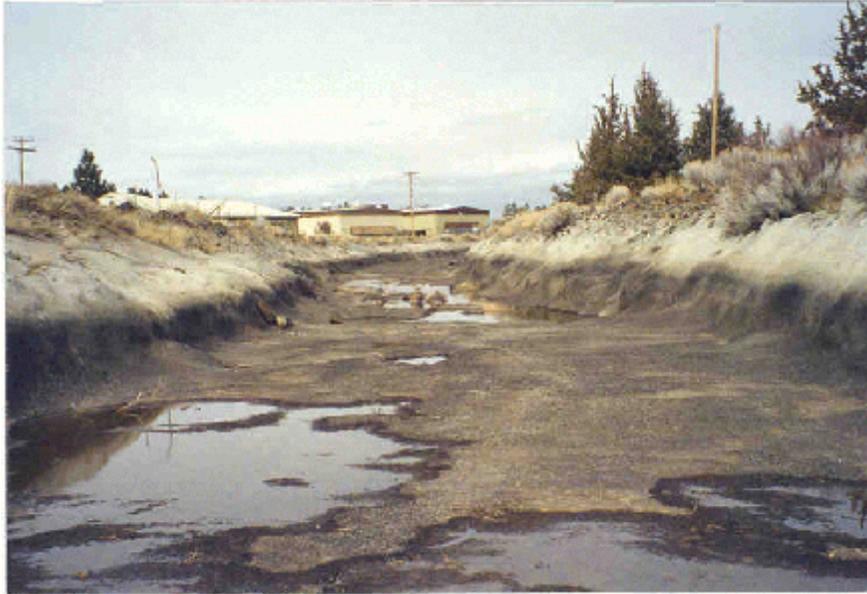
Photograph 117.—Canal overview - Excellent condition after 7 years of service.

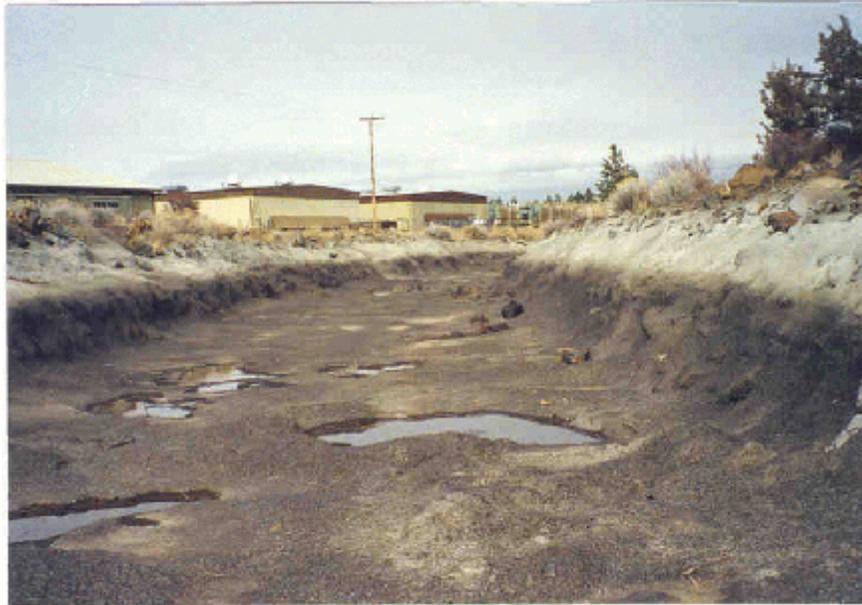
Photograph 120.—Canal overview - Excellent condition after 7 years of service.

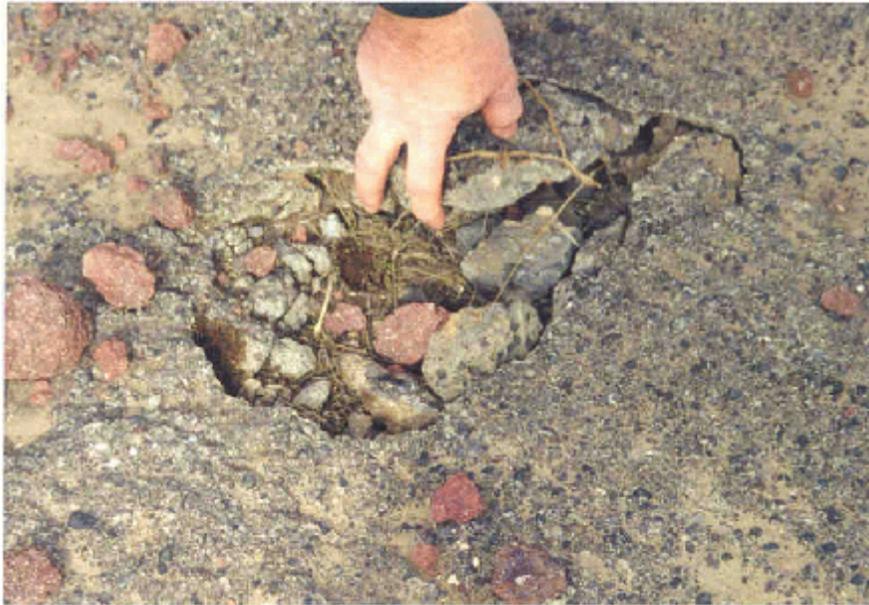
Photograph 122.—Closeup of 1-ft-diameter hole in shotcrete lining.
Shotcrete is less than 1 inch thick.

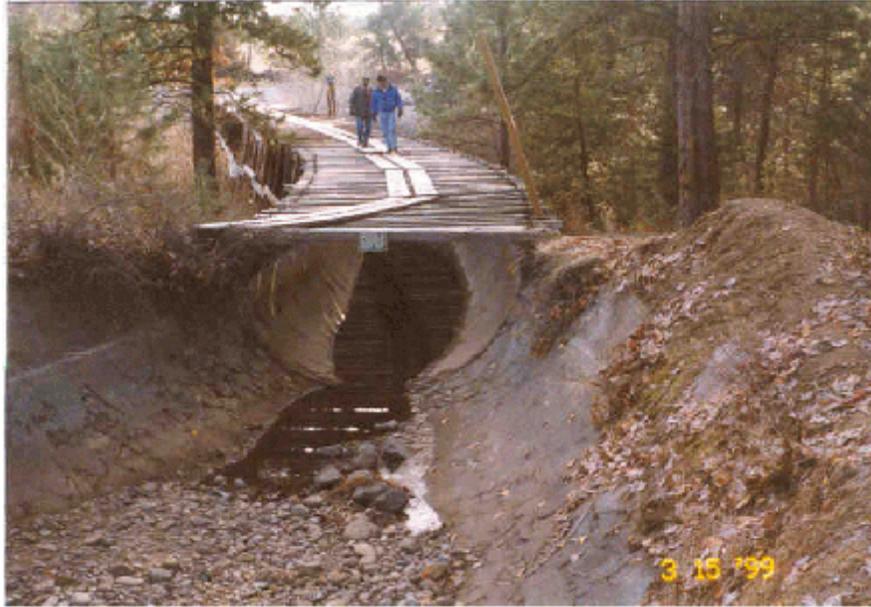
Photograph 123.—Flume overview - Very good condition after 5 years of service, with no leaks.

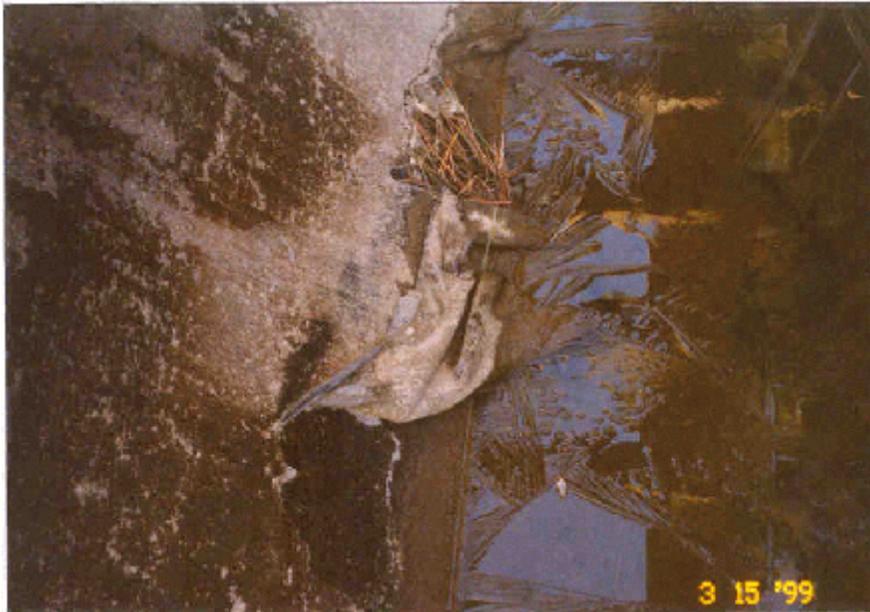
Photograph 125.—Large blister in the invert.

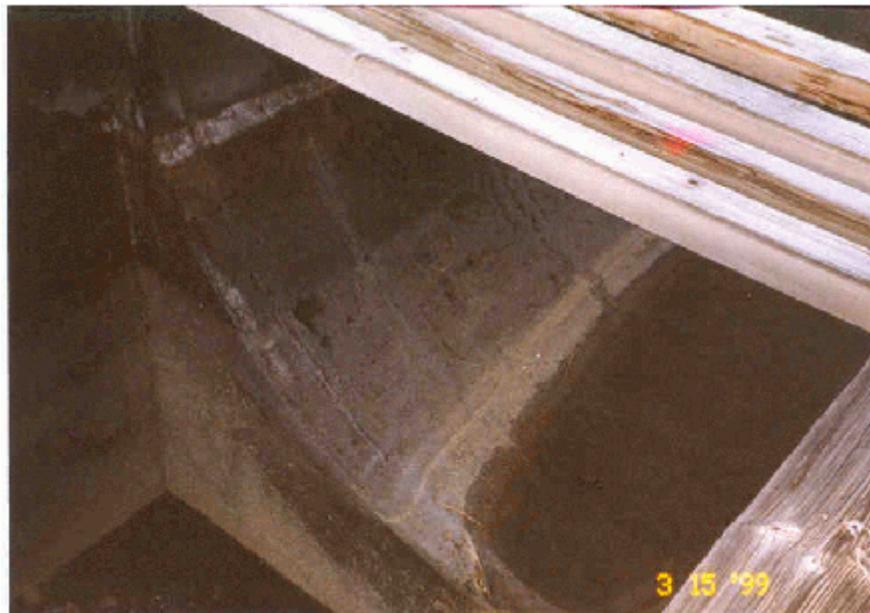
Photograph 126.—Liquid Boot and geotextile used at the cleanout drain are holding up well.

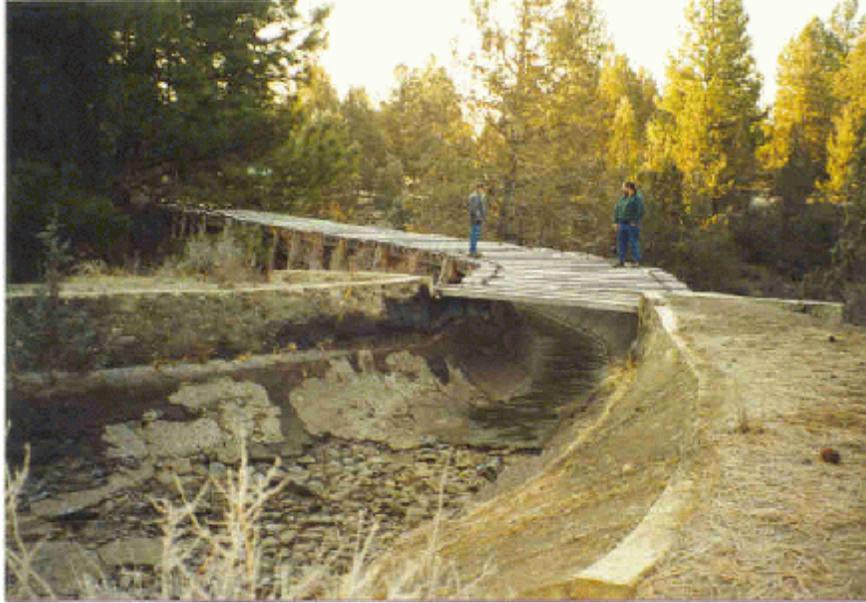
Photograph 127.—Flume overview - Very good condition after 4 years of service.

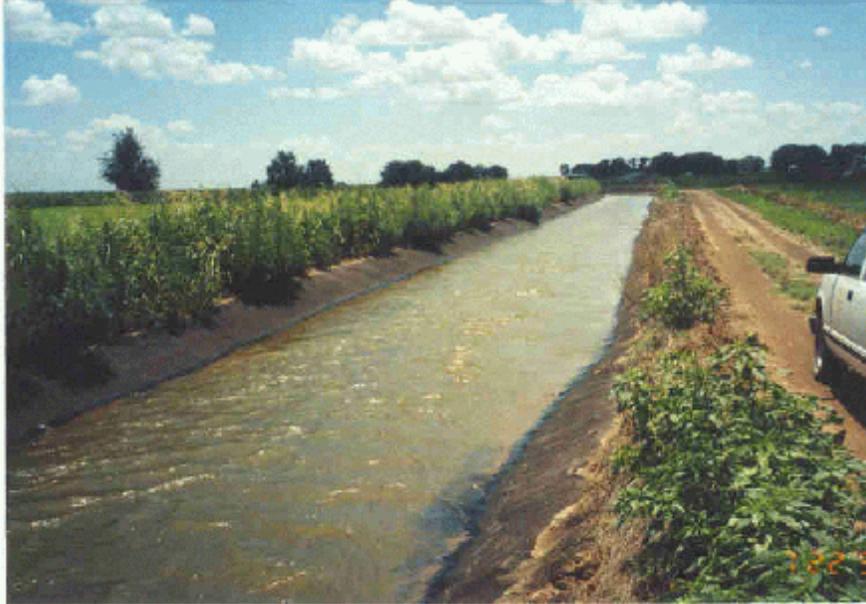
Photograph 129.—Canal overview - Very good condition after 5 years of service.
(Photograph courtesy of Lugert-Altus Irrigation District).

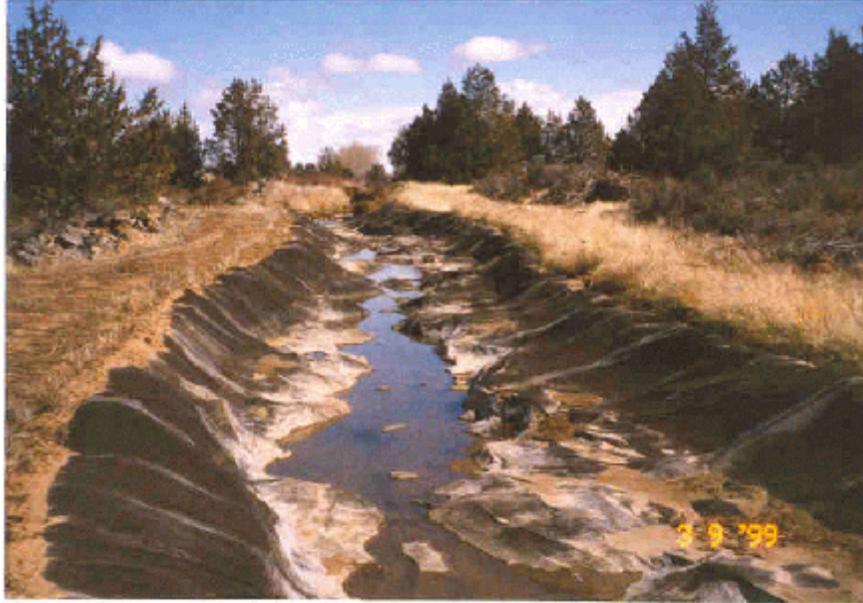
Photograph 131.—Canal overview - Very good condition after 1½ years of service.
