**CANAL-LINING DEMONSTRATION PROJECT
YEAR 7 DURABILITY REPORT**

September 1999

**U.S. DEPARTMENT OF THE INTERIOR
Bureau of Reclamation**

**Pacific Northwest Region
Water Conservation Center**

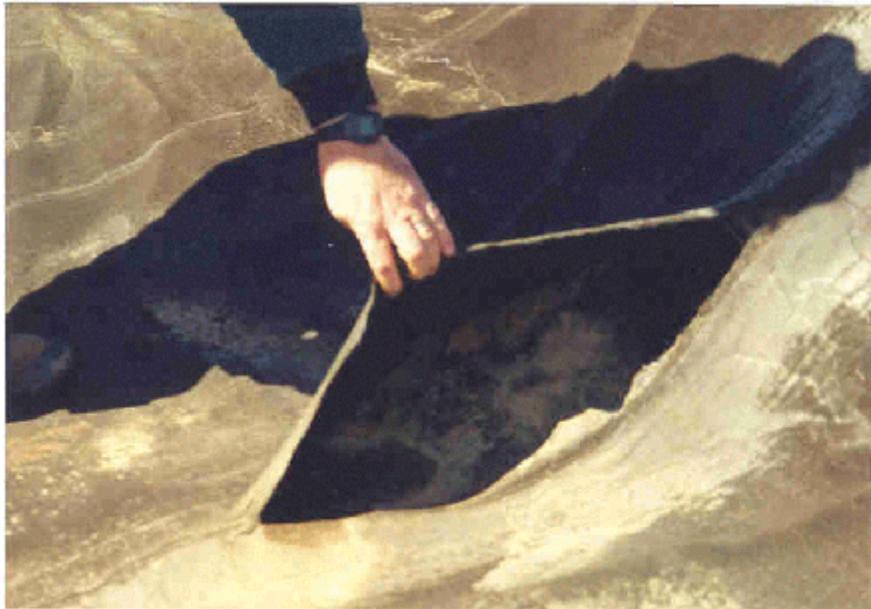
Photograph 133.—Largest unbonded seam measures about 2 feet long.

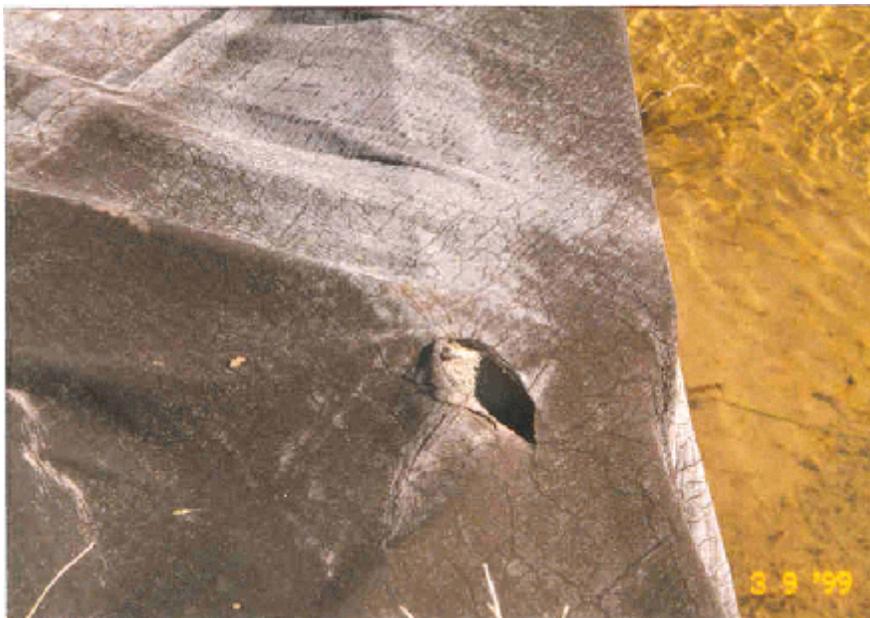
Photograph 136.—Small tear in Teranap over corner of concrete wingwall at the turnout.
