Photogrammetric Processing from Remotely Operated Vehicle (ROV) Data: Trinity Dam Intake Tunnel

**Technical Memorandum No. 8530-2016-31
Research and Development Office
Science and Technology Program
(Final Report) ST-2016-7738-01**

September 2016

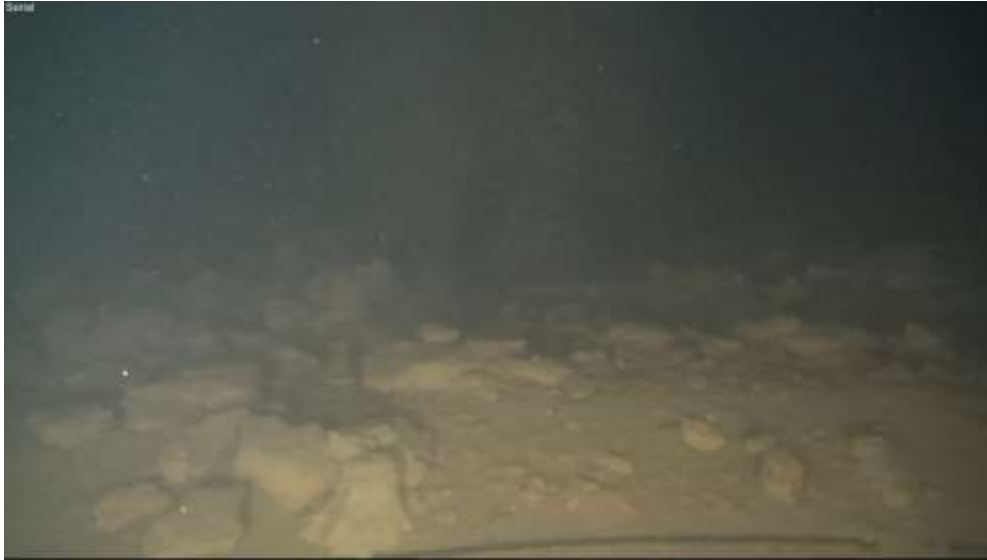
Figure 4 - Third column and sediment on bulkhead seal at a depth of 81 ft. and heading 103.7

The seal plate was initially covered with sediment and wasn't visible. The steel transition from the seal plate to the concrete shaft was visible and was inspected. Laser scans were tested by holding the ROV against the side of the shaft at the steel transition with the thrusters. The lights were turned off during laser scans because they could affect the performance of the laser because the laser operates in the visible light spectrum.

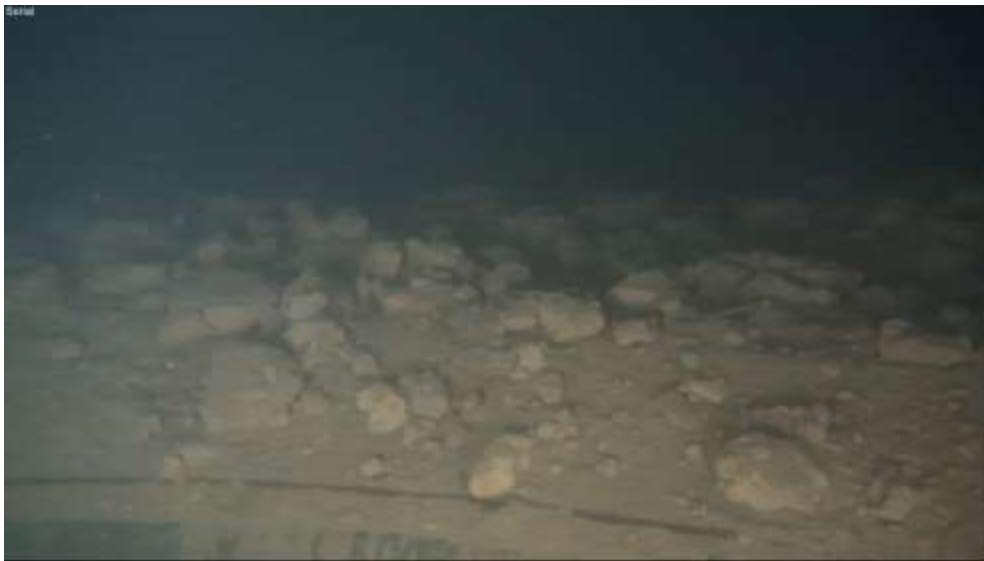
Figure 5 - Bulkhead seal plate partially visible under sediment at a depth of 81.5 ft. and heading 103.7

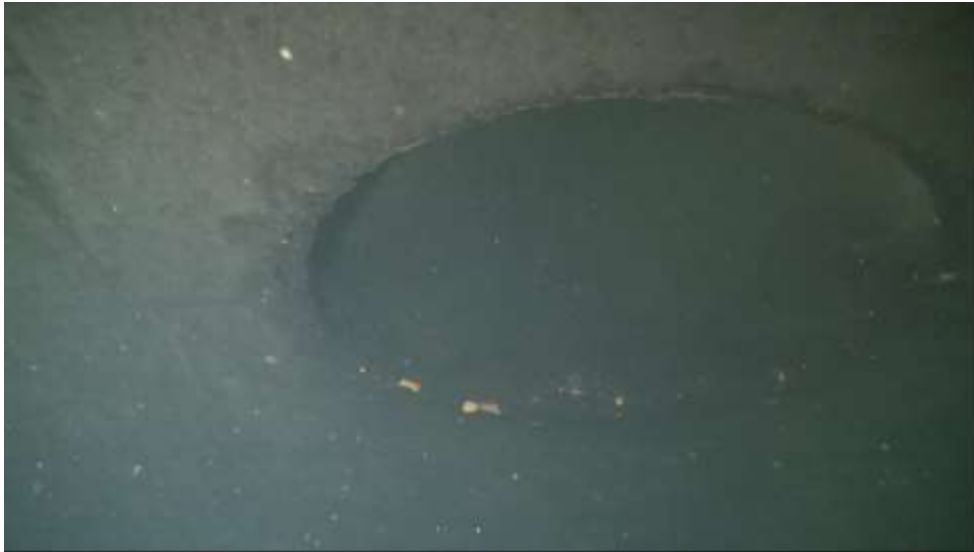
After the seal plates and roller guides were inspected the air vent on the crown downstream of the gate was inspected shown as in Figure 11.

Figure 11 - Air vent downstream of gate

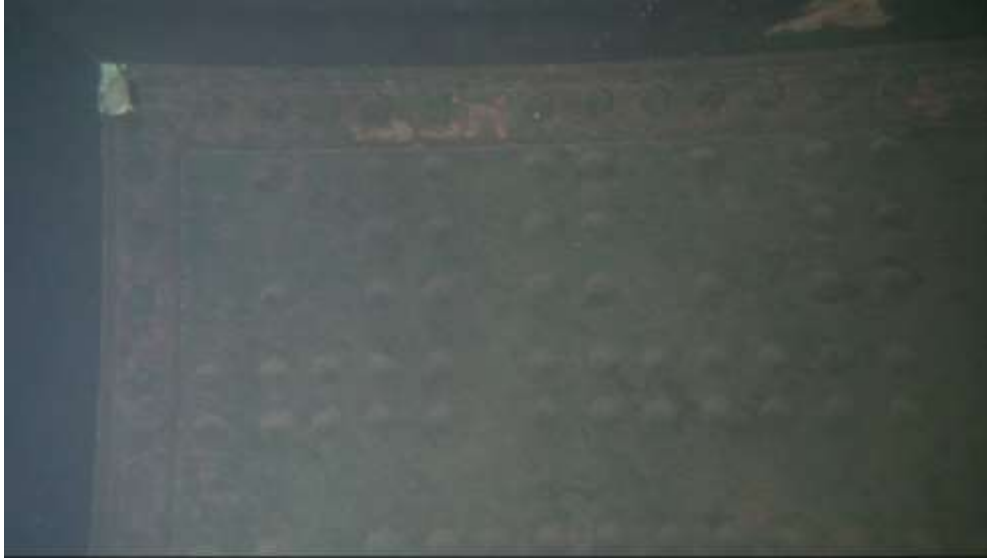
Figure 19 - Top left of roller gate at a depth of 225.2 ft. and heading 177.2

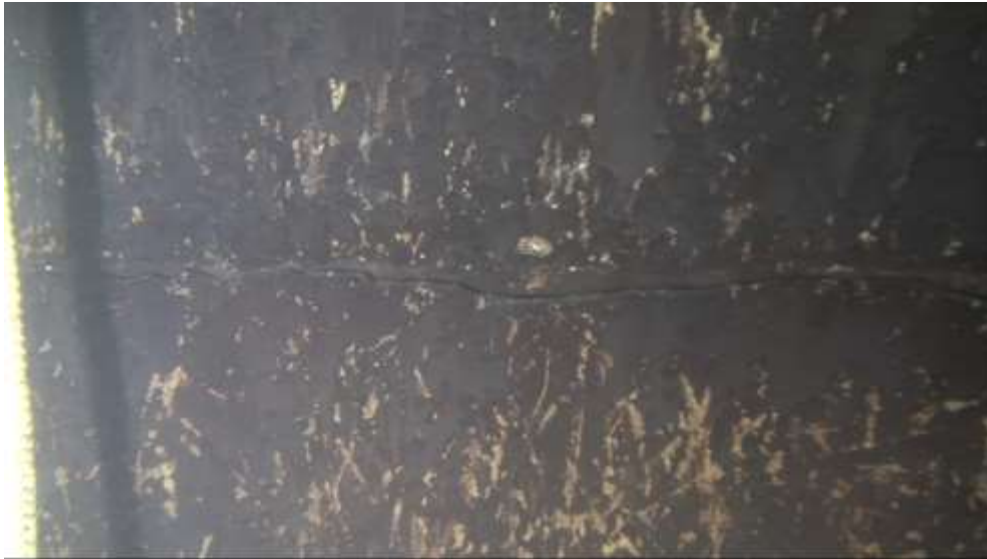
The surface of the shaft was consistent throughout in terms of a light biological covering and excellent quality of the concrete. The biological covering was minimal and easily removed if the ROV brushed up against it. Figure 20 shows the feather edge transition joint between the downstream face of the vertical section and the crown of the elbow. This joint showed the largest separation of all the joints in the structure.

Figure 20 - Joint and downline in shaft at a depth of 198.7 ft. and heading 173.4

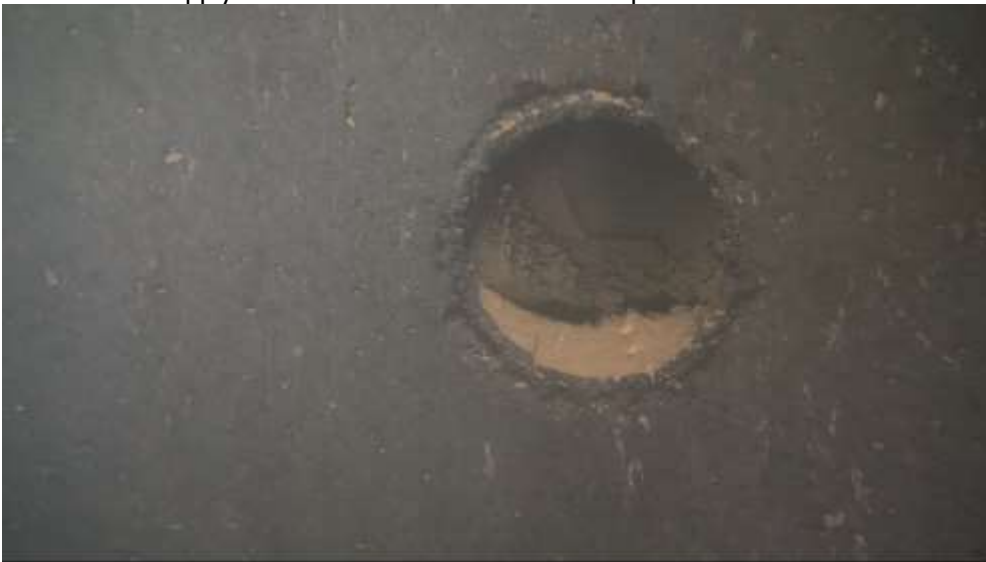
An 8 inch air supply vent was located at 86 feet of depth.

Figure 23 - 8 inch air supply vent at a depth of 86.5 ft. and heading 128.6

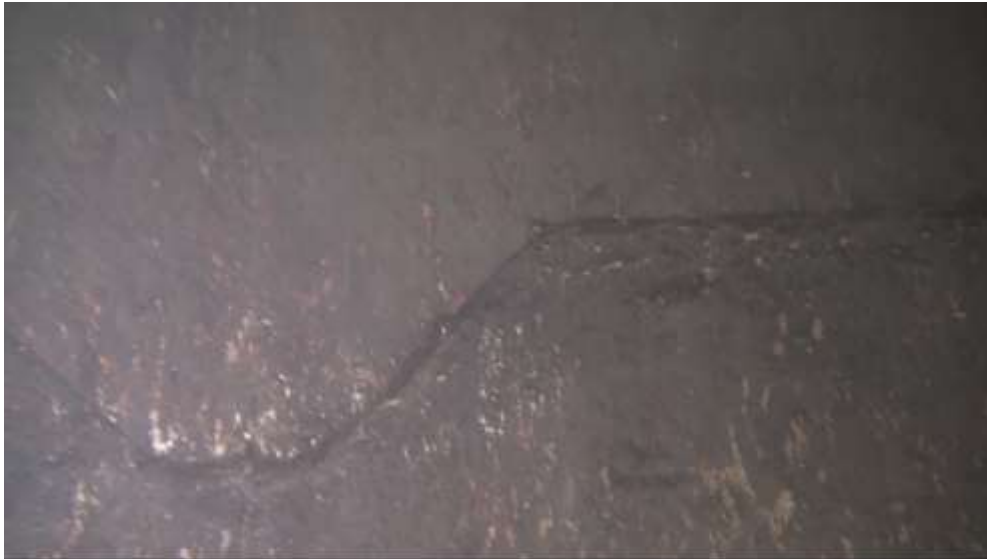
The top of the shaft has a steel ring that mates with the seal on the hemispherical bulkhead. The transition from concrete to the steel ring begins at 85 feet of depth.

Figure 24 - Transition from concrete to steel ring at top of the shaft at a depth of 84.4 ft. and heading 240.4

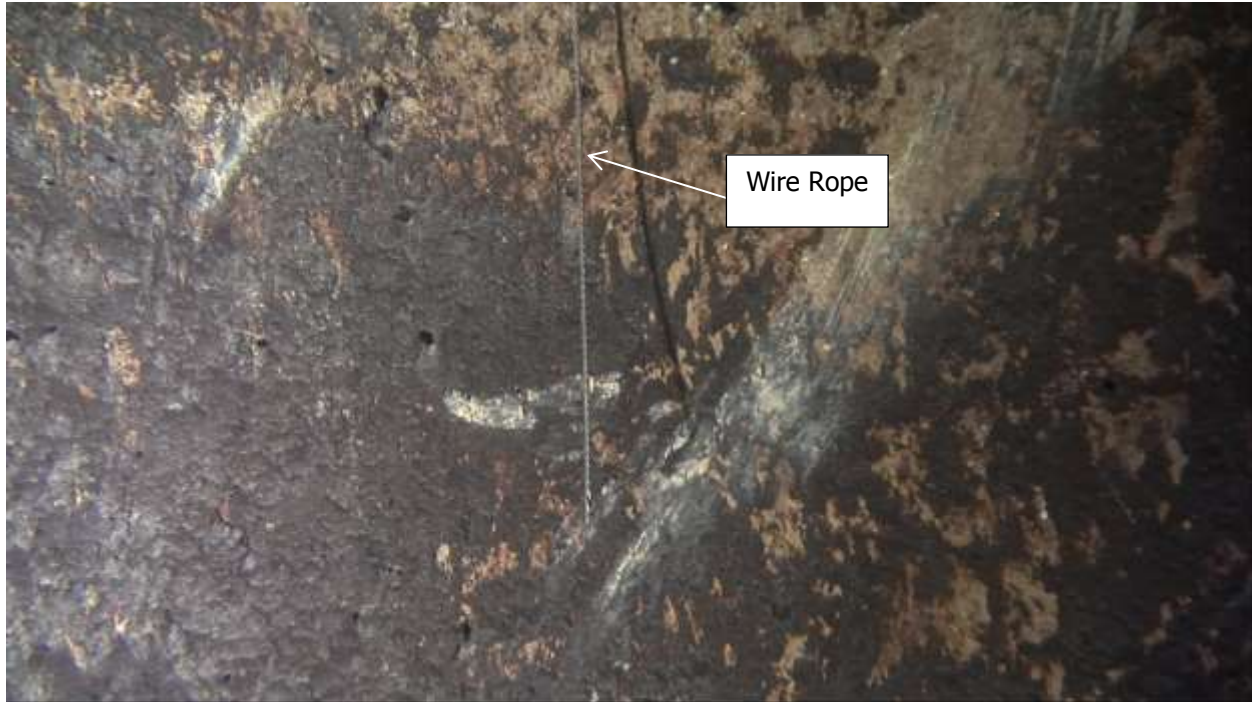
Figure 28- Bottom of Wire rope at a depth of 94.9 ft. and heading 34.2

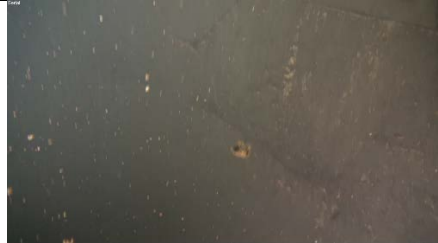
Spall/bug hole
Dive 2 - Dive two was performed on October 22nd 2015 from 17:58 to 21:32. The water elevation at the start of the dive was at 2186 ft. The fixed wheel was in the open position for this dive. The ROV started at the surface and descended down the vertical shaft to the elbow. The ROV then traveled to the fixed wheel gate following the invert of the horizontal section. During this inspection the invert was covered in 1 – 2 inches of sediment obscuring the condition of the invert concrete. The gate seals and a majority of the transition to the gate were inspected including a bypass pipe.

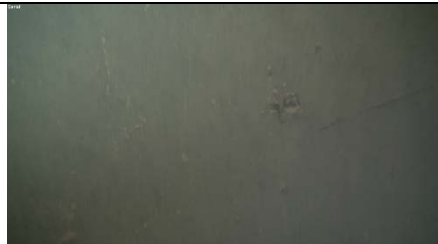
Small bug hole
145728	6:25

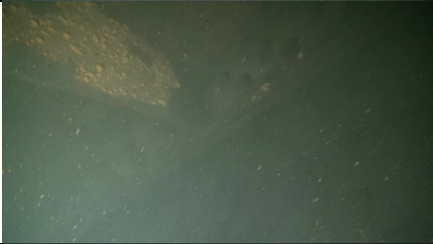
Slime
160728	3:45

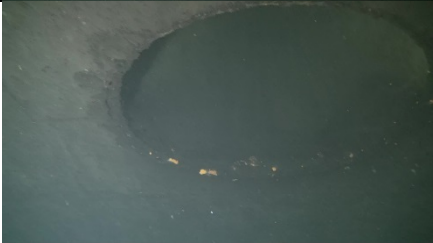
Air vent
160728	7:25	 	Rock pocket
161728	3:15

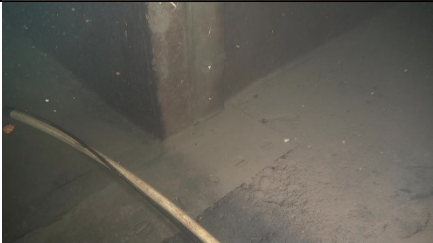
Rock pocket/cavitation?
162728	6:39

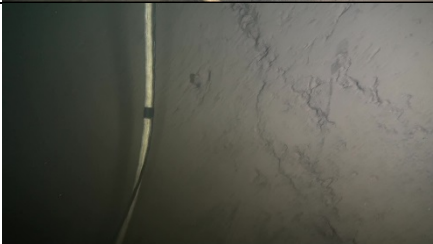
Rock pockets
162728	8:15

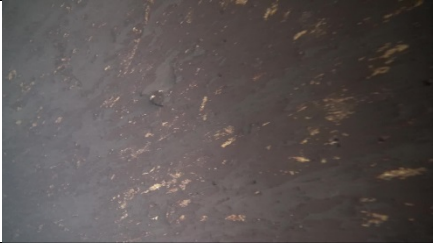
Rough coating/biofilm
172728	0:38

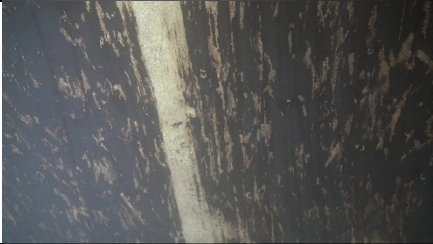
Scrape from ROV
172728	2:24

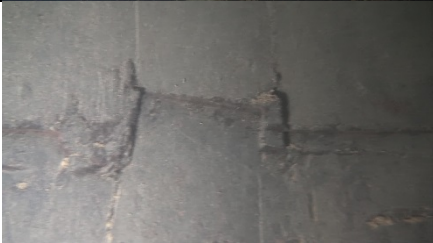
Form work rough area
172728	9:50

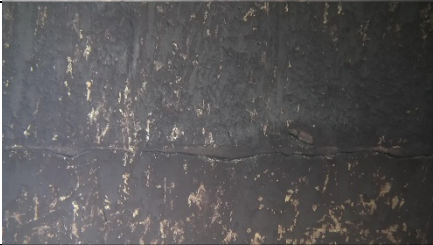
Rough joint
173728	1:25

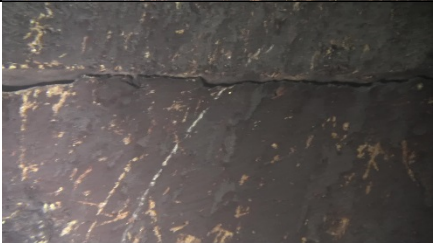
Rough joint
173728	5:59

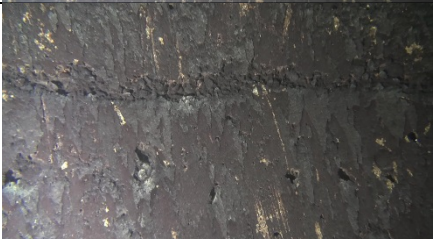
Rock pocket at joint

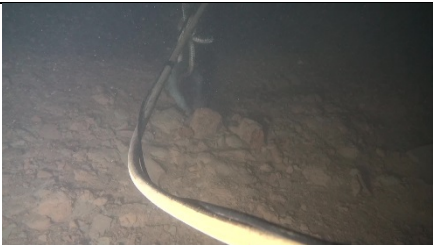
Rope in mud at elbow
134550	8:55

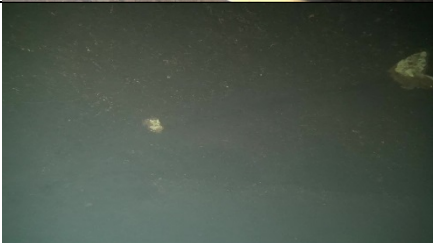
Chips
135550	1:35

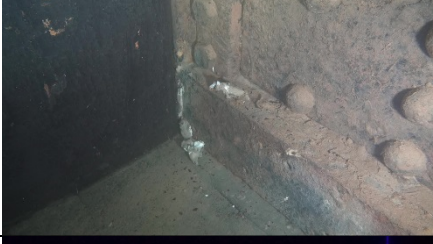
Growth on gate
174058	5:52

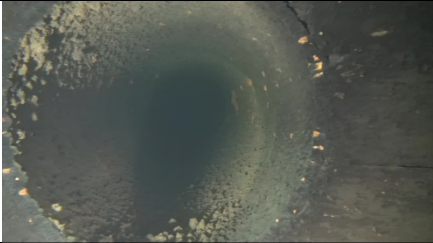
Pipe opening
080201	8:27

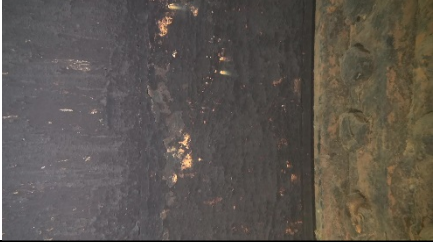
Rust near gate

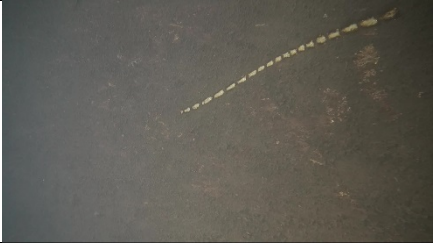
Scrape marks from ROV?
080208	9:31

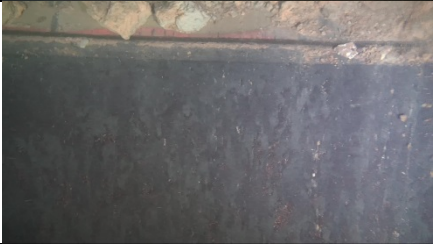
Red coating at top of gate seal
081202	6:54

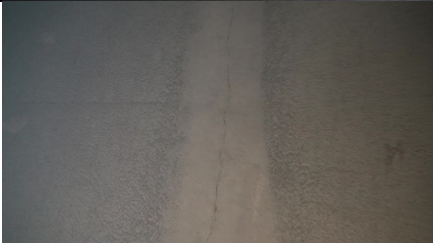
Crack in joint?
081202	8:08

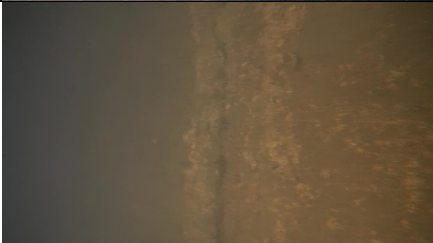
Rough joint
082202	6:34

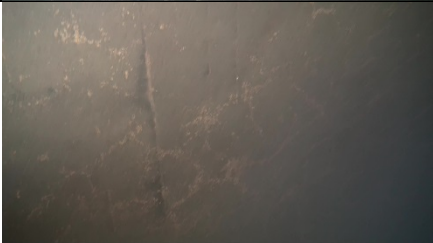
Joint spall, rock pockets? Cracking?
083244	7:25	 	Defect
084244	1:35

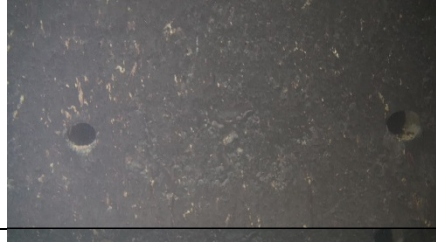
Holes – depth about 123-119 ft, down
113851	3:15

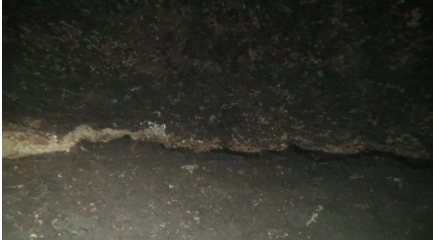
Crack/joint near elbow
165813	9:08

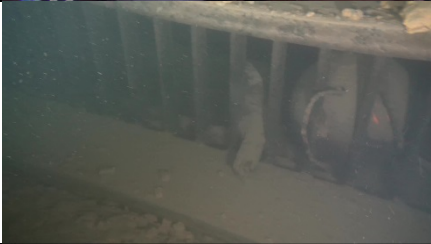
Debris at bottom of trashrack
153004	8:36

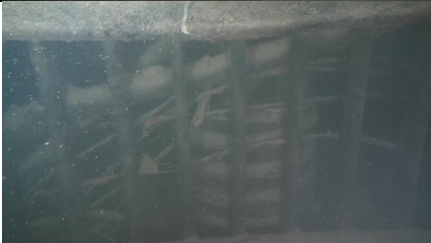
Debris at bottom of trashrack
162622	5:45

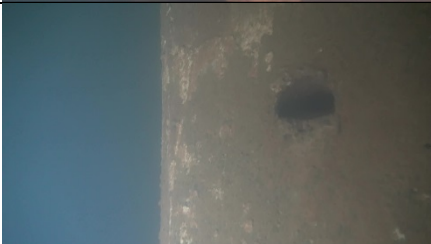
Hole – outside of tower
173758`	6:46
