FLAMING GORGE RIVER OUTLET PIPE FAILURE ROOT CAUSE ANALYSIS

FLAMING GORGE DAM FLAMING GORGE FIELD DIVISION COLORADO RIVER STORAGE PROJECT UPPER COLORADO REGION

U.S. Department of the Interior
Bureau of Reclamation
Denver, Colorado

August 1997

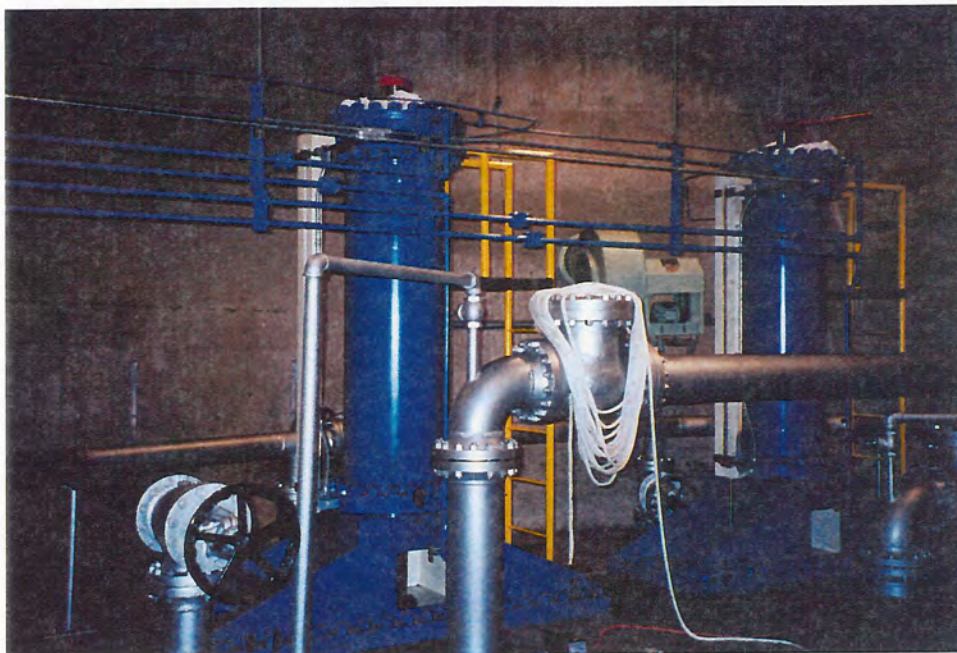
leakage in the hydraulic operating system. Subsequent testing after the outlet pipe failure indicated that the gate would drift approximately 1 inch per day. The hoist cylinder packing for ring follower gate No. 2 has a substantial amount of leakage past the packing and was scheduled for overhaul for the fall of this year (photograph 11). The gates are equipped with manual gate hangers to hold the ring follower gates open in the event of leakage such as this. The manual gate hangers were not engaged on either gate at the time of the outlet pipe failure. Failure to use the gate hanger is one of the primary factors leading to the pipe failure.

Photograph 11 - Hoist cylinders for ring follower gates located in gate control house.

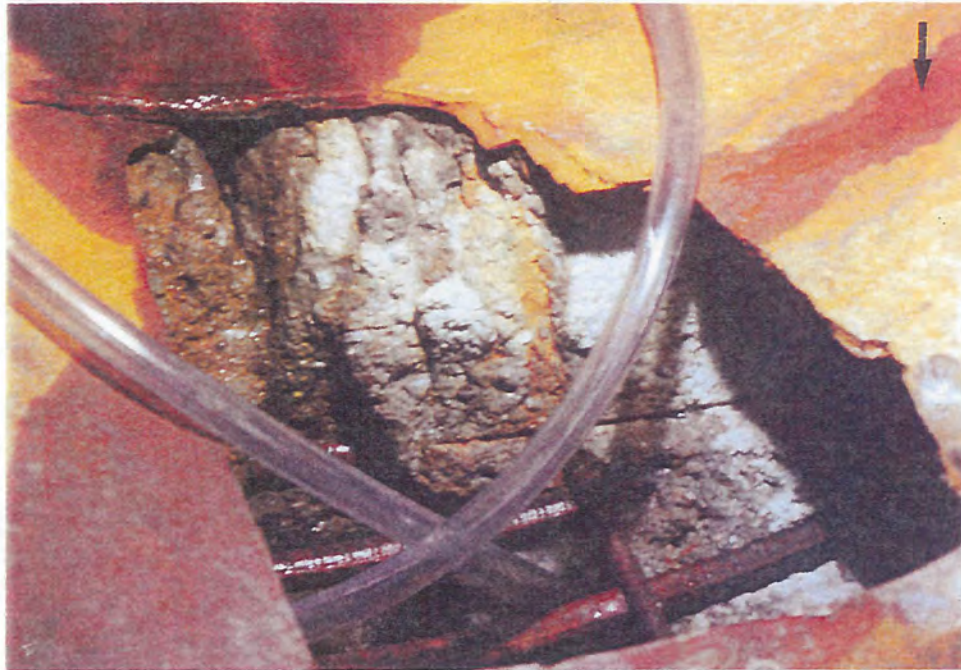
Subsequent to penetration, damage continued by the erosion mechanism culminating in rupture of the pipe. Severe pipe vibration augmented cavitation and produced some areas of low cycle fatigue.

Figure 1. Overview of Fractured Pipe

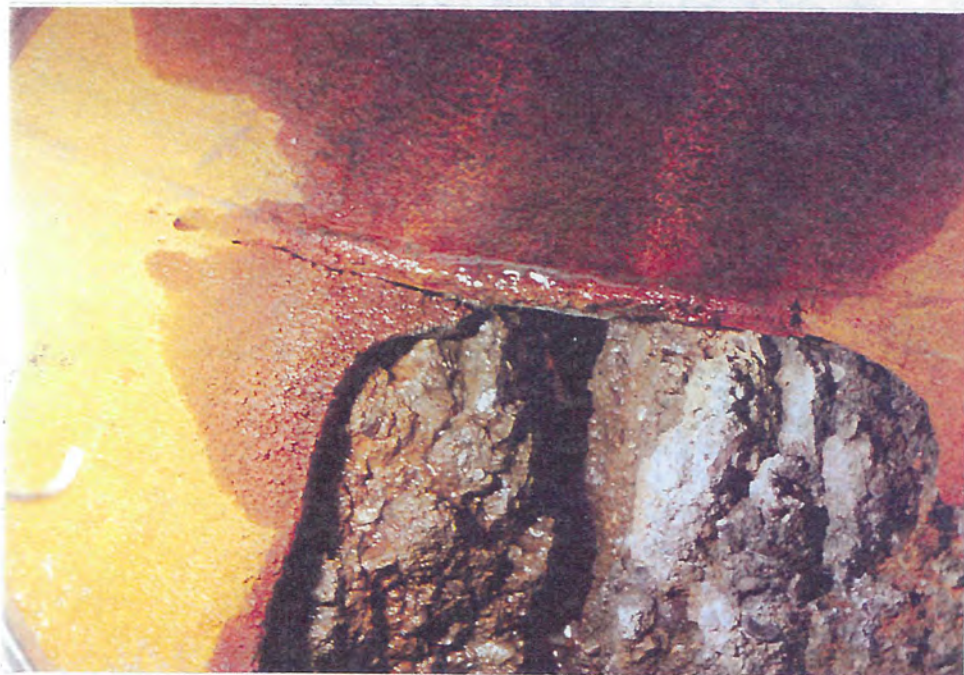
Figure 2. View of Fracture Along Weld

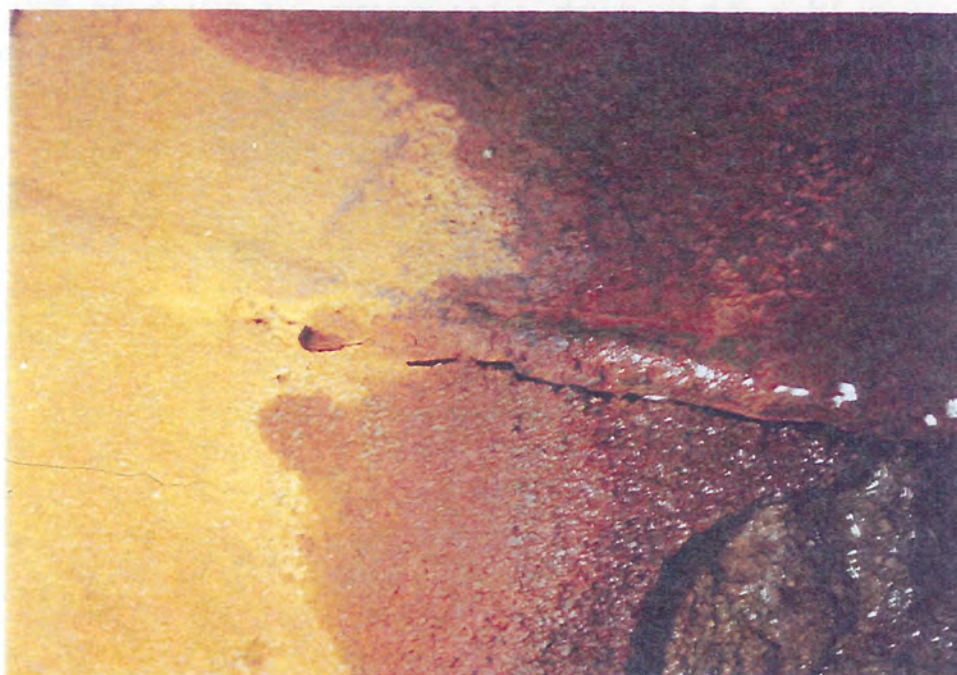
Figure 3. View of Extension of Fracture Adjacent to Piece Torn Out

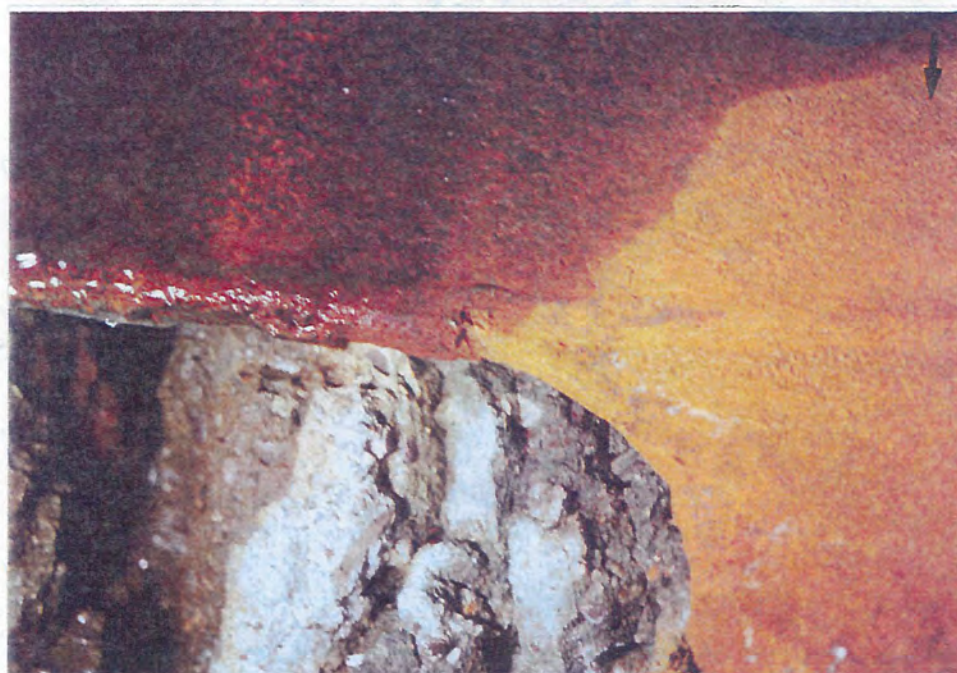
Figure 4. Area Where Fracture Deviates From Heat Affected Zone

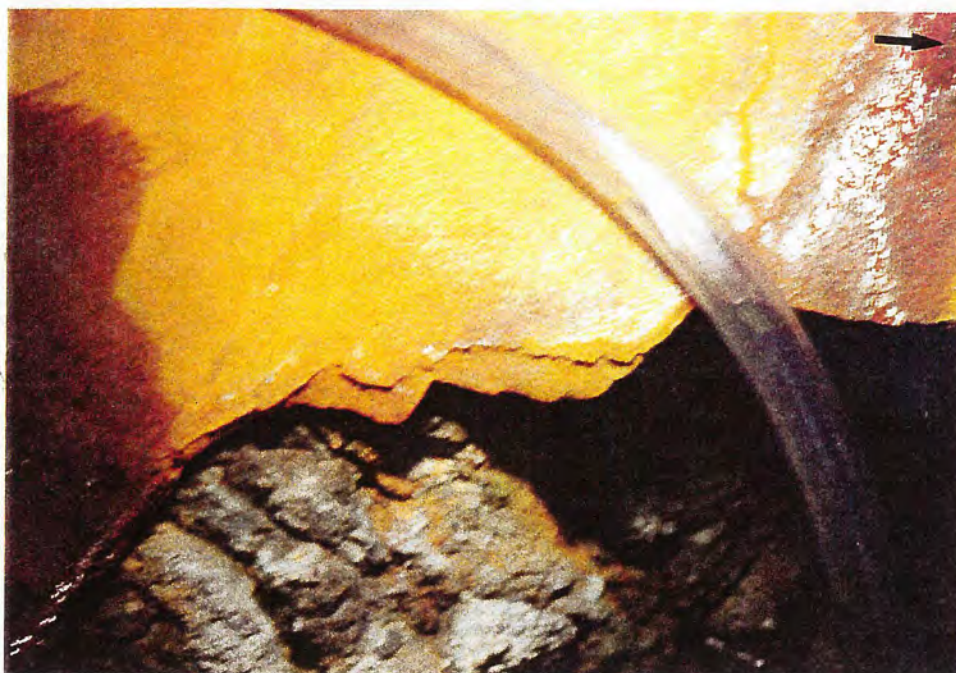
Figure 5. Area of Ragged Fracture

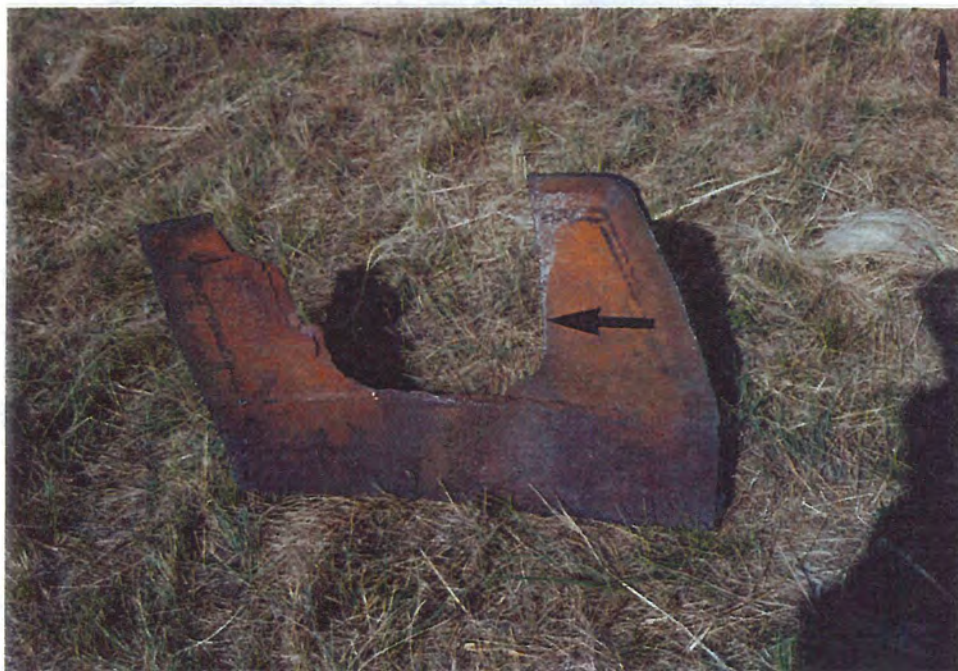
Figure 8. Section Removed From Pipe For Fractographic Examination

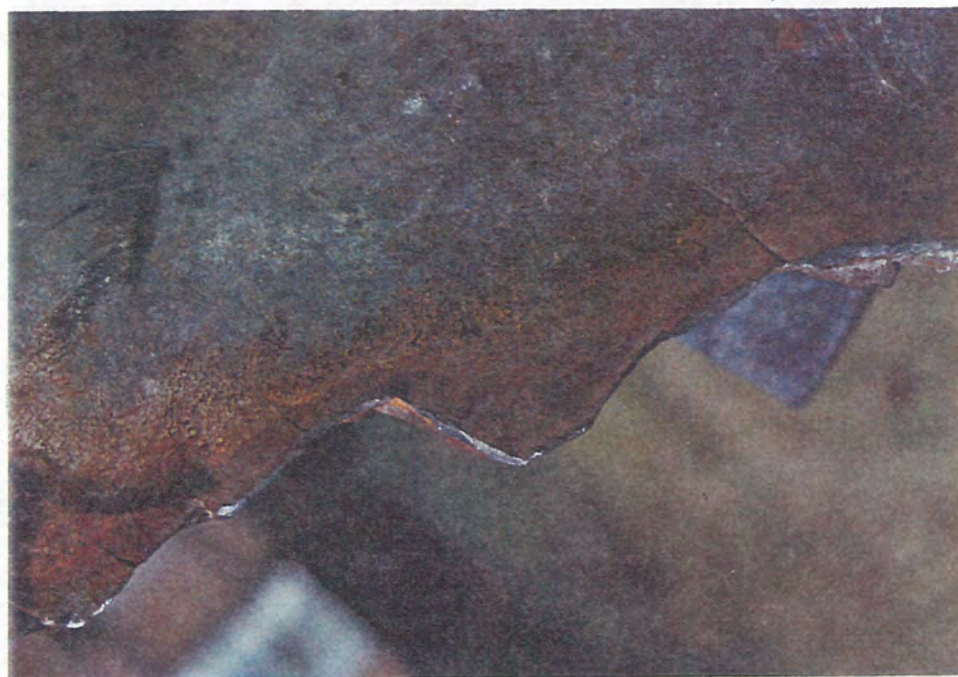
Figure 9. Lateral Cracking Along Fracture Surface

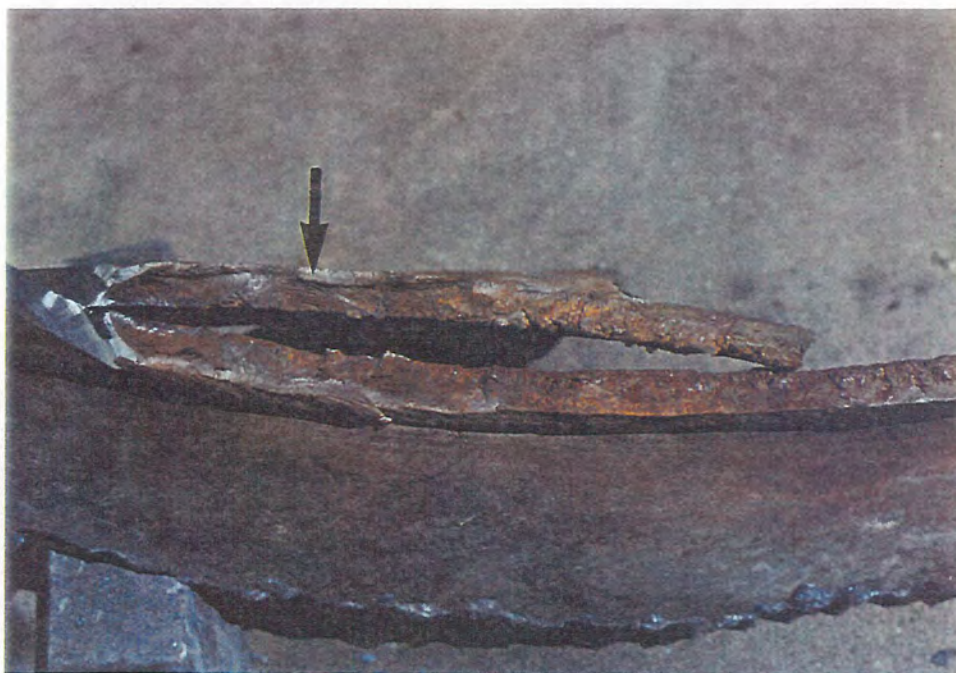
Figure 11. Matching Fracture Surfaces of Crack of Figure 10

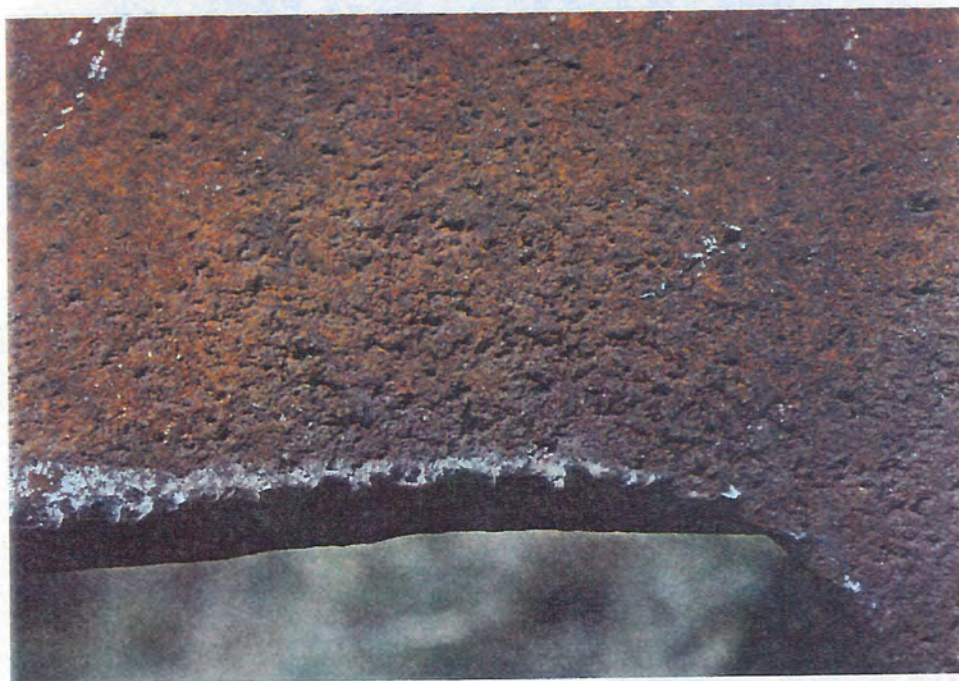
Figure 12. Close-up of Cavitation Damage, Interior Surface

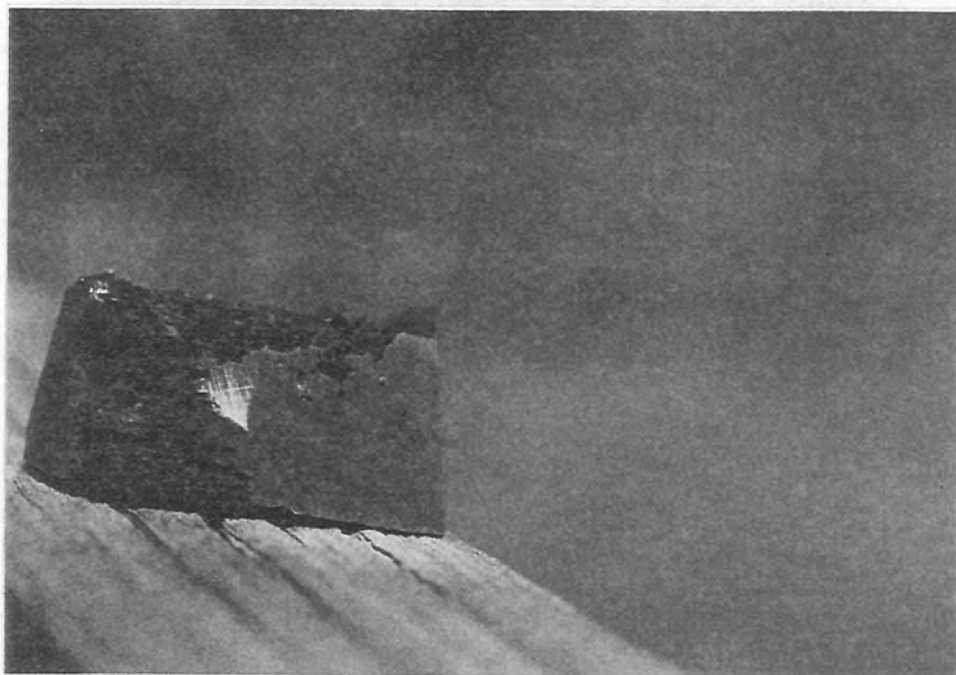
Figure 14. Polished Section Showing Depth of
Cavitation Pit

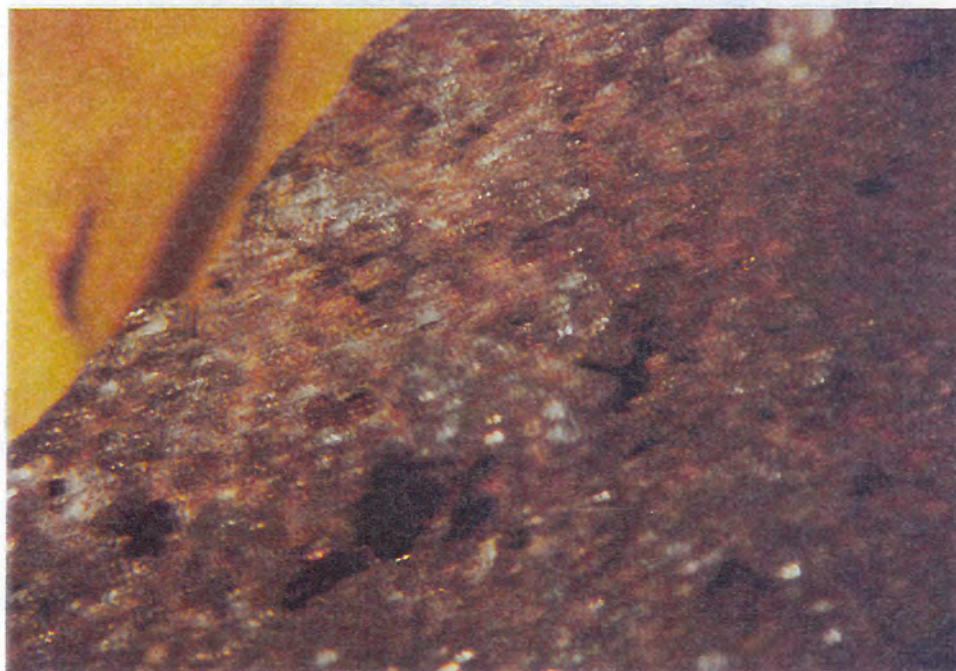
Figure 16. Cavitation Pits As View From Surface

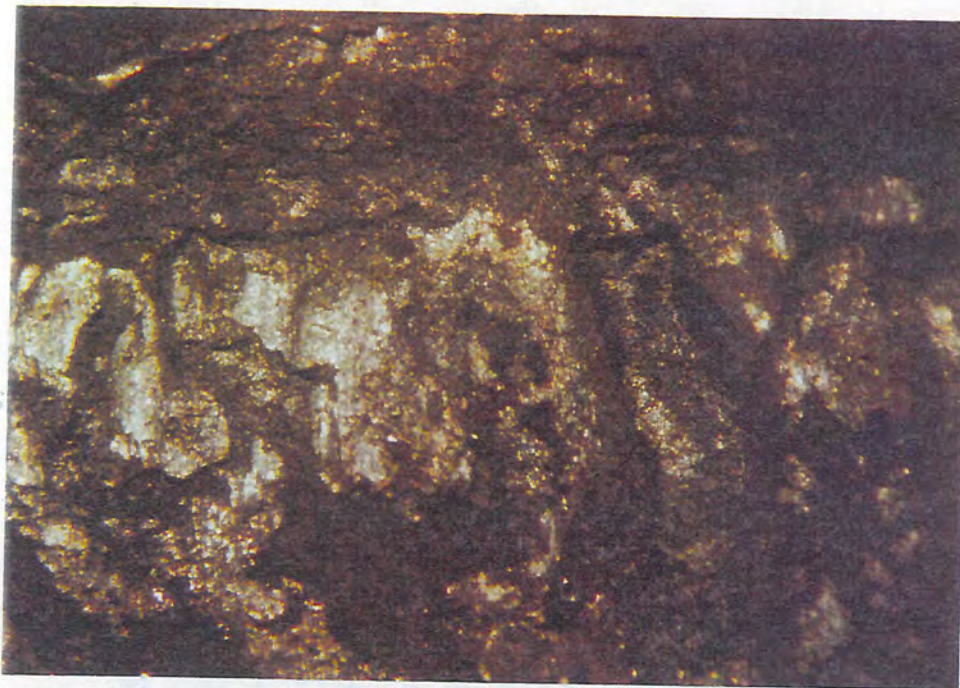
Figure 17. Erosion Through The Plate

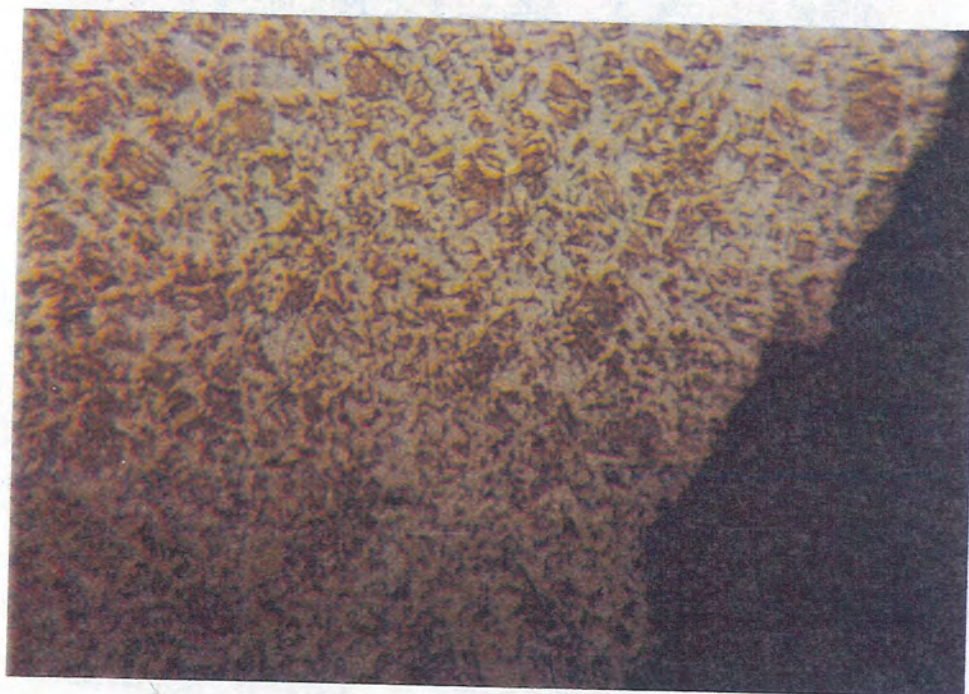
Figure 20. Microstructure at Fracture Surface

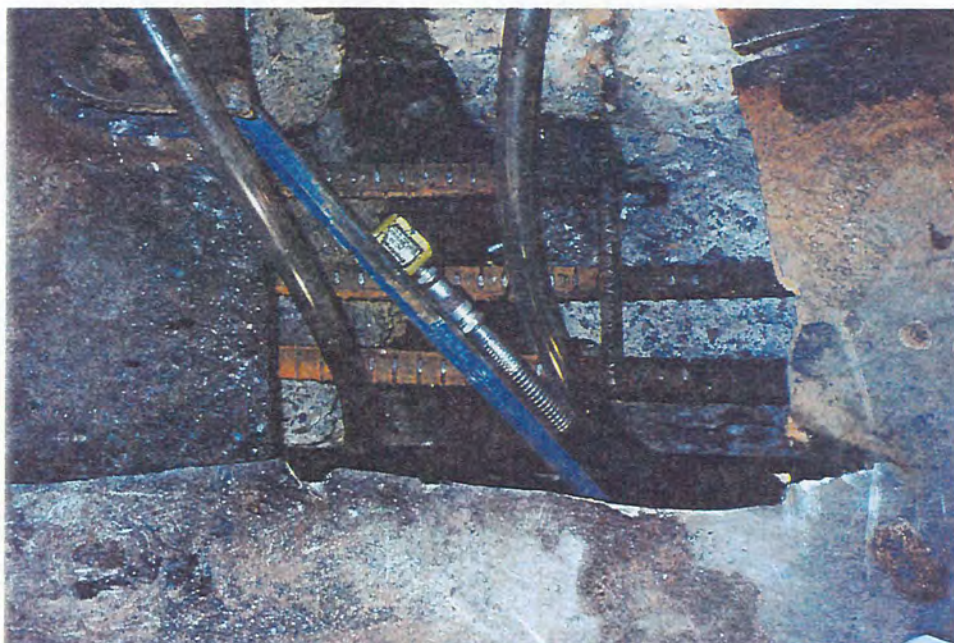
Photograph No. 6. - Flow is from top to bottom. Shown is the invert looking downward from the inside of the outlet works pipe.
