# **DESCHUTES—CANAL-LINING DEMONSTRATION PROJECT DURABILITY REPORT—YEAR 2**

September 1994

**U.S. DEPARTMENT OF THE INTERIOR**  
Bureau of Reclamation

Technical Service Center  
Research and Laboratory Services Division  
Materials Engineering Branch

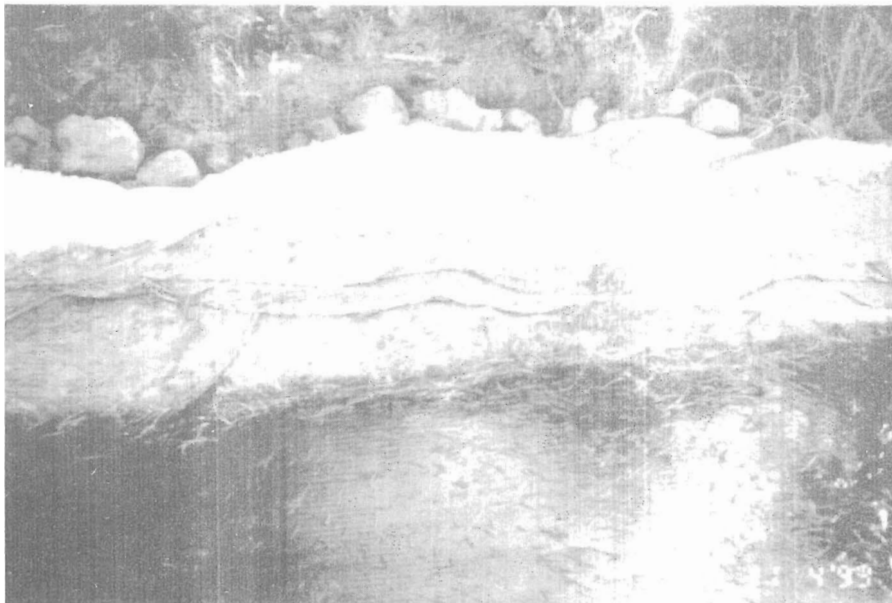
**Condition:** Excellent - actually performing much better than expected. The exposed geotextile is collecting dirt. About 1 inch of sediment has collected in the canal invert, which is actually beneficial because the sediment anchors the exposed geomembrane and provides UV protection. The geotextile is in good condition with little deterioration to date. "Scuffing" of the geotextile along the top of each berm is probably caused by animals or workers entering and exiting the canal. Many of the geotextile seams still need to be sewn. As photo 17 shows, hog-rings have not been effective for seaming the geotextile except where spaced very closely (every 6 inches). Many unsewn seams beneath the waterline are filled with sediment, which is forcing open the unseamed sections further. Where the PVC geomembrane is exposed on the sides of the canal, it has turned white in color. Any exposed PVC beneath the waterline remains a gray color. This color change may be a sign of deterioration. The integrity of the geotextile cover is essential for protection of the PVC geomembrane from UV light.

Photograph 18. - Dirt and sediment collecting on geotextile provides additional UV protection.

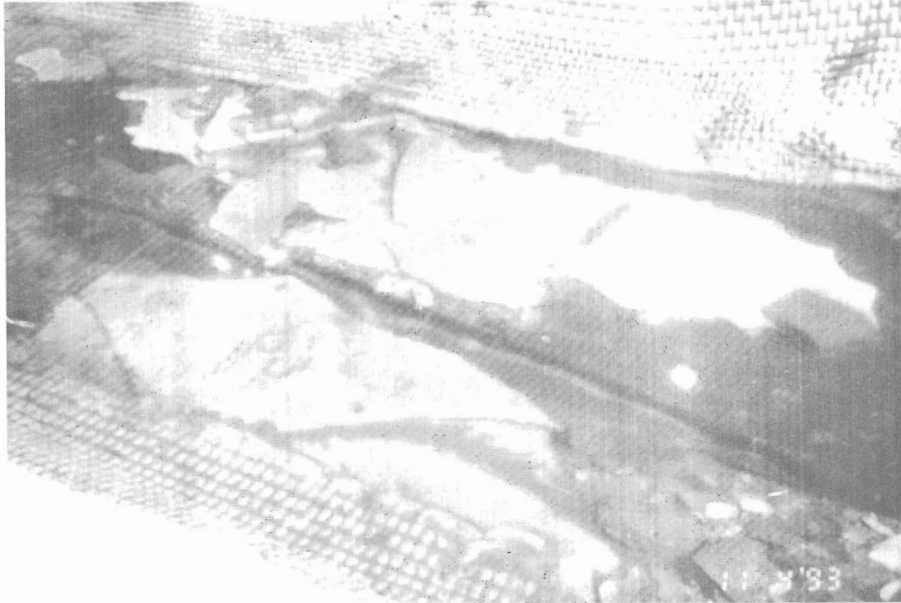
Photograph 41. - White "chalky" portland cement deposits in invert.

To confirm that the samples are hydrated portland cement, four physically distinct portions of the samples were analyzed using X-ray diffraction technique. All were found to contain major amounts of portlandite  $[\text{Ca}(\text{OH})_2]$  and ettringite  $[\text{Ca}_6\text{Al}_2(\text{SO}_4)_3(\text{OH})_{12} \cdot 26\text{H}_2\text{O}]$ , both of which are portland cement hydration products.

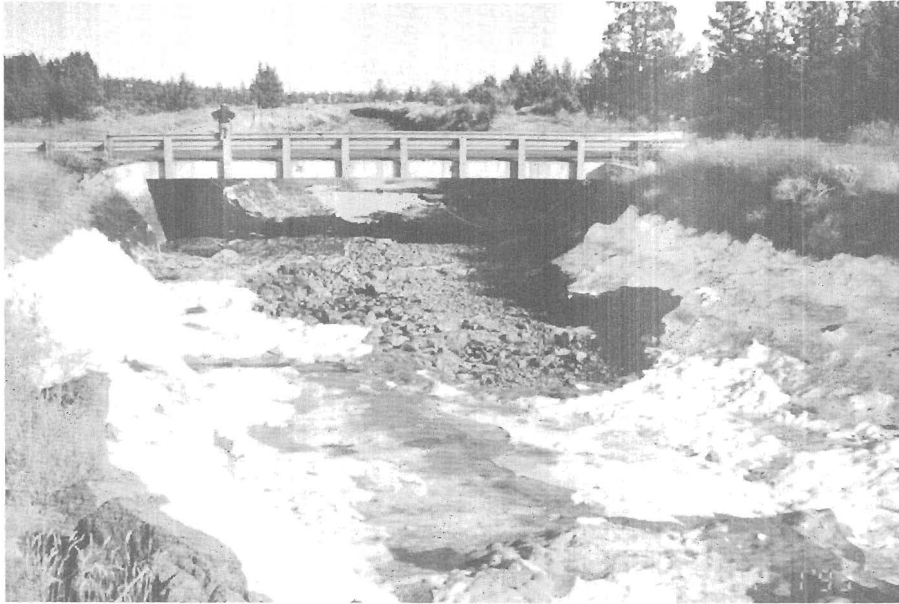
Photograph 45. - Canal overview—foam in the invert has washed out near the bridge.

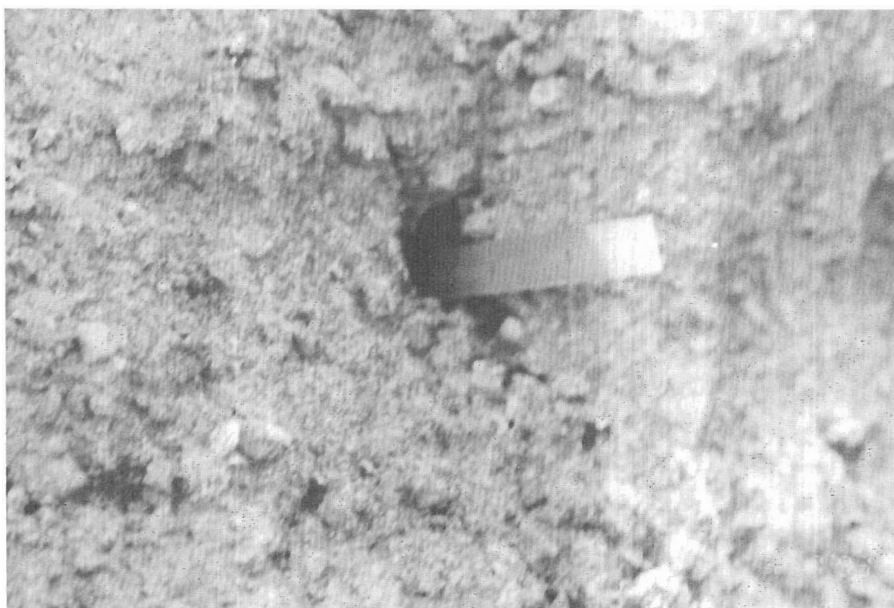
Contraction cracks on the sidewalls have developed every 100 to 200 feet. Crack width varies from hairline to 1/8 inch. Cracks do not extend completely across the canal prism, but instead usually disappear somewhere in the invert. These cracks will be monitored for growth. Also, some small irregular voids (holes) were found in the shotcrete, ranging in depth up to 4 inches (see photo 67).

Photograph 68. - Occasional holes in shotcrete up to 4 inches deep.
