**DESCHUTES—CANAL-LINING
DEMONSTRATION PROJECT
YEAR 5 DURABILITY REPORT**

Upper Deschutes River Basin Water Conservation Program

January 1997

**U.S. DEPARTMENT OF THE INTERIOR
Bureau of Reclamation**

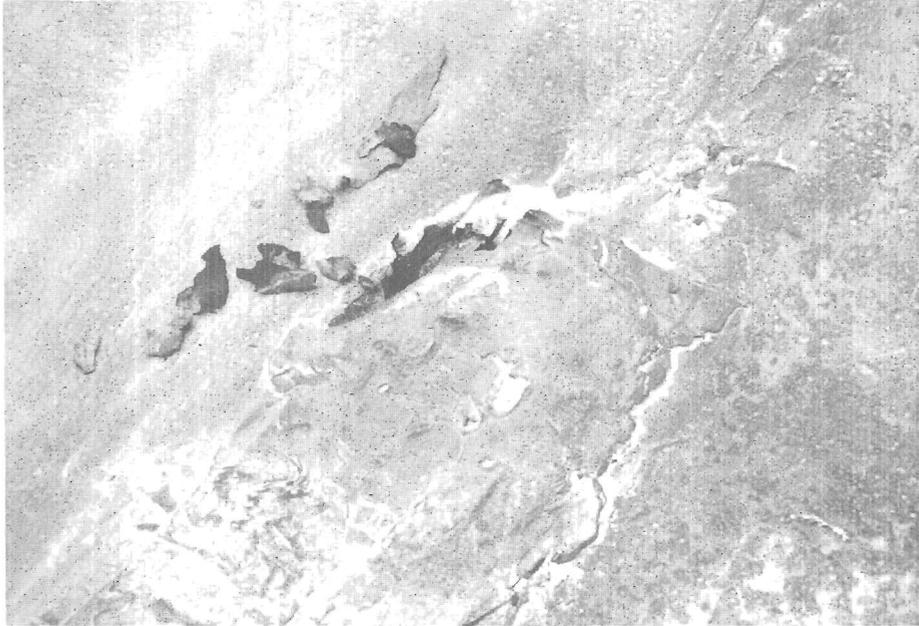
Photograph 7.—Sandblasting did not remove the tar-based joint patch that was previously used to seal the seams between steel panels.

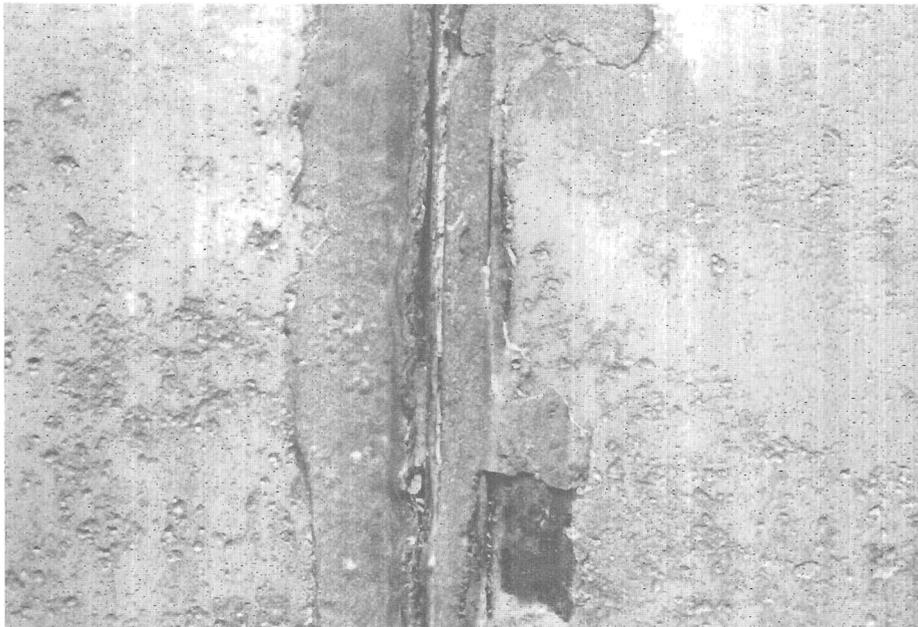
Photograph 8.—Another joint after sandblasting with tar-based joint sealant still intact.

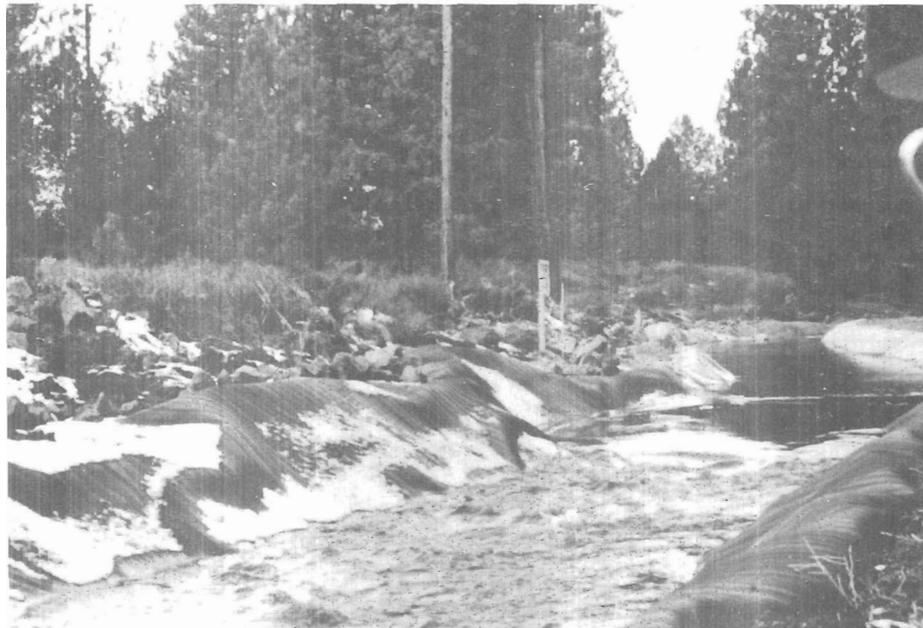
Ice Jams.—Many canals, including the Arnold Canal, do not have adequate slope to drain when the water is turned off. Ponds form in these locations (typically 6 to 12 inches deep) and rain and snow add to the ponds. Before lining the Arnold Canal test sections, these ponds were not a problem because the water would slowly seep out of the unlined canal. However, since lining, this ponded water freezes, and ice remains in the canal throughout much of the winter. During winter water runs, ice collects at structures (bridges, siphons, etc.), restricting flow (see photographs 24 through 26) which can cause water to backup and overflow the canal banks. The Arnold Irrigation District has been forced to for go about half its traditional monthly winter water runs since the construction of the test sections. This problem was totally unanticipated. In the future, the possibility of ice jams should be considered when contemplating the rehabilitation (lining) of existing canals to reduce seepage.

Photograph 24.—Ice jam forming on Test Section A-3 during a winter water run.

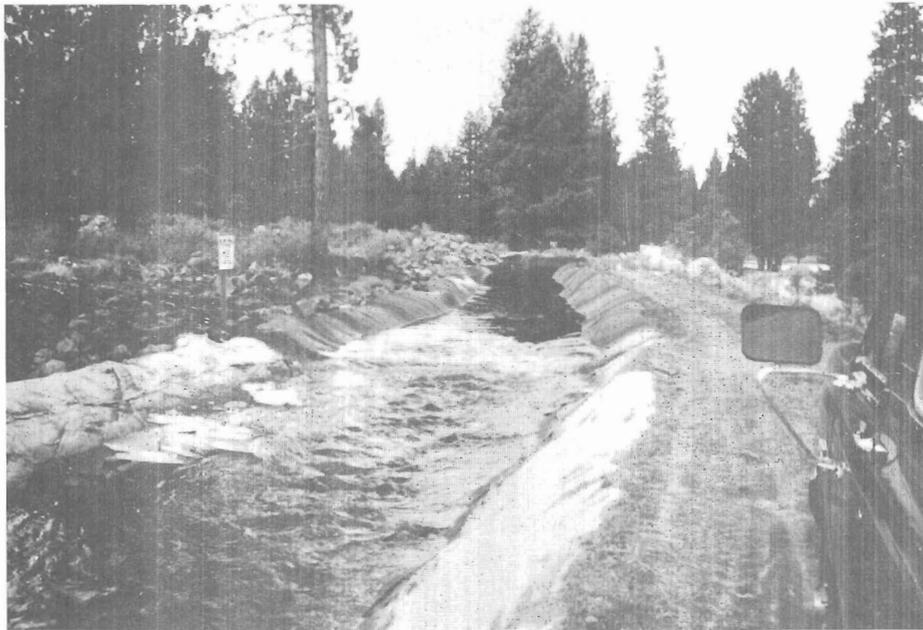
Photograph 25.—Ice jam forming on Test Section A-4 during a winter water run.

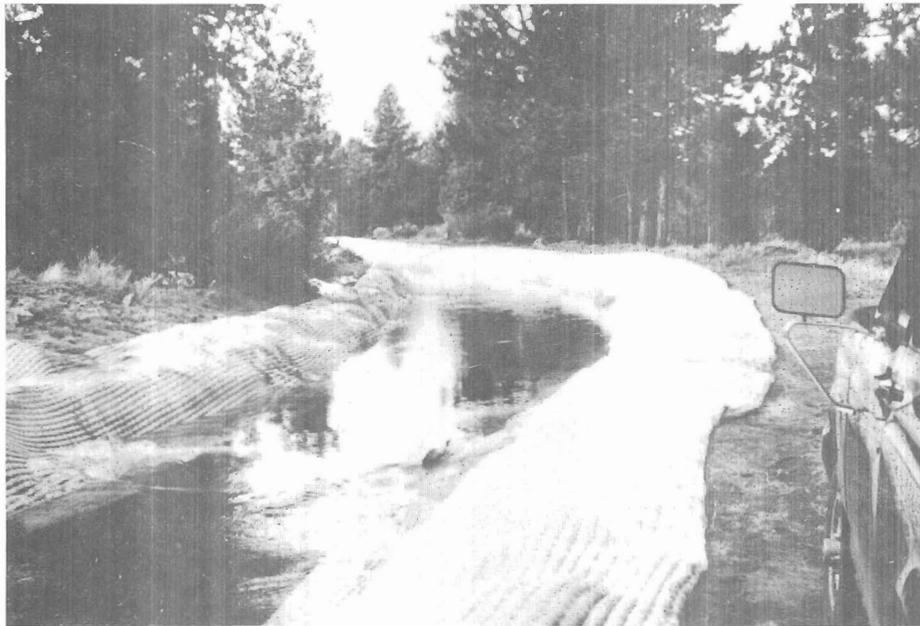
Photograph 26.—Ice jam forming on Test Section A-7 during a winter water run.

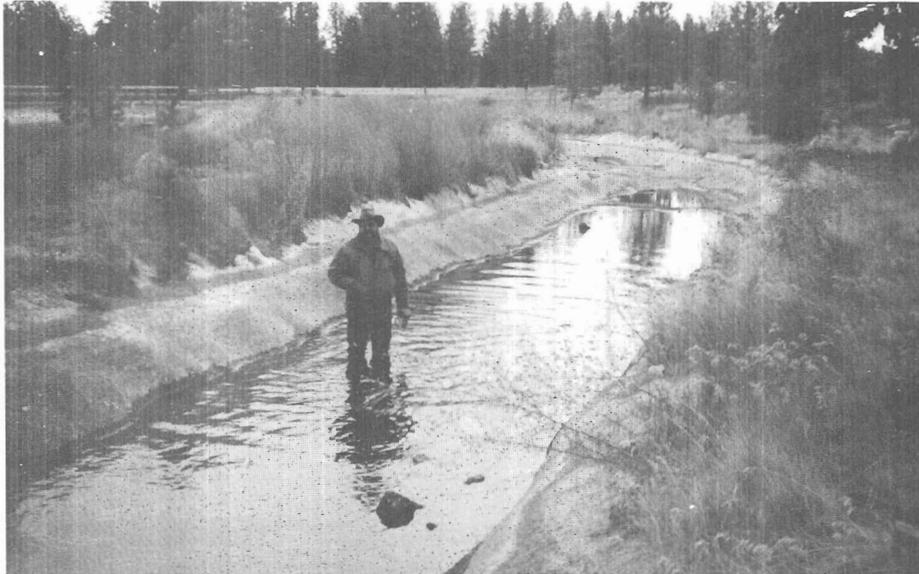
Photograph 27.—Excellent condition after almost 5 years of service.

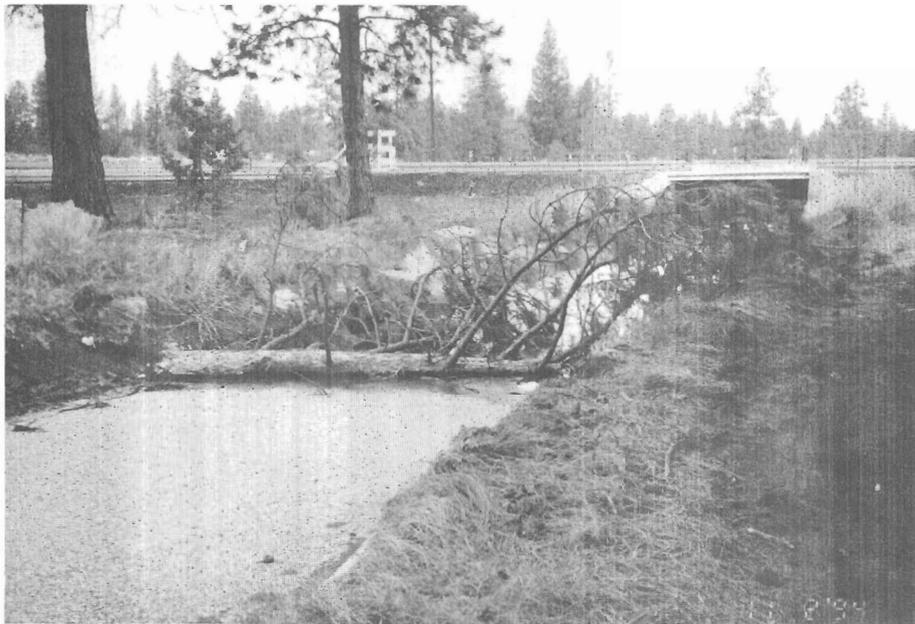
Photograph 34.—A 1994 windstorm deposited this tree in the canal with no damage to the shotcrete lining. The exposed geomembranes did not fare so well.

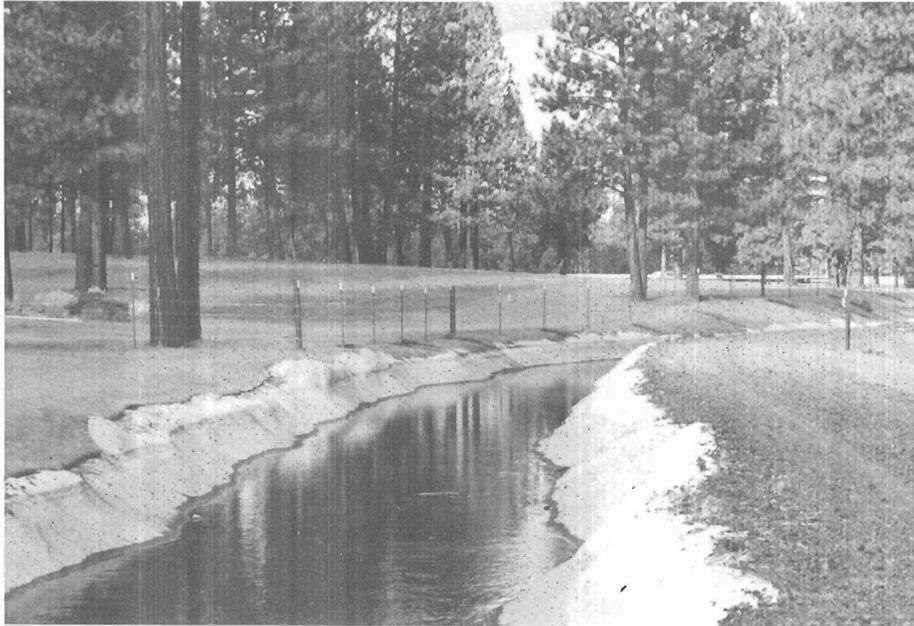
The owner of the golf course adjacent to the canal has installed fencing and planted grass right up to the canal prism (see photo 35). These improvements may be infringing on the districts maintenance right-of-way.

Photograph 35.—Canal overview - excellent condition after 4 years of service.
Landowner has installed fencing and planted grass adjacent to the canal.

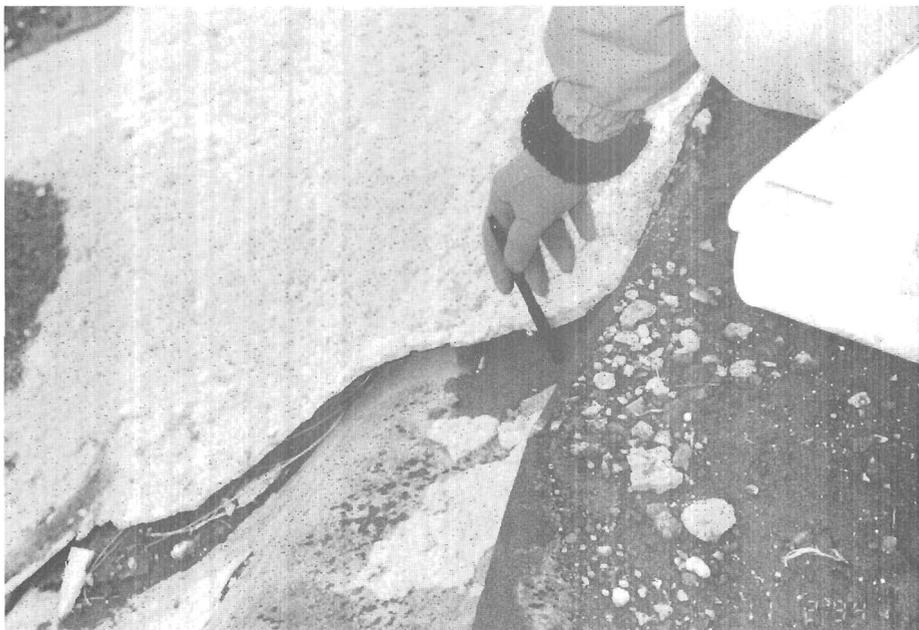
Photograph 40.—Thin shotcrete over anchor trench is less than 1-inch thick.

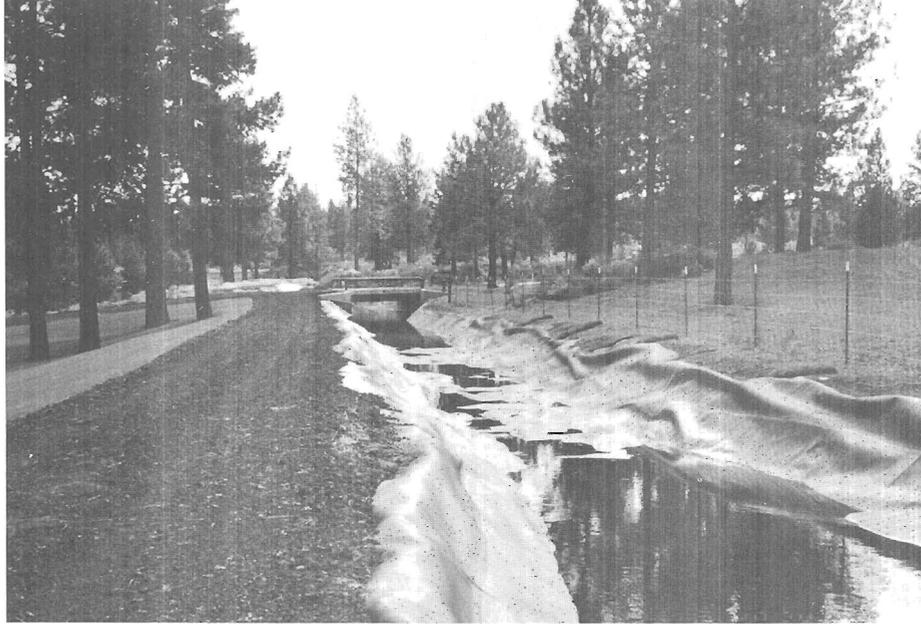
The owner of the golf course adjacent to the canal has installed fencing and planted grass right up to the canal prism (see photo 41). These improvements may be infringing on the districts maintenance right-of-way. Also, runoff from watering the grass could cause stability problems in the canal side slopes.

Photograph 41.—Canal overview - very good condition after 4 years of service.

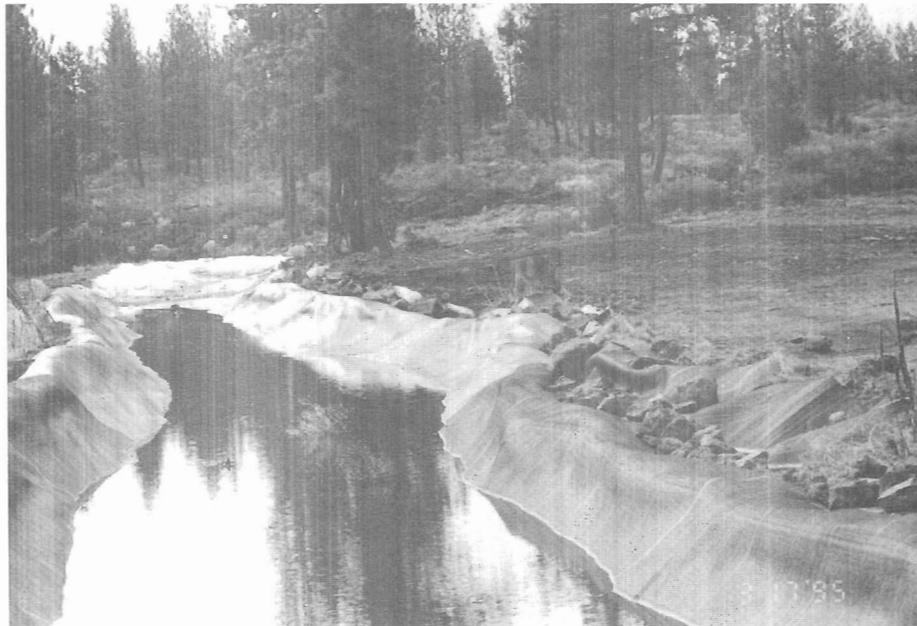
Photograph 44.—Limited freeboard on the right-hand bank.

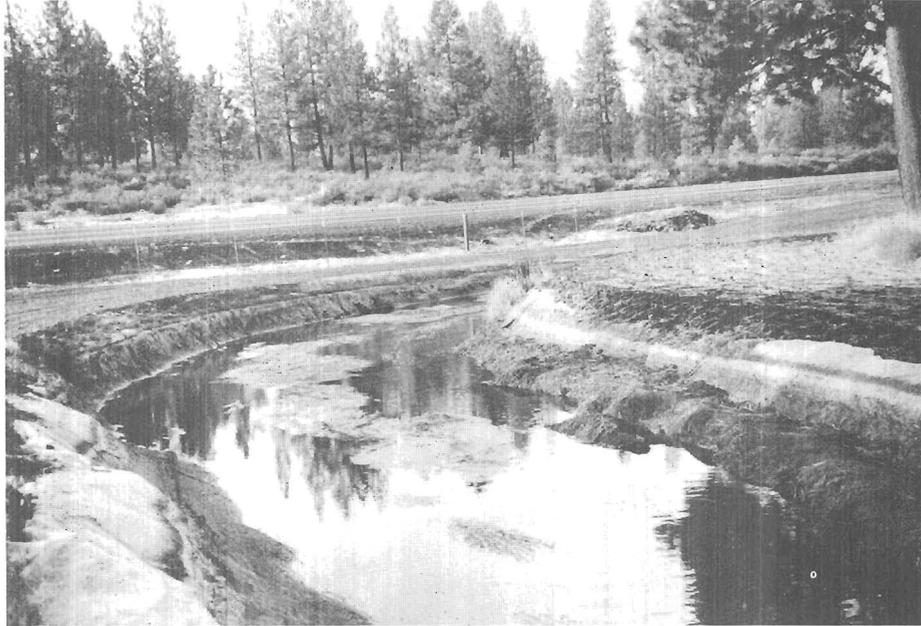
Photograph 47.—Canal overview - very good condition after 4½ years of service.

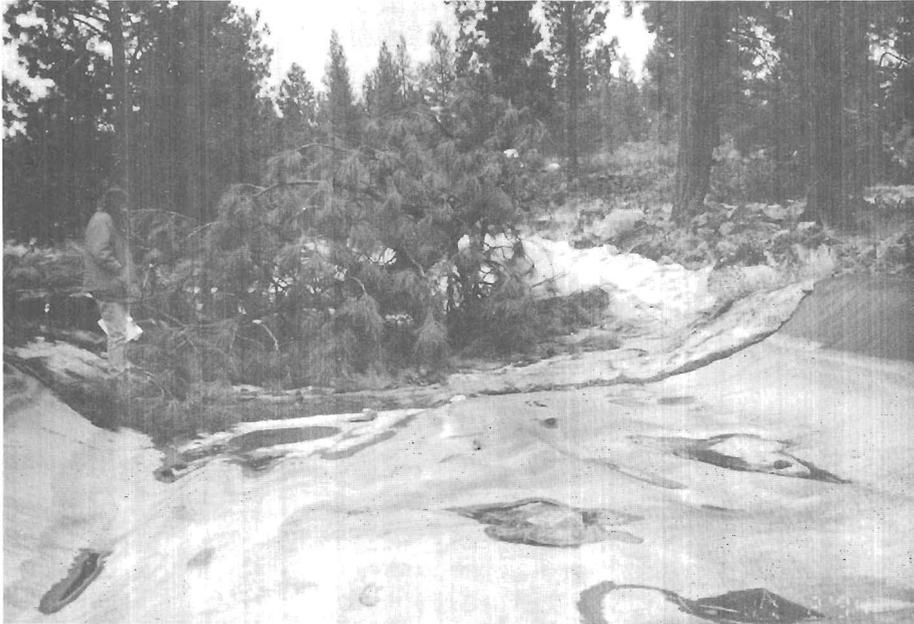
Photograph 53.—A 1994 windstorm deposited a tree in the canal, tearing the geomembrane liner.

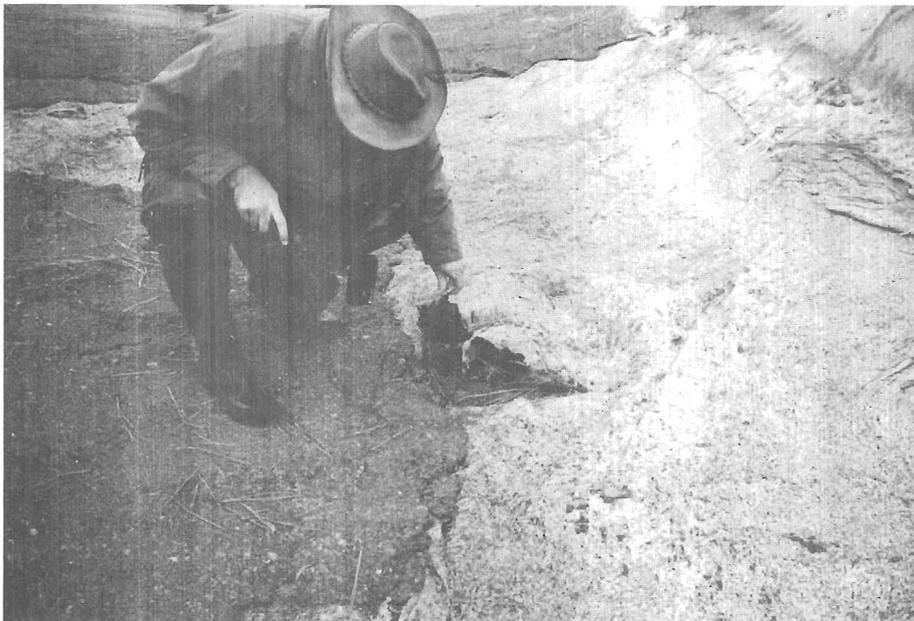
Photograph 54.—Close-up of tear needing repair.

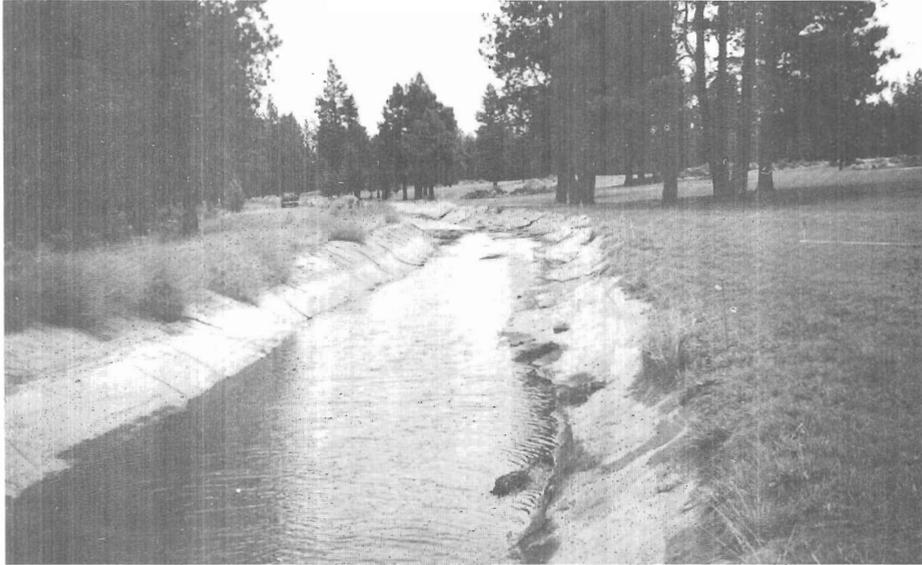
Condition: Very Good - The exposed Hypalon geomembrane and longitudinal seams are holding up well. Standing water covers almost the entire invert, typically 6 to 12 inches deep. The majority of the canal has several inches of sediment, with vegetation growing in the sediment. The upstream transition between Test Sections 4 and 5 (station 30+00) has been covered with a 7-foot concrete cap, which is working well. A surveying stake has been driven through the Hypalon liner on the left bank, but is well above the waterline. A couple of small tears have developed at the anchor trench (stations 31+00 left and 33+00 right), and a sharp subgrade rock has punctured the liner at the waterline (station 33+20). The right canal bank is unstable and has noticeable sloughing beneath the liner (approximately stations 33+00 to 33+50).

Photograph 55.—Canal overview - very good condition after 4½ years of service.

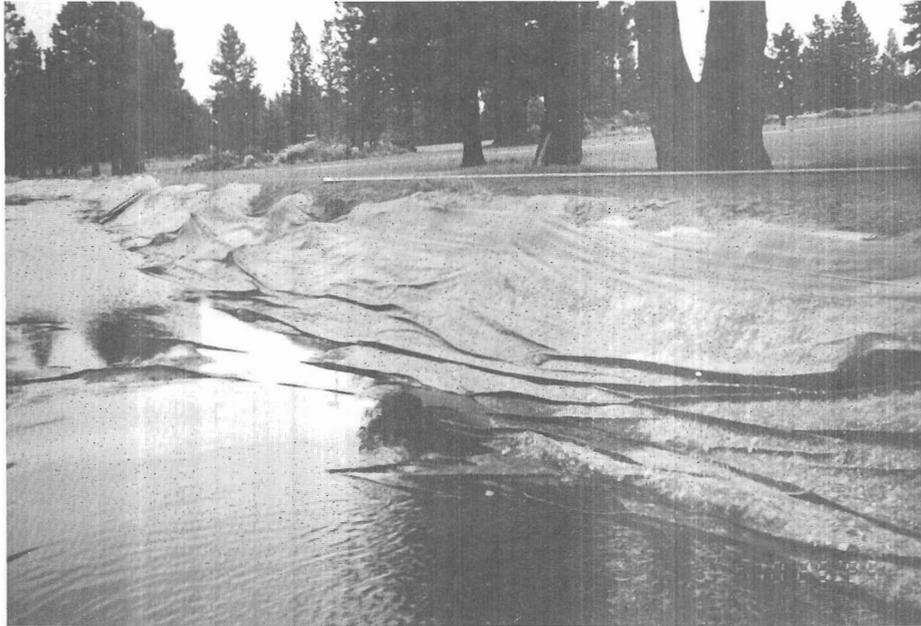
Photograph 57.—Sloughing of the embankment beneath the geomembrane liner (stations 33+00 to 35+50).

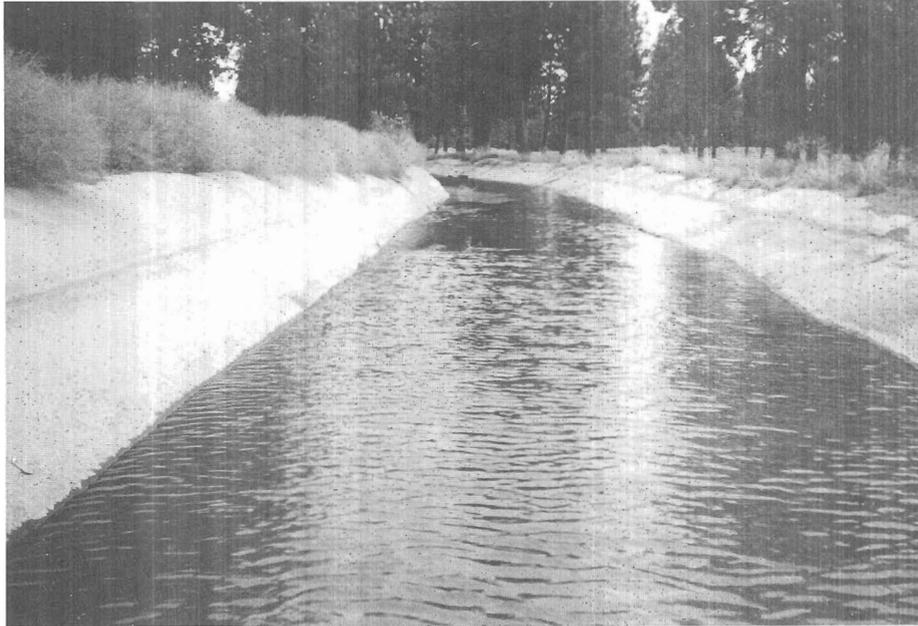
Condition: Very Good - After 4½ years, the exposed Hypalon geomembrane and longitudinal seams are holding up well. Standing water covers most of the invert, typically 6 to 12 inches deep. The majority of the canal has several inches of sediment, with vegetation growing underwater. The upstream transition between Test Sections 5 and 6 (station 35+00) has a transverse adhesive-bonded Hypalon/Hypalon seam which is working well. A concrete cap at this location would facilitate future ponding tests.

Photograph 61.—Canal overview - very good condition after 4½ years of service.

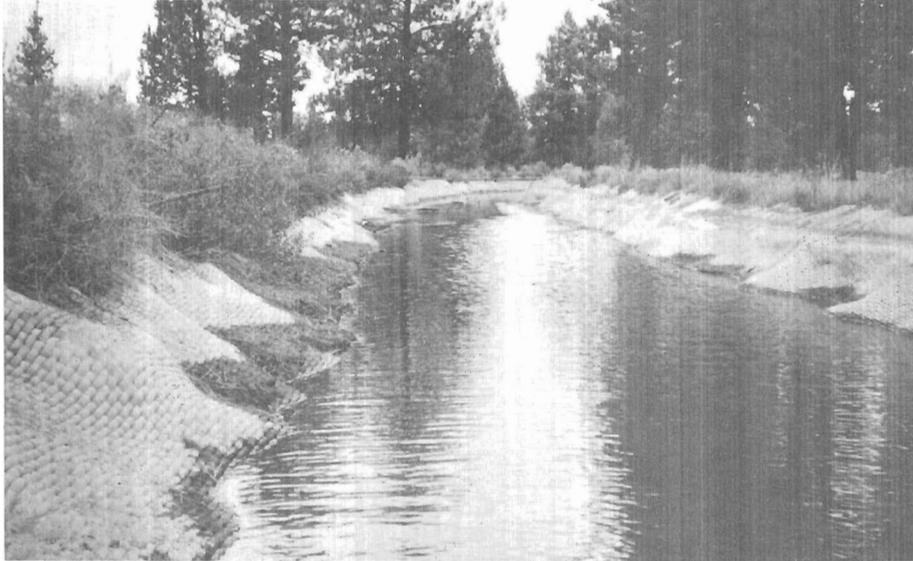
Condition: Excellent - The grout-filled mattress is in excellent condition with only small occasional defects. The grout-filled mattress is completely protecting the underlying PVC geomembrane. After 5 years of service, no freeze/thaw damage has occurred. The mattress is fairly uniformly grouted in spite of the uneven rocky subgrade. A small amount of cement paste (no aggregate) is present in the invert between the concrete "bricks." The first 500 feet of this test section has a great deal of sediment (up to 1 foot deep), underwater vegetation, and 6 to 12 inches of standing water. The second 300 feet has no sediment and no standing water, suggesting higher velocities and slope to drain. The outer fabric of the grout mattress is beginning to deteriorate, especially where subjected to abrasion. Above the waterline, the geotextile is quite weak and tears easily.

Photograph 66.—Canal overview - excellent condition after 5 years of service. The first 500 feet of this test section has a great deal of sediment and standing water.

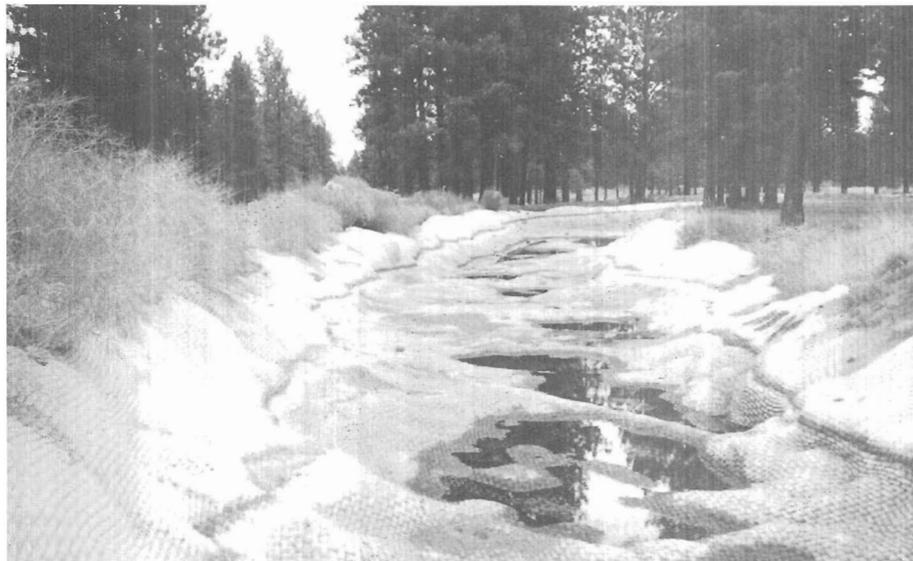
Photograph 67.—The second 300 feet has no sediment or standing water, indicating higher velocities and a steeper slope.

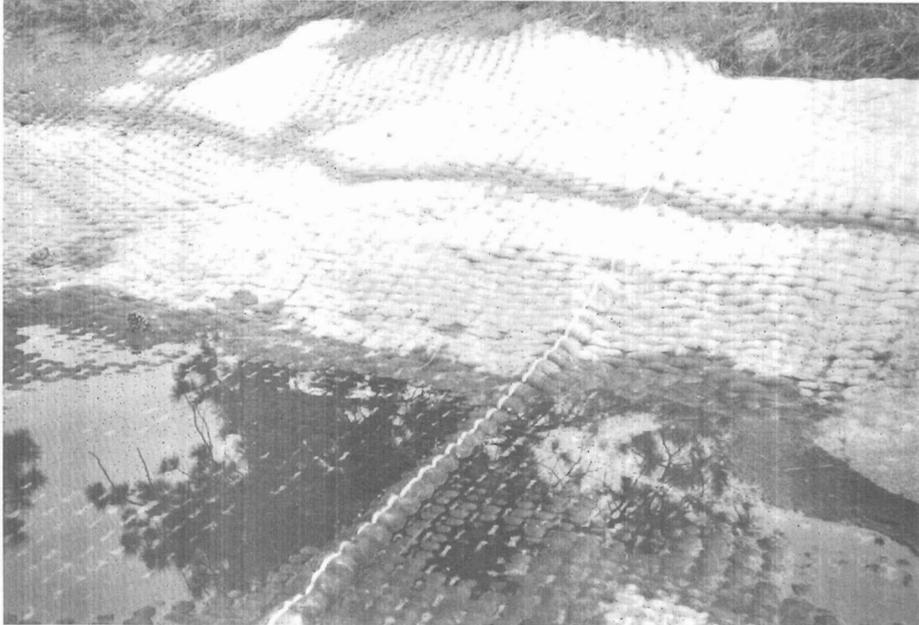
Photograph 68.—Factory installed zippers are performing well and give a tidy finished appearance.

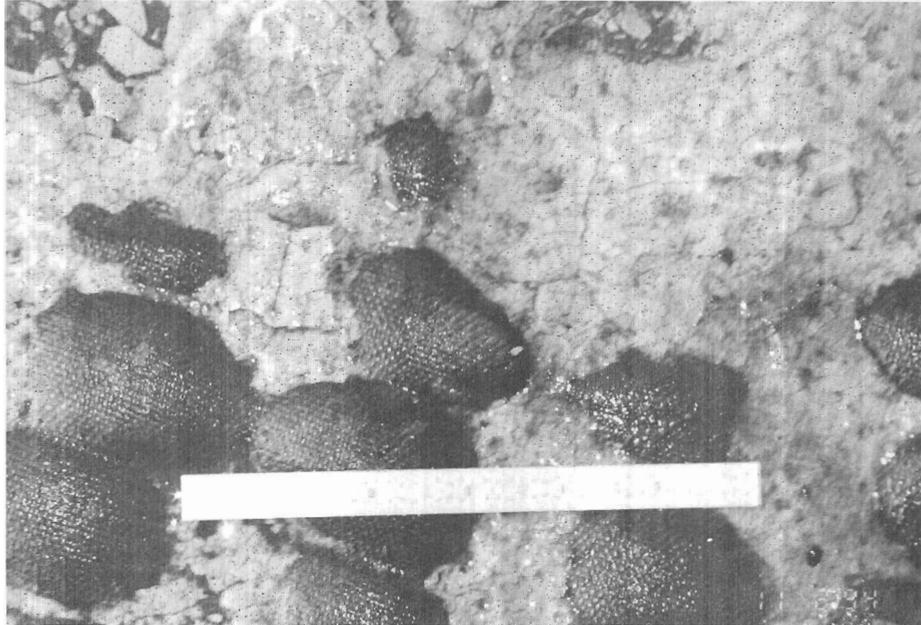
Photograph 72.—Cement paste probably oozed through the outer geotextile during the grouting operation.

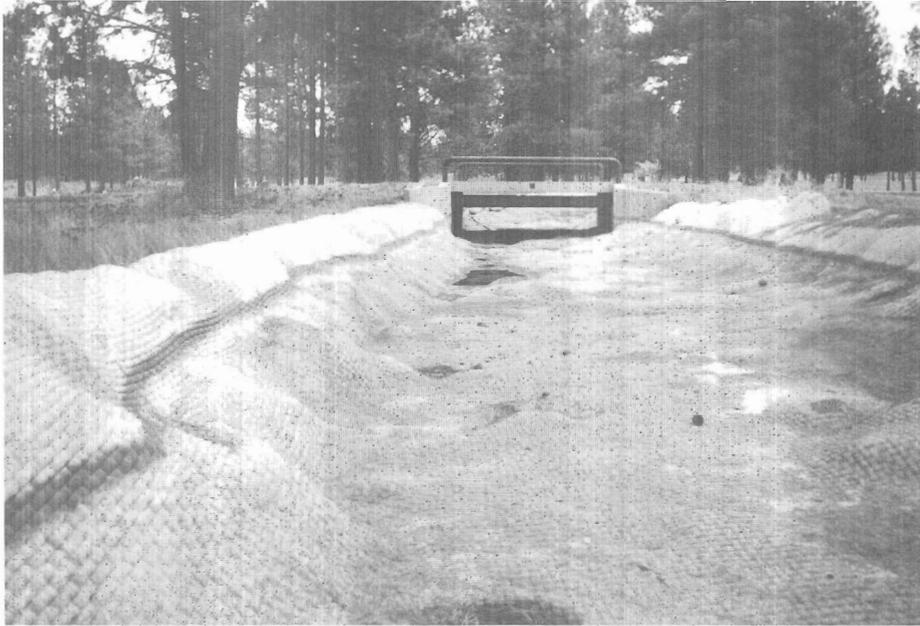
Condition: Excellent - The grout-filled mattress is in excellent condition after 4 to 5 years of service, with no freeze/thaw damage. The first 200 feet with zippered seams has a much neater appearance than the second 500 feet with sewn seams. Both areas are uniformly grouted in spite of the uneven rocky subgrade. A small amount of cement paste is present in the invert between the concrete "bricks." No sediment or standing water is present in the invert suggesting higher velocities and a steeper slope through this test section. The slope visibly increases past the bridge (station 49+50). The grout-filled mattress is well tied-in to the bridge, with no gaps that would allow seepage. The outer fabric of the grout mattress is in good condition, with little deterioration, except for one location (station 54+50 left bank) where the geotextile has worn away, and several concrete "bricks" are missing. A subgrade rock (see photo 77) caused the grout mattress to be very thin at this location.

Photograph 73.—Canal overview - excellent condition after 4 to 5 years of service.

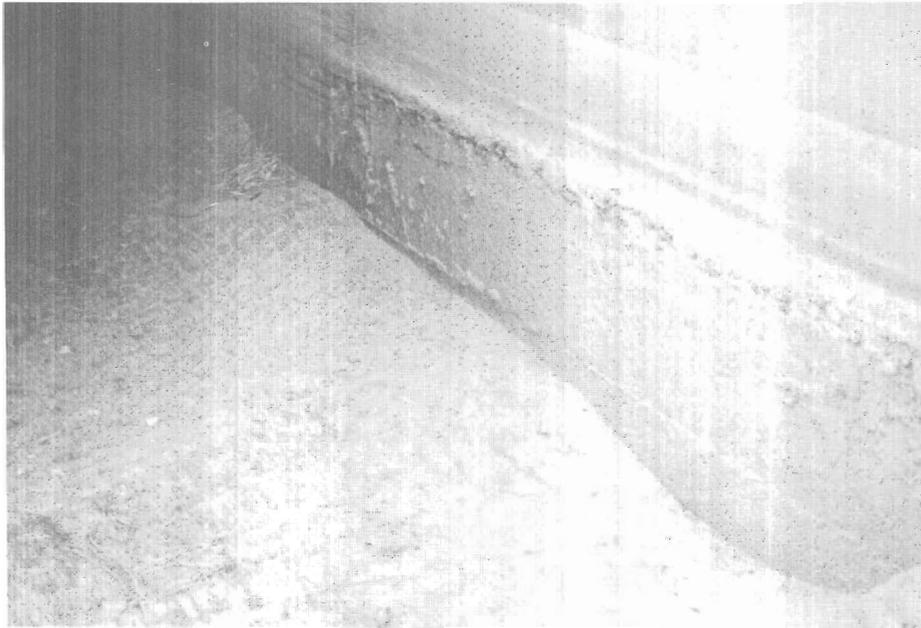
Photograph 74.—The grout-filled mattress is well tied-in under the bridge.

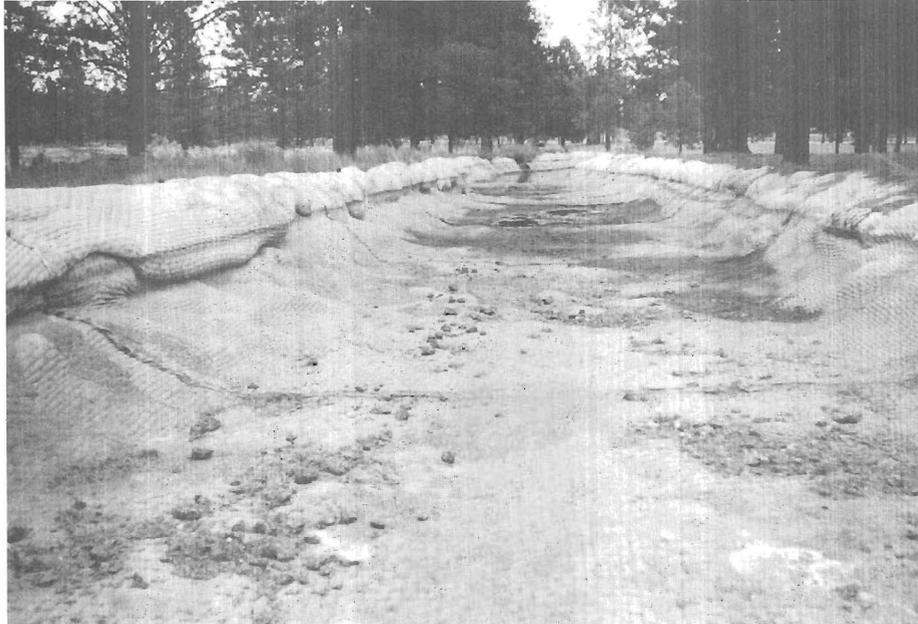
Photograph 75.—Little sediment or standing water in this test section.

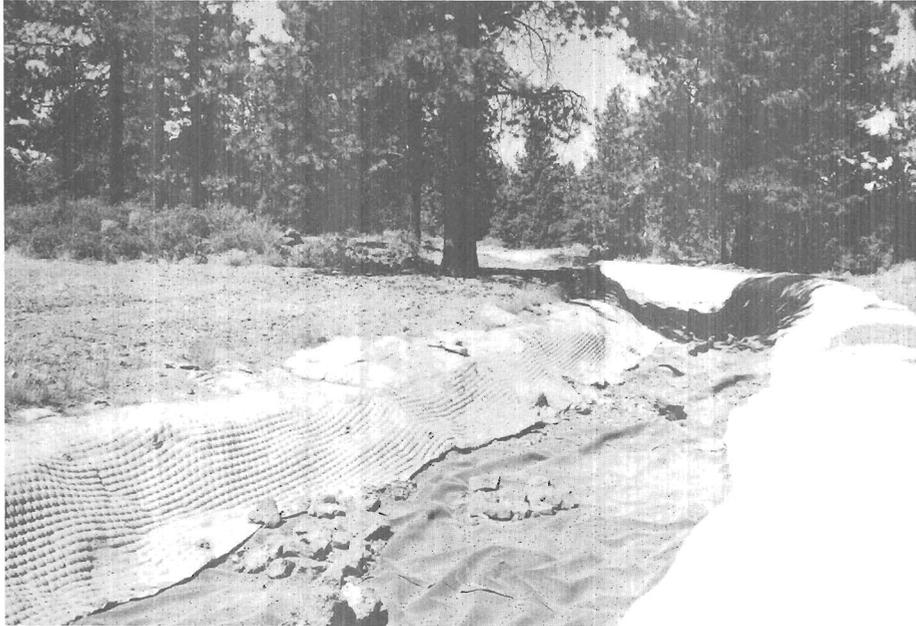
Photograph 79.—In 1993 and 1994, the irrigation district used rocks and concrete parking blocks to ballast the liner "whales" with little success.

Performed: In 1994, Polyflex and Canamer repaired 20 to 30 small tears in test sections A-9 and A-10 (A-9 cost = \$3,000), and the district placed concrete parking blocks and riprap over "whales" (A-9 cost = \$3,000). The district also placed a concrete pad over the transition between Test Sections A-8 and A-9 at station 55+00 (since A-8 already has a concrete lining, full cost for A-9 = \$240). In 1995, the contractor removed all the exposed geomembrane from the invert on test sections A-9 and A-10 (A-9 cost = \$7,500).

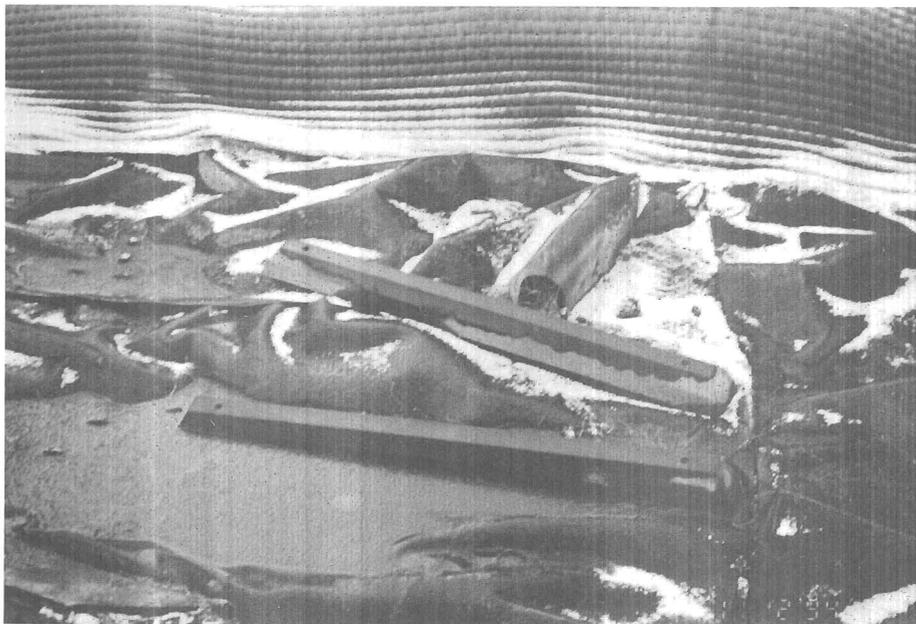
Photograph 80.—Concrete parking blocks used as ballast.

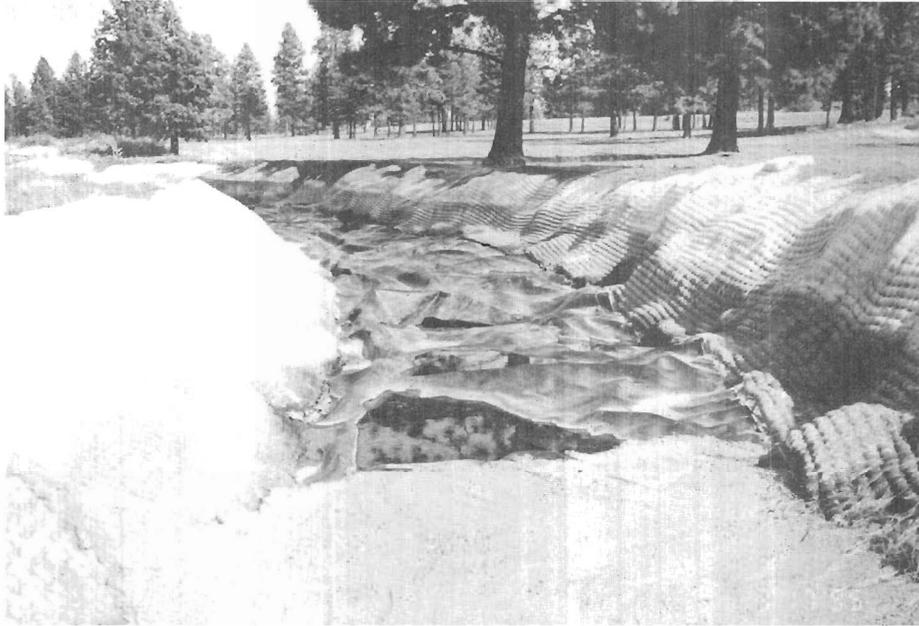
Photograph 81.—Irrigation district installed a concrete patch at upstream transition to test section A-9.

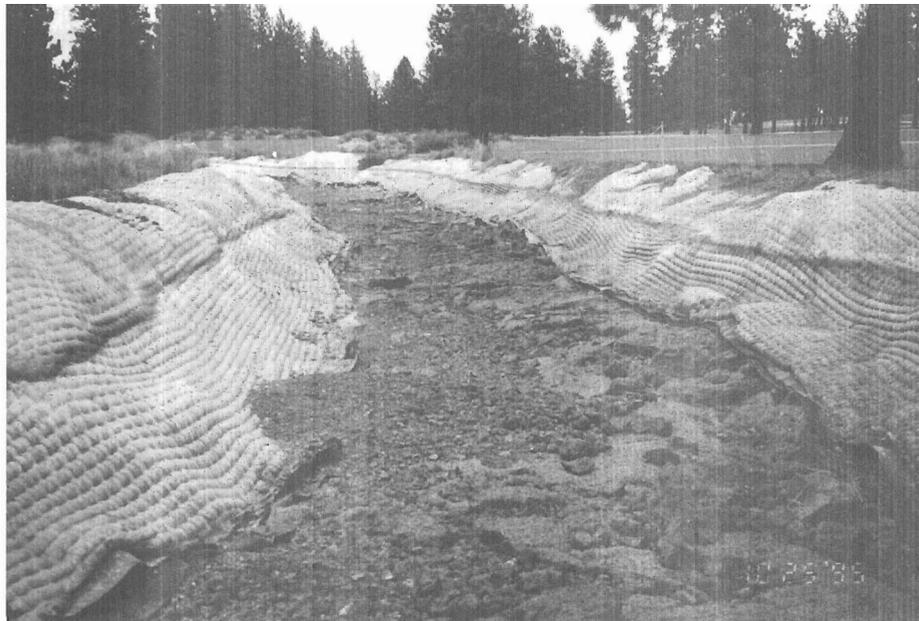
Photograph 88.—Geomembrane liner removed from invert and test section abandoned after 2½ years of service.

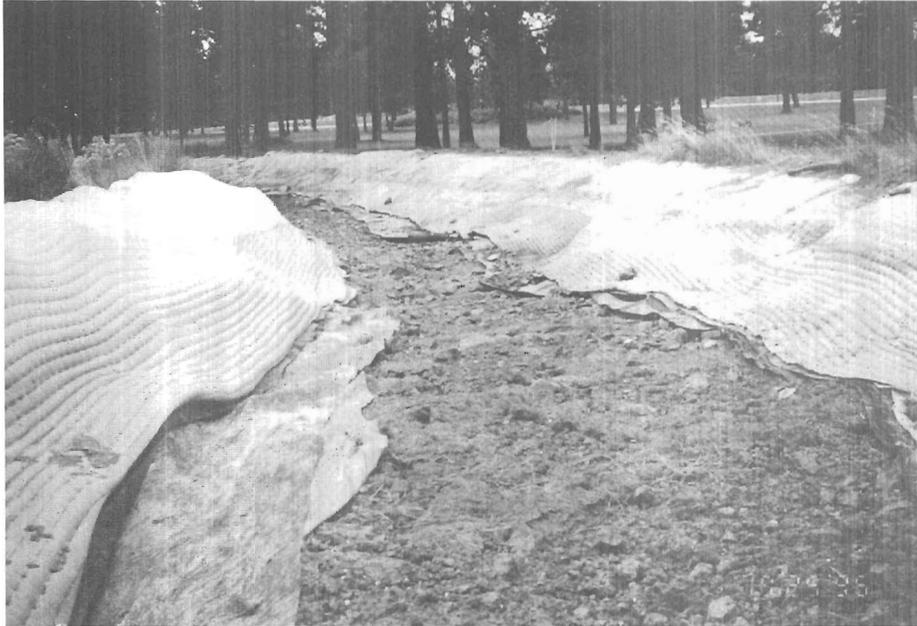
Photograph 91.—Test section removed from study after 2½ years of service. Geomembrane liner in the invert was removed in the Spring of 1995.

Performed: In previous years, the district removed Portland cement deposits from this test section (cost = \$320). In 1994, Polyflex and Canamer repaired 20 to 30 small tears in test sections A-9 and A-10 (A-10 cost = \$3,000), and the district placed concrete parking blocks and riprap over "whales" (A-10 cost = \$3,000). In 1995, the contractor removed all the exposed geomembrane from the invert on test sections A-9 and A-10 (A-10 cost = \$7,500).

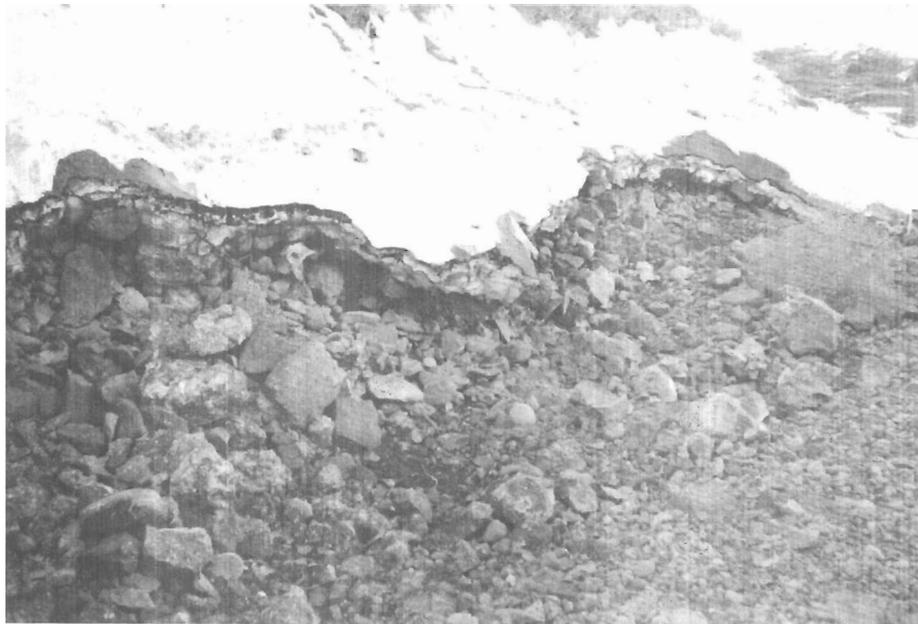
Photograph 96.—Typical subgrade conditions beneath the foam.

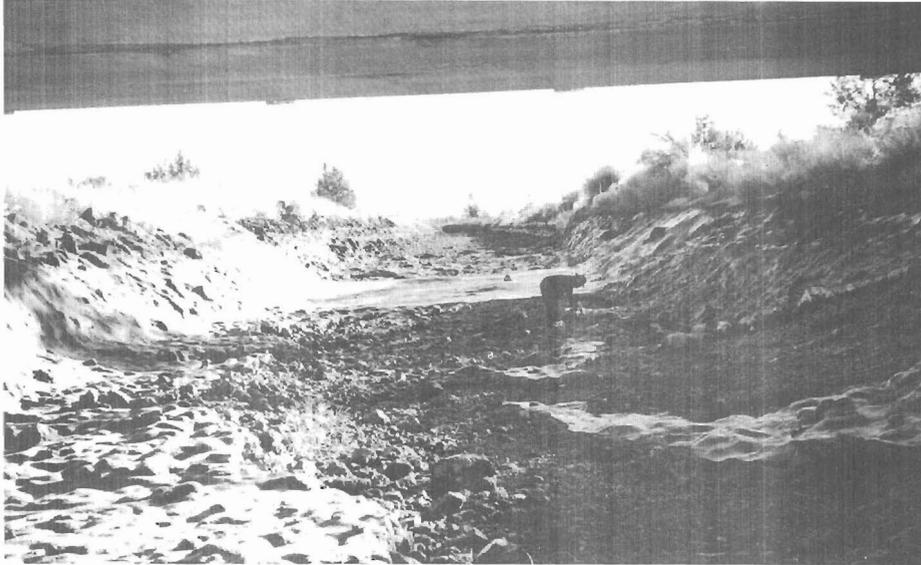
Condition: Partially failed - About half (4,000 ft²) of the invert foam is missing. The foam washout started in an area of loose sand and gravel in Test Section 1 in the first few weeks of service (summer 1993). The foam failure propagated downstream into Test Section 2, stopping where the foam is bonded to a solid concrete slab crossing the canal (buried pipe crossing). A small amount (10 percent) of the remaining invert foam has lost its protective coating. On the sideslopes, very little of the foam has lost its protective coating. Above the waterline, the foam and coating are intact. The coating shows moderate degradation on the south-facing sideslope and only minor degradation on the north-facing sideslope. Overall, the coating is in far better condition than on Test Section 1. Finally, a few cracks have developed in the foam downstream of the concrete apron. These cracks measure up to 8 inches long and extend completely through the foam and coating.

Photograph 99.—Canal overview - poor condition (partially failed) after 4 years of service.

Needed: None - No repairs are planned - extensive repairs to foam and coating are needed, but repaired foam would probably also wash out. Therefore, this test section will only be monitored for additional failures. If repairs were to be performed, the irrigation district would need spray foam equipment, spray foam material, protective coatings, and specialized training.

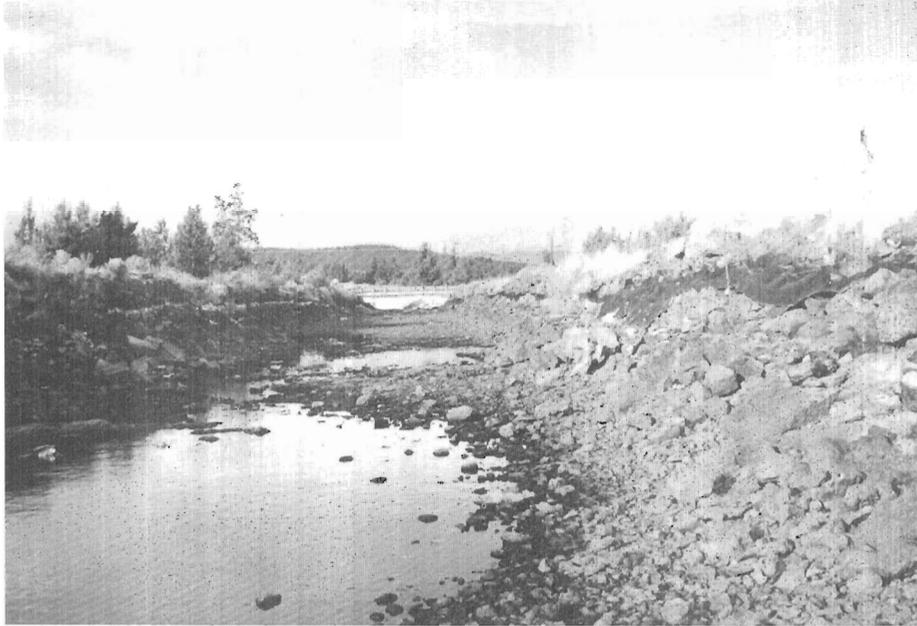
Condition: Complete failure - Sections of the geotextile liners washed out the first time the canal was filled with water (May 1993). The geotextiles tore at the foam anchor trench, and several large sections of geotextile washed downstream, damaging a pipeline crossing. The irrigation district removed all remaining liner in these two test sections. See the "2-Year Durability Report" for further details.

Photograph 103.—The foam anchor trench is all that remains of Test Sections N-3 and N-4.

May 1993 - The irrigation district removed all remaining geotextile liners (cost = \$1,387 each), and repaired the damaged pipeline crossing (cost = \$ 803 per test section)

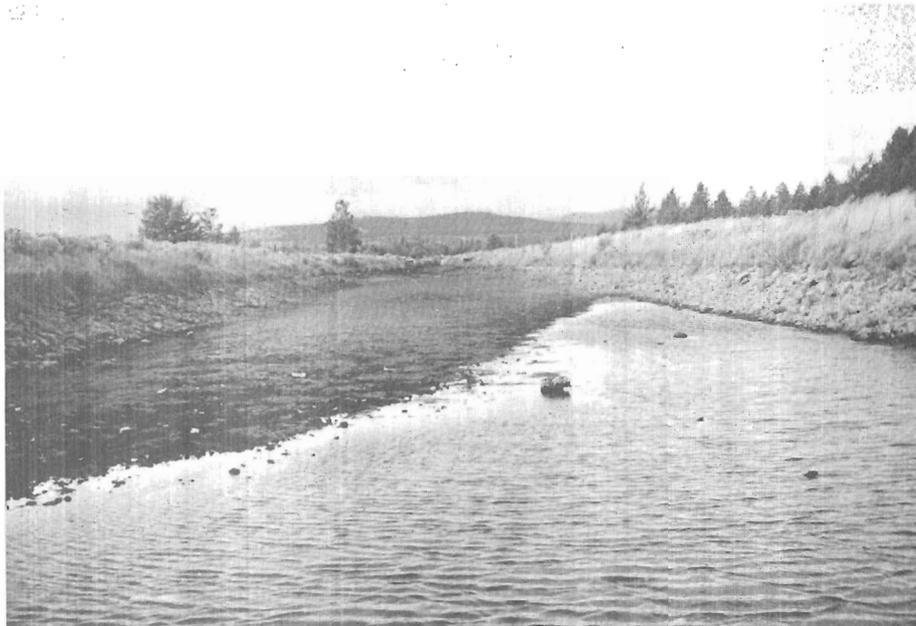
The material for this test section has not yet been determined. Photograph 105 shows the existing subgrade condition with extensive silt deposits in the invert.

Photograph 105.—Future site for Test Section N-5.

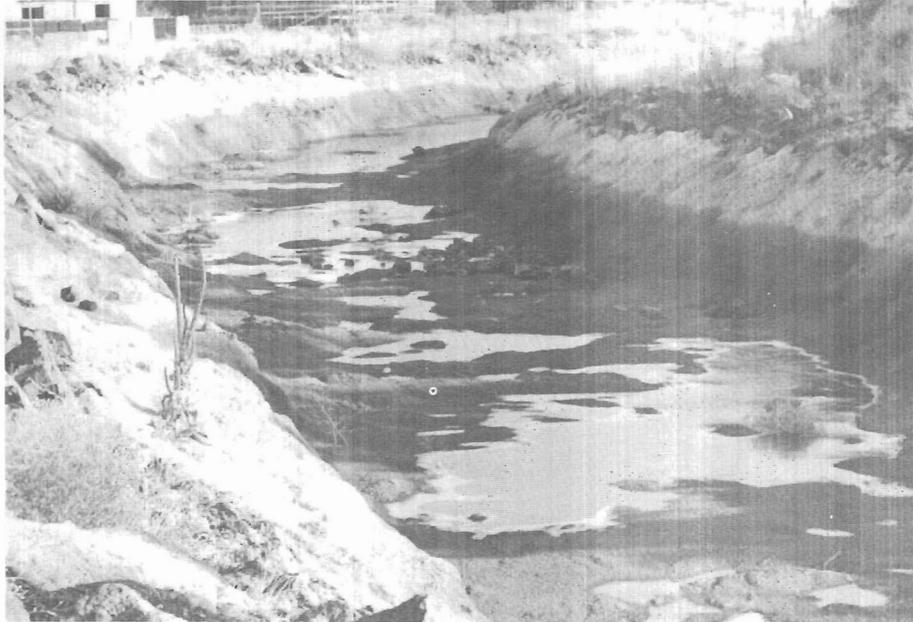
Condition: Excellent - All the shotcrete is in excellent condition. In fact, the district is so pleased with the performance and water savings of these shotcrete test sections that they are contracting to line an additional 12 miles of this canal with roller compacted concrete beginning in 1997.

Photograph 106.—Canal overview - shotcrete test sections are in excellent condition after 4½ years service.

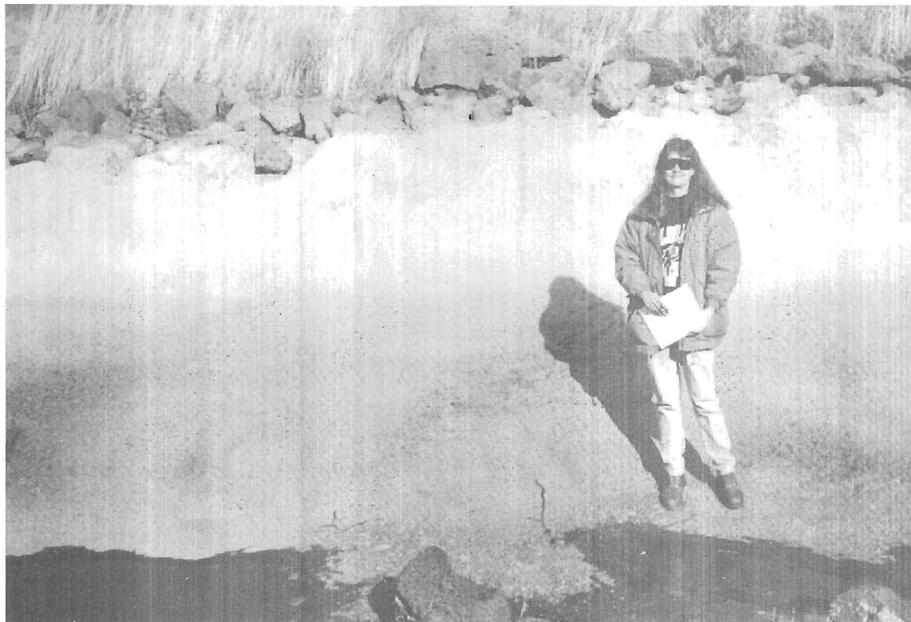
Photograph 107.—Typical transverse contraction crack which starts on the sideslope and then disappears somewhere in the invert.
