**DESCHUTES—CANAL-LINING
DEMONSTRATION PROJECT
YEAR 5 DURABILITY REPORT**

Upper Deschutes River Basin Water Conservation Program

January 1997

**U.S. DEPARTMENT OF THE INTERIOR
Bureau of Reclamation**

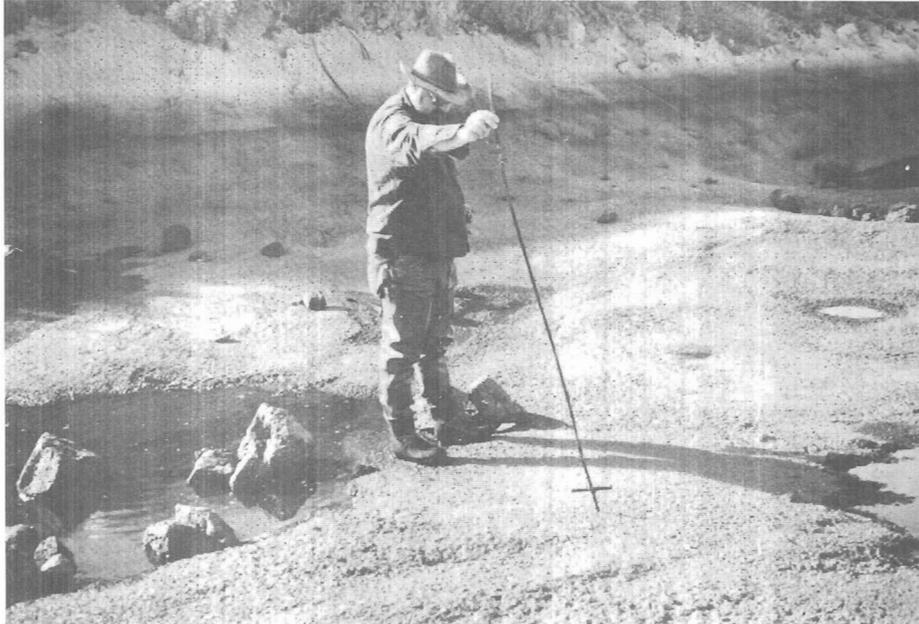
Photograph 112.—Installation contractor's thickness probe for assuring 3-inch shotcrete thickness.

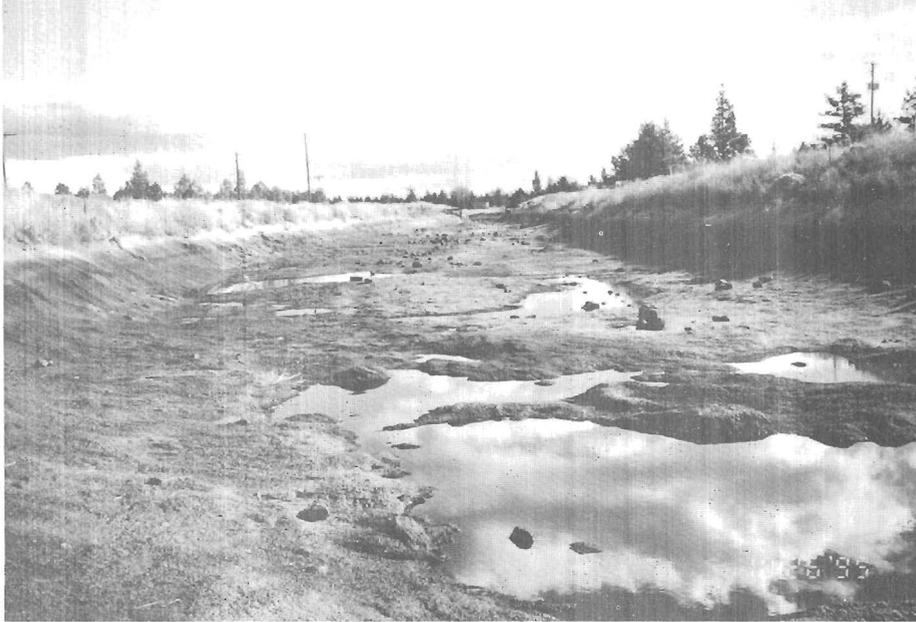
Condition: Excellent - Shotcrete performing well after 4½ years of service. This test section has some cracking, voids, exposed subgrade rocks, and vegetation typical of all the shotcrete test sections.

Photograph 116.—Canal overview - excellent condition after 4½ years of service.

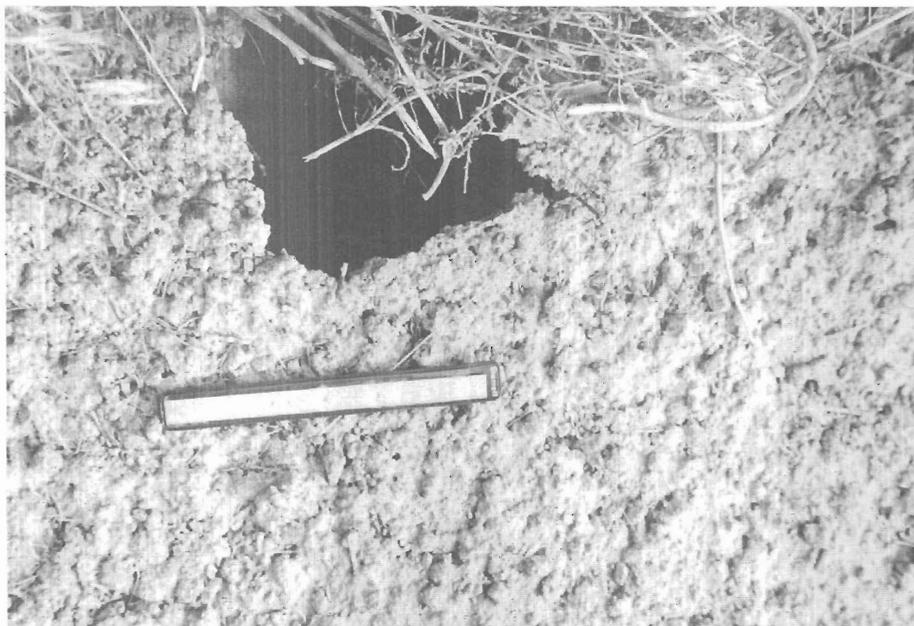
Photograph 121.—Possible animal burrow behind shotcrete at top of side slope.

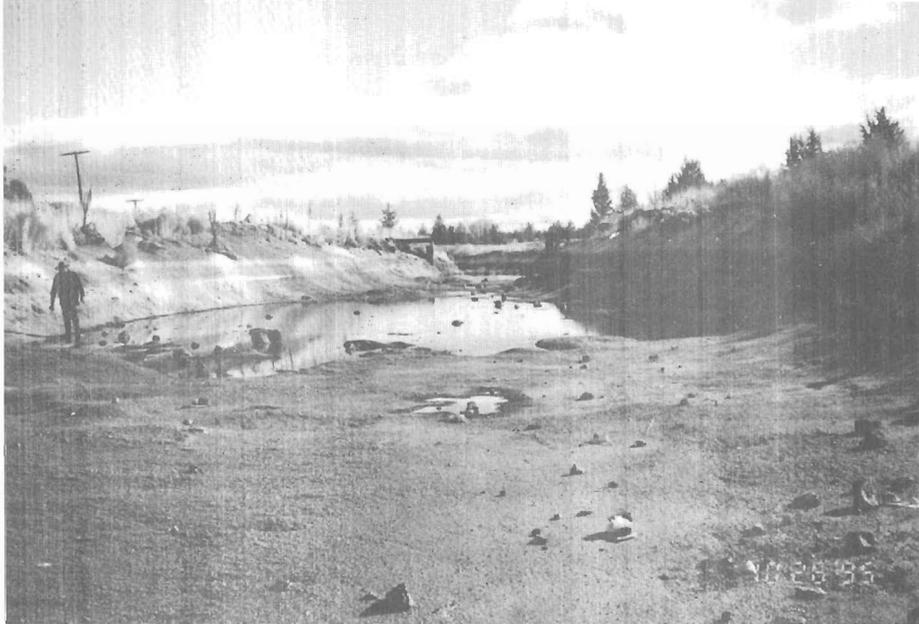
Condition: Excellent - Shotcrete performing well after 4½ years of service. This test section has some cracking, voids, exposed subgrade rocks, and vegetation typical of all the shotcrete test sections.

Photograph 122.—Canal overview - Excellent condition after 4½ years of service.

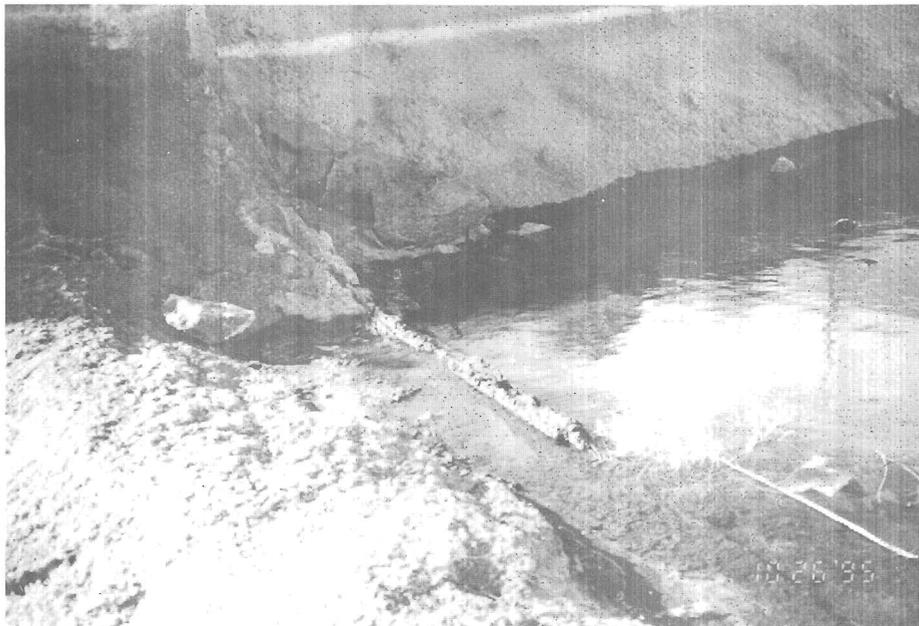
Photograph 125.—Remains of dike at drop structure from the 1994 ponding test.

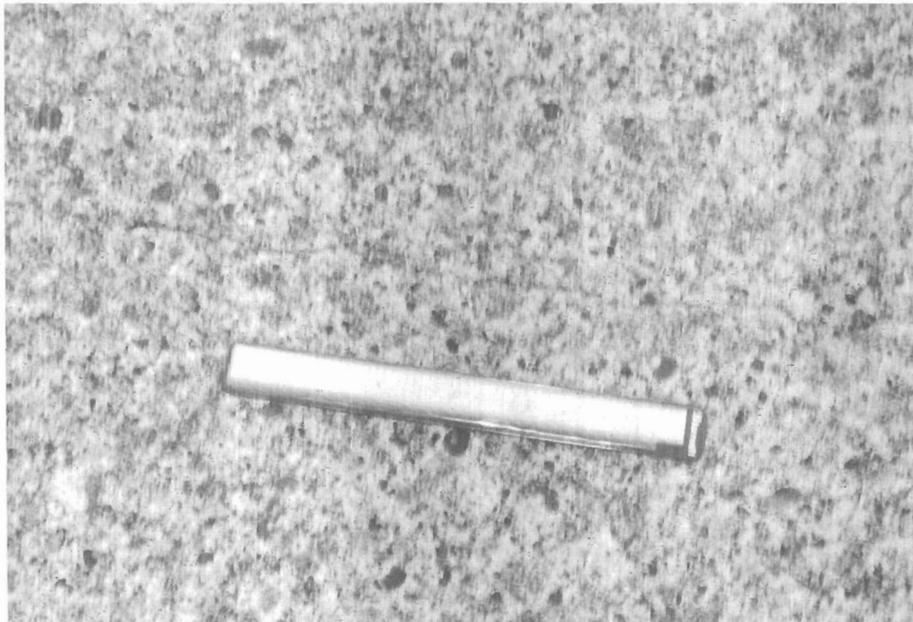
Photograph 127.—Close-up of invert crack.

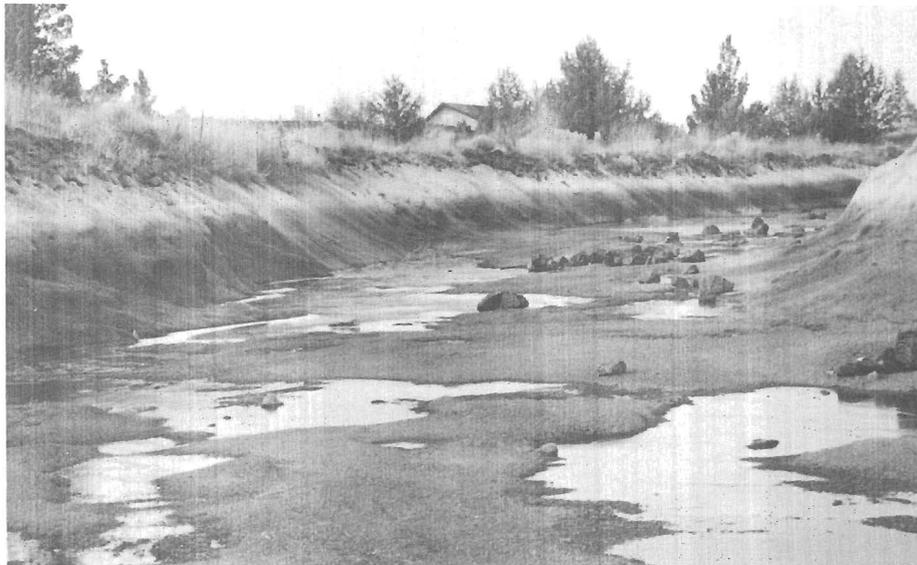
Condition: Excellent - The shotcrete is performing well after 4½ years of service. This test section has some cracking, voids, exposed subgrade rocks, and vegetation typical of all the shotcrete test sections. Cracking appears to be slightly more prevalent than in Test Sections N-6 and N-7.

Photograph 128.—Canal overview - excellent condition after 4½ years of service.

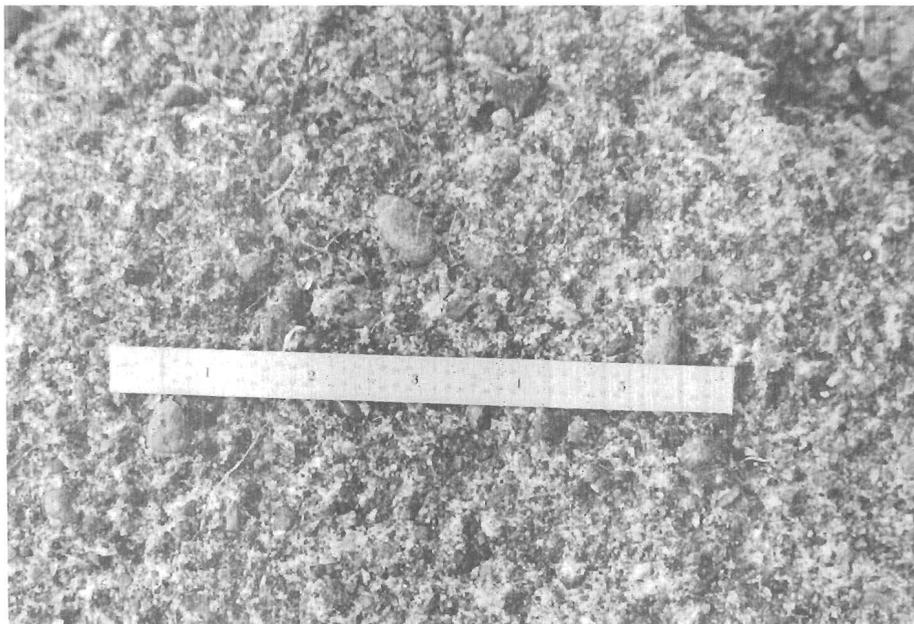
Photograph 129.—Polyfibers are visible on the surface of the shotcrete.

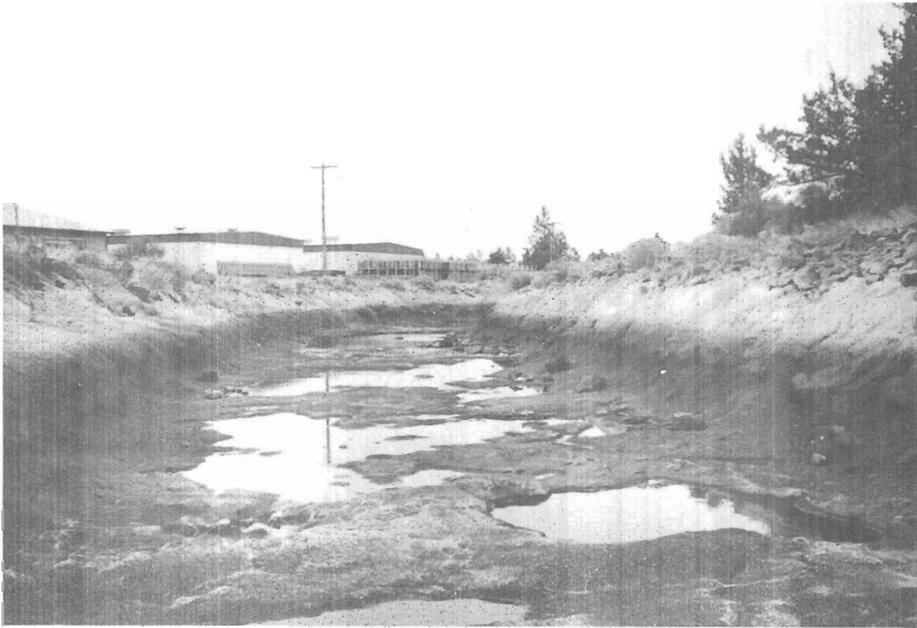
Condition: Excellent - Shotcrete performing well after 4½ years of service

Photograph 134.—Canal overview - excellent condition after 4½ years of service.

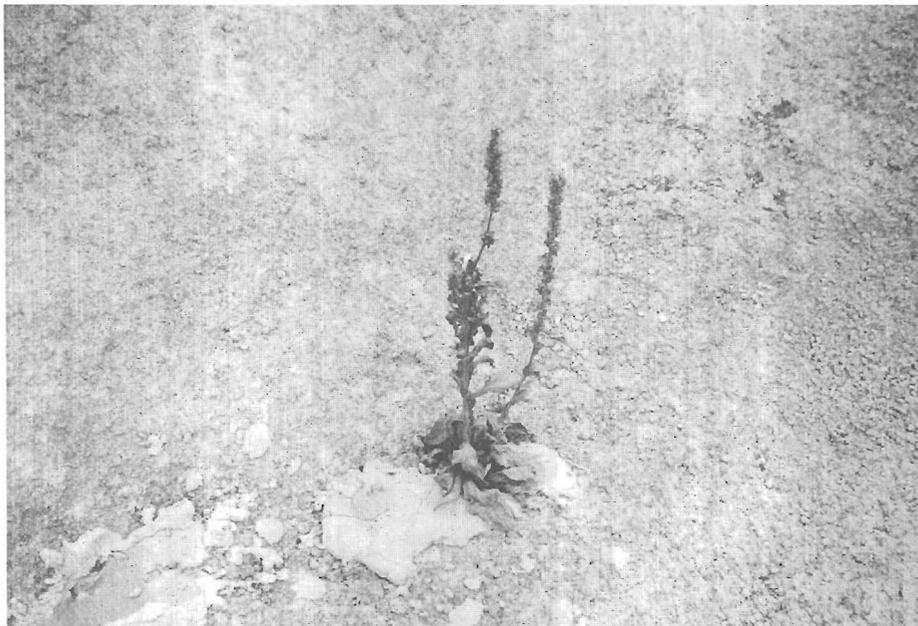
Photograph 139.—The district patched a couple of small holes at this location, but vegetation still finds a toe hold.

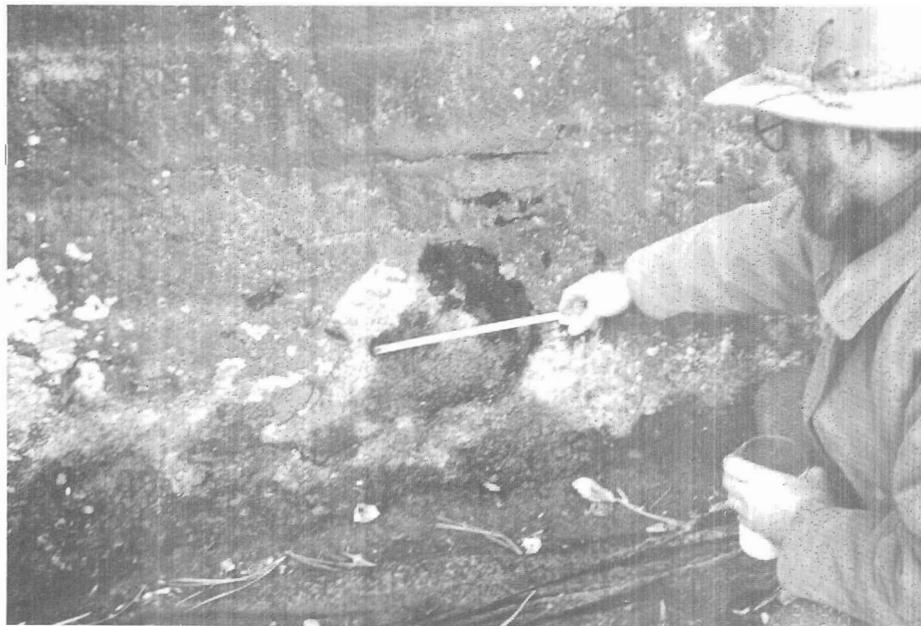
Photograph 143.—Small disbonded blister on left side wall
measures about 12 inches in diameter.

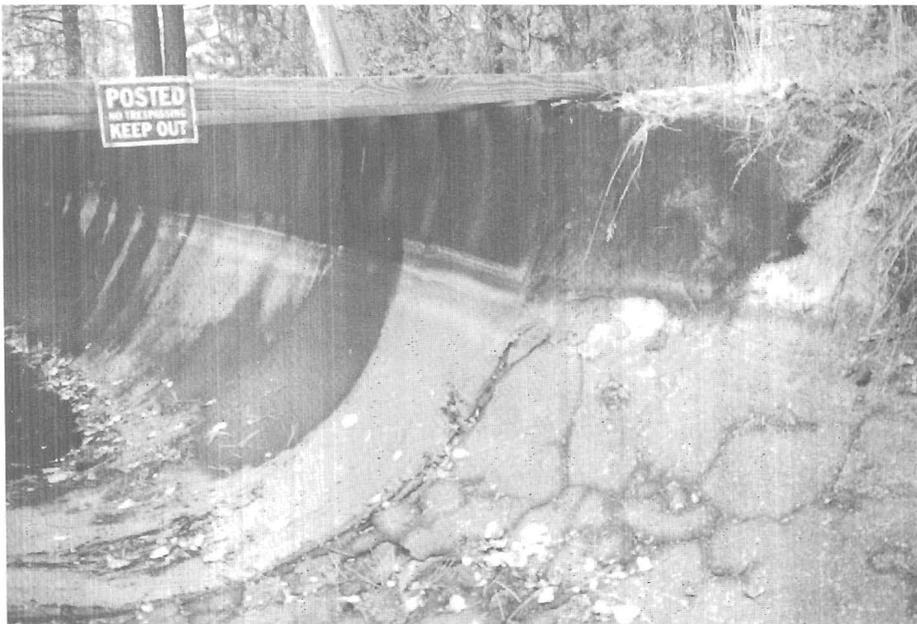
Photograph 149.—Liquid Boot has completely washed away from the upstream and downstream transitions

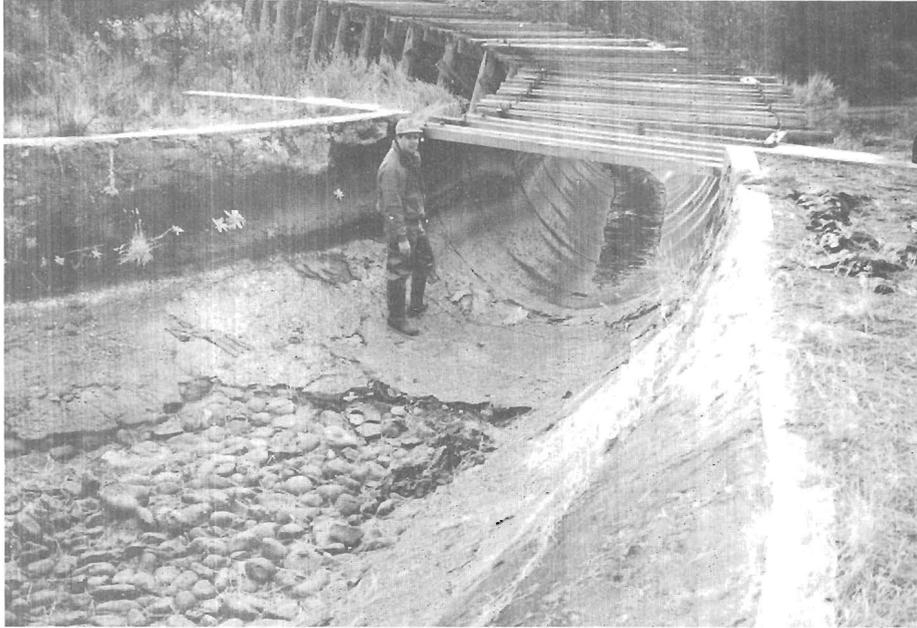
| Condition: | <p>Very Good - The Liquid Boot is well bonded to 99 percent of the steel flume. No leakage is evident. After being drained for 3 to 4 weeks, 3 inches of standing water is still in much of the flume. Several blisters (about 40) have developed in the Liquid Boot, directly over the old tar material in the seams between the flume's 3-foot-wide steel panels. All of the blisters are in the bottom of the invert, except for a couple, which are 1 to 2 feet up the side. The blisters typically measure 4 inches across, with the largest measuring 6 inches across by 24 inches long. All of the blisters are full of sand and sediment. Apparently the Liquid Boot is poorly bonded to the old tar material, and the Liquid Boot deforms and blisters under the force of the flowing water. Once a small hole develops in the blister, the flowing water deposits sand and debris, causing the blister to grow in size. The water released from the Liquid Boot emulsion during construction probably contributed to the poor bond in the invert. Also, the blisters are more prevalent in the upstream, shaded end of the flume. During construction, the cooler temperatures in the shaded areas might have retarded cure, and weakened the bond. No cut off trench or geotextile was used on this test section.</p> <p>Based on the experience gained from the construction of this test section, the Liquid Boot manufacturer (LBI) made several modifications to the construction process. A light tack coat of the "A" component improves the bond of the Liquid Boot. Also, bond in the invert can be improved by coating the side walls first, then coating the invert after the water released from the Liquid Boot on the side walls has evaporated.</p> |

Photograph 150.—Flume overview - very good condition after 1½ years of service.

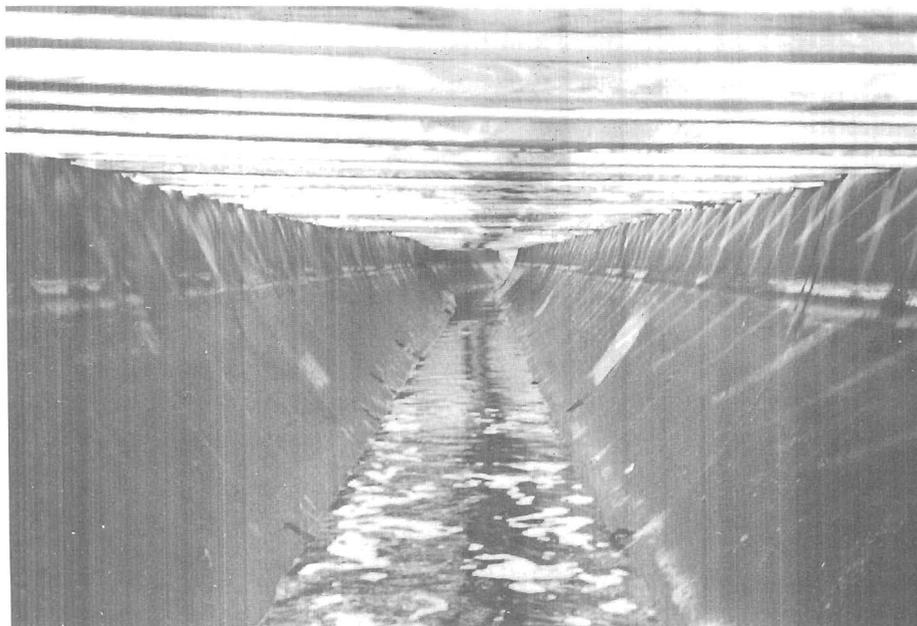
Photograph 151.—Flume interior - very good condition after 1½ years of service.

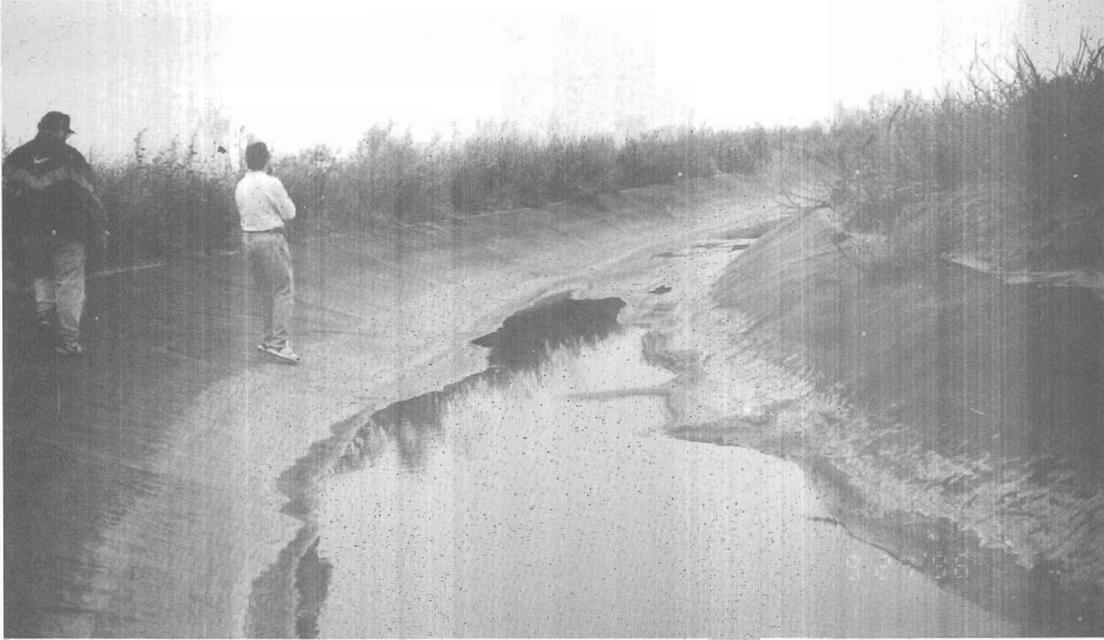
| Condition: | <p>Very Good - After 2½ years of service (3 irrigation seasons), the Teranap is in very good condition. The Teranap shows some surface alligator cracking, but is still quite flexible. The seams are well bonded, and small areas of standing water indicate that the seepage rate is essentially zero (less than 0.1 feet/day). Little to no sediment has collected in this reach of canal.</p> <p>In September 1996, a large storm deposited about 4½ inches of rain in 1 hour. Surface runoff from the area north and west of the test section flows into a small drainage ditch that crosses the canal siphon at the upstream end of the test section. The surface runoff exceeded the capacity of the drainage ditch and flooded into the canal. The runoff washed away the berm cover and anchor stakes on the west canal bank, ran under the liner, and washed-out about 300 feet of the Teranap on the west bank. The Teranap tore in several places (mostly along seams) and was deposited in the canal invert. The irrigation district reshaped the exposed subgrade and used a backhoe to pull the Teranap back into position. The district then resecured the liner with stakes (rebar) driven through the liner, and repaired the tears with a propane torch and additional Teranap where needed. The district plans to raise the berm to prevent future washouts, and is cleaning and enlarging the drainage ditch to increase capacity.</p> |

Photograph 154.—Canal overview - very good condition after 2½ years of service.

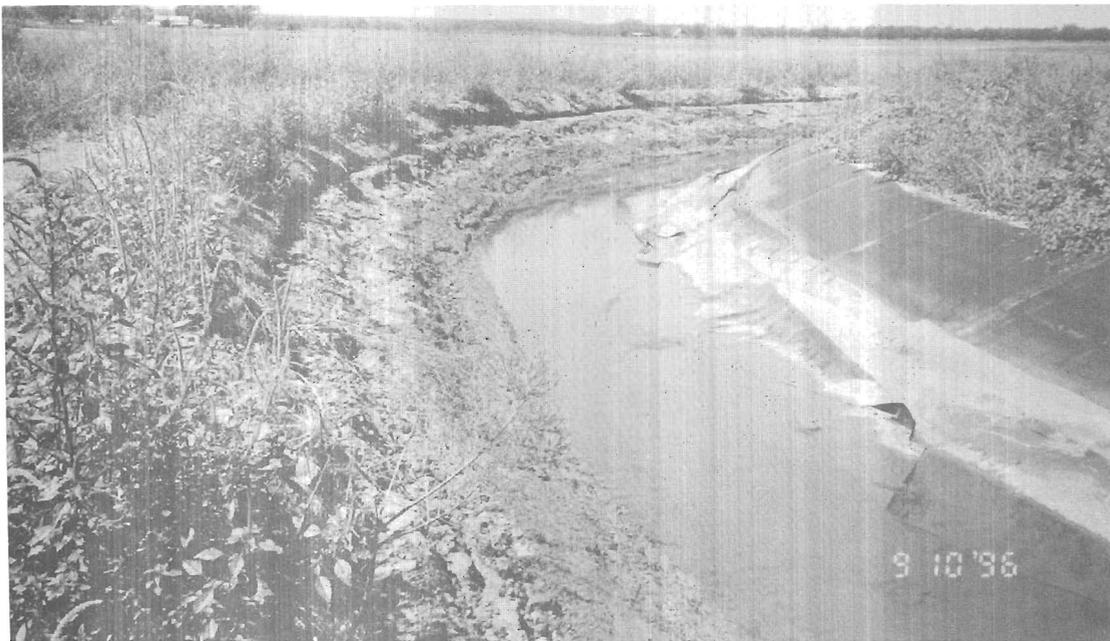
Photograph 157.—Wash-out extends around the first bend.

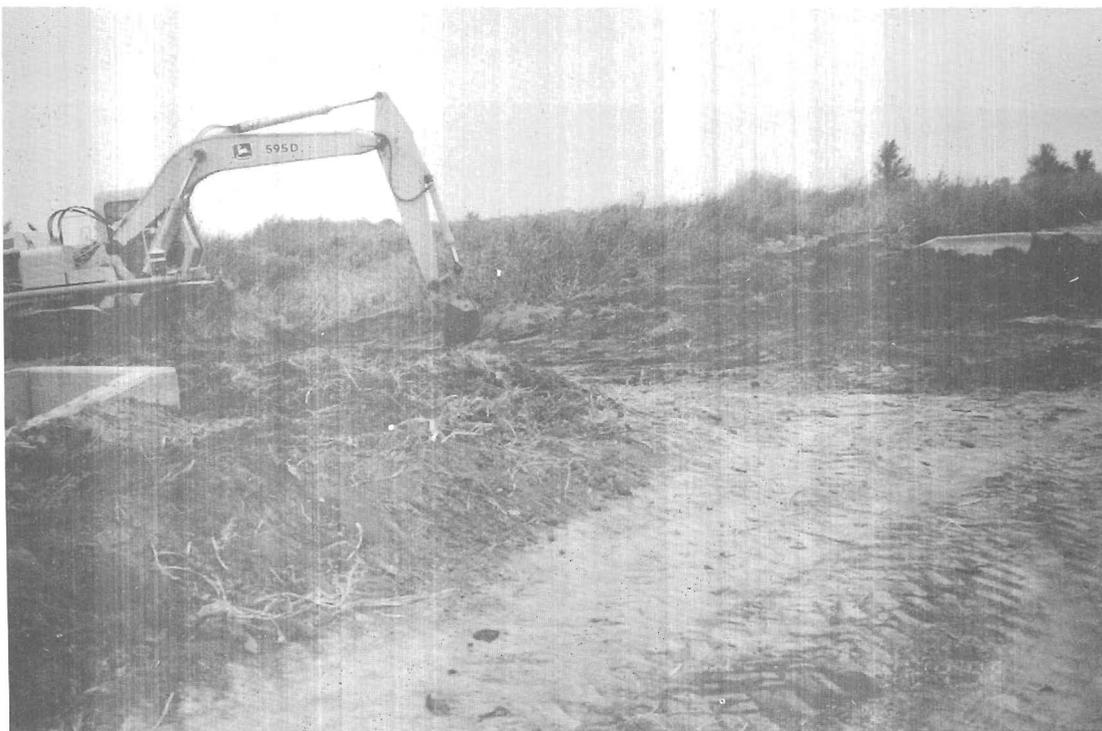
Photograph 165.—District is cleaning out and increasing capacity of drainage channel that crossed canal at upstream siphon.

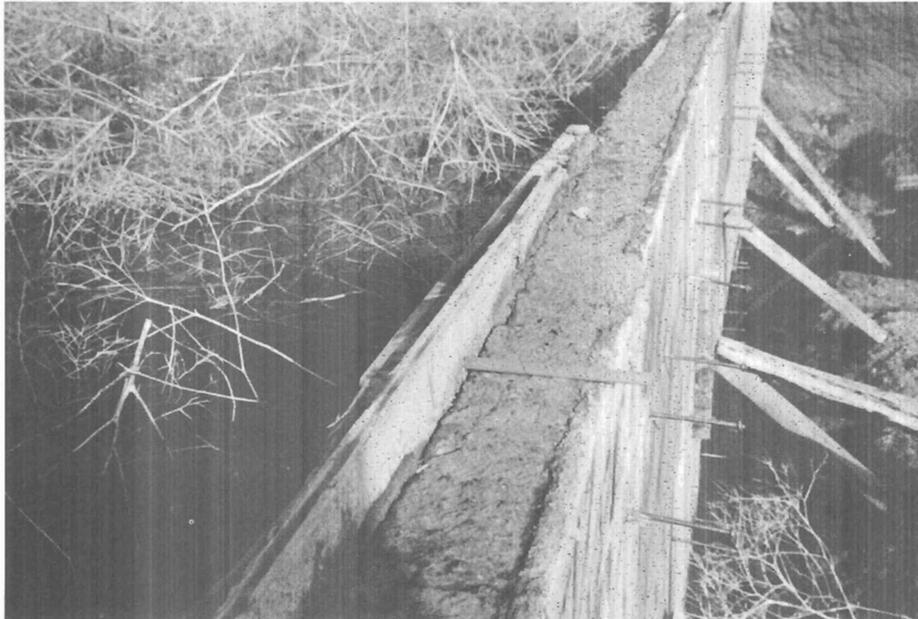
Photograph 167.—Concrete dike is 4 inches thick.

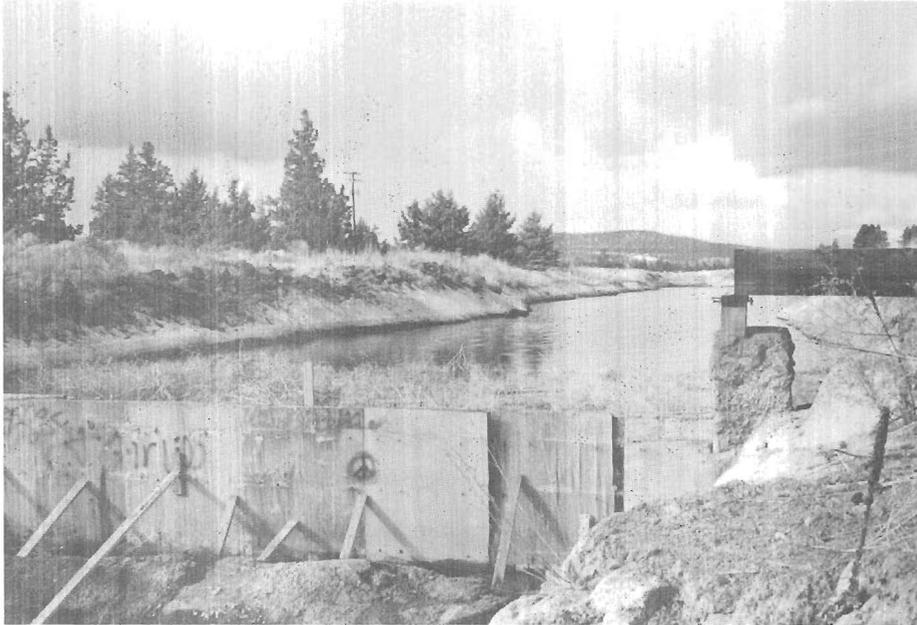
Photograph 168.—Ponded water behind dike.
